# Furnace Malfunction & Forensic Engineering Wiring Reconstruction

By John Certuse, P.E. (NAFE 708F)

## Abstract

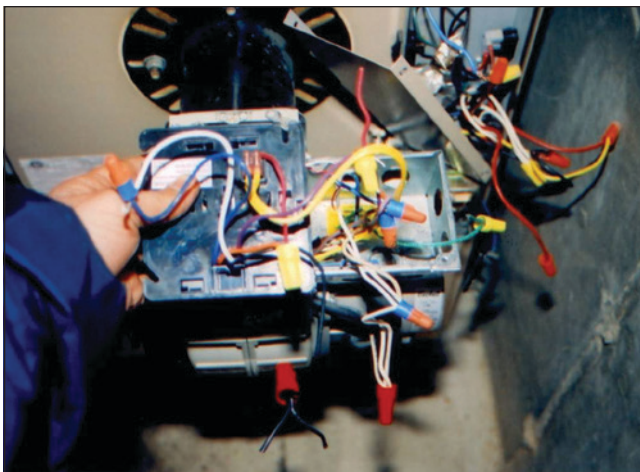
**Figure 8**  
Furnace wiring.

Fire investigators determined that the furnace wiring had not been preserved after the fire as shown in **Figure 8**. Portions of it were disposed of during the removal and replacement of the fire-damaged appliance.

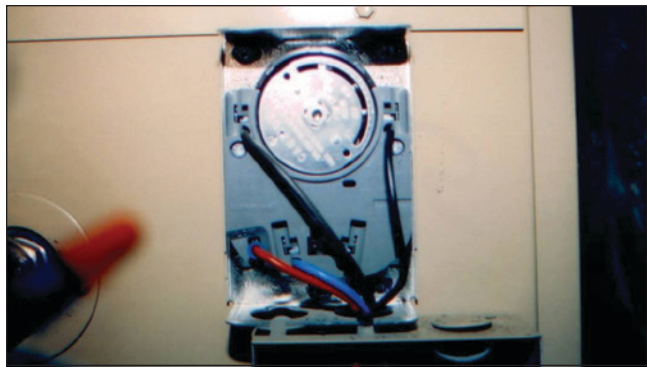
**Figure 9**

Several furnace components were damaged as a result of the fire, including the circulating fan and high temperature control (as seen in **Figure 9**). As a result, pre-fire operability of the furnace could not be determined.

Fan limit and high temperature control into the furnace.

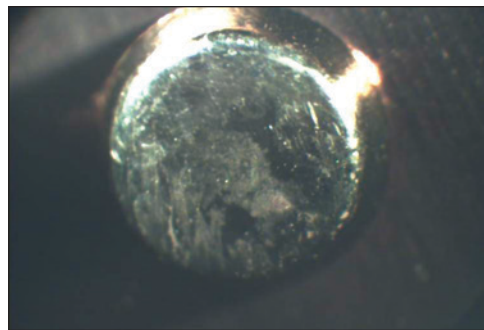
**Figure 10**

Upon examining the contacts, as viewed in **Figure 10**, there was no evidence of any past electrical activity. Accordingly, it did not appear that the high limit control was wired into the control circuit that would have shut the oil burner down in the event of a high temperature.

High limit control shows no electrical activity.

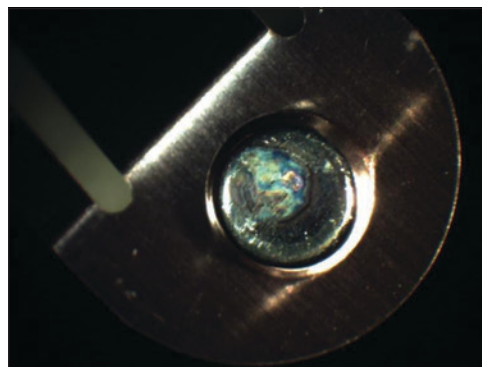
**Figure 11**

Testing of an identical "exemplar" control showed that a visible arc overheating of the high temperature control contact was seen after only one cycle of operation. This testing validated the hypothesis that the high limit control was never properly wired into the circuit of the furnace.

Arcing found on contact of high limit switch that was properly wired into circuit. Compare to contact shown in Figure 10.

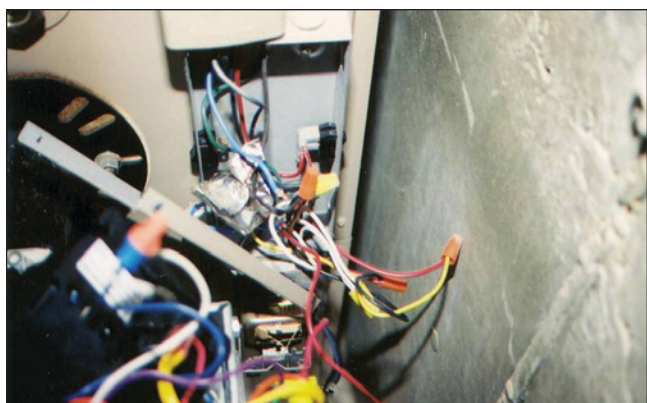
**Figure 12**

With the hypothesis apparently confirmed, the next challenge was to determine whether the high limit control was indeed not wired into the circuit, and (if possible) to identify the party responsible for the error in wiring — be that the installer or the manufacturer. The furnace wiring is depicted in **Figure 12**.

Furnace wiring.

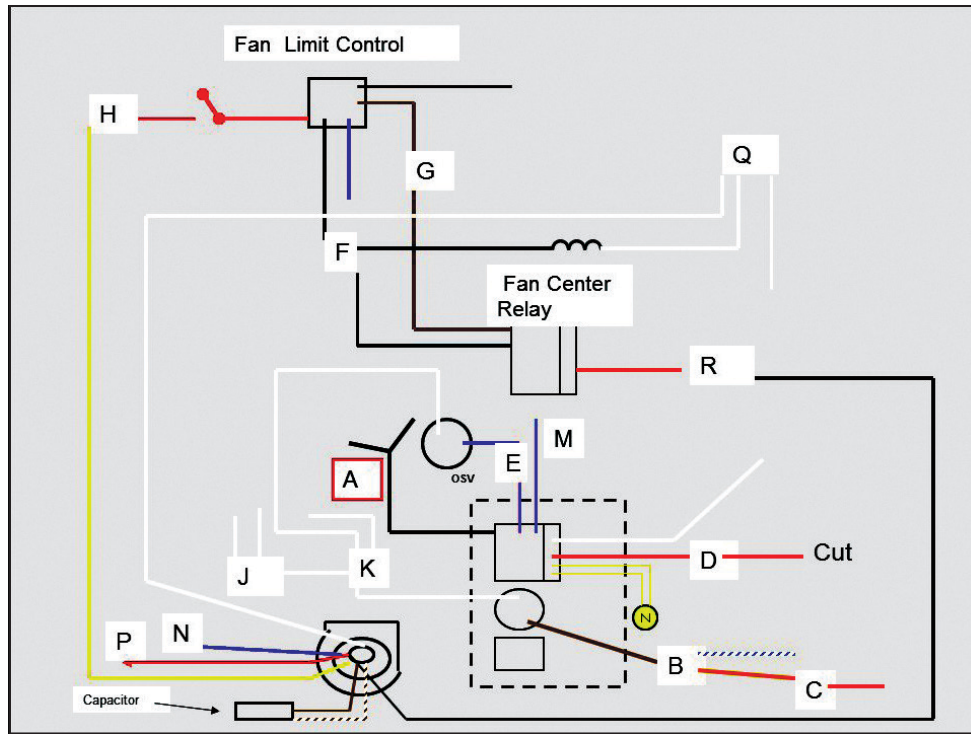
**Figure 13**

Although the furnace had much of its wiring detached and removed when it was detached from the system ductwork and electrical service by the initial contractors, a detailed "as-built" wiring circuit diagram of the existing wires was created (via inspection) and is shown in **Figure 13**.

As-built wiring of disassembled furnace.

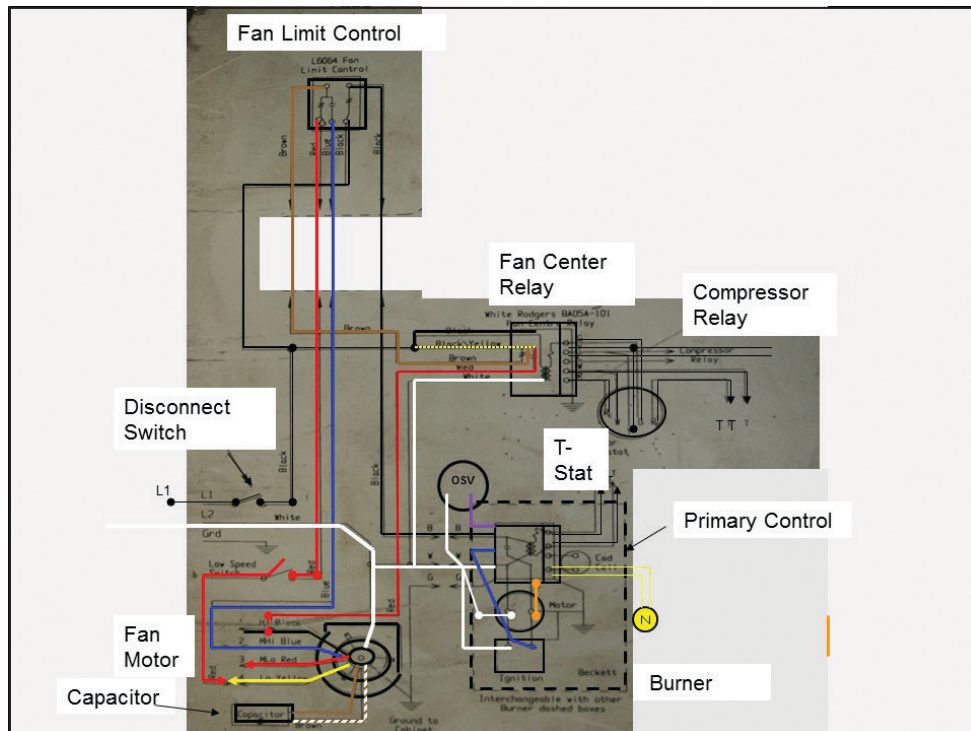
**Figure 14**

Colored wire lines superimposed over manufacturer's wiring diagram for both furnace and primary high limit control.

Where the as-built wiring drawing was the same as the manufacturer's wiring diagram, the as-built wiring circuits were superimposed onto the manufacturer's wiring diagram, as shown in **Figure 14**.

By comparing the as-built wiring on the manufacturer's wiring diagram, deviations between the two could be identified.

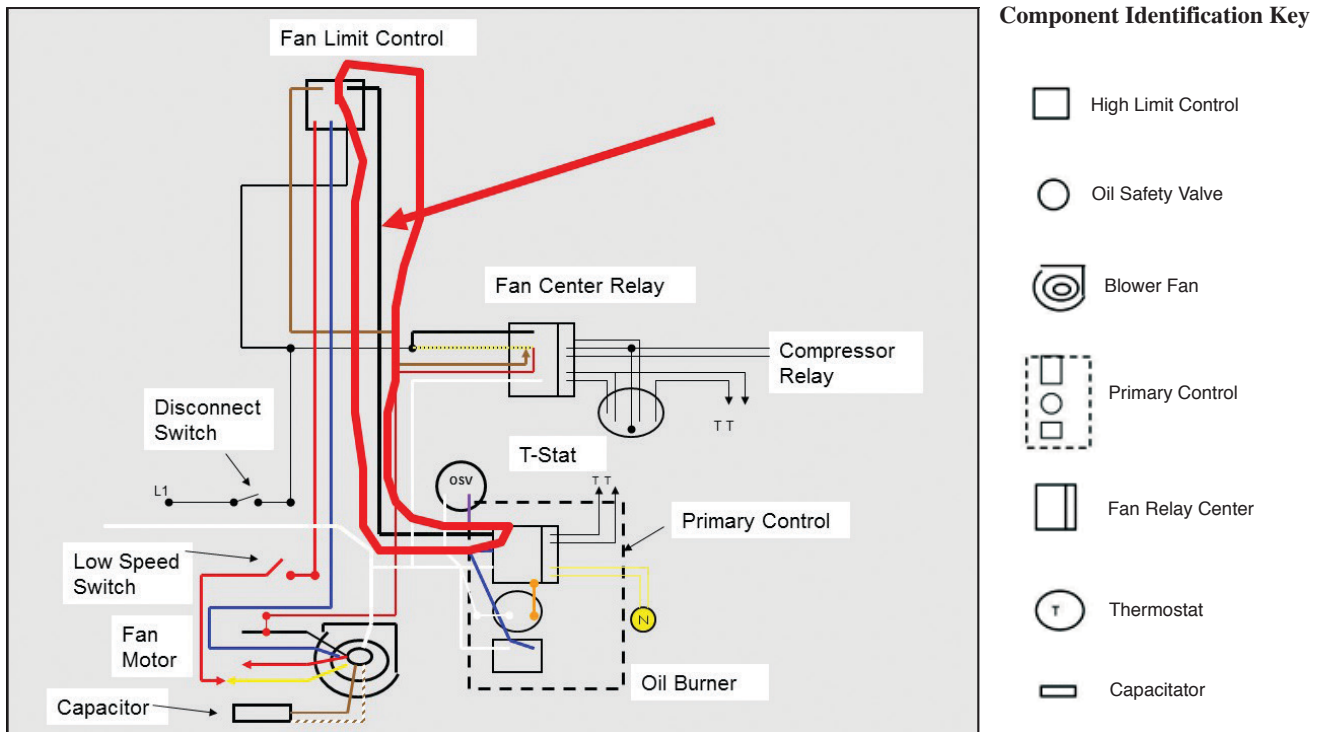
After the as-built wiring diagram and the manufacturer's wiring diagram were compared, the investigation identified that there was a parallel circuit from the building's power connection leading into the oil burner that bypassed the high limit control (shown in **Figure 15**).

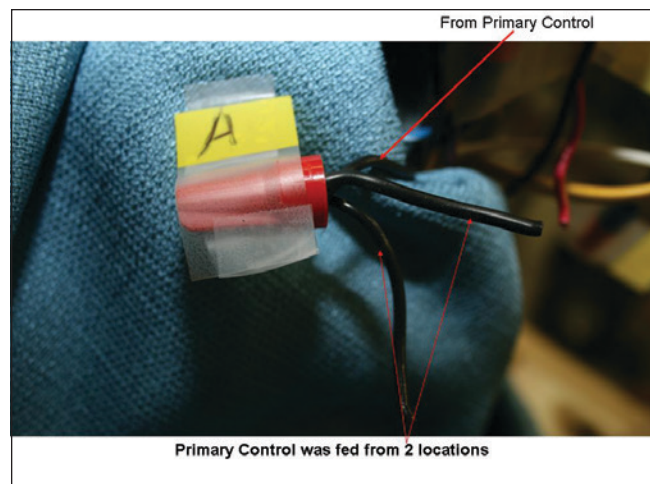
With this wiring configuration, the furnace burner could be energized upon a call for heat from the thermostat, regardless of the temperature being generated by the burner without the safety feature of the high limit controller. The extra power supply wire is shown in **Figure 16**.

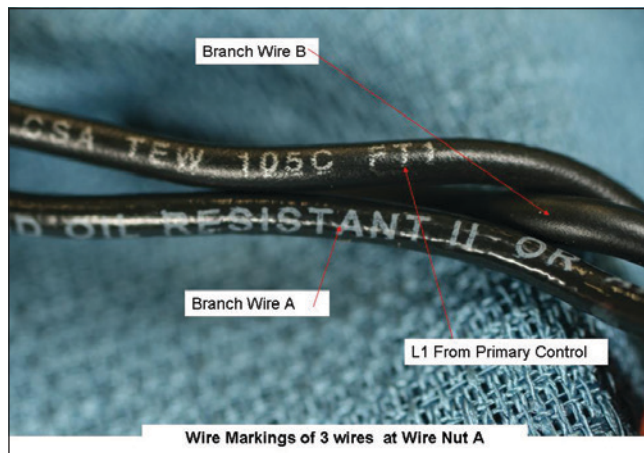
During examination of the identified wire that was a deviation from the manufacturer's wiring (**Figure 17**), the following wire characteristics were identified:

**Figure 17**  
Wire markings of three wires at wire nut A.

Appears that coated wires are NOT manufacturers Wiring...
