Forensic Engineering Investigation and Analysis of a Tower Crane Collapse

By Bransford Pickett, MScBa, P.E. (NAFE 795M)

Abstract

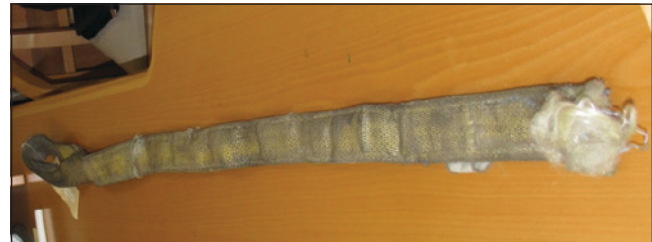
Figure 5

- a. Sling color was uniform, consistent with normal usage, wear, and tear.
- b. The sling surface was dirty, consistent with a construction environment, such as the incident site where the sling was retrieved.

- c. The sling showed two key distinct areas of damage.
 - i. One sling eye was missing. The sling eye was completely severed at stitched location of the three-ply load-bearing splice.

Ex_Lift sling section retrieved after crane incident.

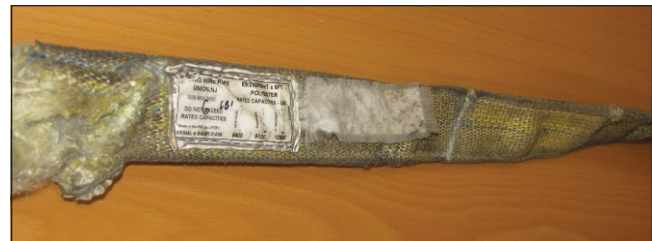
Figure 6

Label of the sling is intact, and information is readable.

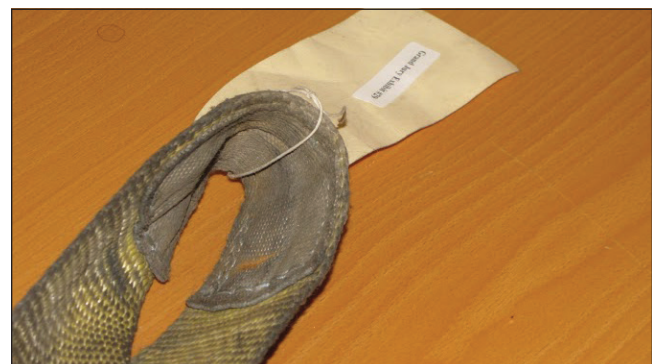
Figure 7

The intact eye of sling showing wear pad and color consistent with other photos.

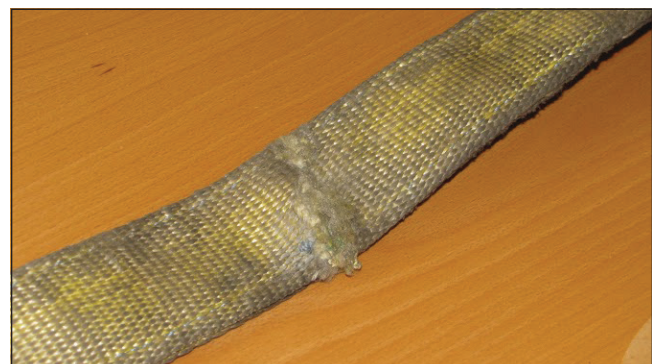
Figure 8

- ii. There were contact abrasion lines on the face of the sling diagonal to the sling's longitudinal axis.
- d. When the eye of the sling at the stitching was opened up and inspected, the color was consistent with the rest of the sling. A bleached sling typically shows drastic color and texture contrast between the body of the sling and the location where ply of the eyes are sewn together. None was observed.

Abrasion contact mark on the sling face.

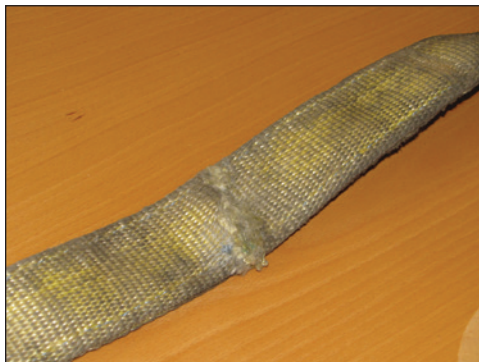
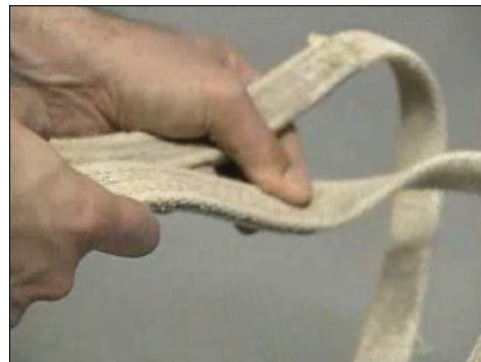
Figure 10

Shows a side-by-side comparison of Ex_Lift sling on the left and bleached UV-degraded sling on the right.

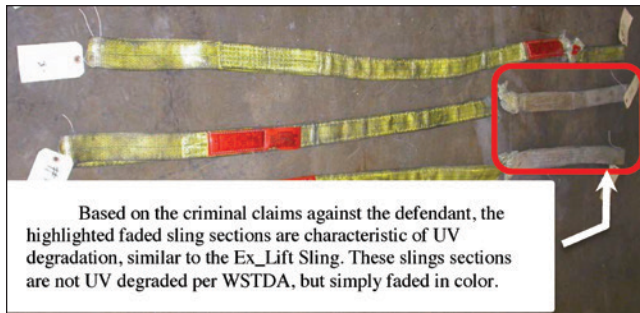
Figure 11

The highlighted faded sections should be regarded as UV-degraded based on the report's criteria. Color fading was used to evaluate the Ex_Lift.

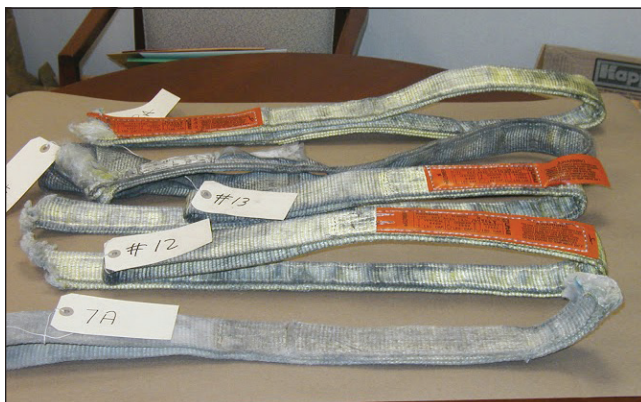
Figure 13

The faded color of the All_Lift slings, 7A, #12, and #13 shown above did not experience the texture change of stiffness and brittleness that typically accompanies UV degradation.

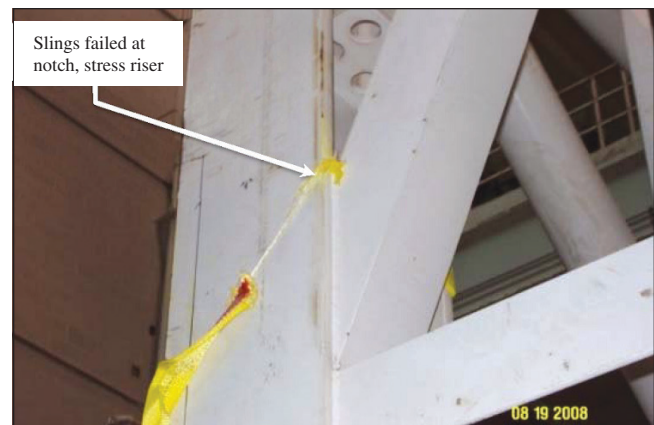
Figure 21
Typical sling pulled to failure. The slings failed at the stress riser, as expected.

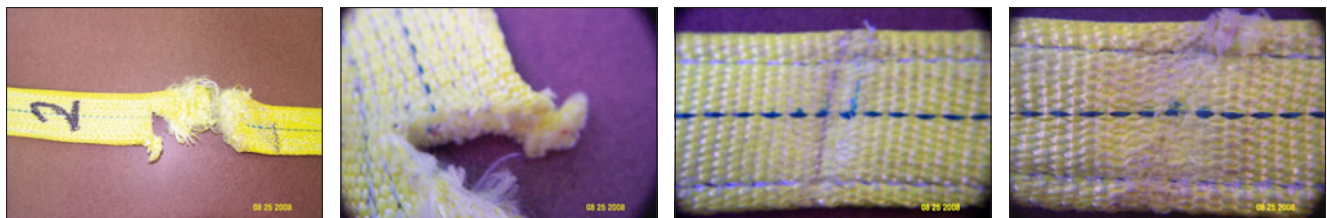
Figure 24

Pictures of sling tests 2 and 4 are presented in **Figure 24** and **Figure 25**, respectively. In each case, the failed surfaces show distress from contact with the crane tower leg and the notch. The abraded and sheared surfaces are consistent with the mechanical failures of the slings retrieved at the incident site. However, neither of the tested slings shows any melted fibers consistent with the slings retrieved at the incident site. The lack of melted fibers across all tested slings suggests that the regulatory agency-sponsored test did not capture the sling's failure process at the time of the incident.

Pictures of the sheared or abraded surfaces of All_Lift Sling #2 test. Note no visible signs of melting on the surfaces.

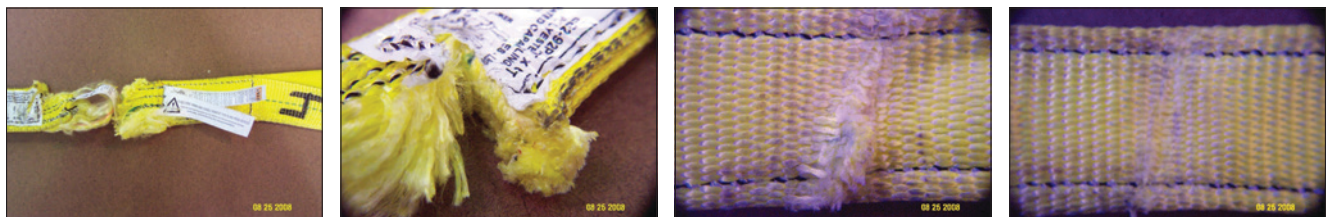
Figure 25

The Ex_Lift sling test 4 and 5 conducted on behalf of the regulatory agency had recorded failure times of

1,083 and 1,041 seconds, respectively — a failure rate that is a couple of thousand times slower than a nominal failure time to produce melting of the sling fibers. This failure process that results in melting of the fibers (as noted at the time of the inspection) is called the adiabatic process (defined below).

Pictures of the sheared and abraded surfaces of Ex_Lift sling #4 test. Note no visible signs of melting on the surfaces.

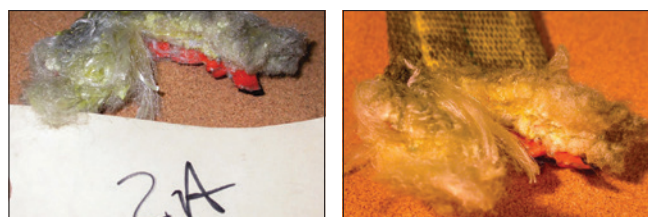
Figure 26

All_Lift Sling 2A sheared surface showing some melted fibers as well as frayed fibers that are a result of tensile failure.

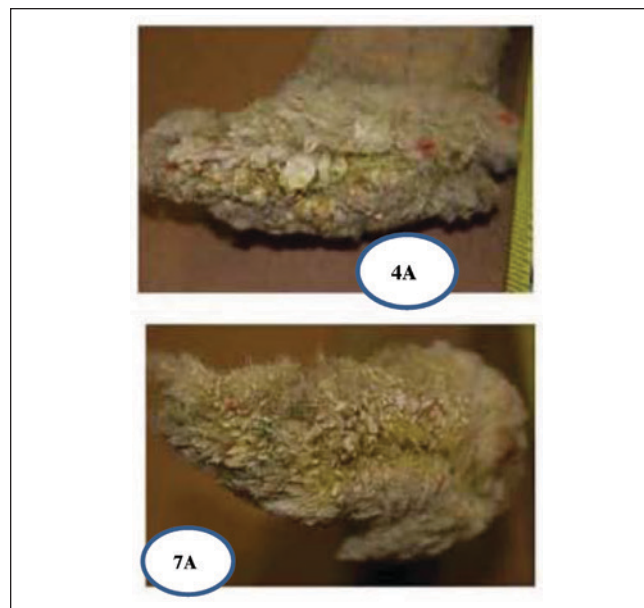
Inspection of All_Lift sling section 4A in **Figure 27** was one of two sections with the greatest amount of visible melted fibers across the sheared surface. Failures of the type shown are typically characterized by rapid application of a tensile load while the material is subject to shear or abrasion. The entire process lasts a fraction of a second, and the melted fibers are a result of the thermodynamic adiabatic process.

Figure 27 shows the sheared failure surfaces of All_Lift sling sections 4A and 7A. The failure process is similar to that of **Figure 26**, sling section 2A.

Figure 27
Sheared surfaces of All_Lift sling pieces 4A and 7A.

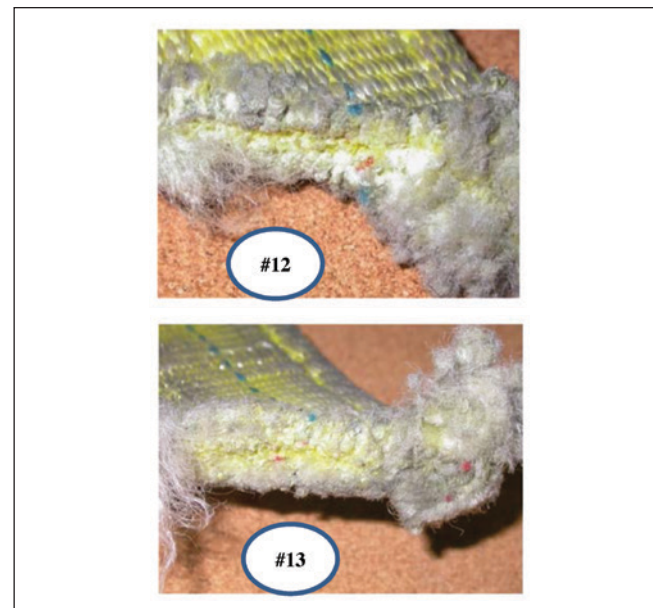
Figure 28 below shows section #12 and #13. The melted fibers are visible and stands in contrast to the frayed fibers located toward the edge of the sling sections.

Figure 28
Two All_Lift sling sections #12 and #13. High-speed shear failure process is predominant in both sections.

Based on the adiabatic failure process experienced by the slings that rigged the collar tie to the crane tower, the NW, NE, and SE slings failed before the SW sling. The SW Ex_Lift sling showed substantial slow-speed tensile failure, as can be seen by the frayed extended fibers circled in **Figure 28**.

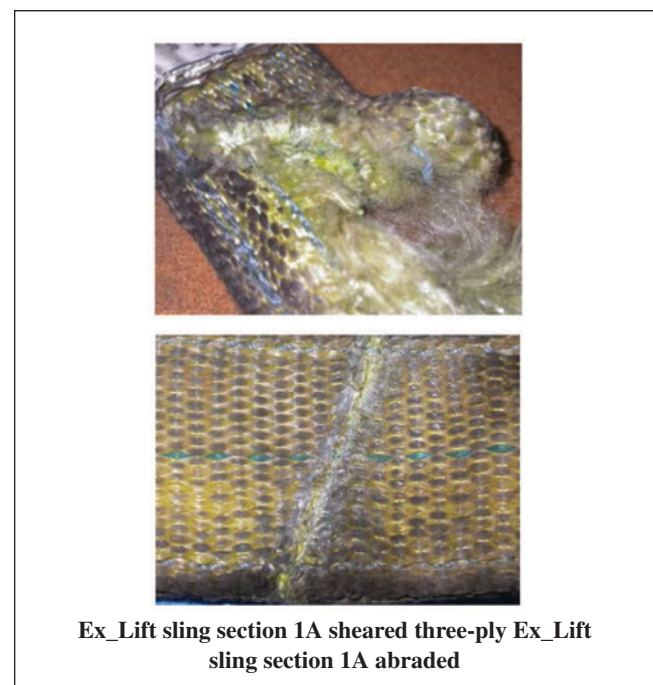
Ex_Lift sling section 1A sheared three-ply Ex_Lift sling section 1A abraded

Finally, **Figure 29** shows two failed sections of the Ex_Lift sling. The top section is the three-ply shear failure surface, and the bottom section is the high-speed abrasion resulting from contact between the sling

Figure 29
Above is the Ex_Lift sling section 1A, a three-ply adiabatic shear failure with melted fibers. Below is the Ex_Lift sling section 1A with adiabatic abrasion damage.

surface and the edge crane tower leg. The melted fibers are clearly visible to the unaided eye. At the time of inspection, the melted fibers covered more than 70% to 75% of the sheared surface. The common failure process across sling sections 2A, 4A, 7A, #12, and #13 is adiabatic. The long extended frayed fibers are evidence of slow-speed tensile failure that is considered to be a less relevant failure mode based on the amount of material frayed — and one that followed the high-speed failure.

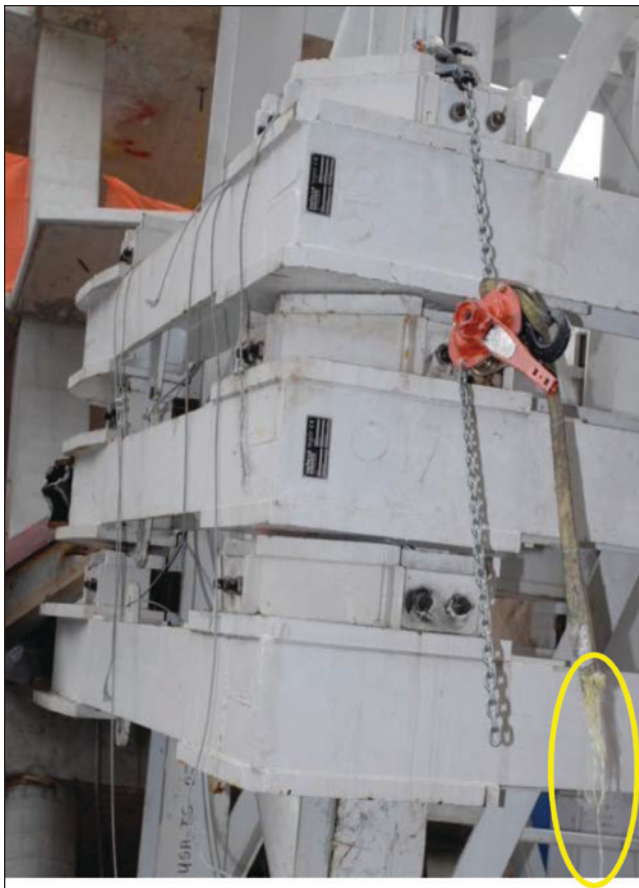
Figure 30

Several incident site photographs were reviewed to determine where sling sections were located just prior to the incident. **Figure 30** shows the SW (southwest) corner of the collapsed crane tower. Suspended from the crane tower section is the Ex_Lift sling 1A attached to the lever hoist.

SW corner with Ex_Lift sling 1A. Visibly extended fibers are evidence of slow-speed failure.

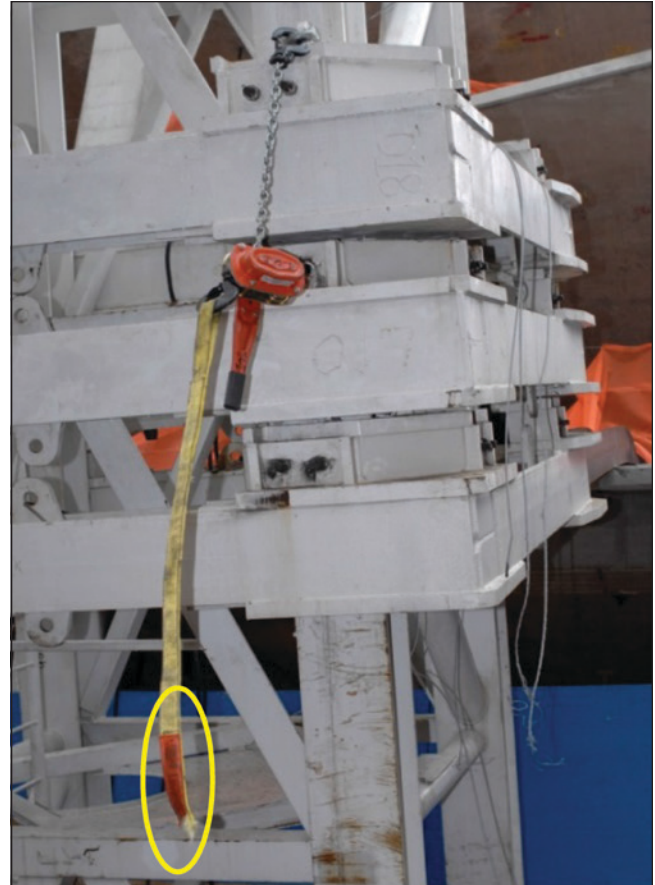
Figure 31

In **Figure 31**, All_Lift sling section 2A is suspended from the collapsed tower. This section combines with All_Lift section 11 to form a complete sling. Note: This sling was the only All_Lift to have been damaged at the red identification tag. In **Figure 32**, sling #12 and #13 identification tags are intact and undamaged.

SE corner with All_Lift sling 2A. Extended fibers are evidence of some slow-speed failure as well.

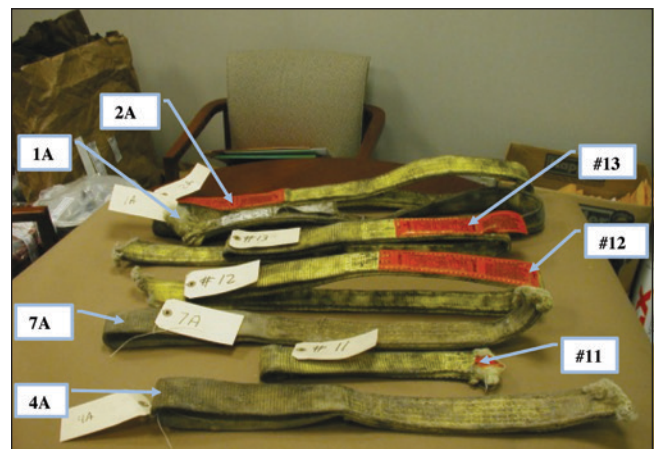
Figure 32

Sling sections retrieved from the incident site. A total of seven sections were retrieved. The Ex_Lift sling 1A, All_Lift slings 2A, 4A, 7A, #11, #12, & #13 tagged and labeled.

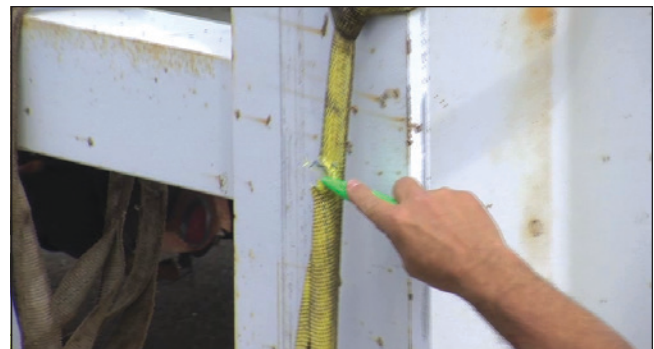
Figure 48

Loaded sling being weakened by cutting.

The Ex_Lift sling shown in **Figure 48** and **Figure 49** was cut more than 50% of its width (the double blue tread along the width of the sling is regarded as the sling's center line) using a utility knife. The collar tie remained suspended in equilibrium after more than 20 minutes.

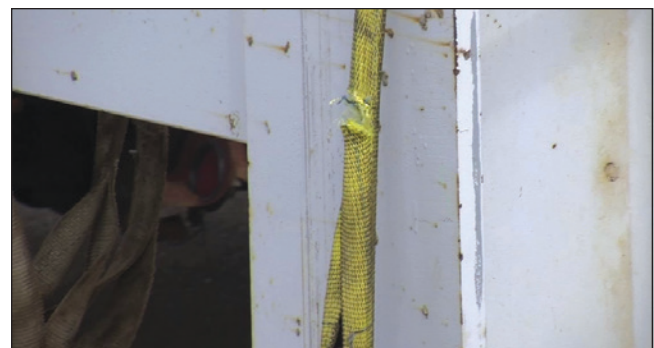
Figure 49

Weakened sling was cut beyond half its width, weakening more than 50%.

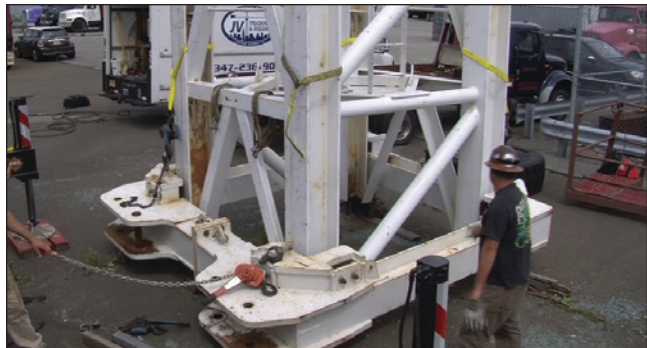
Figure 52

Post shock load configuration of the suspended collar tie. The collar dropped an estimated 8 inches.

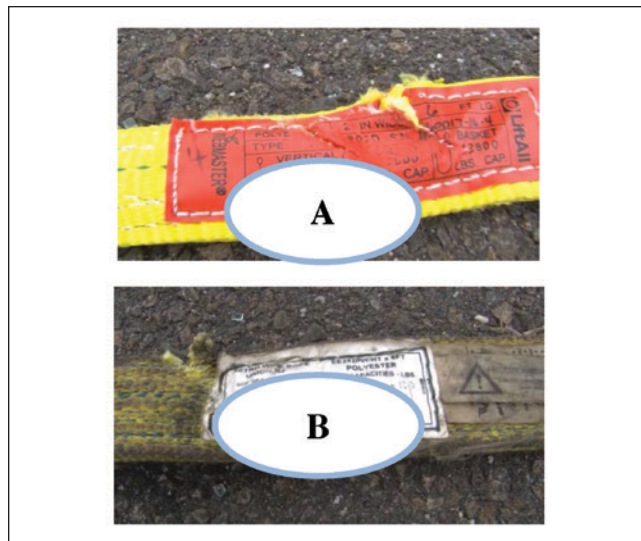
Figure 53

The following five pictures show the damage to the slings that resulted from the dynamic test. The cuts are less than 50% of the sling width. The damage to the slings was a result of the slings being placed in the notch. The Ex_Lift sling damage in the three-ply area was restricted to shear.

Damage sustained by tested slings. No ultimate slings' failure occurred after one sling was completely cut.
