# Forensic Engineering Evaluation and Testing of Horizontal Intrusion Protection Equipment for Stand-Up Forklifts

By Ben T. Railsback, M.S., P.E. (NAFE 713S) and Richard M. Ziernicki, Ph.D., P.E. (NAFE 308F)

## Abstract

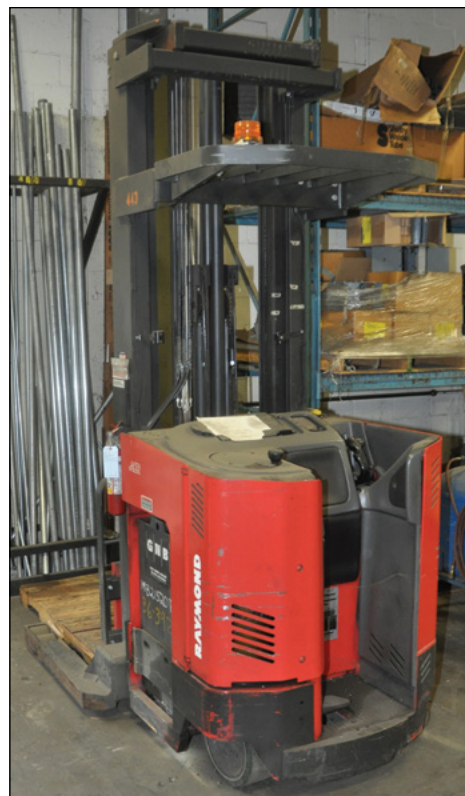
**Figure 1**

Stand-up narrow aisle forklift.

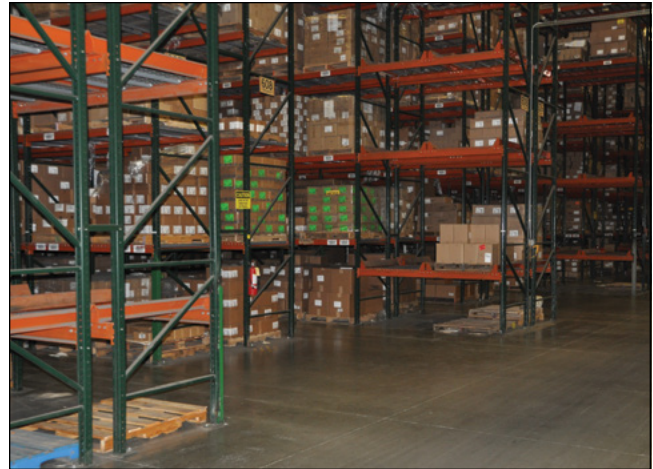
**Figure 2**  
Warehouse rack (modified after the incident).

The horizontal beam that the forklift operator and the forklift collided with deformed approximately 2½ inches at a location about 80 inches from the left side of the beam and 28 inches from the right end of the beam. The rear beam, wire decking, and beam braces do not appear to have deformed in the collision. The vertical uprights did not deform or appear to sustain damage

from the collision either. The forklift operator’s body, the forklift, and the rack beam appear to have absorbed all of the kinetic energy associated with the truck and load at the time of the collision.

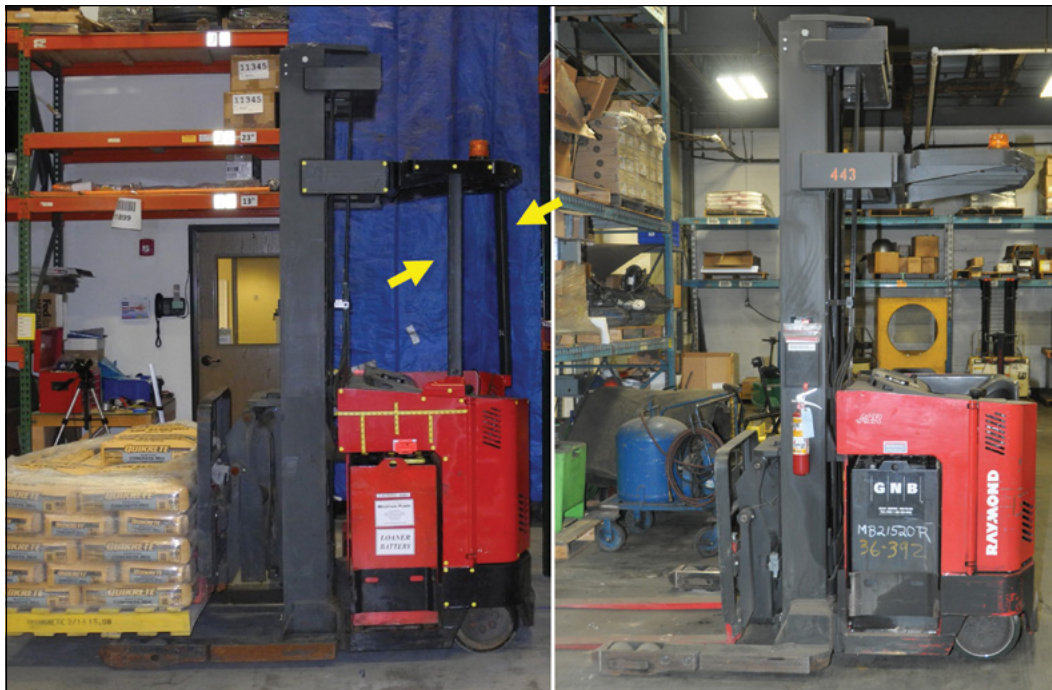
**Figure 3**

Exemplar truck with horizontal intrusion post protection (left) and subject truck without posts (right).

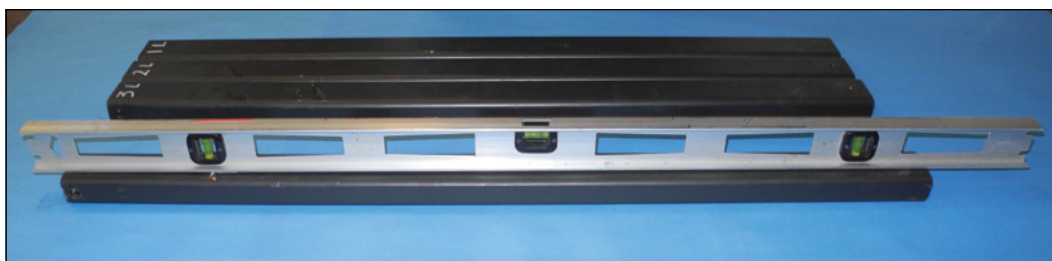
The four tests produced increasing deflection in the rack beam and rack system but little or no deflection in the horizontal intrusion post. Post deflections are shown in **Table 2**. Post deflection or deformation was measured while the post was still installed on the forklift, and then again after removal from the forklift. Values of maximum deflection differ between the two methods because the first method reflects slight shifting of the post during the test relative to the weldment mounts, while the latter method documents only deformation in the post. **Figure 6** is a photograph of the posts after testing with little visible deflection.

Posts after collision testing – little visible deflection.

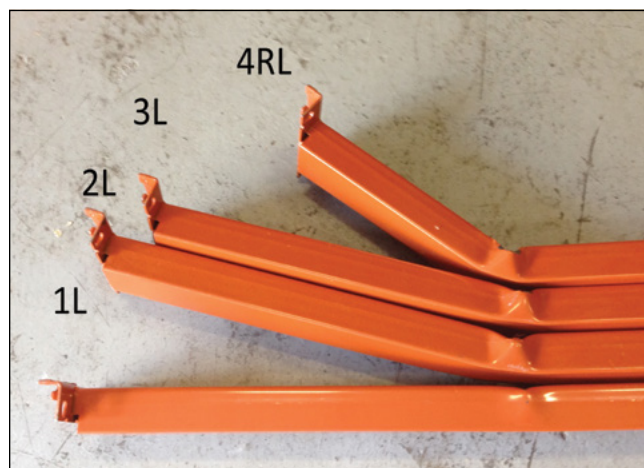
Rack beam deformation is shown in **Table 3**. The deformation distance reported is the maximum deformation of the rack beam relative to the two ends of the beam. The test attempted to replicate the distance from the vertical upright during the subject incident of 28 inches; however, the forklift was driven into the rack, and the impact location varied slightly. The distance from the vertical upright is reported in **Table 3**. Static deformation of the rack system was also documented by the total distance that the forklift traveled after contact with the rack beam and consists of both rack beam deflection and the deformation of the rack system. While the forklift remained in close proximity to the area of contact in the first, second, and third test, it rebounded several inches in the fourth test. Therefore, forklift travel measured at rest after contact under-reports total rack deformation in the fourth test. In the first test, the vertical uprights deformed significantly while the rack beam did not. In the second and third tests (with the added reinforcement), the deformation occurred primarily in the rack beams, while the vertical uprights remained undeformed. In the fourth and final test, the rack beams and vertical uprights both deformed. **Figure 7** displays the deformed end of the rack beams after testing.

Deformed rack beams after testing.

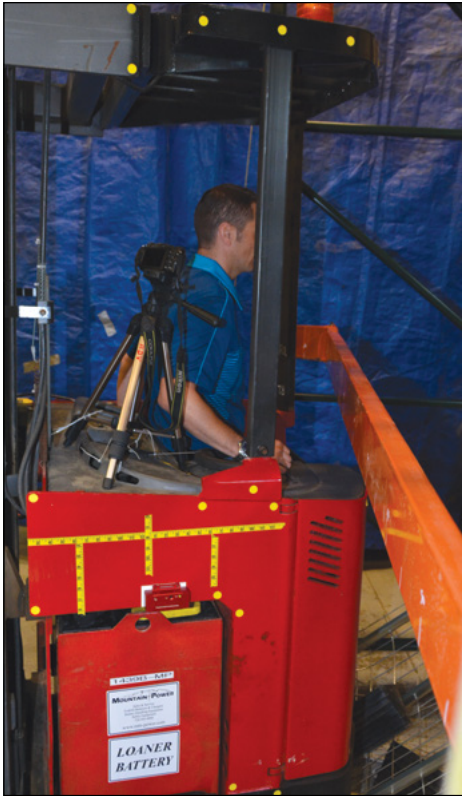
**Figure 8**

Of foremost importance, the testing performed as a part of this research further shows that the manufacturer's horizontal intrusion protection was effective at a speed of 3.4 mph with a full load. The protection would therefore be effective at higher speeds as well. Since the subject forklift involved in the incident was reportedly operating with a load of approximately 972 pounds, the load used in this testing exceeded the load in the incident. Further, the incident occurred at a speed lower than the maximum test speeds — and at a significantly lower amount of kinetic energy. Even at a higher load, higher impact speed, and higher kinetic energy, the rack beam was held outside of the operator compartment by the post guarding system. Since the rack beam did not significantly intrude in the operator compartment, the volume or space required by the operator was not compromised. **Figures 8 and 9** show that the operator compartment space was maintained during the fourth test at 3.4 mph. Therefore, it is clear that the manufacturer's horizontal intrusion protection system would have prevented the crushing injuries sustained by the operator.

Operator able to stand inside compartment after fourth test.

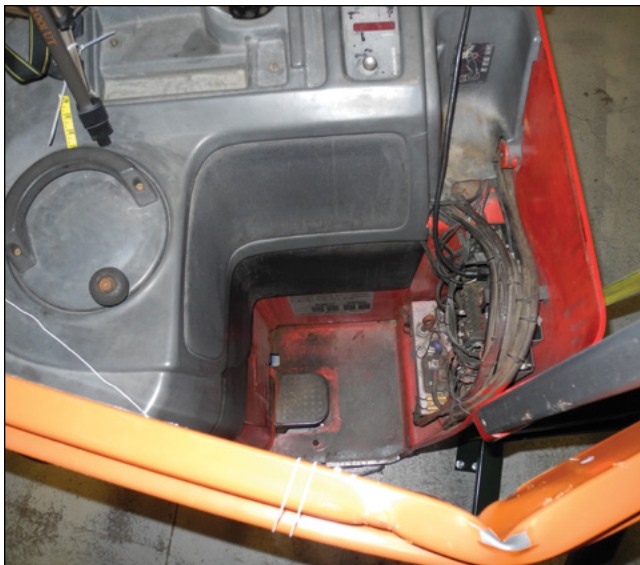
**Figure 9**

Deformed rack beams outside of operator compartment  
after the fourth 3.4-mph test.
