Forensic Engineering Analysis of a Shopping Mall Explosion

By Jerry R. Tindal, PE (NAFE 642M)

On May 7, 2009 a catastrophic explosion occurred at a shopping mall located just outside of Washington, D.C. As a result of the explosion, several persons, including multiple firefighters, were injured, and a large portion of the mall was destroyed. This paper examines the cause of the explosion.

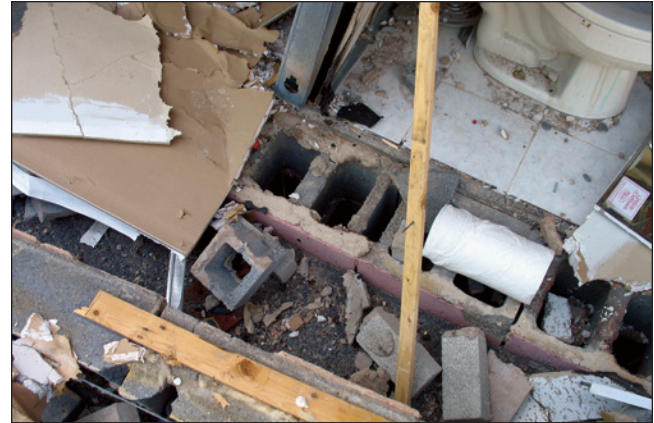
Figure 10

The asphalt surface behind the mall extends all the way to the exterior CMU wall of the structure.

The asphalt ground covering inhibited vertical dissipation of the gas and facilitated lateral travel of the gas toward and into the building.

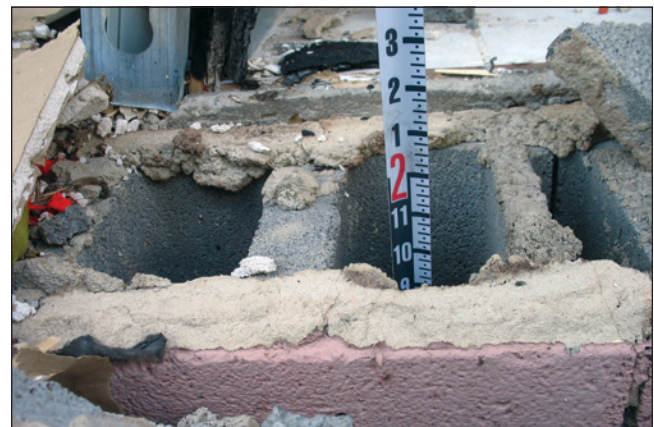
Figure 11

The hollow core CMU exterior walls extend into the ground well below the asphalt surface.

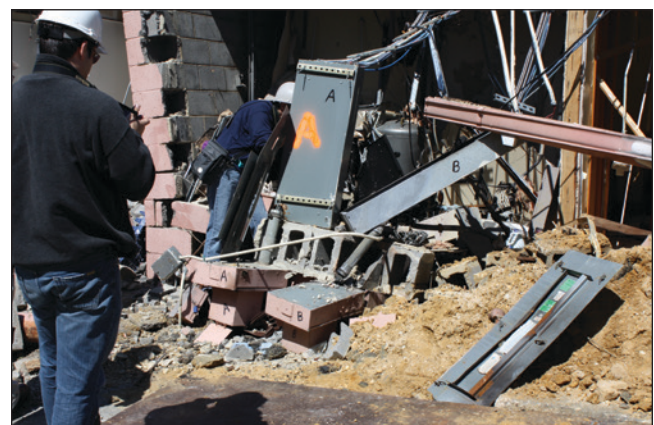
Figure 12

Penetrations through the CMU walls and the concrete slab in the rear of the building included electrical and plumbing.

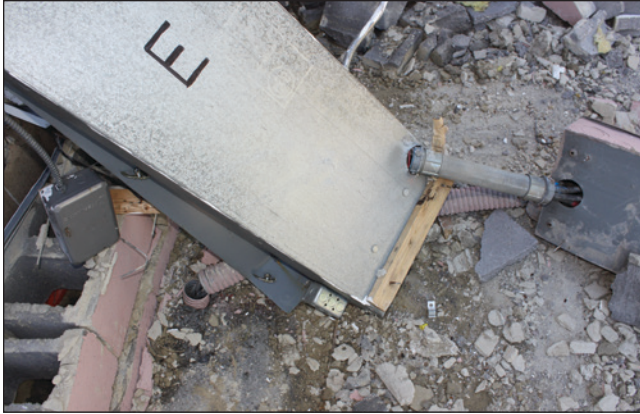
Figure 13

Electrical conduit penetrations through the asphalt and into electrical panels that were located inside the building.

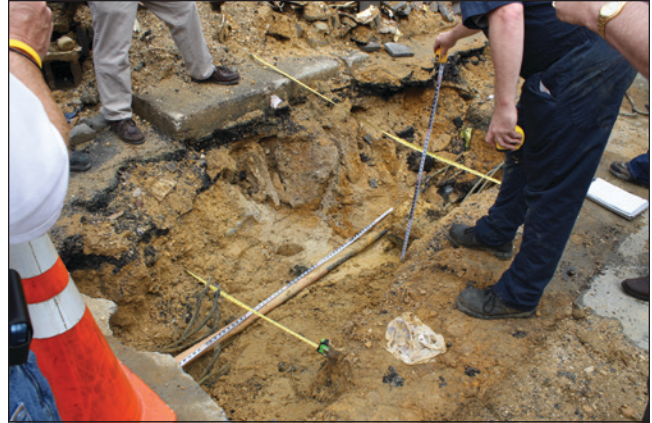
Figure 15

A close-up view of the excavated area. The 2-inch plastic gas main is approximately 9 feet from the rear exterior wall of the building.

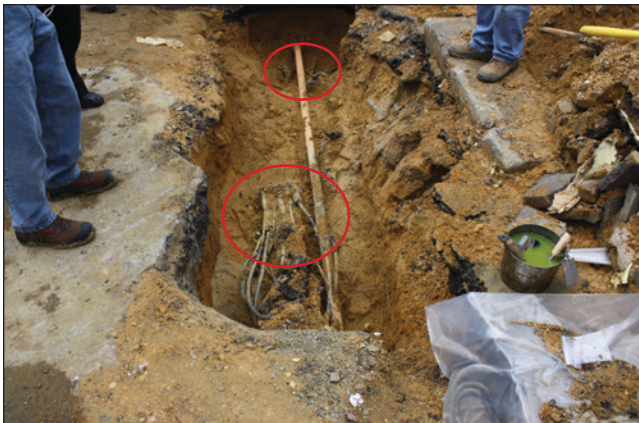
Figure 16

The gas line converged on and crossed in between a nest of multiple electrical power cables. The power cable remains were located on both sides of the gas main. The cable remains are circled.

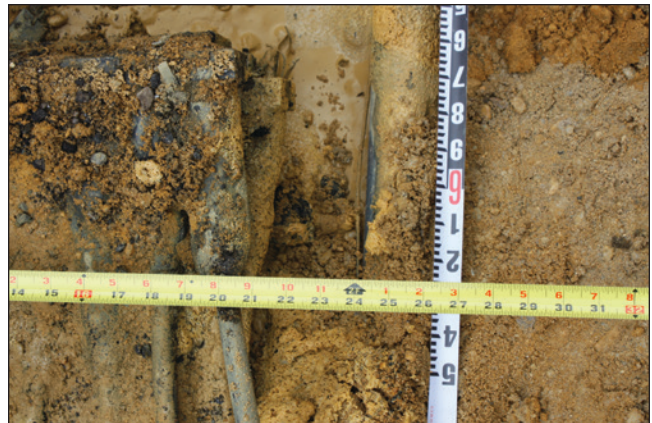
Figure 17

Most of the remains of the destroyed electrical cables were removed before the joint exam by employees of the gas company. Clearances to the remaining cable sections were approximately 3 inches.

The clearance requirement stipulated in the NESC between underground gas lines and underground electrical cables is a minimum of 12 inches. Had the gas utility company contacted the electric utility at the time they were installing the gas line, the electric utility would likely have stipulated a 12-inch clearance be maintained between the two utilities.

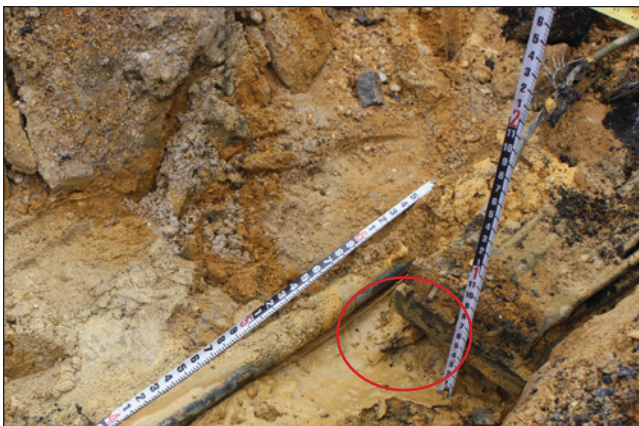
Figure 18

The faulting cables had charred and burned holes through the plastic gas main, allowing gas to escape. Note the stub of a destroyed section of power cable (circled) adjacent to the burned section of gas line.

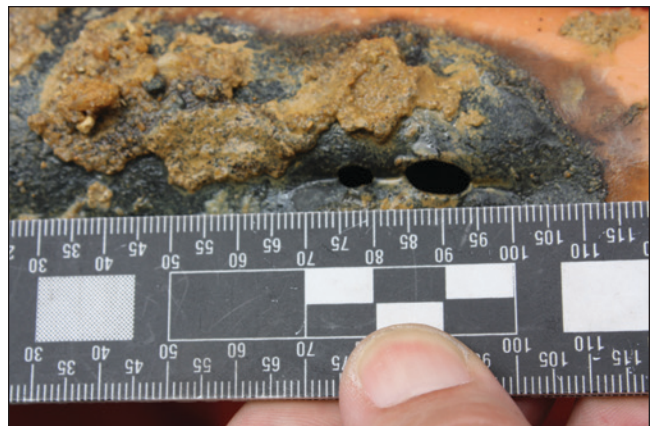
Figure 19

A close-up view of some of the holes charred, melted, and burned in the plastic gas main. The pipe was heavily charred, melted, and burned around the circumference with multiple holes.
