Journal of the
National
Academy OF
Forensic
Engineers[®]

Forensic Engineering Analysis of a Sequence of Power Infrastructure Failures Atop an Office Building

By Mauricio Cueva-Eguiguren, PE (NAFE 776S)

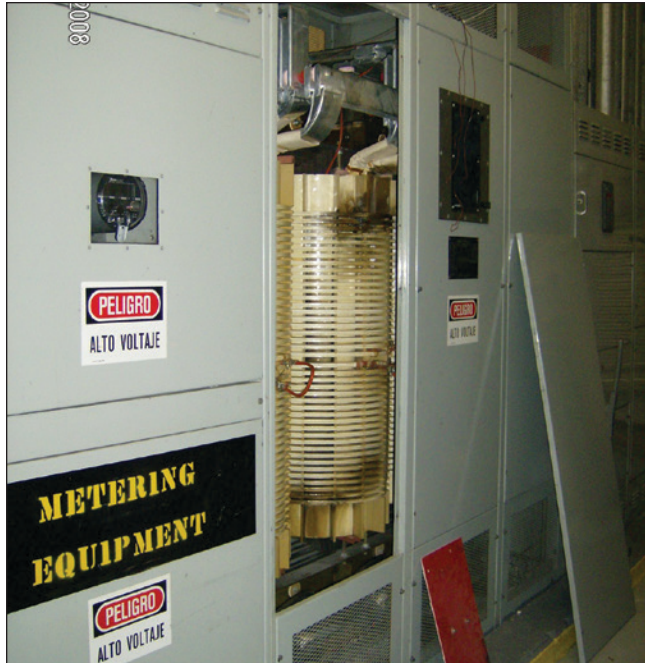
The transformer in the building was used to reduce the utility power from 13.2kV to 480/277VAC for use in the building. This transformer is a three-phase 3,000kVA, 13.2kV-480/277 VAC stepdown transformer manufactured in May 2003 (see **Figure 1**). This transformer has five taps on the primary side (13.2kV). Cooling for the electrical room was through a dedicated ventilation system, which brought outside air into the room exhausting to the outside. The electrical room did not have humidity control.

Figure 1
Transformer 13.2kV – 480/277V.

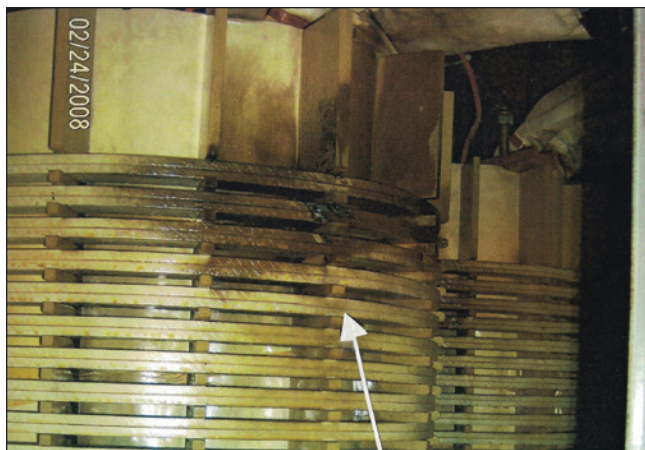
A site inspection was conducted on May 22, 2008 in order to investigate the transformer failure. The site inspection revealed several short circuits in the transformer windings, as shown on **Figures 2** through **6**. In addition, the manufacturer’s drawings, operation and maintenance manuals were reviewed in order to determine if the installation of the transformer complied with the manufacturer’s recommendations⁴.

- The National Climate Data Center (NCDC) reported that 0.04 inches of water precipitation occurred in San Juan, Puerto Rico on February 9, 2008 with an average temperature for the day of 77 degrees Fahrenheit, signifying the presence of elevated humidity.
- Evidence of multiple short circuits was visible in the center and right sides of the primary windings of the transformer.
- A previous transformer failure occurred on a similar transformer in 2002 following an extended shutdown similar to the 2008 shutdown. An investigation following the 2002 transformer failure revealed high levels of moisture in the transformer windings.

Figure 2
Transformer short circuit #1.

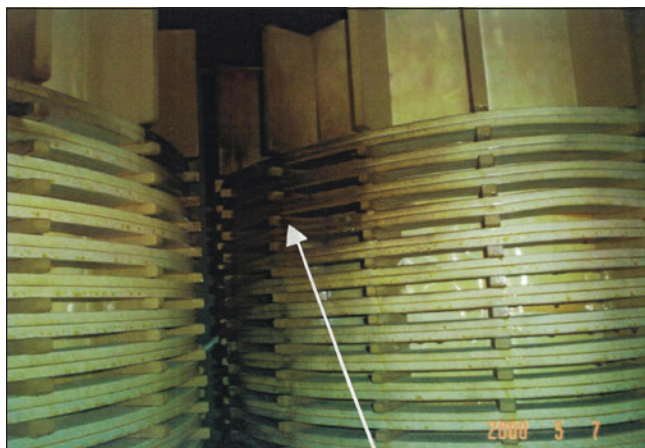
Figure 3
Transformer short circuit #2.

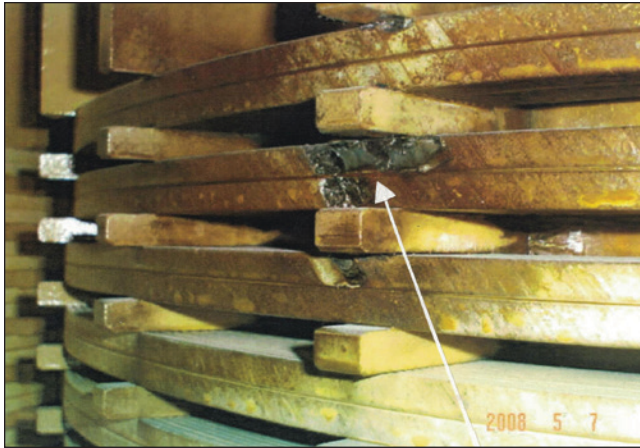
Figure 4

Transformer short circuit #1 close-up.

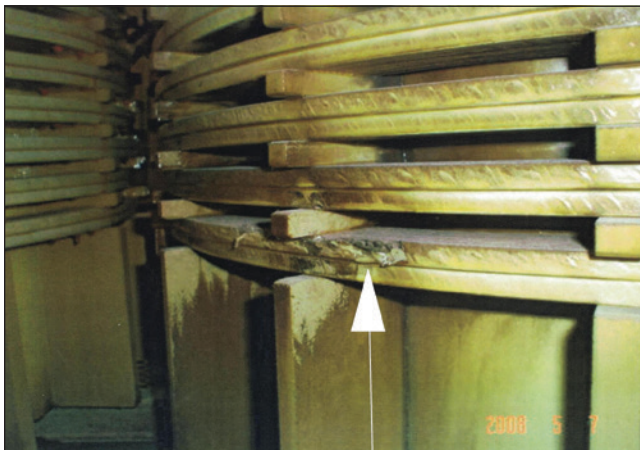
Figure 5

Transformer short circuit #2 close-up.

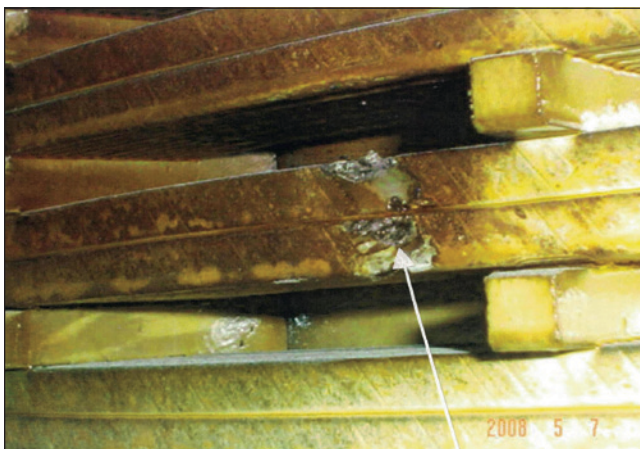
Figure 6

Transformer short circuit #3 close-up.

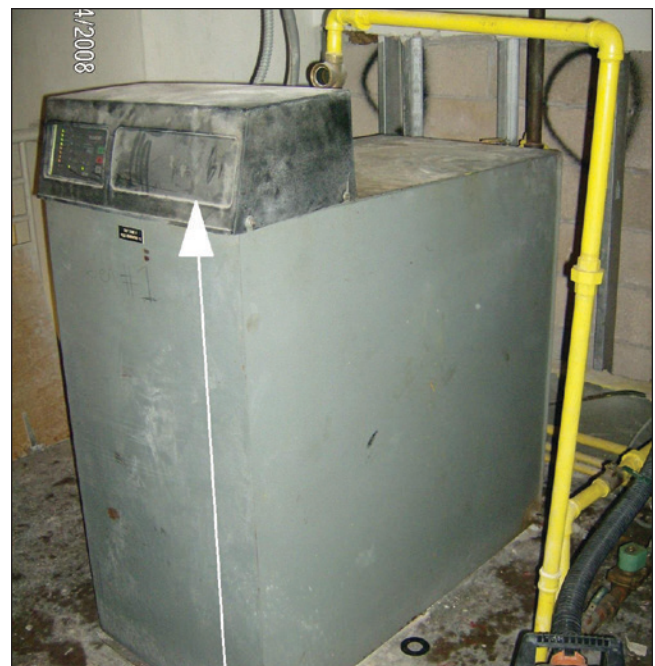
Figure 7

The “A” and “B” emergency generators were located on the mezzanine of the 18th floor with the corresponding fuel day tanks. Since the “A” and “B” fuel day tanks do not hold sufficient fuel for the emergency generators to operate for extended periods of time, these fuel day tanks are supplied with fuel from two 5,000-gallon fuel tanks located in the cellar. The fuel from these two tanks is supplied through two 15.6 gpm fuel pumps; only one pump is required for the “A” and “B” fuel day tanks to be refilled, with the second pump as backup (see **Figures 7 through 10**).

Fuel day tank “A” with control panel.

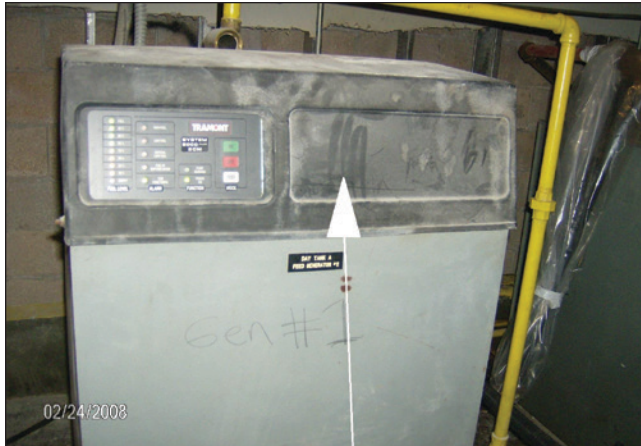
Figure 8
Fuel day tank "A" with control panel.

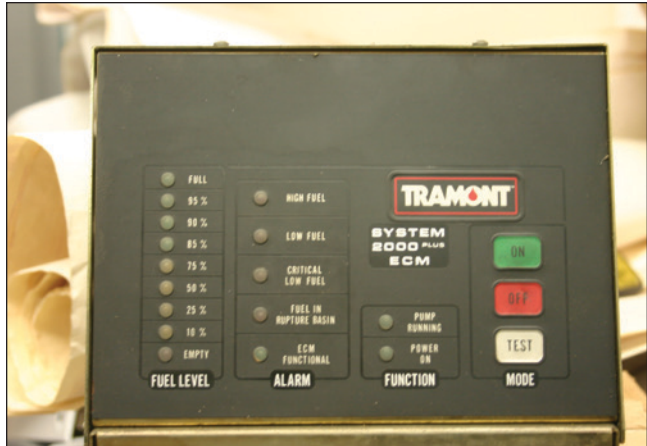
panels used the signals to process the information within these panels (see **Figures 11 and 12**). A signal was sent from these control panels to the emergency generator control panels located in the emergency generator room and to a remote alarm panel located in the lobby of the building.

Figure 11
Fuel day tank "A" control panel (front view).

The results of the visual and functional tests for both control panels showed that they operated properly. It was concluded that the control panel "A" malfunction was a time-specific malfunction that took place on or about February 12, 2008 and not a long-term effect.

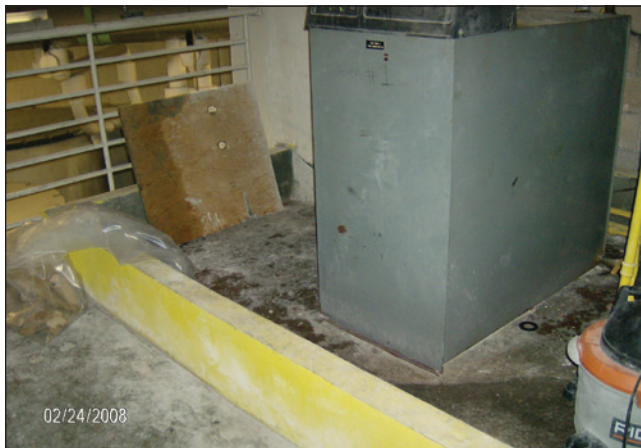
The “A” and “B” fuel day tanks had a containment basin, which held approximately 615 gallons. The containment basin was designed to hold the fuel from these day tanks in the event that there was a rupture in either tank. In addition, this containment basin had a level switch, which provided a local audible alarm on the 18th floor in the event of either fuel day tank rupture.

Figure 9
Fuel day tank "A" and catch basin.

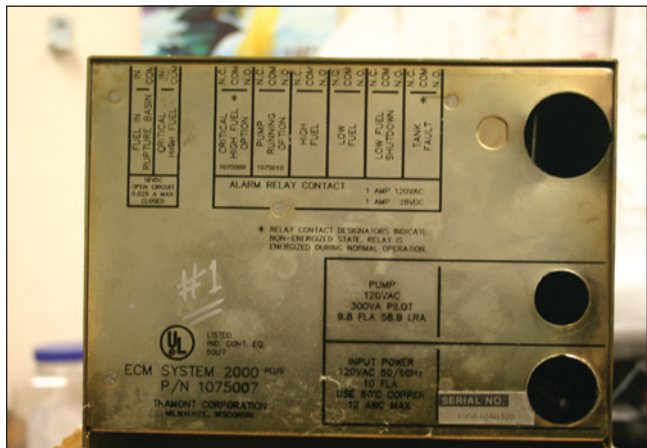
Figure 12
Day tank "A" control panel (rear view).

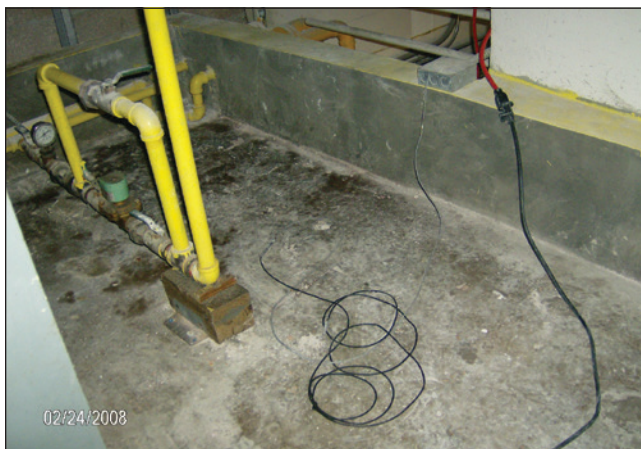
Figure 10
Fuel day tank "A" catch basin.

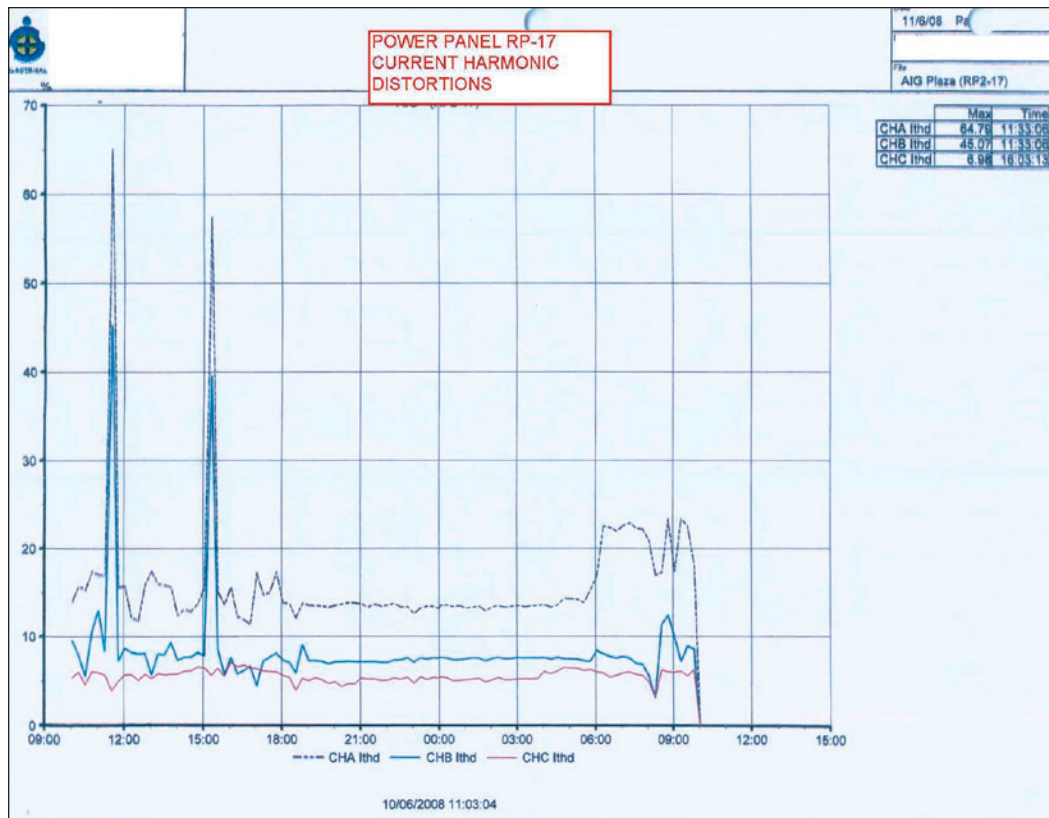
The results of the visual and functional tests for the electrical power service from the utility, emergency generator, and power panel RP2-17 revealed a high level of harmonics that exceeded the industry standard levels. The harmonic levels recorded for power panel RP2-17 greatly exceeded the recommended industry standard levels. The results were as follows:

In accordance with Institute of Electronics & Electrical Engineers (IEEE) Standard 141, 1993 revision, *Recommended Practice for Power Distribution for Industrial Plants*⁵, the recommended maximum harmonic content for operating electronic equipment in industrial facilities is less than 5% for total harmonics with a maximum individual harmonics content of 3%. As shown in **Table 1**, the total harmonic current content for power panel RP2-17 is more than 21 times higher than the recommended value in this standard.

Figure 14
Power panel RP2-17 – current harmonic distortions.

Based on the above, it is evident when the 3,000kVA, 13.2kV-480/277 VAC stepdown transformer failed, the two emergency generators operated in order to provide electrical power to the building. When the emergency generators operated, the fuel day tank control panels “A” and “B” operated with distorted voltage and current waveforms supplied by Panel RP2-17. The distorted voltage and current waveforms were most likely due to the current and voltages harmonics created by the capacitor banks, which were installed in 2002 (see **Figures 14 and 15**). The distorted voltage and current waveforms have adverse effects in communications and electronic equipment, such as the fuel day tank control panels “A” and “B” as stated in industry standards IEEE 141³ IEEE 241² and IEEE 519⁵. The adverse effects include misoperations of electronic equipment, as was the case with the fuel day tank control panel “A” on February 11, 2008.

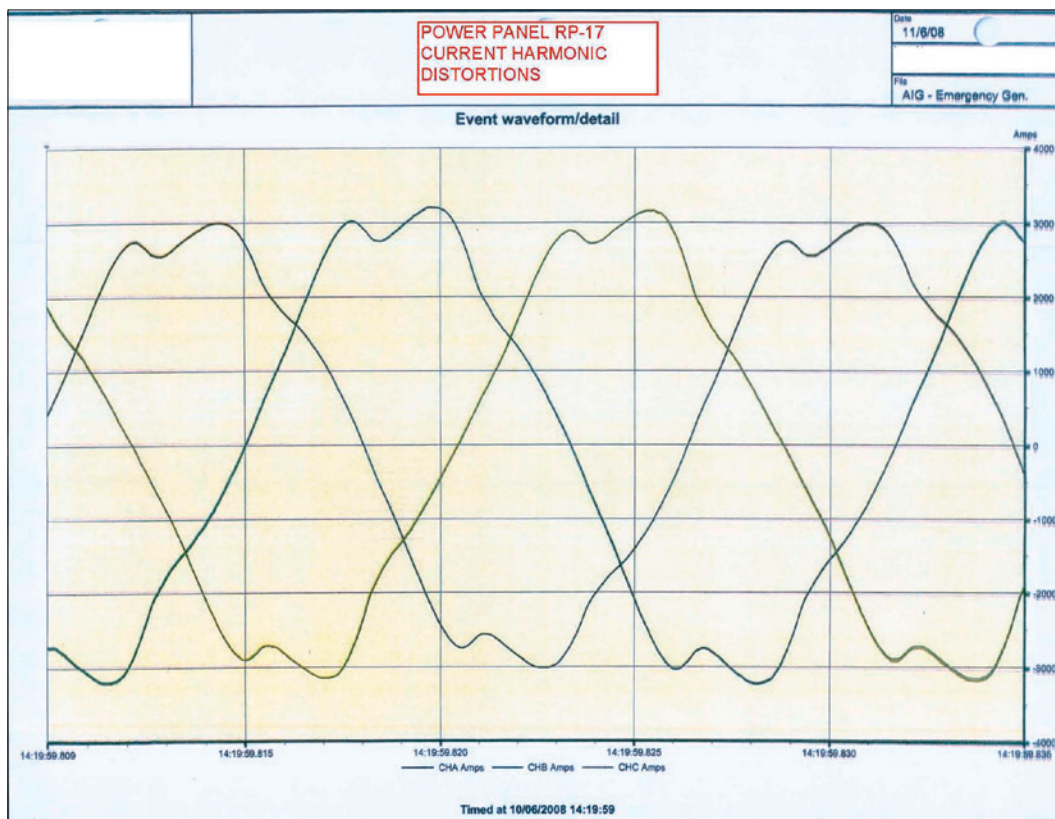
Figure 15
Power panel RP2-17 – sine wave current and voltage harmonic distortions.
