Journal of the
National
Academy OF
Forensic
Engineers[®]

Forensic Engineering Analysis of Failed UTV Roll Cages

By Olof H. Jacobson, MS, PE (NAFE 496F), Stephen A. Batzer, PhD, PE (NAFE 677M),
Mark H. Kittel, PE (NAFE 757M), Jesse A. Grantham, PhD, PE (NAFE 597S),
Guy J. Barbera, PE (NAFE 732M), and Allen Molitoris, PE (NAFE 464C)

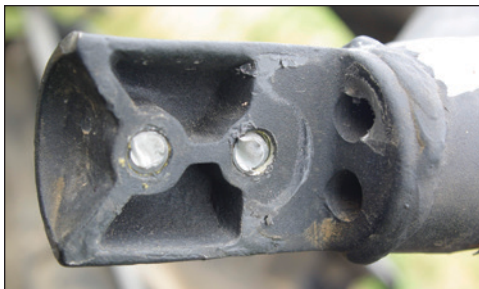
Figure 10

Case A: Failed bolted connection in side header tube.

The bolted joints in the roll cage were loaded transversely, and the bolts failed in single shear. This is a fundamental design weakness. Bolts are typically loaded in tension, but if they must be loaded in shear, they should be loaded in double-shear. In addition, the cross-sectional area of the bolts should be sufficient to support the expected loads such that the strength of the bolted joints is consistent with the overall strength of the roll cage.

If tube joints are necessary, the tubes could be joined by using one of several standard methods. For example, a reduced diameter tube end inserted inside a full diameter tube end locked together with through bolts would not load the bolt in shear, and the joint could be as strong as the base steel tubing. Other alternate designs include

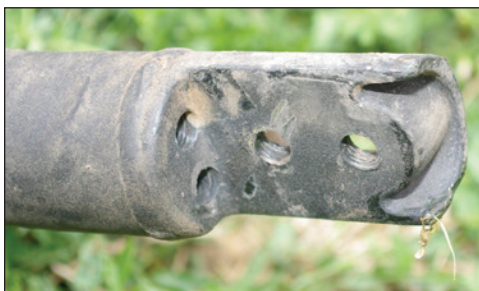
Figure 11

Case A: Failed bolted connection in side header tube.

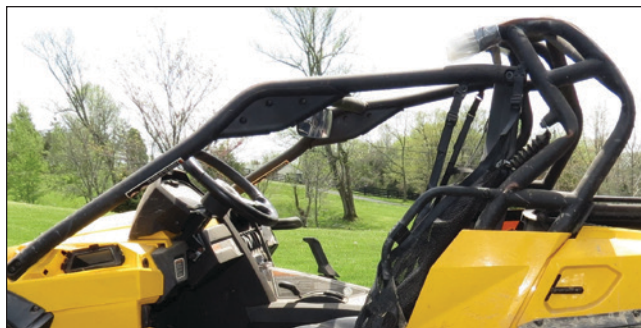
deformed roll cage is seen in **Figures 14** and **15**. Note the similarity to the deformation pattern in Case A seen in **Figures 8** and **9**. The bolted connections failed in the same manner as in Case A.

The permanent downward deformation of the roll cage at the B-pillars measured $2\frac{3}{4}$ inches on the driver's side and $\frac{1}{2}$ inch on the passenger's side. The downward deformation of the header tubes of the forward portion of the roll cage (at the failed bolted connections) measured 10 inches on the driver's side and $6\frac{1}{4}$ inches on the passenger's side. The A-pillars were deformed downward 7 inches on the driver's side and 8 inches on the passenger's side. The maximum dynamic deformation during the pitchover was in excess of these static measurements.

Figure 14
Case B. Side view of failed roll cage.

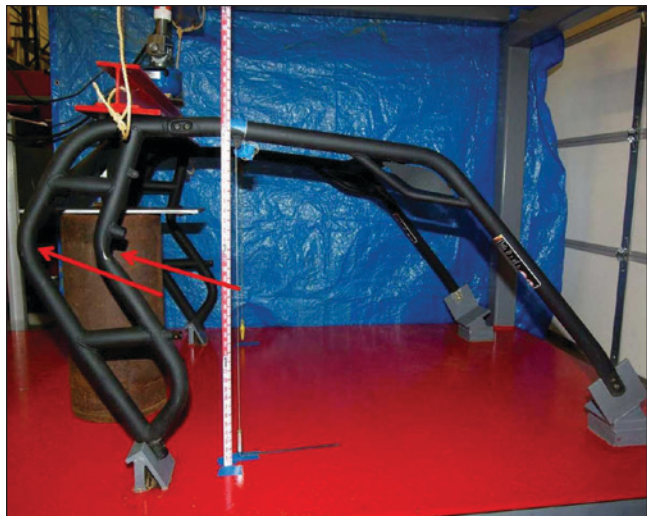
Figure 18

The test setup is shown in **Figure 18**, and the load displacement data is shown in **Figure 19**. The B-pillars buckled at a vertical load of 16,510 pounds.

Laboratory testing of an exemplar roll cage. Z-shaped B-pillars buckled at bends (arrows).

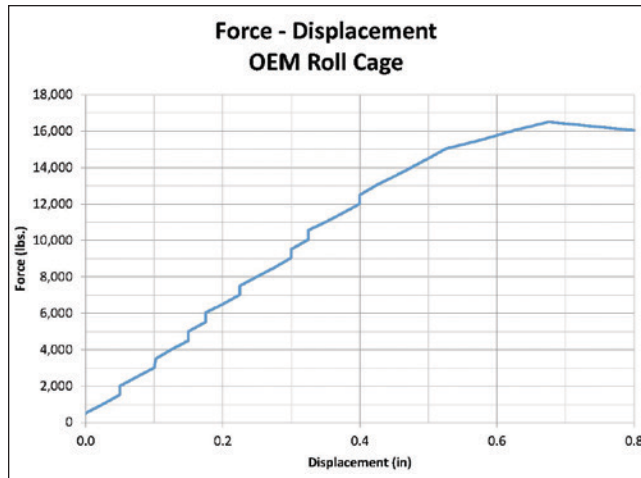
Figure 19

Load/displacement data from test shown in Figure 18.
Peak force was 16,510 pounds.
