# Effects of Evidence Spoliation on Forensic Engineering Analysis of Alleged Brake Servicing Defects

By John Leffler, PE (NAFE 709S)

*A forensic case involved an allegation of defective minivan brake repairs. On a wet two-lane road, the minivan left the road while stopping, and impacted a telephone pole. The plaintiff driver's complaints implied a dragging brake, and the plaintiff's expert reported a bent lower caliper bolt. This forensic investigation involved instrumented exemplar analysis of the effects on caliper drag that could be caused by a bent caliper bolt. The investigation methodology was chosen (in part) based on significant evidence spoliation on the part of the plaintiff's expert. This paper will also discuss the effects of the spoliation and resulting limitations on the scope of the analysis.*

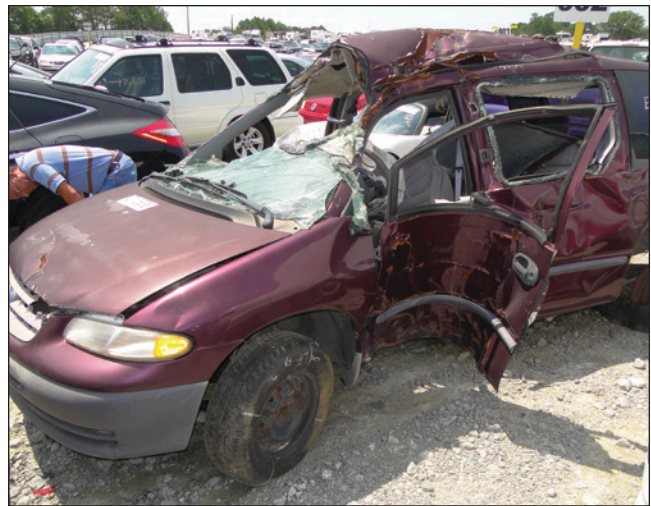
In November of 2008, the plaintiff was driving a "loaner" pre-owned 1999 Plymouth Voyager minivan provided by a vehicle reseller while the plaintiff's car was being serviced. On the second day of the plaintiff's use of the minivan, the plaintiff was driving in rainy daylight on a straight two-lane road with a posted 45-mph speed limit. When approaching a vehicle waiting to turn left into a driveway, the minivan left the road — the plaintiff recalled only that she applied the brakes when approaching the stopped car. The minivan went onto the right shoulder and across a residential lawn, rotating about 80 degrees clockwise about a vertical axis, eventually stopping when the driver's door impacted a telephone pole. The plaintiff and a passenger were injured (**Figure 1**).

**Figure 1**  
Impact damage to minivan.

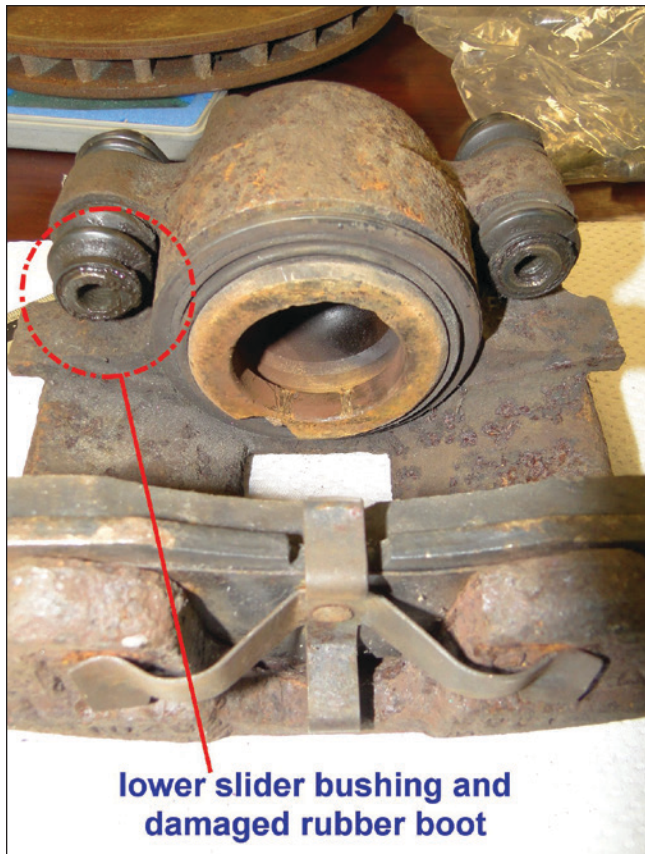
a. Inspection of the subject caliper components did not reveal undue corrosion overall. The passenger's side (right) front caliper was the primary focus as it was this caliper that had the bent lower bolt (see **Figures 4** through **7**). Note that regardless of where a bending load would have been applied along the bolt head or the slider bushing, the bending would manifest itself at the "weak point" of the threads, due to the stiffening support provided by the slider bushing. The lower slider bushing's boot was damaged, but the surface of the bushing did not show any corrosion. Note that by design the bushing is completely "suspended" within the rubber boot, and does not contact the caliper casting directly. Of interest, **Figure 8** shows an impact/wiping deformation area observed on the inboard end of the bent slider bushing; the most likely cause

Lower slider bushing and boot.

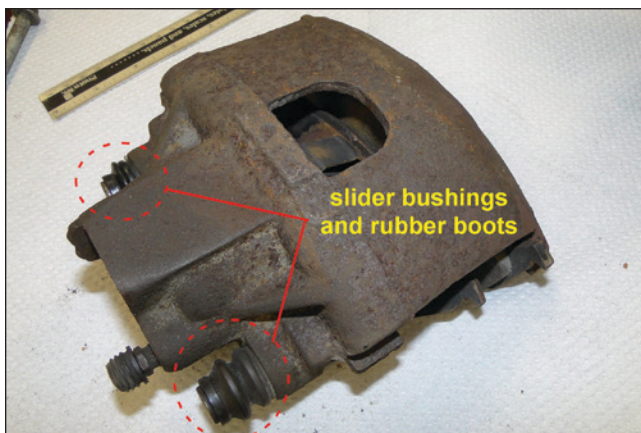
Right caliper.

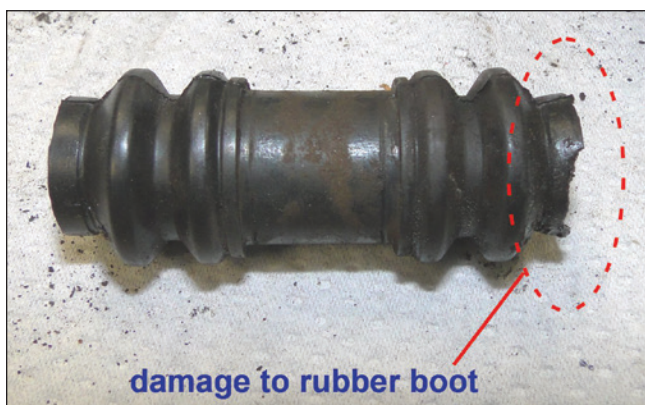
Damage to lower slider's rubber boot.

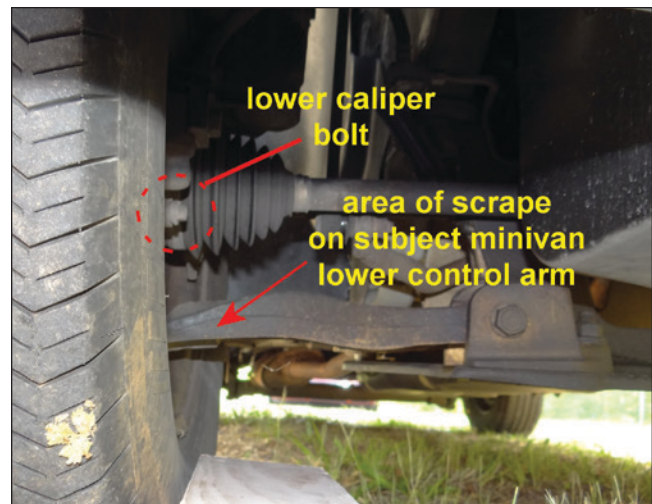
d. The subject lower bolt also could have been deformed by some external force application unrelated to the dealership's servicing. For example, the vehicle had been stored at an auction yard for years following the incident. This auction yard (like many) moves vehicles around through the use of large wheel loaders equipped with long forks that the drivers basically shove under the vehicles to pick them up. **Figure 9** shows (on an exemplar minivan) how the lower caliper bolt could have been readily contacted by fork tips; additionally, there was a fresh scrape mark on the front

**Figure 9**  
Accessibility of lower caliper bolt to fork tips (exemplar).

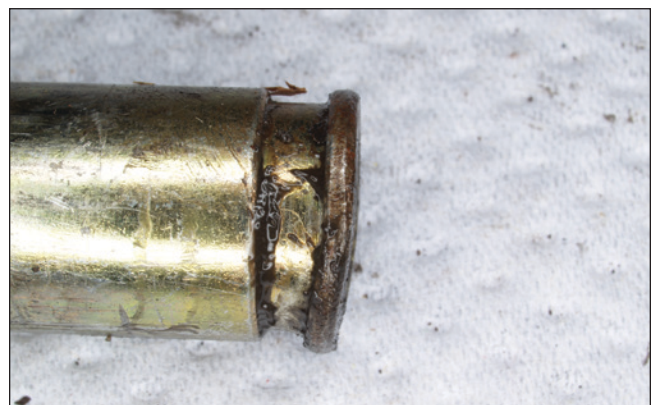
surface of the right front lower control arm (below and behind the lower caliper bolt) in photographs taken by the dealership's expert two months after the incident. Consistent with this scenario, it is also of note that not only the lower caliper bolt was deformed, but the face of that bolt's slider bushing (that contacts the suspension upright) also showed deformation consistent with a bending force being applied to the bolt (or bushing) while it was in place on the vehicle (**Figure 10**). It is not conclusively known, however, what the rotational orientation was of the bend in the bolt (and slider bushing) preceding their removal by the plaintiff's expert, as he had taken few photographs of the components during disassembly. Low-resolution zoomed-in portions of the few digital images taken by the plaintiff's expert appeared to show that the bolt was bent vertically up, but this was not conclusive.

**Figure 10**  
Deformed end of lower slider bushing.

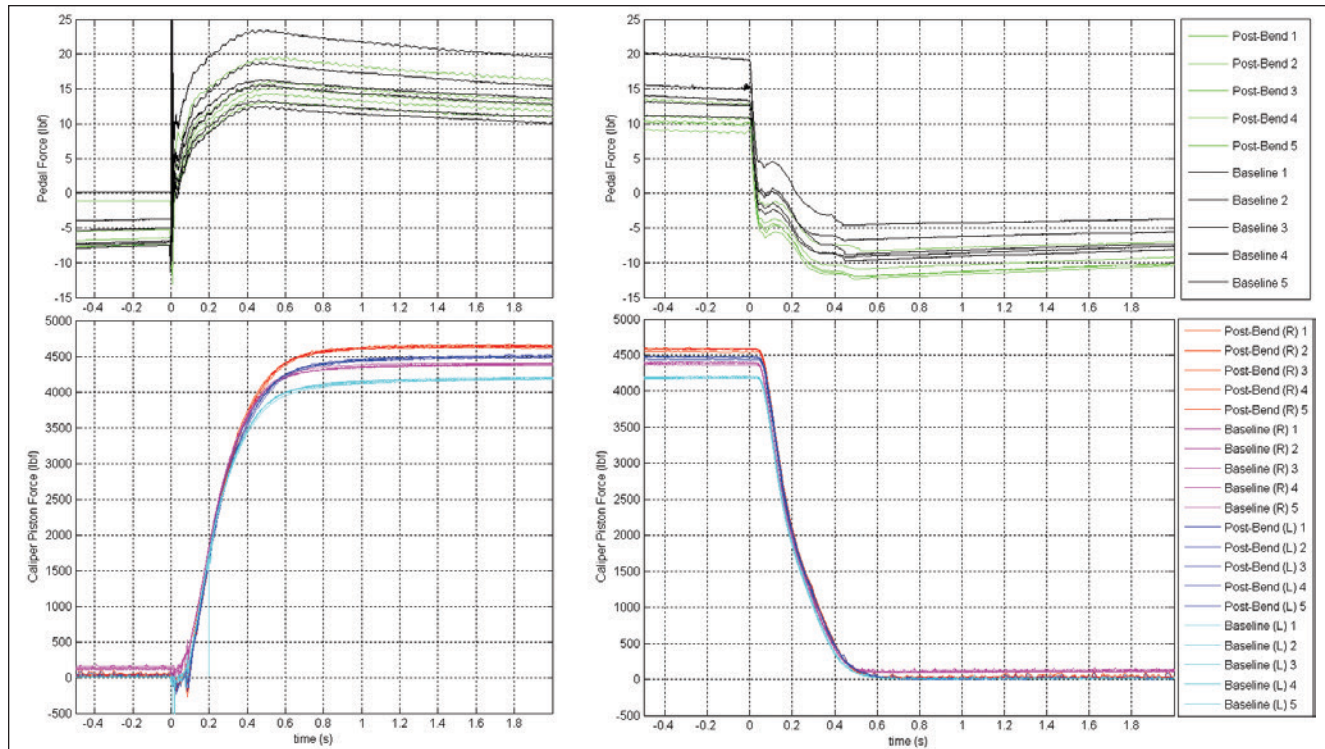
**Figure 18**

4. The data is summarized in **Figure 18**. Pedal input force is in the top charts, at both application (top left) and pedal release (top right). The "baseline" tests were before the caliper bolts were bent, and five data sets were taken. The caliper piston output force is shown at application (bottom left) and release (bottom right).

Test data summary plot.

c. Caliper response – application: The right side baseline and bent-bolt response curves were closer together than the left side, but in both cases there was more caliper force with the bent bolt than without. Each group of five traces appeared to be fairly consistent, despite minor variations in the pedal input force. And the force onset profile appears quite similar for all four sets of five traces.

d. Caliper response – release: In all cases, the caliper force release took no more than 0.03-0.04 seconds to occur. The “gentle” ramp down of forces after 0.04 seconds could be due to a combination of the sensor response and the elasticity of the caliper assembly. And in each trace, the force eventually goes to ~0 after 0.6 seconds.

- i. The consistency of profile with each of the different plot traces appears to show that the apparatus and method provide usable results.
- ii. The bent bolt did not cause a significant comparative lag in either caliper force onset (upon pedal application) or release.

iii. There did not appear to be residual caliper force (i.e., brake drag) due to the bent bolt, such that would cause overheating of the brakes and vaporization of the brake fluid.
