# The Impact of the Lack of Marine and Rail Standards on the Transportation of Large Power Transformers

By David Gillingham, P. Eng. (NAFE 935A)

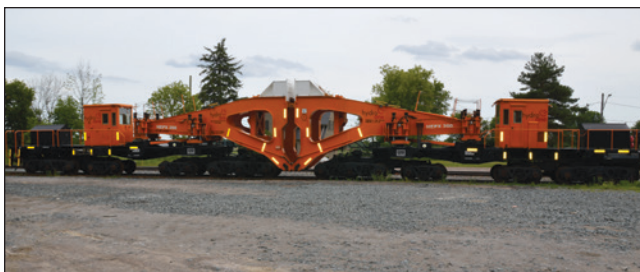
**Figure 2**

Unloaded Schnabel car parked on a siding. The transformer would be inserted between the two support arms.

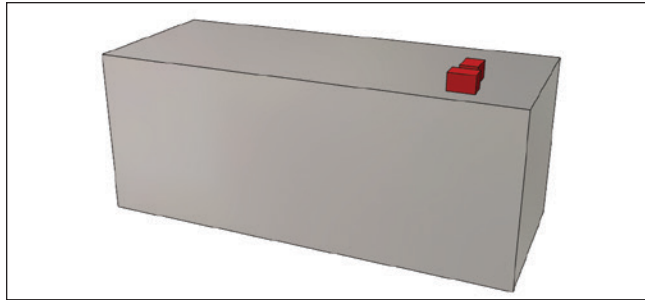
**Figure 4**

Upon arrival at site, the forensic engineer reviewed the impact recorder data, and determined that the unit had sustained a number of significant acceleration events. Further inspection by the engineer also revealed several damaged internal components.

Transformer showing location of impact recorders.

During this inspection, the representative discovered several pieces of pressboard that were loose or completely dislodged from their mounting locations. Additionally, he also found several internal securing bolts to be loose, in addition to a number of other cracked, broken, and abraded components within the transformer, including fragments of magnetic debris on the tank floor.

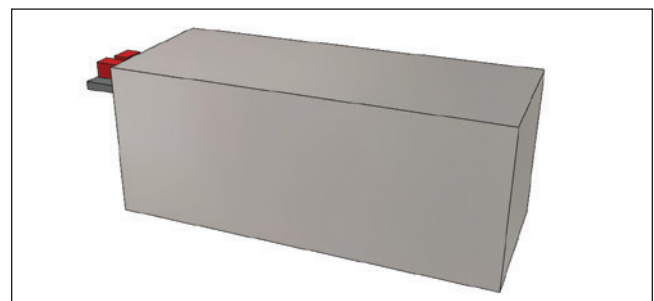
**Figure 6**

Prior to leaving the manufacturing facility, the transformer was fitted with two impact recorders, as shown in **Figure 6**. The data logs from these impact recorders showed that this transformer experienced two significant impact events during its voyage. The first occurred on the truck after leaving the manufacturer — where it sustained damage to a bushing cover and grounding link cover that were situated on top of the transformer when it failed to meet the clearance under an overpass. A second incident occurred when

Transformer showing location of impact recorders.

The forensic engineer reviewing the logs from the two impact recorders found two anomalous events. The first event, recorded while the transformer was on the truck, was an excessive impact in the vertical (z) axis. Only fractions of a g acceleration were recorded in the transverse and longitudinal (x and y) axes, likely due to the normal deceleration of the truck and the location of the impact recorders. The forensic engineer confirmed this event by correlating the impact recorder logs with the driver's logs.

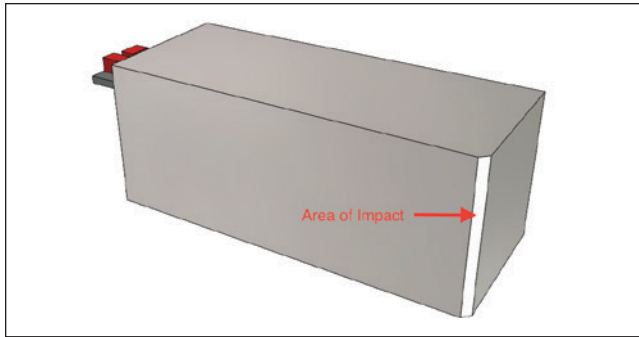
**Figure 7**

the transformer impacted the side of the vessel during offloading, as shown in **Figure 7**. This impact event was observed and logged by the marine surveyor, whose report was used by the forensic engineer as evidence for his investigation.

Transformer showing location of impact in white.

Because the impact recorders were mounted near one top corner of the transformer— and the observed damage was to the opposite corner — it is reasonable to believe that they did not record significant accelerations during the offloading impact. The concept of angular velocity dictates that the closer the impact recorder is to the pivot point of the transformer, the smaller the acceleration it will log. It may have been possible to extrapolate the acceleration forces applied to the opposite end of the transformer during this event; however, a second set of impact recorders installed at the end closer to the impact would have logged a more accurate value of acceleration, as well as provided an additional data set for validation. Despite the logged acceleration values being within acceptable limits, based on the analysis of the marine surveyor's report and the events following the detection of the hot spot, the forensic engineer deemed it reasonable to believe that the transformer was damaged, at least in part, by the impact with the sidewall of the marine vessel.

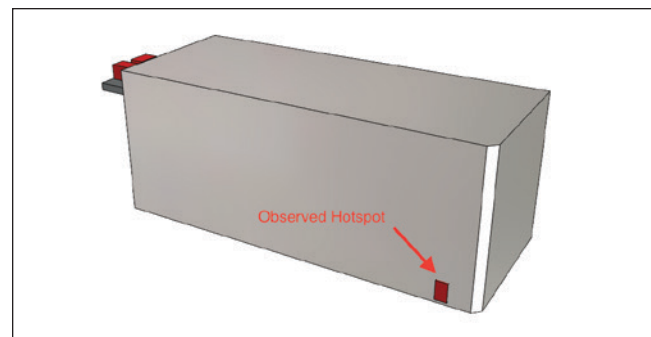
**Figure 8**

Following the commissioning and energization of the transformer, the owner observed internal gassing. Using an infrared imaging camera, they discovered a hot spot near one of the mounting feet for the core and coil assembly, as shown by the red spot in **Figure 8**. The owner conducted an internal inspection of the transformer tank and provided photographs to the forensic engineer. After analyzing the photographs, as well as construction drawings of the transformer core assembly, the forensic engineer subsequently determined that the core assembly had shifted within the tank, placing one of the three mounting feet too close to the tank wall. This physical shift changed the electrical dynamics of the transformer, which led to arcing activity between the core assembly and the tank wall.

Transformer showing location of hot spot.

Additionally, the lack of inclinometers installed on the transformer during the ocean voyage left a large data gap with respect to angles of inclination of the transformer. Due to the core assembly being mounted toward the top of the transformer, even a moderate angle of inclination might have caused the core assembly base to shift within the tank. Without this data, the forensic engineer could not determine if the misalignment of the core was a result of excessive inclination of the transformer during the ocean voyage.

- The core assembly shifted due to reduction of friction forces caused by high-frequency (engine) vibration during transport;
- The core assembly shifted during the impact sustained when the transformer contacted the ship wall during offloading.

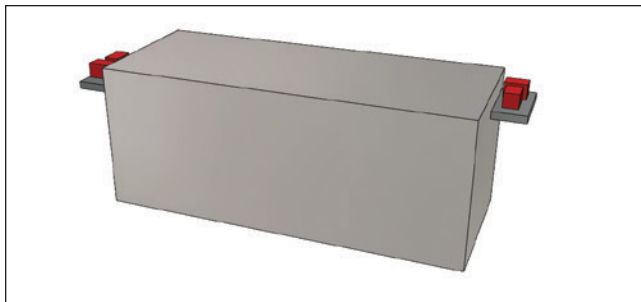
**Figure 9**

each end, as shown in **Figure 9**), with a third mounted directly on the railcar; however, the location and orientation of this one was not known. Once the transformer railcar was parked on a siding near the substation — and before the transformer was offloaded to the multi-axle transport vehicle — the manufacturer's representative downloaded and reviewed the impact recorder data, noting high levels of vibration. However, none of the recorders logged any significant impacts. Because of the high levels of vibration recorded by the impact recorder, the manufacturer put the rail transporter on notice for potential damages to the transformer, pending an internal inspection and electrical testing. The forensic engineer was mandated directly by the rail transporter. A marine surveyor also attended the site investigation along with the manufacturer's technician.

Transformer showing locations of impact recorders.

During the internal inspection, the forensic engineer found all blocking and bracing to be in place and secure. Of particular note were the cushioning pads under the transformer core, which were of considerable interest due to the high levels of vibration recorded by the impact recorders. The forensic engineer noted that these were still in place under the core, and remained secured to the pins that extended out of the transformer core. The forensic engineer also found spacer blocks on the outside of the core sections were still in place and secure, and the cords used for securing internal

Based on the internal examination and discussions with the manufacturer's representative, the forensic engineer determined that despite the high levels of vibration logged by the impact recorders, the transformer was not damaged during transport. The working hypothesis for this was that there was sufficient internal bracing and other protective measures, which reduced the fragility of the transformer so that it could withstand high levels of vibration.
