Journal of the
National
Academy OF
Forensic
Engineers[®]

Vol. 33 No. 2 December 2016

Forensic Engineering Analyses of a Home Fire

By R. Vasu Vasudevan, PE (NAFE 619F) and Jeremy Britton, PE (NAFE 943M)

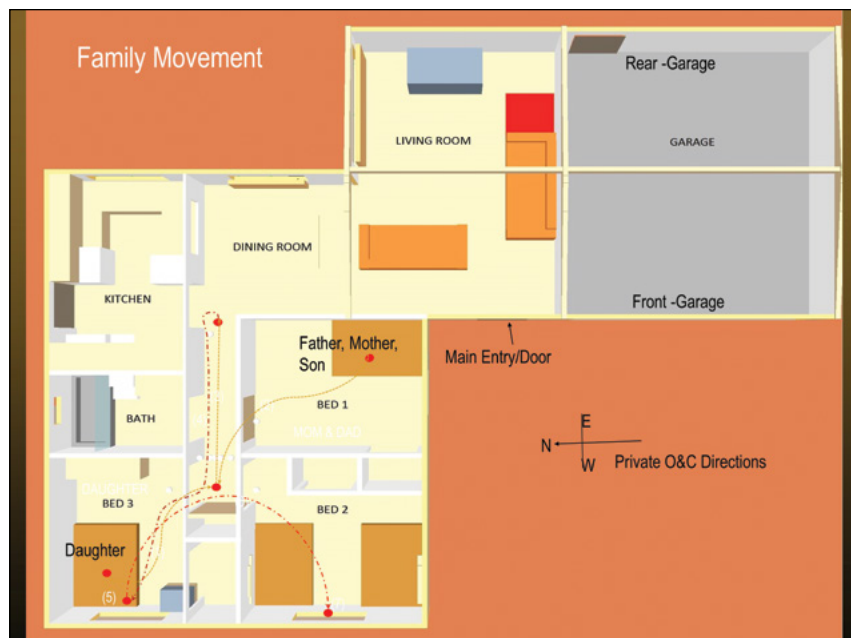
Figure 1
Family movement.

In the early morning hours of August 21, 2011, a disastrous fire occurred in a tenant-occupied detached single family home. The family was asleep when the daughter woke up, saw smoke in her bedroom (bedroom 3), and screamed. The father, mother, and son were sleeping in the master bedroom (bedroom 1), were awakened by the scream, and met the daughter in the hallway (Figure 1). Led by the father, they slowly moved to exit through the front entry door. When the family reached the end of the hallway, the fire and smoke intensity was too severe to exit through the front or kitchen. So they retracted to the daughter's bedroom and attempted to exit through the window. The window proved too difficult to open; therefore, they moved to the bedroom (bedroom 2) across the hallway. The father broke the window glass, slid out, and fell outside. He

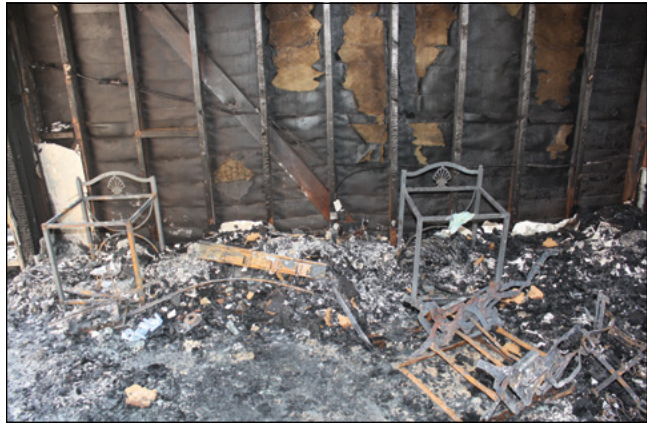
Figure 2
Origin area of FD.

Sheriff and fire department investigators performed the origin and cause (O&C) investigation after the fire was controlled and suppressed. They observed the remains of a candle (**Figure 2** and **3**) in the northeast corner of the living room and then talked to the father in the hospital. When the father was asked whether candles were used the previous night, his answer was yes. Based on the fire department report, the origin of the fire was located in the northeast corner of the living room on the lower shelf of a metal & glass end table, and the candle(s) was listed as the cause of ignition.

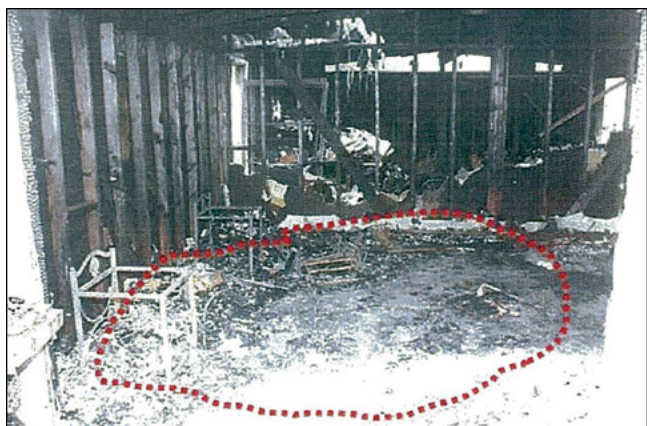
Figure 4
Origin area of private O&C.

A private fire O&C investigator, retained and shared by the gas utility and the landlord's insurance companies, performed an investigation the next morning (8/22/2011). The O&C investigator talked to sheriff's department investigators and learned about the candle. He opined that the origin was approximately half of the area comprising the east side of the living room (**Figure 4**). The electrical circuitry/wires and systems of the building were eliminated with the exception of the electrical/electronic components (namely, the remains of TV and stereo equipment) belonging to the tenant, which were found along the east wall of the living room. Though these components were within his origin area, the unattended candle was, in his opinion, the cause (ignition source) for the fire.

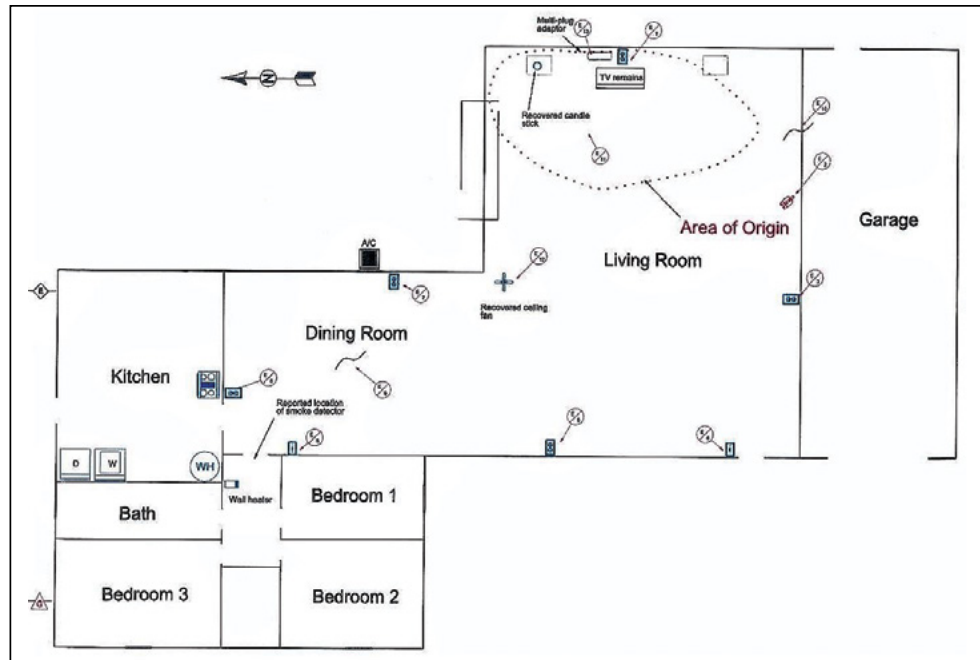
Figure 5
Evidence locations.

This private O&C investigator had collected several items as evidence (**Figure 5** and **Figure 6**). The alleged unattended candle was not saved/preserved by any of the scene investigators.

Thirteen electrical items from the subject home were examined (Figure 5 and Figure 6). For each item, the failure/damage hypothesis was synthesized, and postulates were generated/tested to determine whether an item had an internal failure and produced (or was capable of producing) heat for the ignition of the coterminous fuel.

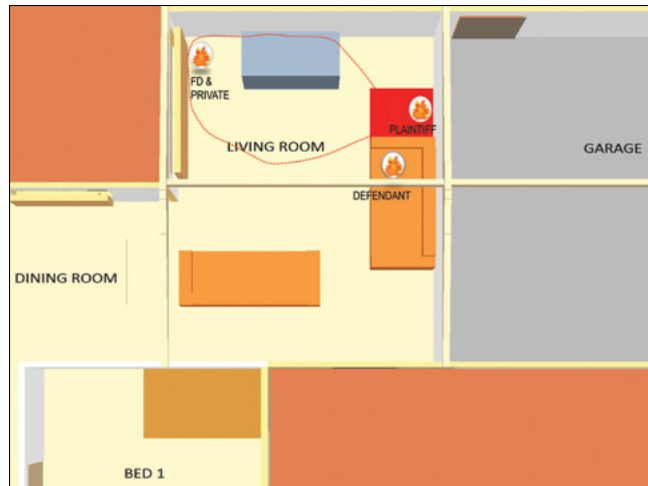
Figure 10

Four O&C investigations were performed, and the investigators had different opinions (**Figure 10**). The fire department investigator (#1) opined that the origin was in the northeast corner of the living room, and the unattended candle was the cause (ignition source). As mentioned, the first O&C investigator of the landlord

(#2) opined that the area of origin was approximately the east half of the living room, the building electrical system was eliminated, the tenant's electrical and electronic equipment could not be eliminated, and the unattended candle was the cause.

The O&C expert (#3) of the tenant (plaintiff) opined that the origin was in the south wall close to the east

Disputed origins within living room.

end of the couch. He further concluded that electrical failure/heating at the male-female plugs of the extension cords was the cause. The defendant (landlord) retained a second O&C expert (#4), who opined a flashover had occurred in the living room, the origin could not be determined, and the candle on the north wall of the living room above the couch was the cause. His origin was different than scene investigators (#1 and #2), and he stated that his opinions were based upon the review of the family photos and depositions (fire department, plaintiff experts, and family). He did not perform scene investigations nor examine the preserved evidence.

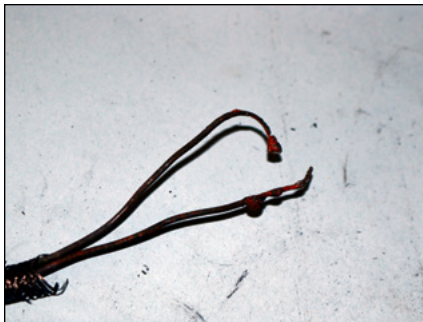
Figure 12

Analyses of the microscopic photos of evidence item #10 (Figure 12 and 13) and X-rays of evidence item #13 (Figure 14), combined with observed failure modes of these items, supported the hypothesis that there were no internal electrical failures within the items (causative of ignition) but that these items were damaged by external exposure to fire. Evidence item

Evidence item #10 melted conductors.

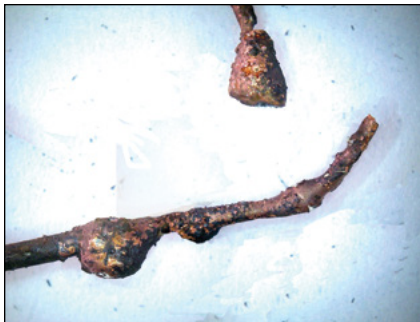
Figure 13

Microscopic view of evidence #10.

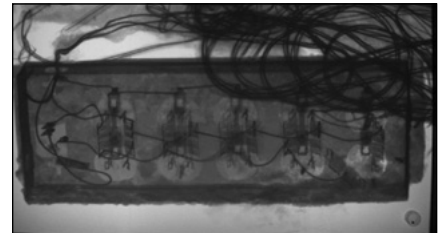
Figure 14

X-Ray evidence item #13 Power-Tap.

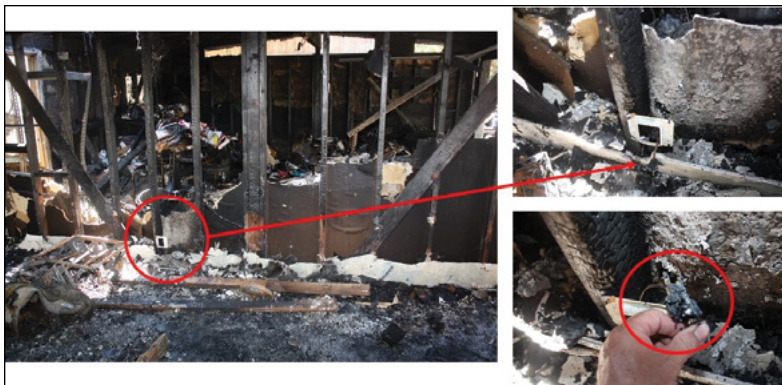
Figure 15

Evidence #2 male-female plug remains in the living room.

#2, identified as a male plug from the south wall of the living room (**Figure 15** to **16**), had evidence of localized re-solidified and fused/bonded metal. The examinations determined that these were parts of male and female plugs of extension cords.

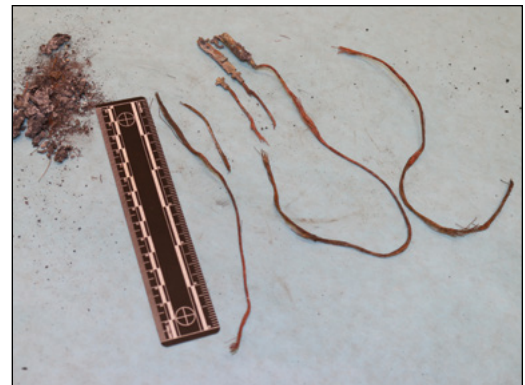
Figure 16

View of male-female plug remains collected.

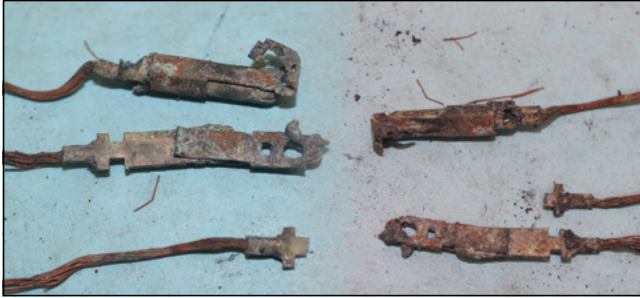
The two extension cords were daisy-chained, the failure-mode was localized, and internal melting of the prongs/blades was consistent with electrical resistance heating and faults/arcs (**Figure 17** and **18**). Evidence item #3 shows the remains of the outlet behind the couch in the south wall of the living room (**Figure 19**).

Figure 17
Closer view of male-female prongs.

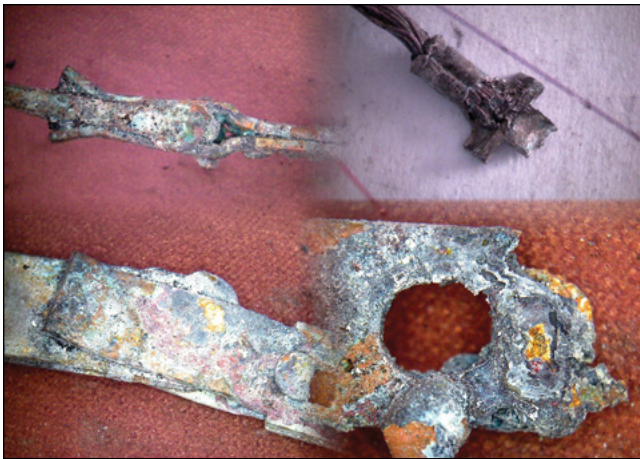
Figure 18
Microscopic views of male-female prongs.

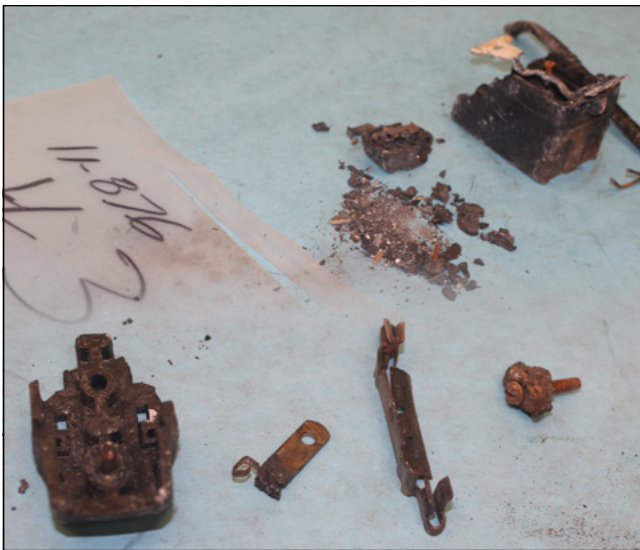
Figure 19
Evidence #3 outlet from the south wall of living room.

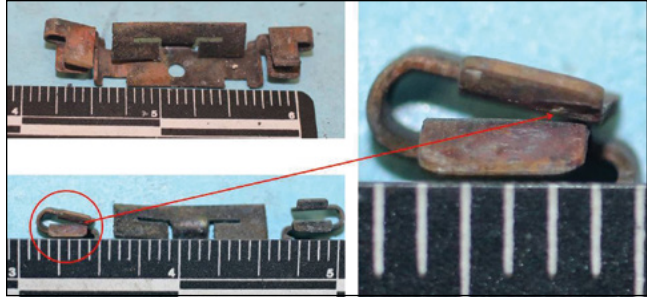
Closer examinations found the witness mark of an arc within the line-side slot of the receptacle (**Figure 20**). This suggested that there was a plug in that receptacle, and a parting arc had occurred when the energized blade was pulled/separated from the receptacle during the fire spread.

Figure 20
Witness mark of parting arc within evidence #3.

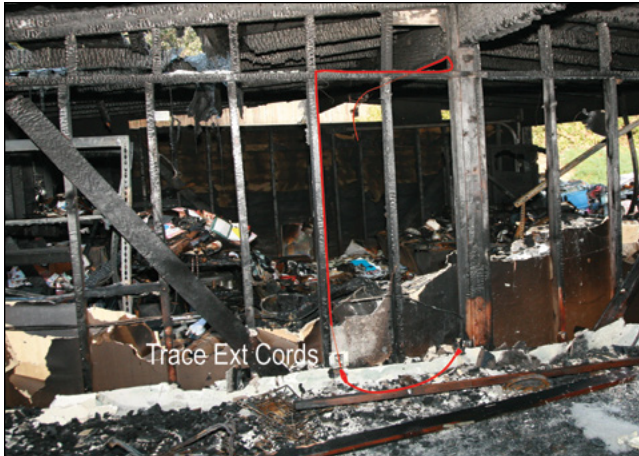
Figure 21

Engineering analyses determined that the male plug of the short extension cord (A) was plugged into the receptacle (Evidence item #3) behind the couch. The male plug of another extension cord (B) was plugged into the female plug of extension cord (A). The daisy-chained cords went through the wall into the garage, up to the bottom of the roof beam, and ran (north to south)

Trace of extension cords from living room to garage.

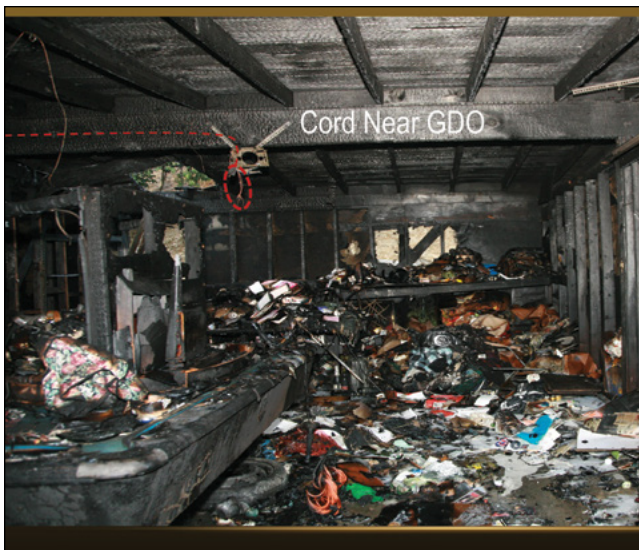
Figure 22

View of the trace of cords in garage.

along the side of the beam (supported by nails) and into the receptacle box, where the power cord of the GDO was plugged (**Figure 22**).

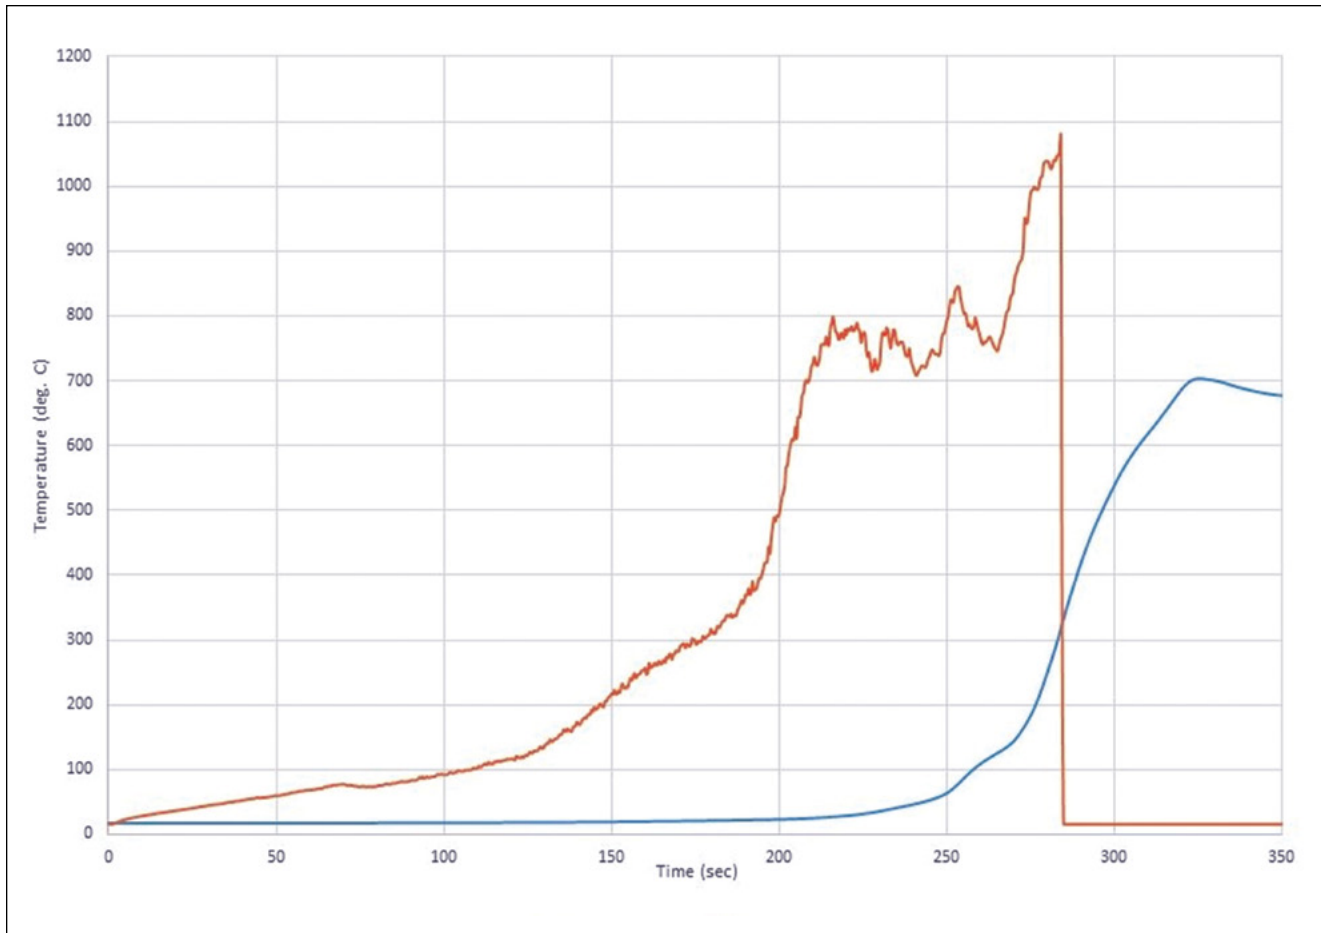
Figure 33

analyses showed that simulation temperatures at item #2 were significantly below the melting temperature of copper, the temperatures at item #10 exceeded this threshold (**Figure 33**), and the fire would burn through the drywall into the garage. These were consistent with the evidence and damage.

Q5 modified simulation temperatures @ 1-foot and 8-foot (red) elevations south wall.
