Journal of the  
**National**  
**Academy** OF  
**Forensic**  
**Engineers**<sup>®</sup>

Vol. 34 No. 2 December 2017

# Forensic Engineering Analysis of Alleged Construction Defects

By Michael Stall, PE (NAFE 955M)

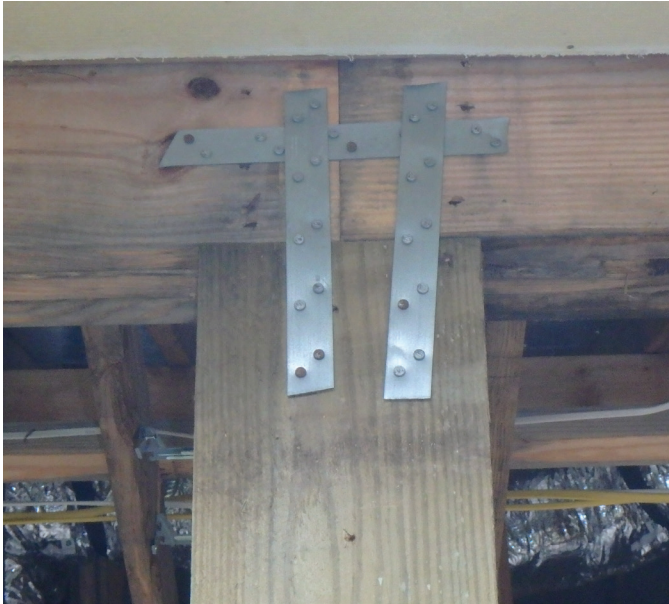
**Figure 2**  
Defective connection.

**Figure 2** shows a builder-caused defect where the column-to-beam connection was not constructed as it was designed.

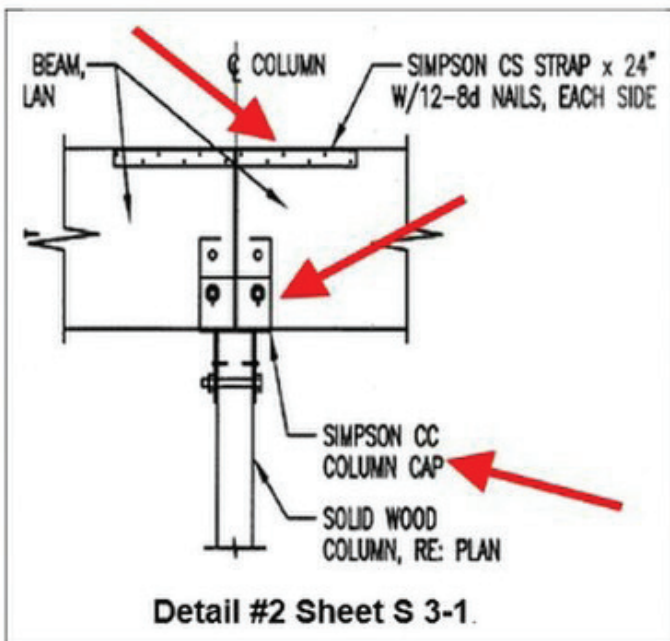
**Figure 3**  
This is how the connection in Figure 2 was designed.

**Figure 3** is the applicable drawing detail that specified the required column cap, which was not installed by the contractor. There was no mystery in the design, and there was no logical reason why the specified column cap was not installed by the builder. The possible future observable defect would be a distressed or failed connection after a wind storm of sufficient magnitude to stress the defective connection. **Figure 4** provides another example of a builder-caused defect where this post foundation was not constructed as designed — with the wood post being directly embedded in concrete. **Figure 5** shows the drawing detail that specified the required foundation configuration and anchor.

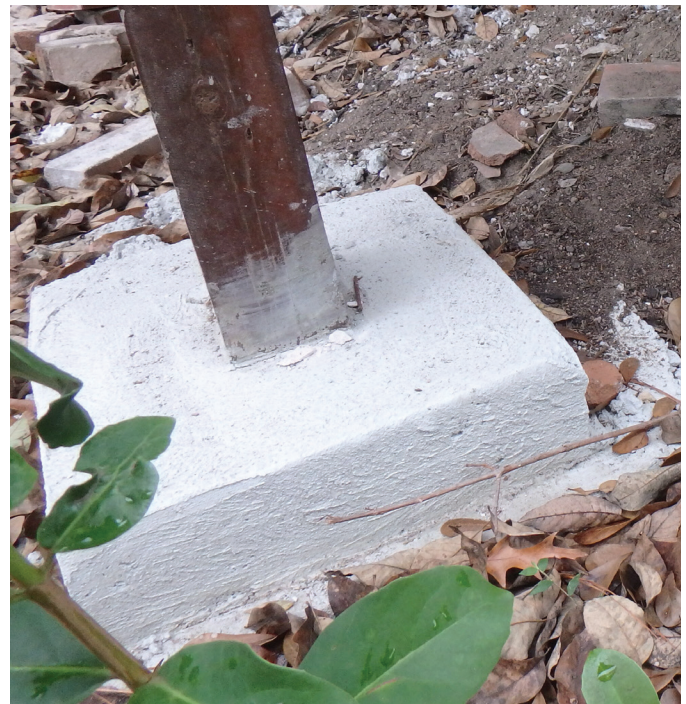
There was no configuration mystery because the design illustrated how the post was supposed to be connected to the concrete. The future defect will be a rotten column because water will seep through the bricks and not drain away from the wood post. These two examples show contractor mistakes that could lead to serious hidden damage during the building's life cycle.

**Figure 4**  
Incorrect configuration.

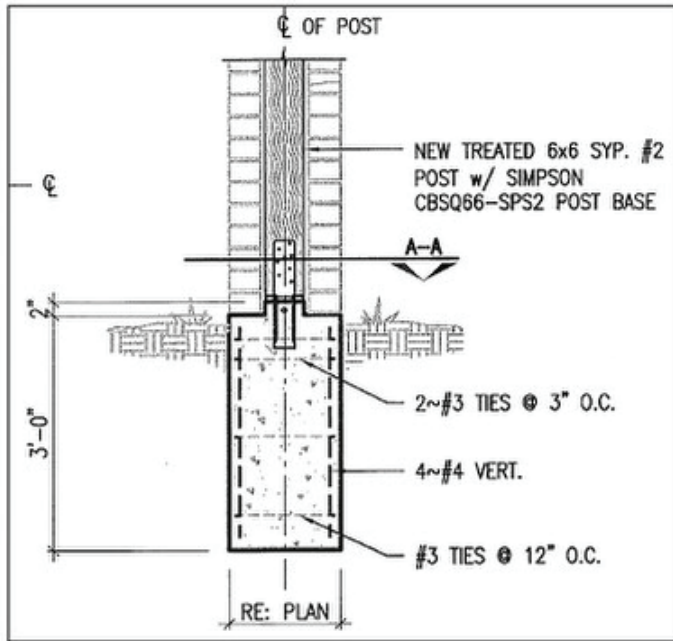
**Figure 5**

This is how the connection in Figure 4 was designed.

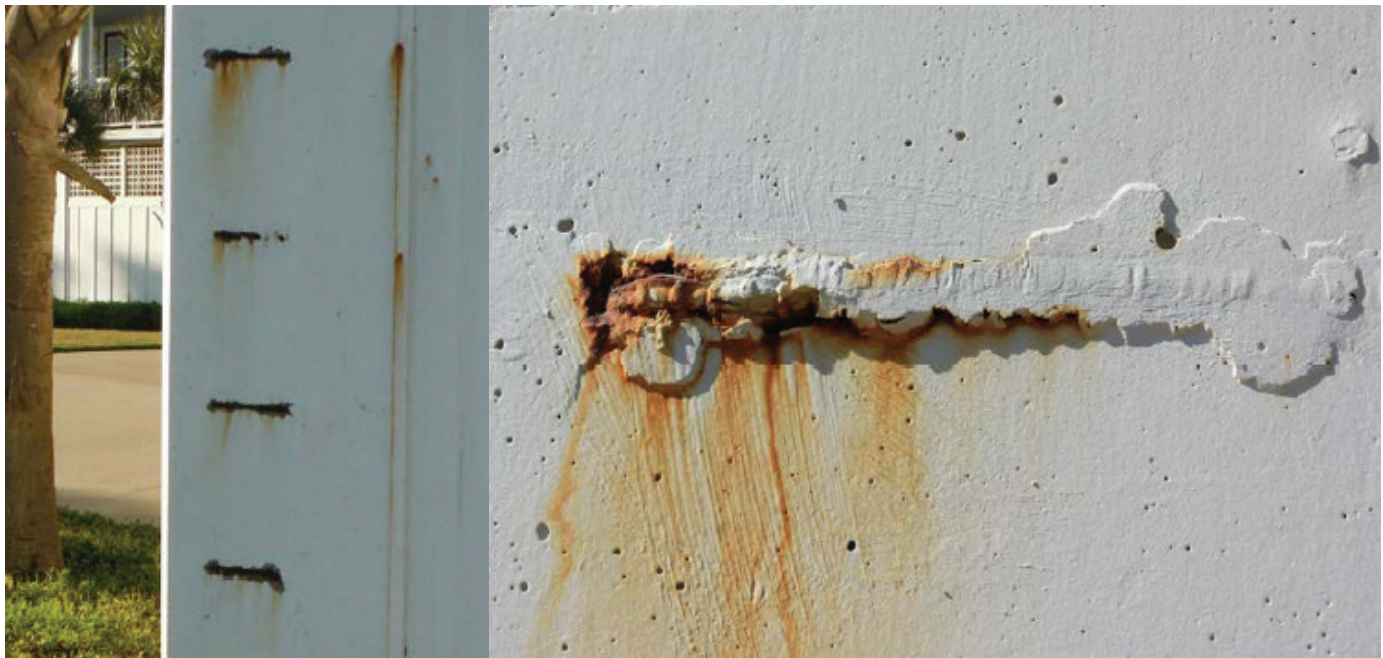
**Figure 6** shows a condition where the contractor failed to provide sufficient concrete cover over reinforcing iron in a high-corrosion environment located near the Gulf of Mexico. Visual observations, coupled with investigation of project documentation, revealed how this mistake occurred. The contractor failed to detail and fabricate the horizontal reinforcing column bands correctly, which resulted in more than 500 columns being compromised because of insufficient concrete cover over the bands.

Since this was a corrosive environment near the beach, the lack of extra concrete cover as specified by the American Concrete Institute (ACI) for corrosive environments resulted in accelerated corrosion and deterioration.

**Figure 6**

Insufficient concrete cover over reinforcing iron results in corrosion.

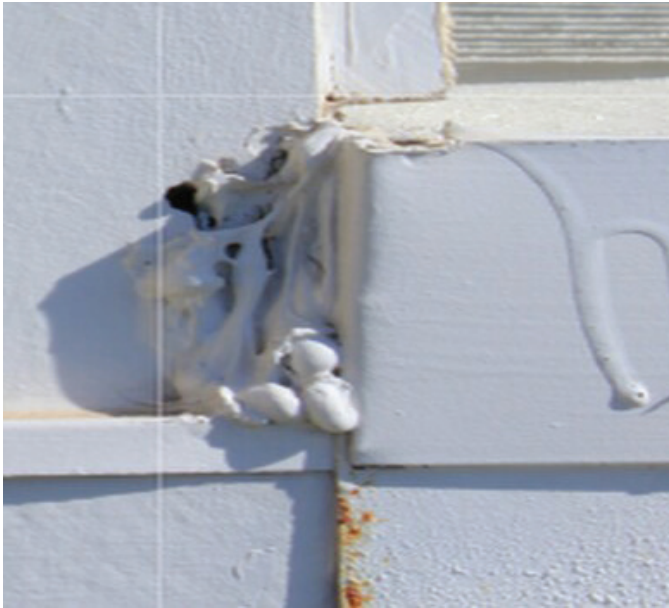
**Figure 8**  
Questionable caulking.

**Figure 8** demonstrates a non-workmanlike caulking application. Based on a visual observation, one could

conclude that the builder made a mistake, but that could be wrong. This could be a post-construction hurricane repair activity, the building could have been recaulked and painted, or a condominium owner could have done this. Interviewing the condominium owner, evaluating the layers of paint, researching condominium maintenance records, and considering other information (such as construction punch lists and hurricane repair scopes) could result in the conclusion that this is a post-construction mess not caused by the builder. These two examples show either simple construction defects or deficiencies that could have been caused by activities the builder was not responsible for. The forensic engineer must keep an open mind that will evaluate all information and then make conclusions based on that information.

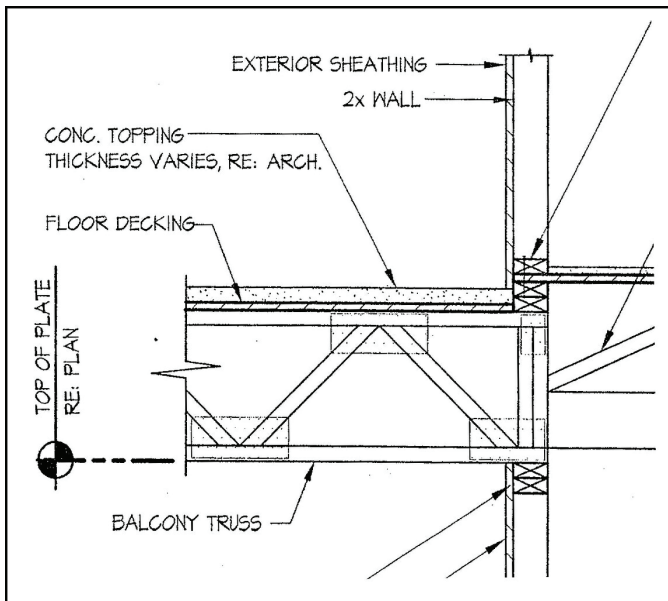
**Figure 10**

Wall/patio interface design.

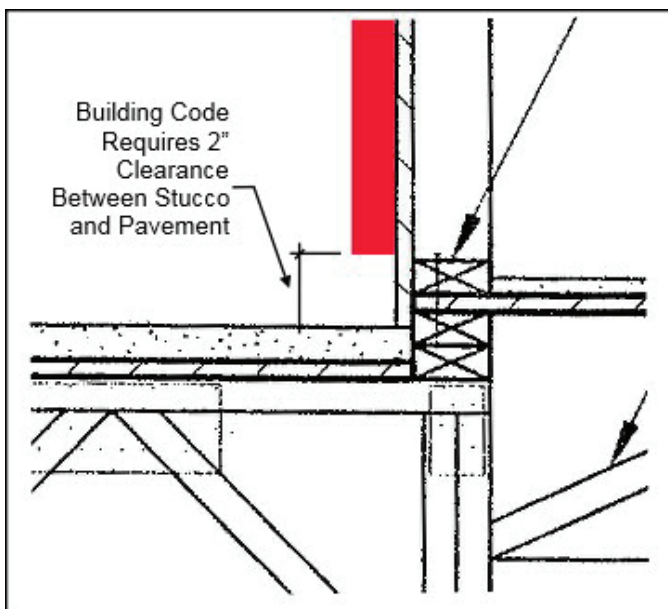
**Figure 11** shows the code-required distance between the stucco and the patio, which is not possible unless a system of flashing was designed to cover the bottom plates and the bottom edge of the sheathing — something that would not be acceptable because the threshold elevation would have to be raised to allow continuous integration of the wall flashing with a threshold door pan flashing assembly to ensure the threshold would not leak.

Stucco Code requirement.

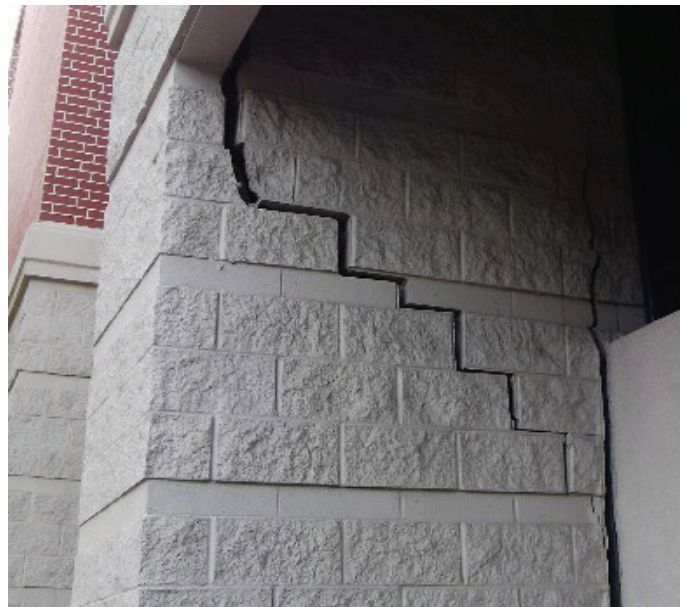
**Figure 12** is an example of what was first thought by building owners to be a construction defect, but subsequent investigation and analysis determined the

Failing support walls.

failure was caused by a structural engineering design error.

The initial forensic engineering observations were of a failing structure that appeared to be collapsing in certain areas. The first possible cause investigated was whether underground utilities in the area were leaking and causing this failure. When an in-depth evaluation of the utilities was performed (using in-line cameras and other location equipment as part of the forensic analysis), the conclusion was that there were no utility leaks causing erosion or failure of the soil around the building.

The next phase of the forensic evaluation was to interview the structural engineer who was honest and admitted that the failure shown in **Figure 12** was a design mistake because the backfilled soil around the building had insufficient strength for the load imposed by the bricks, concrete blocks, and supporting concrete footings. The conclusion of the structural engineer was that to prevent future collapse — and to stabilize the perimeter of the building — helical piers needed to be installed to provide sufficient supporting strength for the footings, concrete blocks, and brick veneer on the four-story building.

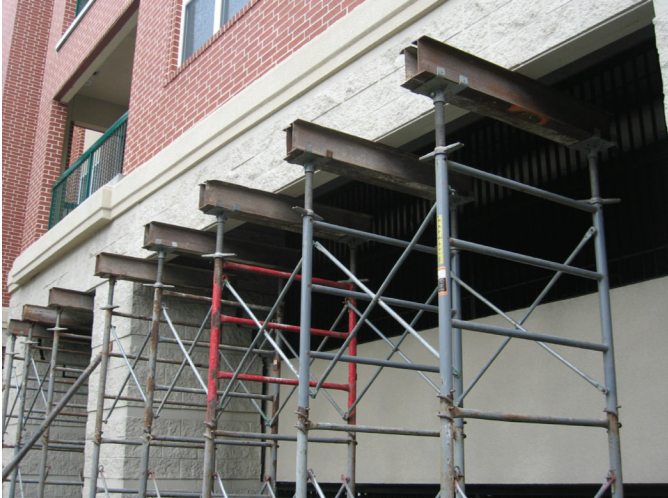
**Figure 13** shows another design error that was discovered in addition to the failure shown in **Figure 12**. **Figure 13** shows one of the numerous headers that were supporting open spans between the concrete block columns around the perimeter of the building. Other fractures observed at the corners required forensic evaluation

**Figure 13**  
Over-spanned headers.

to determine the cause. The structural engineer reviewed the calculations with the forensic engineer and concluded that the headers were over-spanned for the capacity of the built-up steel header members, proving that this was a design error, not the responsibility of the builder.

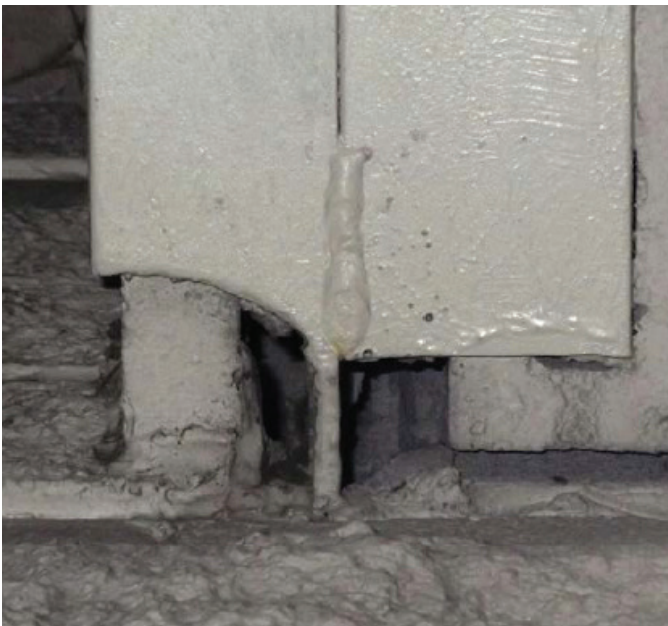
**Figure 14** shows a combined design and construction error. The over-spanned header shown in **Figure 13** that was incorrectly designed by the structural engineer was also mistakenly cut by the contractor, which resulted in the header improperly bearing a sharp edge rather than the entire width of the member. The original design mistake and this construction error combined to create a design

**Figure 14**  
Incorrectly cut header.

and construction defect; however, the over-spanned condition caused by the design mistake was the controlling defect because the bearing issue had not caused damage.

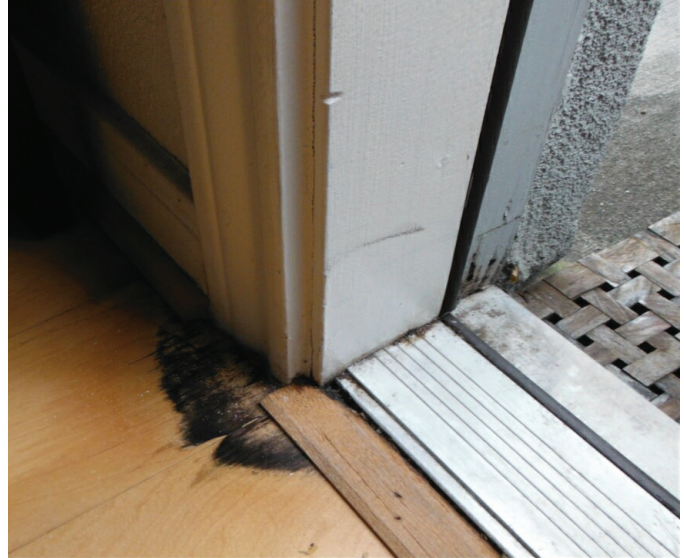
**Figure 15**  
Floor damage.

**Figure 15** shows what appears to be damage to a wood floor and door jamb from a leaking threshold and possible construction defect. **Figure 16** shows the wall base flashing just outside of the door is a deteriorated mess of rusted metal.

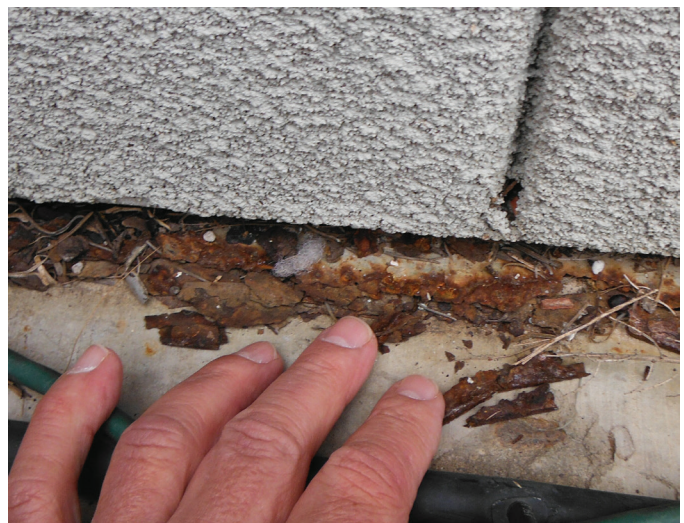
The initial hypothesis could be that this is a construction defect, but further investigation resulted in a different

**Figure 16**  
Rusted flashing.

conclusion. The owner of this condominium unit had an extensive collection of large potted plants and citrus trees on the patio that was serviced by a drip watering system, which resulted in a chronically wet patio. Additionally, the floor drain (located about 4 feet from this wall) was at a higher elevation, so water was not directed away from the flashing. Steel flashing is galvanized when it is manufactured, but when it is cut during fabrication, the exposed

edges are no longer as corrosion resistant as the surface. Normal industry standards are to install metal flashing without corrosion-protective measures on the edges. The solution to this problem was to use lead-coated copper flashing with soldered seams, which are more corrosion resistant than cut galvanized sheet metal. Lead-coated copper was not specified by the designer either because the designer was not aware of it or because it cost more money than the developer wanted to spend. Economics, the designer, the developer, the contractor, and the material provider all had a role in choosing the flashing material that failed.

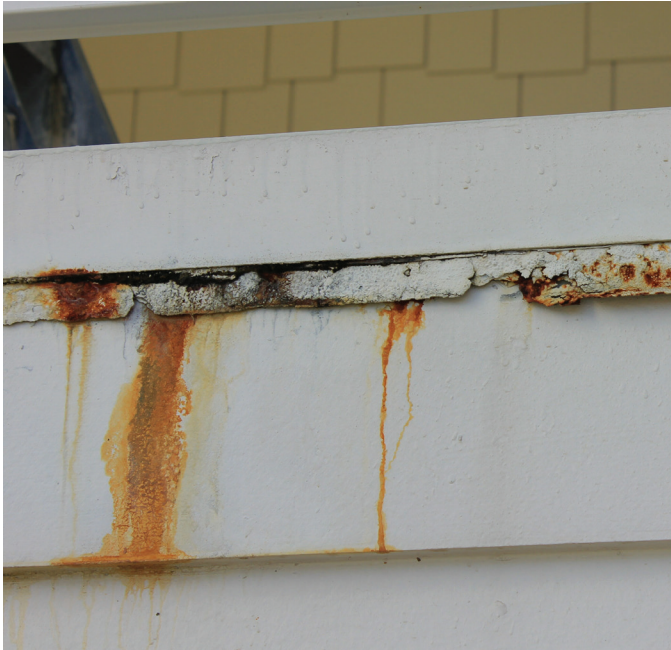
**Figure 17**  
Rusted flashing.

**Figure 17** shows a situation that was observed throughout a 28-building condominium near the beach. This was a disappointing situation for the condominium owners because the condominiums were only about six years old when this evaluation was performed. A cursory visual inspection could lead to the preliminary conclusion that either the wrong flashing material was specified by the designer or the builder failed to use the correct material. Metallurgical evaluation of flashing material that was not rusted showed the galvanizing code for seaward properties, which requires heavier galvanizing than what is used in buildings located away from the beach. In this case, the correct flashing was specified by the designer, but the builder ordered the wrong material.

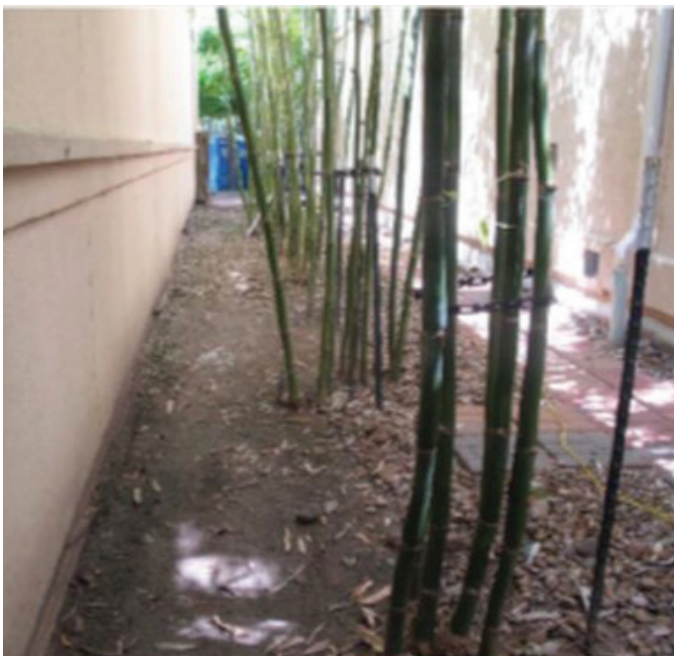
**Figure 18** illustrates what a forensic engineer identified as a failure to grade this side of the building with a swale for proper drainage as required by the code. That engineer concluded that the contractor or developer failed to meet the standard of care because the configuration of this side of the property did not meet the building code requirements for slope and drainage. In fact, the engineer surveyed elevations near the neighboring structure on top of pavers installed after construction and used that as “evidence” to suggest the contractor or developer caused defective drainage on this side of the building.

**Figure 18**  
Observed “defect.”

Reviewing construction photographs and researching the building inspection documentation (which showed the original drainage configuration was code-compliant and approved by the city) were basic forensic engineering evaluation steps that should have been taken prior to reaching final conclusions. Had the engineer performed this diligent analysis, he should have reached the conclusion that the site had been changed materially during the eight years since construction — and that the builder and developer had no responsibility for the changes.

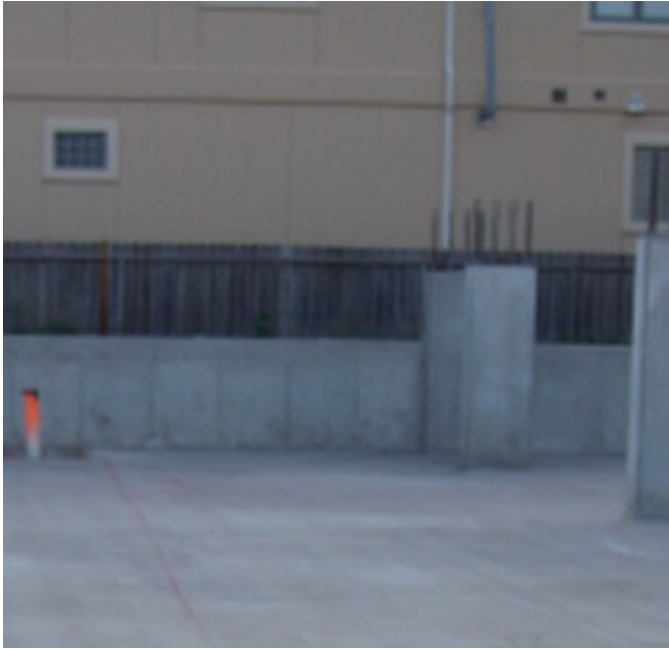
One of the important elements of a forensic evaluation the engineer failed to perform was to investigate the history of the condominium project before making definitive conclusion that the builder or developer failed to meet the standard of care. **Figure 19** is a photograph that was taken during construction, showing clear evidence that over time, site conditions (and related drainage) had changed between the buildings; the photo shows no bamboo was growing during construction and that there was a

**Figure 19**  
Different site condition.

fence between the properties.
