Vol. 34 No. 2 December 2017

# Forensic Engineering Evaluation of an Allegedly Deficient Steam Turbine Foundation

By Dharendra S. “Sax” Saxena, PE (NAFE 586F)

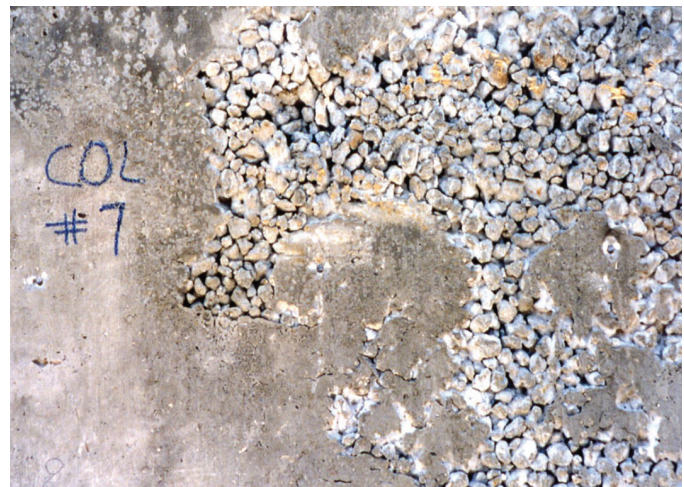
**Figure 1**

During the construction of an STG structure within a powerplant complex in west central Florida, an alleged severe deficiency was asserted regarding concrete structures. A significant amount of concrete was cast into a total of eight structural columns with interconnecting overhead beams. Upon removal of the forms, a visual inspection revealed an objectionable condition in the form of concrete honeycombing, segregated aggregate, voids, and rock pockets. It was observed in a major portion of the 20-ft structure’s height in most of the columns and beams, and appeared more severe in the lower, 8- to 12-ft,

zone. Likely factors contributing to this condition ranged from exceeding the specified lift of deposited layer thickness during concrete placement to inadequate consolidation of placed concrete. **Figures 1** and **2** illustrate these conditions.

Close-up showing honeycombing and segregation of concrete.

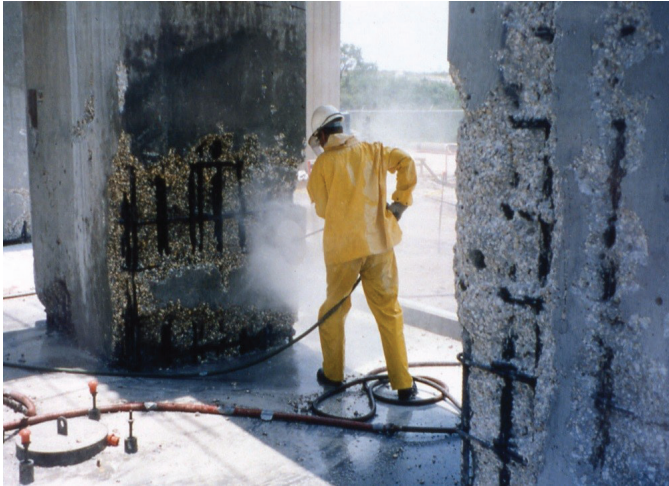
**Figure 2**

Voids and rock pockets being cleaned by hydro-blasting.

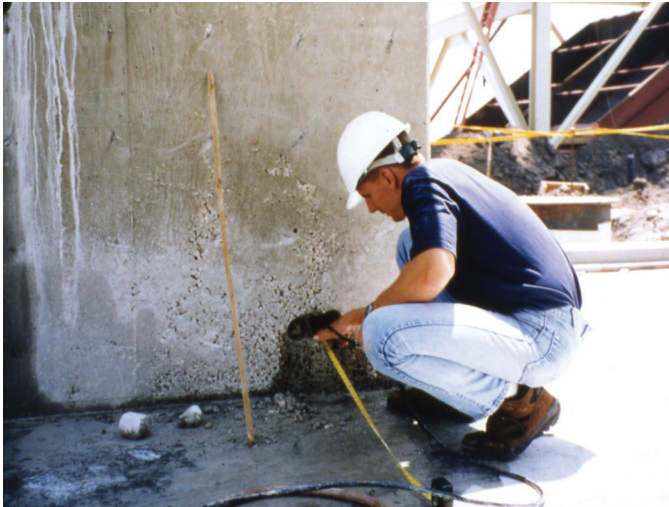
**Figure 3**

Insertion of the video camera through corehole near column base.

documented and evaluated any unusual characteristic within the concrete as is illustrated in **Figures 3** and **4**. All the 22 core locations were examined to complete the internal condition assessment.

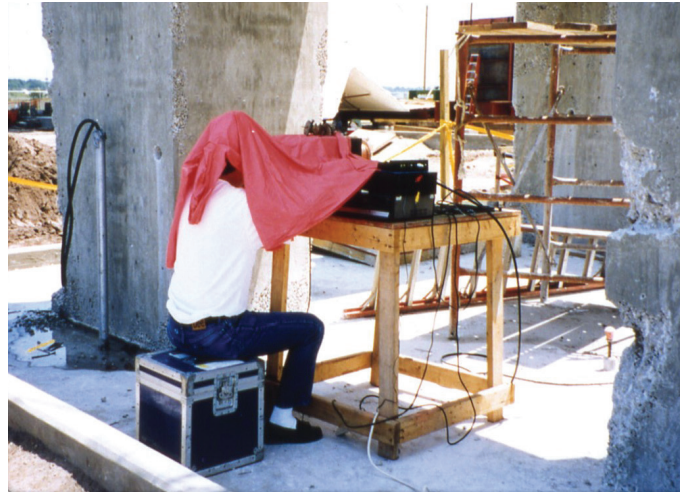
**Figure 4**

Petrographer examining the video screen for internal soundness.

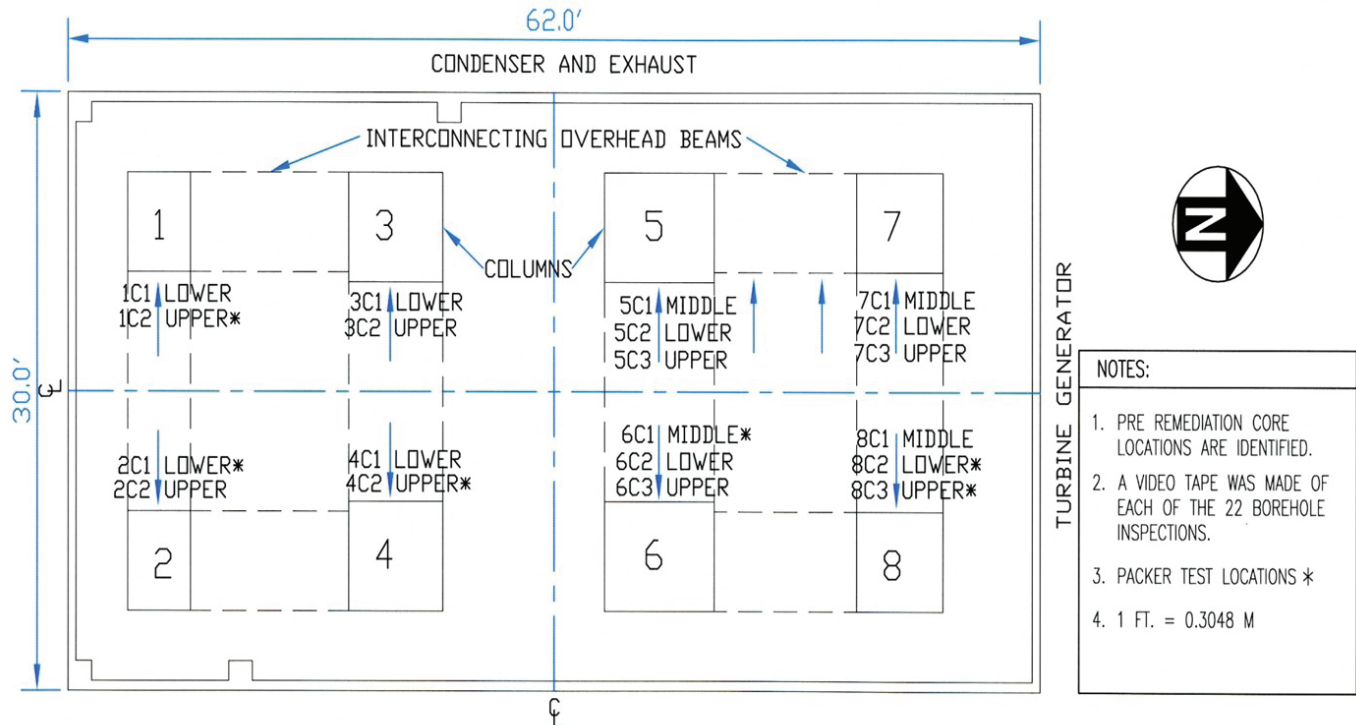
**Figure 5**

STG structure layout identifying columns, overhead beams, core, and Packer test locations.

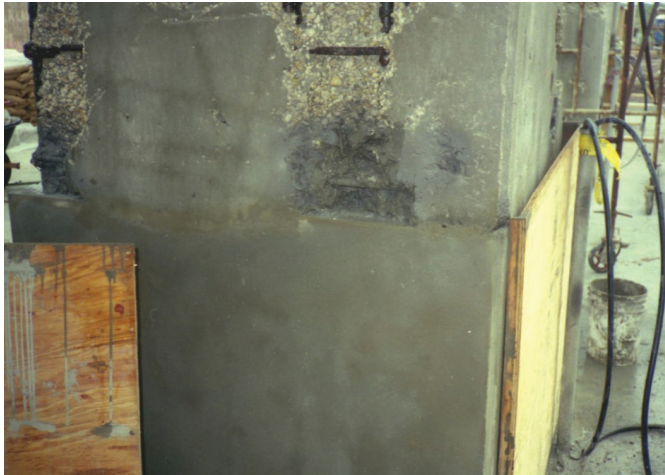
**Figure 6**

View of exposed column with pre- and post-restoration areas.

During the entire Stage 2 restoration program, the retained consultant provided monitoring and inspection services for various operations including quality of the grout, forming, and the application procedures. Any defects in workmanship or grouting quality were immediately noted and corrected by the specialty subcontractor. Some overhead beam areas were determined to be lacking in bond as determined by visual separation in core specimens. These areas revealed insufficient bonding, and the specialty subcontractor was directed to chip the grout out for inspection and re-perform the repairs. A typical photograph showing sections of a pre- and postremediated column is shown in **Figure 6**.

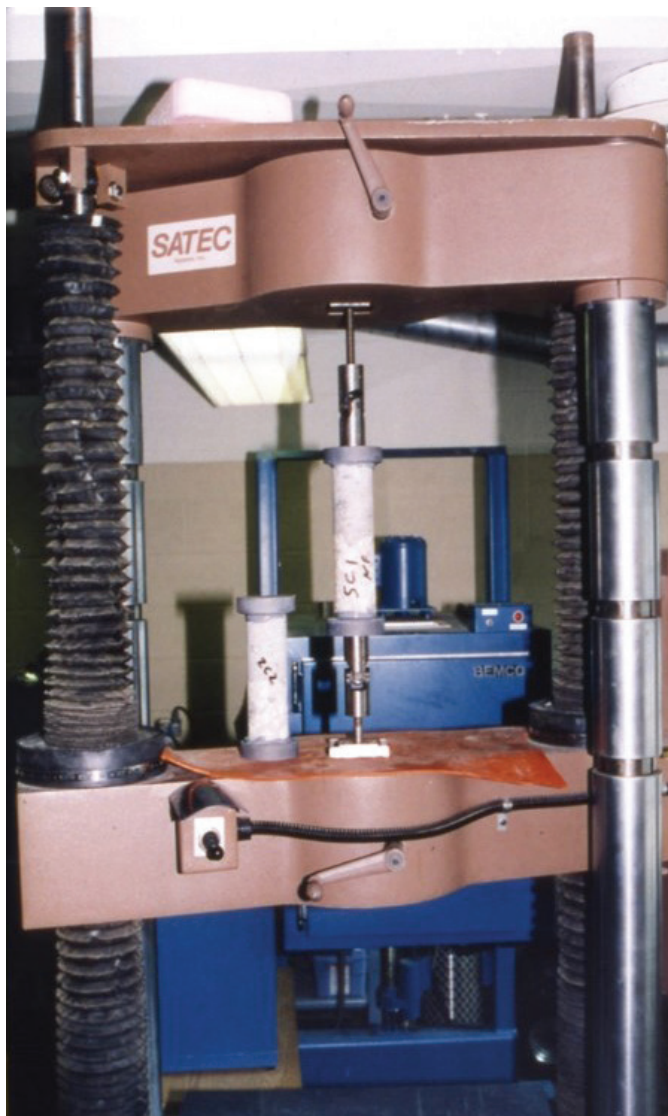
**Figure 7**

Tensile test set-up.

The core specimens were subjected to direct tensile strength tests (ASTM C496) and exhibited failure within the original concrete with the failure mode to be through paste and aggregate as illustrated in **Figures 7 and 8**. In addition, the average direct tensile strength values of the core specimens in remediated or restored areas compared favorably (i.e., equal or greater) with that of the original concrete core specimens. Failure characteristics were noted to be normal.

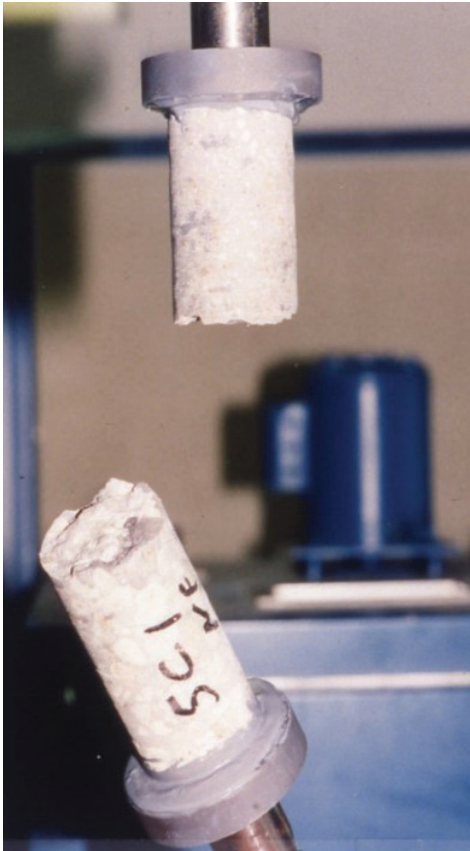
**Figure 8**  
Tensile strength tested core.

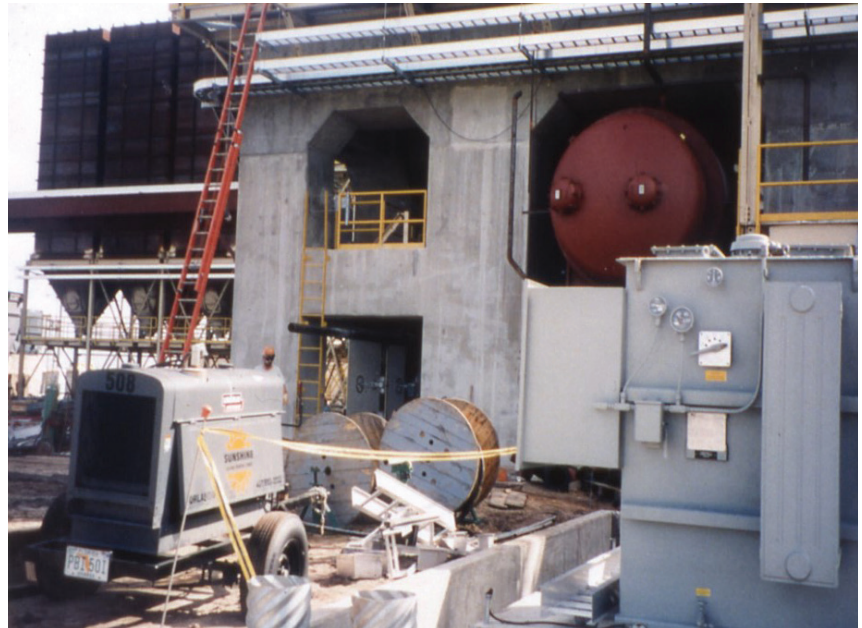
- The final repair resulted in restoration of the STG structure to its originally planned and designed dimensions and design conditions, as depicted in **Figure 10**.

**Figure 10**  
View of repaired STG structure.

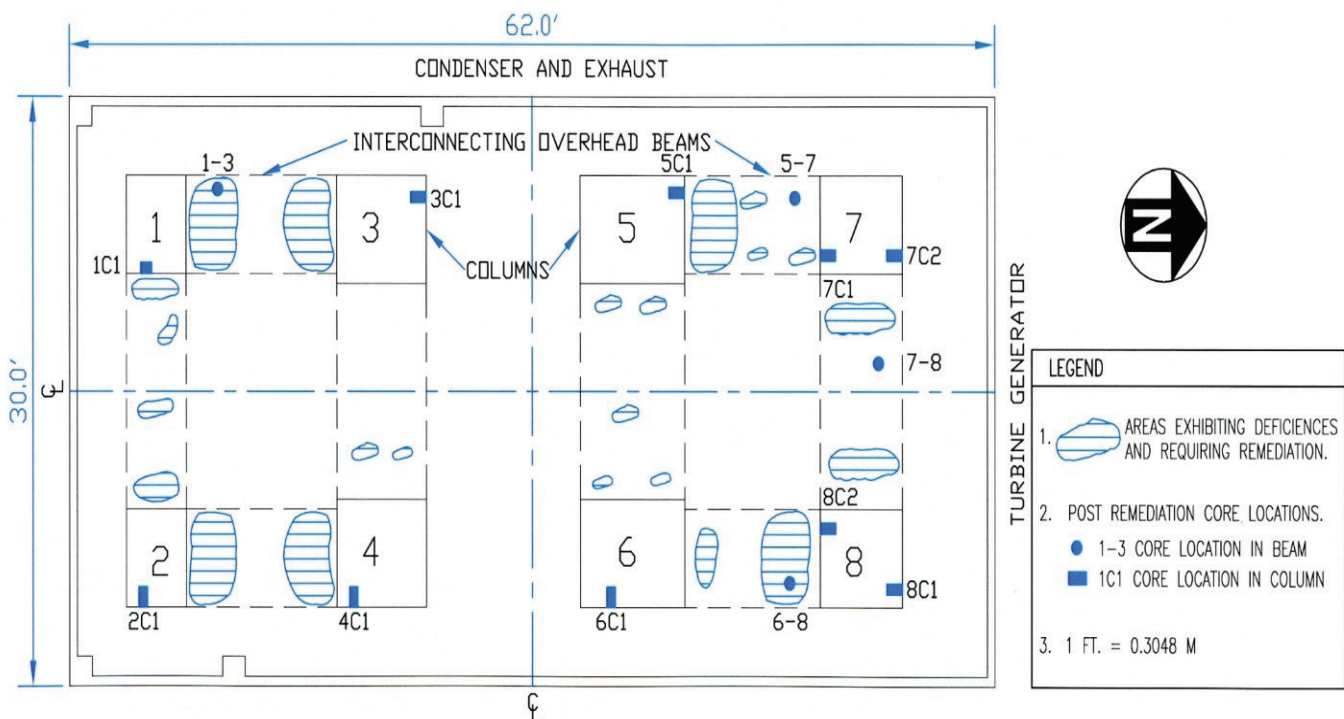
The STG structure layout showing areas exhibiting deficiencies and requiring remediation as well as the PostRS core locations is shown in **Figure 9**.

**Figure 9**  
STG structure layout showing deficient areas and post-remediation core areas.
