Journal of the
National
Academy OF
Forensic
Engineers[®]

Vol. 34 No. 2 December 2017

Forensic Engineering Analysis of a Motorsports Racing Incident

By Stephen D. Knapp, PE (NAFE 891S), Richard M. Ziernicki, PhD, PE (NAFE 308F), and Ben T. Railsback, PE (NAFE 713S)

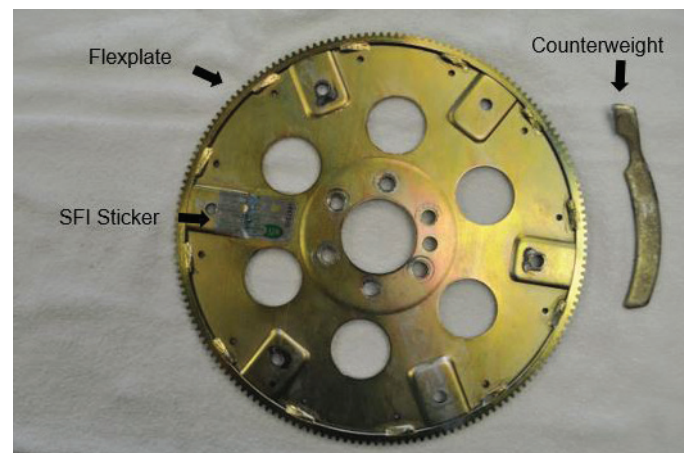
Figure 1
Subject flexplate with separated counterweight.

The subject flexplate (**Figure 1**) includes a stamped steel inner disc with the ring gear and counterweight welded to the inner disc. It was manufactured to work with an externally balanced Chevrolet-based 454 Cubic Inch Displacement (CID) engine. The flexplate was labeled with a SEMA Foundation Inc. (SFI)² 29.1 certification sticker.

flexplate inner disc by hand (manually), rather than using an automated process like the ring gear connection to the disc. As observed in **Figure 1**, the counterweight is detached from the flexplate assembly. Three welds were observed on the subject flexplate steel inner disc in areas that were intended to join the counterweight to the flexplate assembly. However, the welds between the flexplate inner disc and counterweight did not fully join and penetrate the counterweight during the welding process. The lack of weld penetration is clearly visible, as shown in **Figure 5**. It can be seen that between the arrows there is no significant melting consistent with the counterweight having been joined with the flexplate inner disc as a result of the welding process. The lack of penetration, melting, and joining of the two parts is a welding defect known as a “cold weld.” Because the product is coated with a gold-colored anti-corrosion material (zinc dichromate) after welding, certain welding defects, cracks, or disparities would not be visible to those handling the product after it was manufactured by Company D and prior to the counterweight separation.

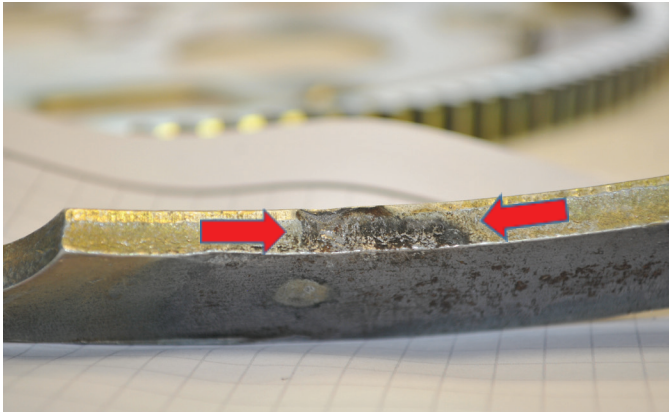
Figure 5
Lack of weld penetration.

Metallurgical analysis consisting of Scanning Electron Microscopy (SEM), sectioning of the counterweight, and metallography further confirmed the lack of weld penetration to the counterweight during the assembly of the flexplate. Metallurgical properties consistent with the machine blank formation of the part were also visible in the area where the weld was attempted. During the stamping process, the counterweight is machine stamped from a sheet of metal under extreme mechanical pressure using a custom die. The pressure initially cuts the materials, but as the process progresses, the remaining stock separates from the stamped sheet metal as a result of high shear forces.

The root cause of the flexplate counterweight detachment was due to a manufacturing defect and failure to properly secure the subject counterweight to the flexplate at the time of assembly. The lack of weld penetration over a small effective weld perimeter allowed the counterweight to fail after minimal use.

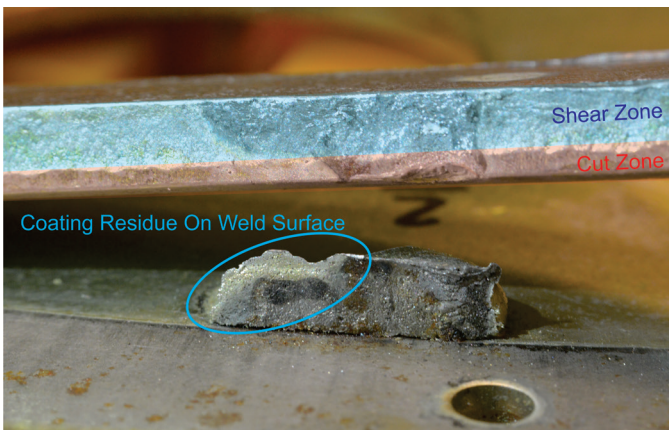
This shearing process creates two very distinct patterns on the edge of the counterweight, as shown in **Figure 6**. The portion of the part that is cut by the die has a clean and smooth edge as highlighted in red text in **Figure 6**. The portion that shears and separates from the stock material has a rough and unfinished surface, as highlighted in

Figure 6
Failed counterweight and weld — blue area indicates shear region; the red area indicates area cut by die; the gold coating found on the weld bead surface is circled in blue.

blue in **Figure 6**. These characteristics run the length of the edge of the counterweight. Melting of the material due to weld penetration would eliminate these surface characteristics during a proper welding process. However, it can be seen in **Figure 6** that these surface characteristics remain in the area that the counterweight was intended to be welded, and confirms that it lacks weld penetration. Further, the gold coating that is applied after the welding process is visible on the surface of the weld circled in blue in **Figure 6**, indicating that the materials were not joined at the time of the gold coating application.

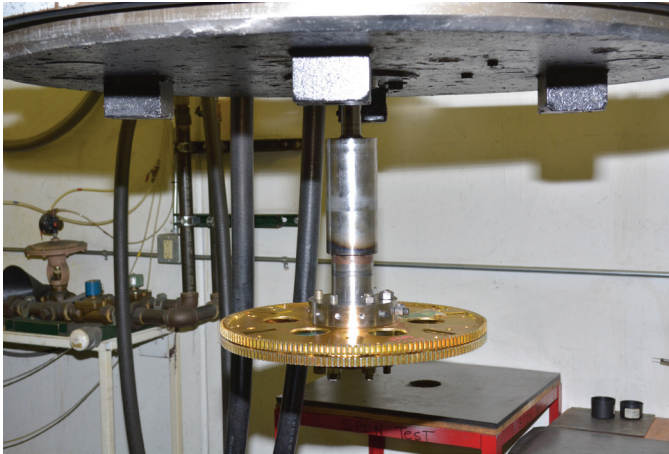
Figure 7

Testing of exemplar externally balanced flexplates.

two exemplar flexplate assemblies were coupled together with a test fixture having their counterweights opposite of each other to make a balanced assembly (**Figure 7**). Spin testing of the exemplar flexplates was conducted above 12,500 rpm for one hour in accordance with SFI 29.1 without failure to either of the flexplate assemblies or attachments of the counterweights.

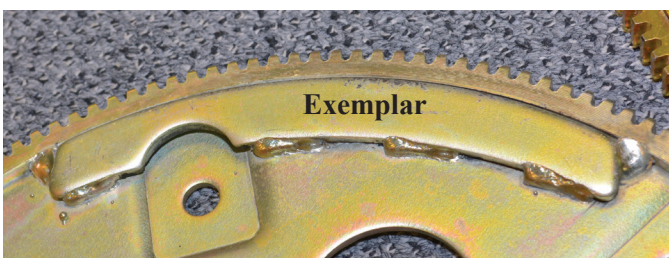
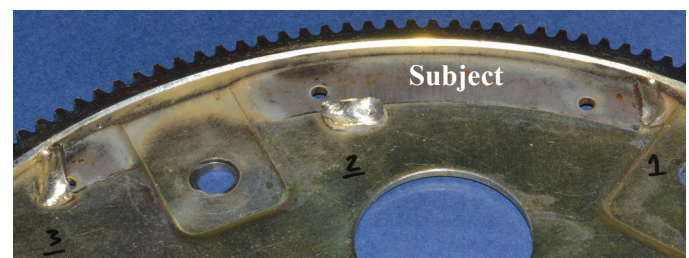
Figure 8

Discovery documents indicated that the Company D “heavy-duty” flexplates were supposed to be manufactured with additional welds as its sales literature indicated: “Balancing weights are not only resistance welded but are also MIG welded for better holding power of these weights.” However, based on visual examination of the subject counterweight, the process of joining the counterweight to the flexplate with resistance welding was omitted on the subject flexplate.

commercially available on the market. Examination of these flexplates shows that the common industry practice of securing the counterweight to the flexplate assembly is with five to six individual MIG welds encompassing the perimeter of the counterweight. This was different than the subject flexplate that used three relatively small MIG welds for securement of the counterweight, as shown in **Figure 8**. While stress analysis shows that the three welds would be adequate to secure the counterweight to the flexplate and even meet the requirements of SFI 29.1, the fewer number of welds increases the probability of a counterweight separation in the event of a defective weld.

Comparison of the counterweight securement between an exemplar and the subject flywheel.
