Vol. 34 No. 2 December 2017

Forensic Engineering Analysis of a Fatal Trailer Wheel-Separation Failure

By Stephen A. Batzer, PhD, PE (NAFE 677M)

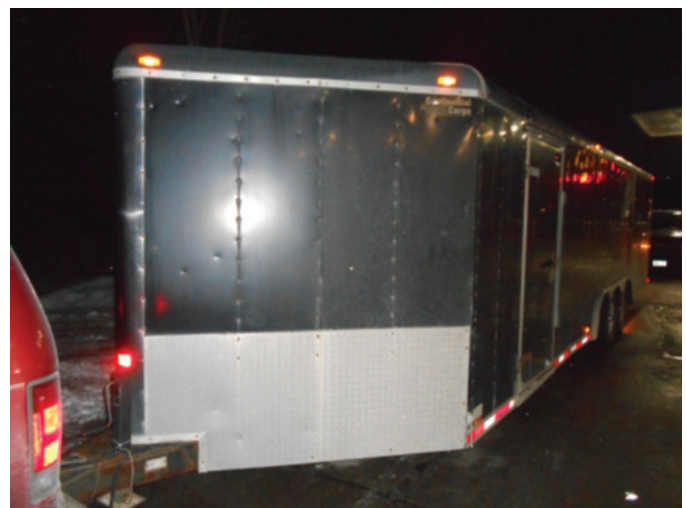
Figure 2

Accident trailer at a gasoline station; the left front wheel is missing.

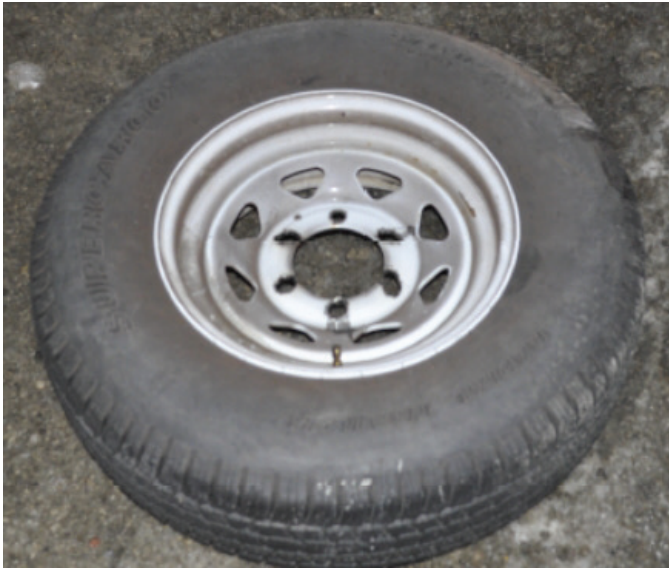
Figure 3

The damage to the stamped steel wheel (**Figure 3**), shows that there had been significant undesirable rotational interaction between the wheel and the studs prior to stud failure. The observed damage to the stud holes must have occurred during the trip. It is not credible that anyone would mount a wheel that showed damage of the sort evident on the wheel. The elongation of the mounting holes showed violent and sustained back-and-forth relative motion of the wheel relative to the hub. Marking on the wheel indicated that it had a 2,600-pound capacity, which indicated that the six-wheel trailer could hold a nominal 15,600 pounds on the wheels plus some additional load through the tongue and trailer hitch. Since the trailer's GVWR was 15,600 pounds (as listed on the data plate), the detached wheel was of the appropriate weight capacity. Loading was also not an issue for the tire, nor the contents, as the driver of the Expedition estimated that the total trailer load was only 6,500 pounds. Furthermore, there was no problem encountered when the trailer was driven back with the same load on only five wheels.

The wheel was in new condition when mounted prior to the subject trip. As shown in **Figure 3**, the detached wheel showed no rust whatsoever, while the other wheels on the trailer exhibited light to moderate rust.

Wheel at point of rest at the accident scene. Note rust-free exterior.

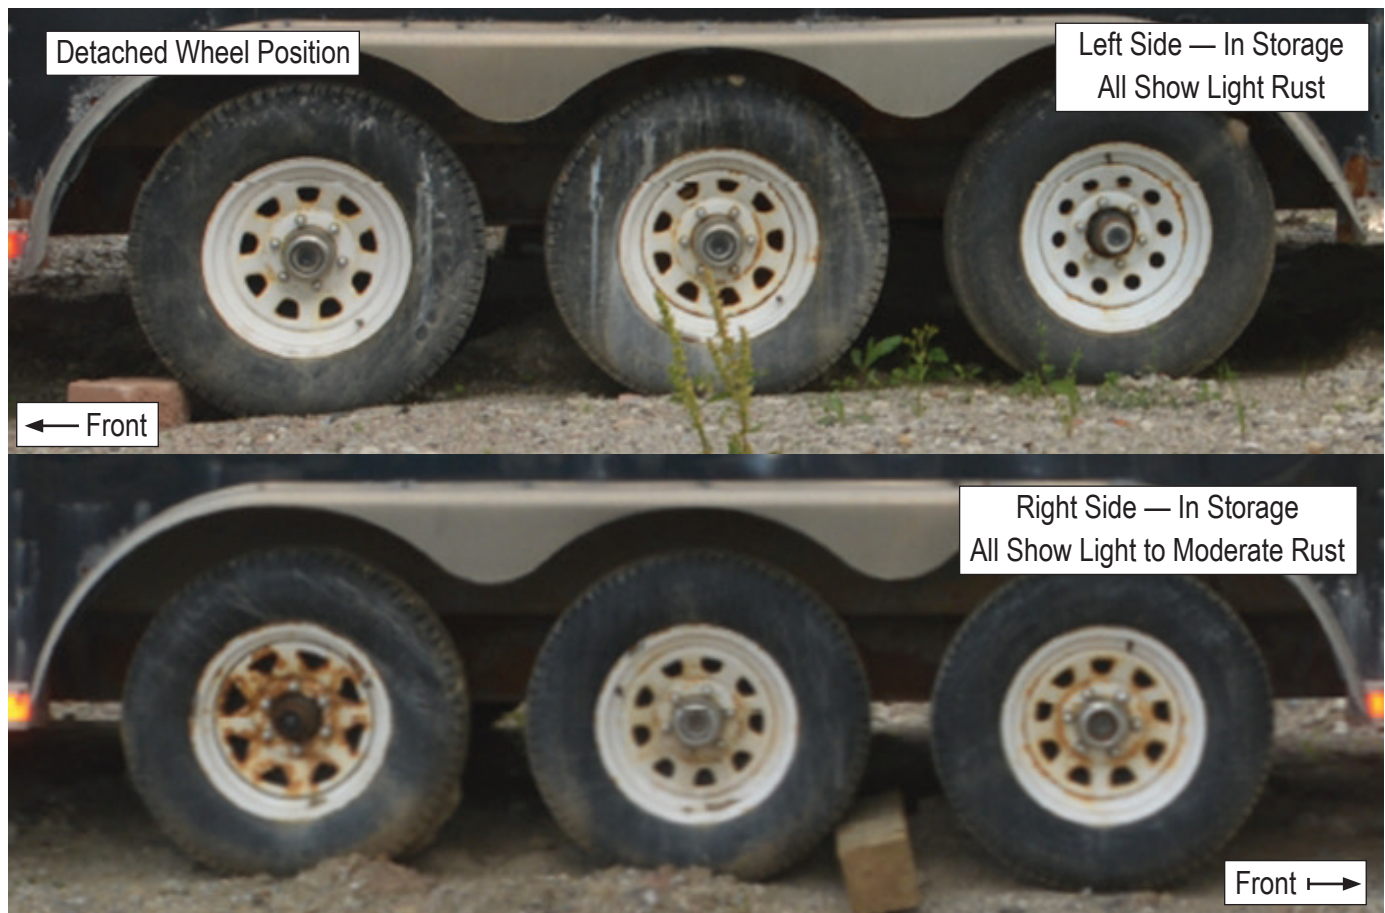
Figure 4

repaired, as six wheels (not five) were present. In addition, the wheels do not correspond one-to-one to scene photographs. They are in varying states of corrosion, and

the wheel cutouts do not match, indicating that the wheels are not identical in model. This shows that various wheels had likely been replaced over time on this trailer.

Accident trailer at a gasoline station; the left front wheel is missing.

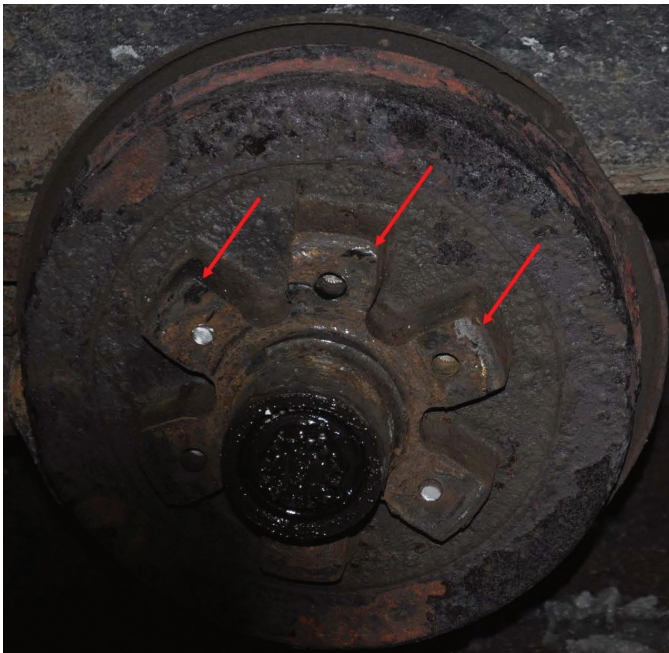
Figure 5 shows the trailer's left side front hub at the scene. Flaking rust plausibly diminishes the ability of the studs to provide the clamping force that fixes the wheel to the hub. This friction is necessary to prevent the wheel from slipping and rotating relative to the hub and damaging the lug studs. There are several high points that wore through the flaking rust near the periphery of each mounting interface. Three of these are called out with red arrows. This photo also documents that the grease cap was dislodged during the wheel loss. Five of the six fractured studs are visible in this photograph. Each shows a silver-colored fresh fracture surface. The two studs at 12 o'clock and 2 o'clock are broken below flush. The fracture surfaces of these two studs are in the vicinity of the stud splines. This indicates that the mounting studs were subject to damaging cantilever bending moments, and their mounting holes through the hub were distorted. Note: In this picture, the 6 o'clock stud is not visible, and the 8 o'clock stud has

Accident trailer left front hub at time of accident.

fractured below flush and is only barely visible. While this hub is rusty, it is not any rustier than the five other hubs, which did not fail. Therefore, the rust is not a reasonable explanation to the loss of clamping force and failure.

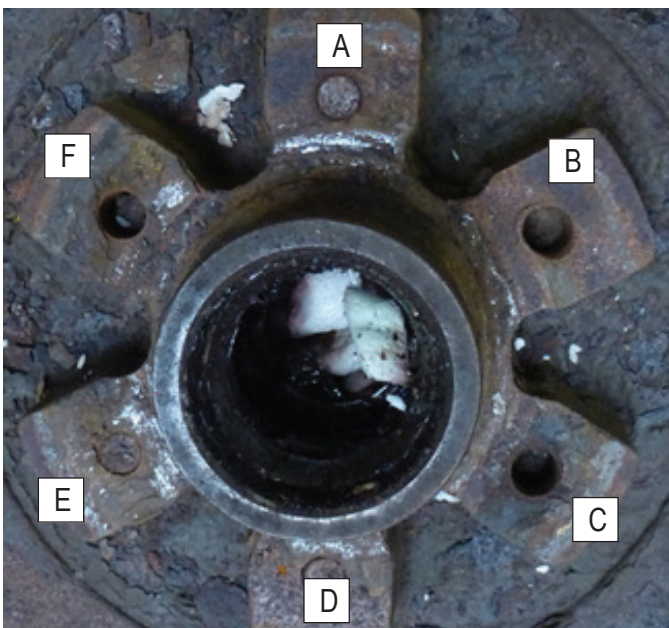
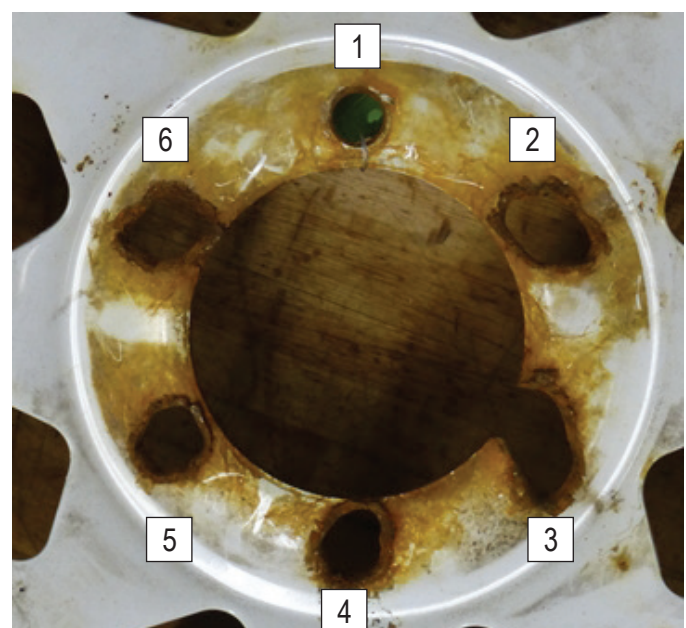
Figure 6

were damaged simultaneously, but they failed sequentially. **Figure 6** shows a close-up photograph of the failed wheel (at left) and the hub (at right). The least-damaged mounting hole was labeled 1. The remaining holes were labeled 2 through 6 clockwise. Shown to the right of the wheel photograph is a close-up photograph of the hub, in what is believed to be the same orientation as it was during the incident to match the wheel (hub stud position A was assembled to wheel hole 1). Note that during the forensic investigation, the studs were not labeled as they are for this paper, as the comparison and analysis had not been made. That is, the original choice of which stud was “A” was made at random, and the stud originally labeled “A” did not line up with wheel hole position 1.

The basis for the postulated match-up of wheel to hub was comparison of maximum damage at each position. Therefore, it is reasonable to assert that the maximum wheel damage, as evidenced by the most elongation of the stud mounting holes, matches the maximum hub damage, as shown by below-flush fracture of the studs. The three most damaged holes are B, C, and F. These correlate to the same positions on the aligned hub photo 2, 3, and 6. Note that the wheel in **Figure 6** is shown from the out-board side, so the hole to stud positions match; they are not mirror images, which they would be if the mounting face of the wheel were shown.

Accident trailer wheel and hub oriented to most likely mounting alignment.

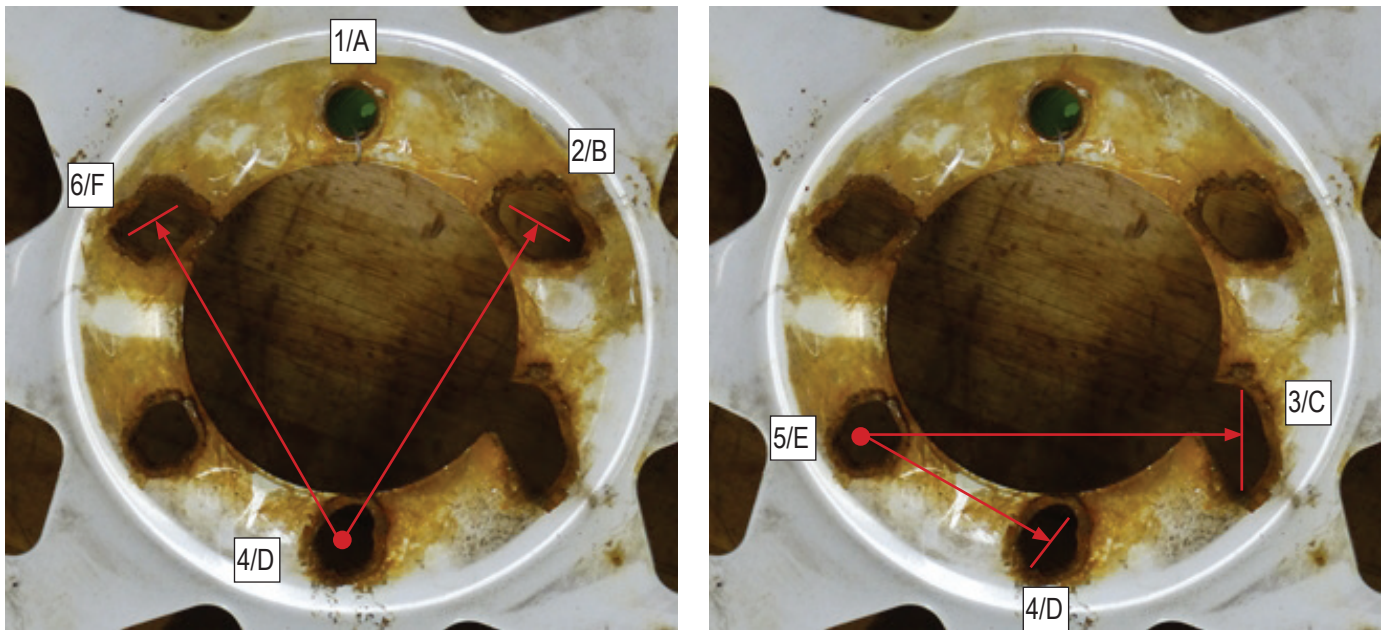
Figure 7

Graphic analysis of stud fracture sequence caused by changing fixation forces.

the impacting steel wheel, and the studs impacted the holes in an orbital motion, causing circumferential damage. At some point, a single stud fractured during this most minimal early stage of damage. This was hub stud A and wheel hole 1, as shown in **Figure 6**. After stud A at wheel hole position 1 fractured, each wheel hole was more or less round due to previous uniform circumferential impacts by the studs. With only five studs remaining, the wheel was less rotationally constrained, and the holes/studs adjacent to hole 1 (that is, hole 2 / stud B and hole 6 / stud F) were disproportionately and incrementally damaged as the wheel rotated approximately about stud D, which is opposite fractured stud A. This caused studs B and F to fracture in close succession, although which of the two studs fractured first is not clear. After studs A, B, and F fractured, the holes at those positions (1, 2, and 6) were no longer damaged. With three remaining studs (C, D, and E), the wheel was even less constrained, and damage occurred to these remaining three studs at an accelerated rate. The damage at wheel hole 3 shows that the wheel rotated about stud E. Both wheel holes 3 and 4 show this damage of rotation about hole 5 / stud E, and studs C and D failed in quick succession. Wheel hole position 4 shows less damage than does wheel hole position 3. Thus, stud D likely fractured before stud C. Stud E failed last, freeing the wheel and tire, which departed and struck the oncoming vehicle. Thus, the progression (as based upon the damage analysis) was likely stud A, next studs B and F, then stud D and C, and finally stud E. This analysis is shown graphically in **Figure 7**.

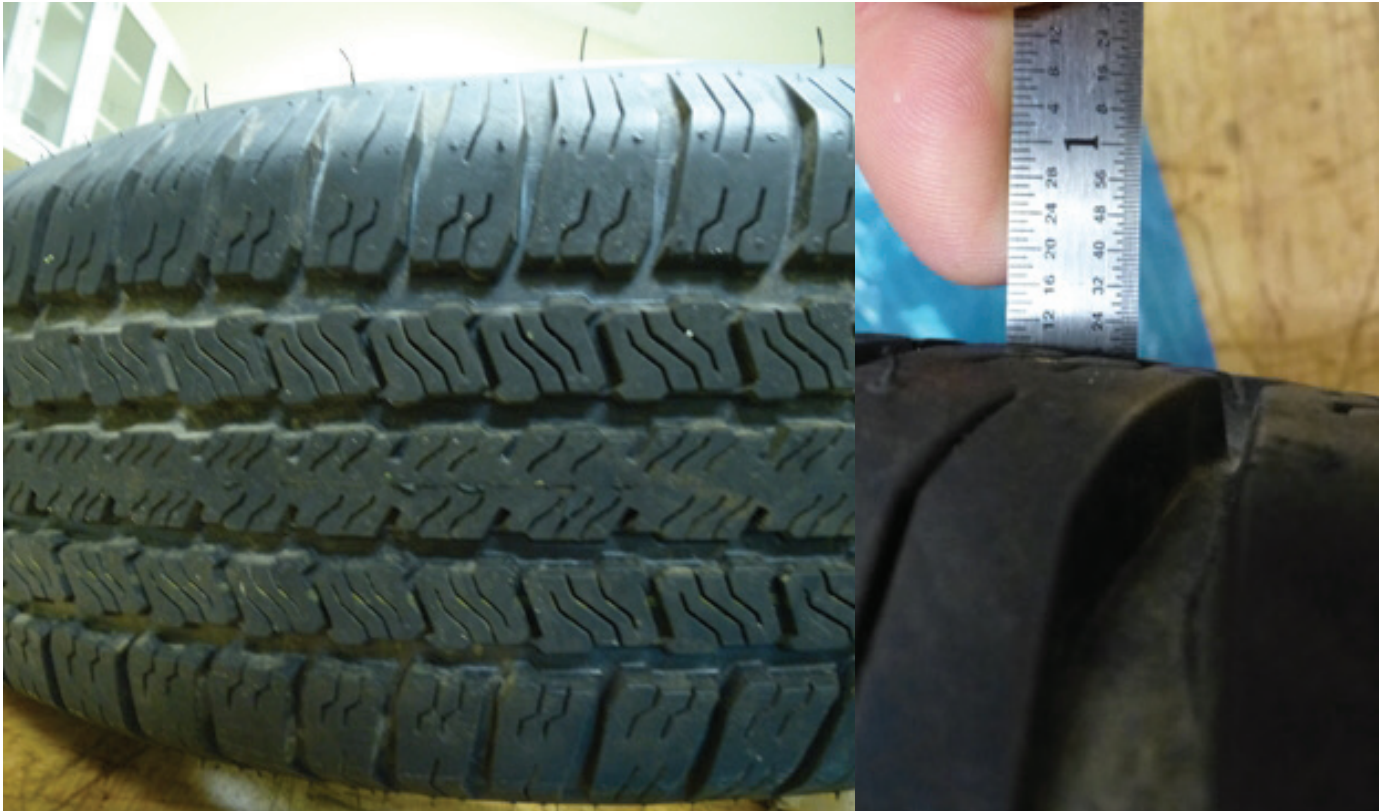
Figure 8

Examination of the accident tire shows that it was in new condition at the time of mounting, just prior to the wheel detachment (**Figure 8**). The measured tire tread depth measured minimum 9/32 inches while new tread depth is 10/32 inches. This is a radial tubeless tire, size ST225/75R15, labeled “FOR TRAILER SERVICE.” Maximum load is 2,830 pounds, Load Range E, 80 psi maximum. The overall diameter is 28.5 inches. As the photo documents, the mold sprues were still present.

Accident trailer tire showing manufacturing sprues and deep tread.

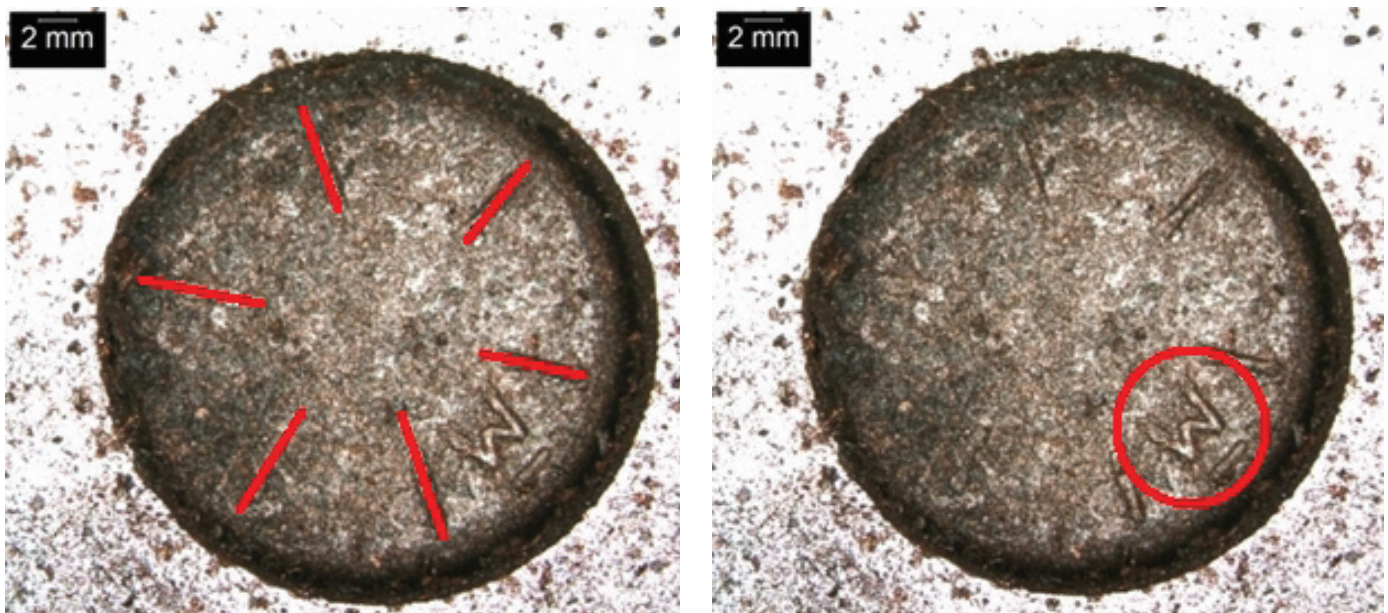
Figure 9

Stud marking indicating SAE grade (left, highlighted in red) and manufacturer (head stamp encircled in red highlight).

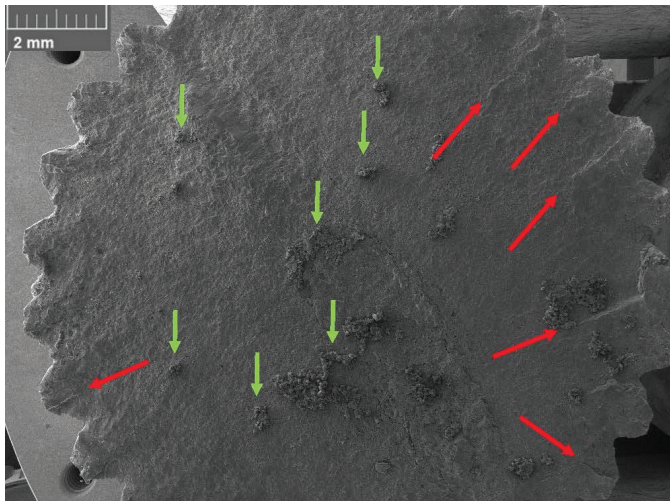
Figure 10

SEM photograph of stud fracture surface.

bath to remove superficial corrosion. Each stud was removed from the bath before the corrosion transformation was complete to prevent collateral damage. The remaining corrosion is clearly depicted by the SEM (scanning electron microscope) photograph set forth in **Figure 10**. Various untransformed surface corrosion areas on the fracture surface of stud A are called out with short downward-facing green arrows.

A macro-indication of fatigue is contained in the SEM photograph. These ratchet marks are called out by red arrows pointing to the periphery, which, in this case, are the splines. SEM photographs of studs A, B, C, E, and F exhibited peripheral ratchet marks, a common feature of fatigue initiation. The uncleaned fracture surface of stud F was subjected to an EDS (energy dispersive spectroscopy) analysis. The principal elements recorded included Fe, O, C, Ca, Cl, Si, and Mn, as documented in **Figure 11**. Trace aluminum was also present. The explanation of each element is straightforward. Iron (Fe) and manganese (Mn) are components of the steel. Oxygen is ubiquitously present and a component of the corrosion product. Carbon may come from oil or biological contamination. Calcium (Ca) and chlorine (Cl) are present in road salt, and are contained in the corrosion products. The aluminum likely came from bearing grease or dirt. A portion of stud F was then destructively tested to provide bulk composition analysis to determine conformance with grade 8 fastener composition. The results of this further analysis are recorded in tabular form in **Figure 11**.

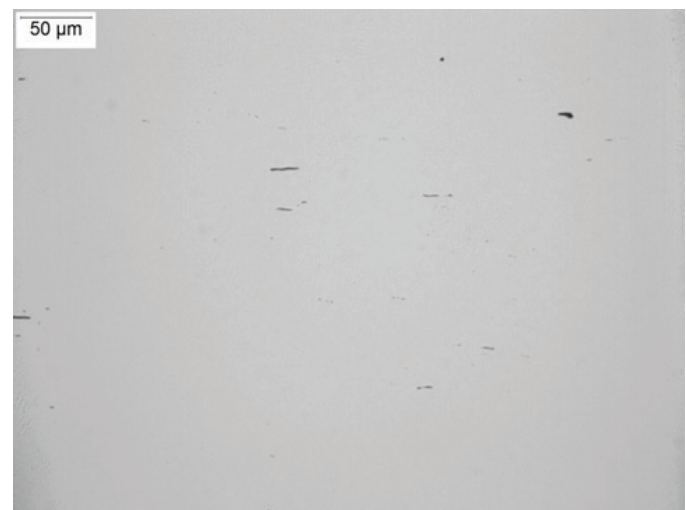
Figure 12

The EDS analysis is consistent with 4037 steel, which is an appropriate alloy for heat treated Grade 8 threaded fasteners. Metallography was conducted on a longitudinal segment of a representative stud (**Figure 12**). This sampling technique was appropriate as the raw material used to manufacture these studs is drawn wire, which produces linear inclusions. No objectionable impurities or pores were detected.

Metallographic sample of representative stud to examine inclusions.

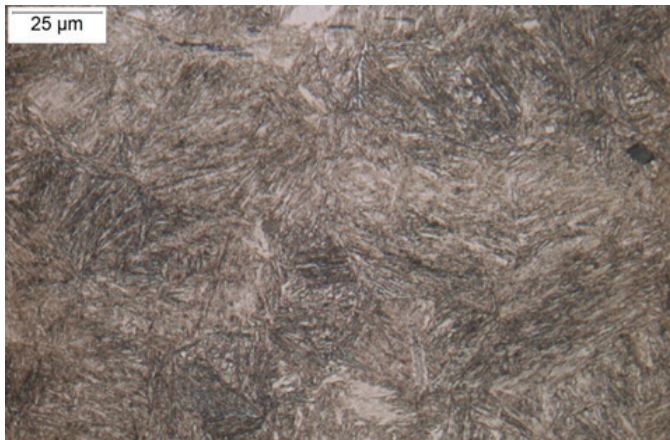
The stud sample was then given a nital (nitric acid 2% in alcohol) etch. This revealed the microstructure as shown in **Figure 13**. This photograph shows martensite,

Figure 13
Metallographic sample of representative stud to examine grain structure.

indicative of an austenitized, quenched and tempered heat treatment to provide strength and toughness. No objectionable grain structure or alloy segregation was detected.

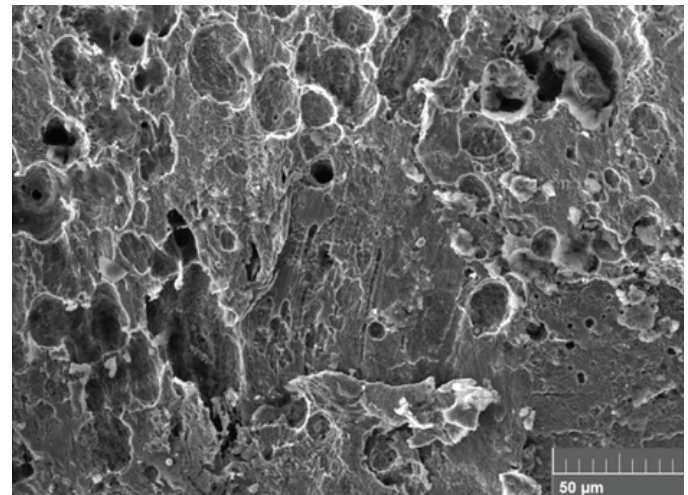
When examined, the cleaned fracture surfaces of the studs showed a variety of features, including residual corrosion products, rubbing of the fracture surfaces, overload dimpling, and fatigue marks. Three different stud SEM micrographs are now shown. The most frequent observation was “no fracture data,” as is shown in **Figure 15**. **Figure 16** shows a region of a stud with residual corrosion products and overload dimples. **Figure 17** shows what was found clearly in five of the six studs: fatigue crack marks. As for the sixth stud, which did not show clear

Figure 15
Corrosion pits caused by acid during cleaning.

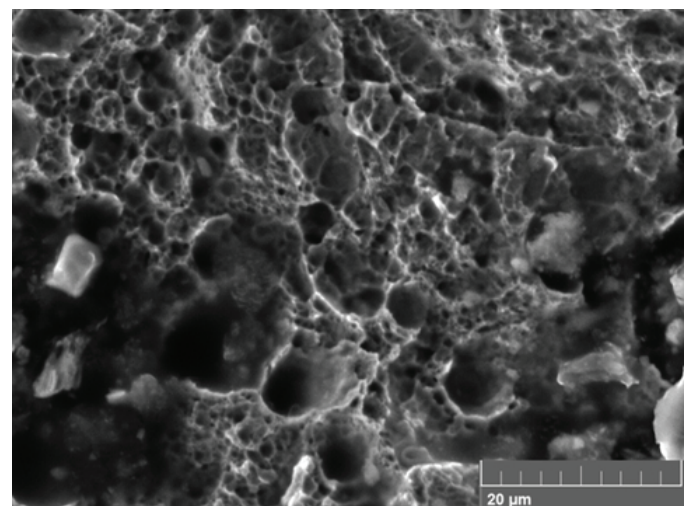
Figure 16
Overload fracture with some residual corrosion products.

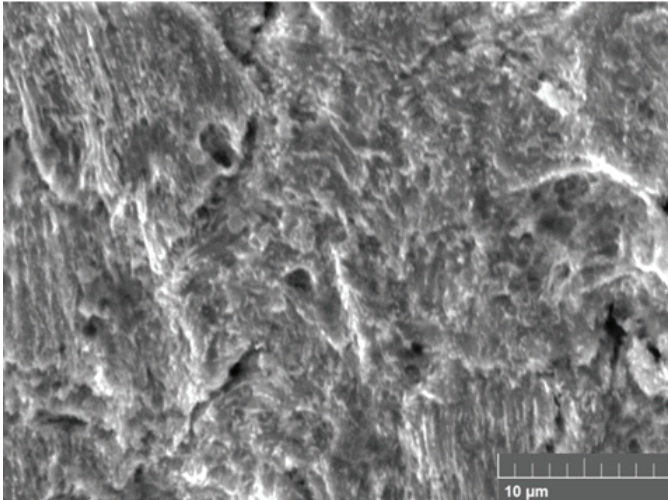
Figure 17

Fatigue striations documenting the stud failure mechanism.

residual fatigue marks, fatigue as a failure mechanism could not be eliminated.
