Forensic Engineering Analysis of an Apartment Building Explosion Involving Flammable Refrigerant

By Jerry R. Tindal, PE (NAFE 642S)

Abstract

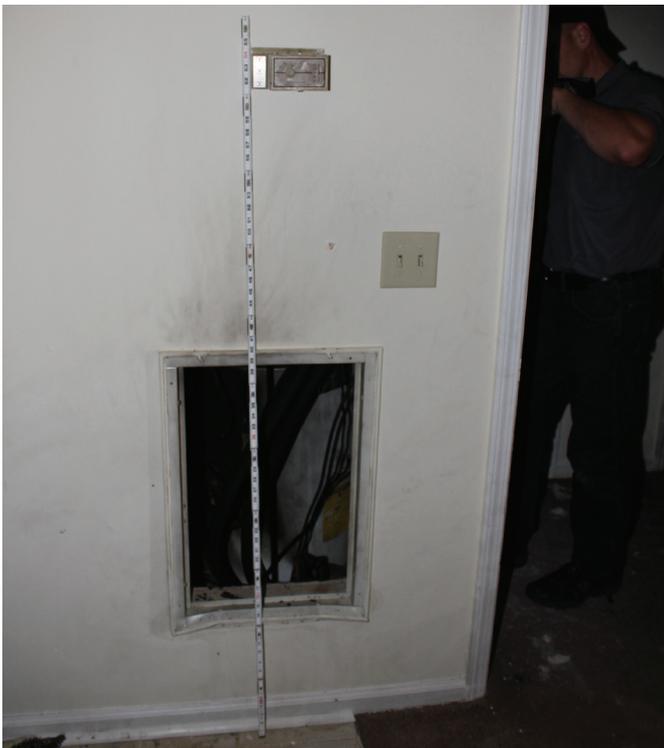
Figure 7

The thermostat was mounted directly above a 16-inch by 25-inch non-ducted return air wall grille opening. The vent opening directly communicated the air space of P-3's mechanical closet to the air space area around the thermostat and the occupant. Responding firefighters used a fire extinguisher to put out a small fire in the mechanical closet. The involved occupant was transported to the hospital with burn injuries.

East wall of living room/dining room area with wall thermostat and return air grille of the mechanical closet.

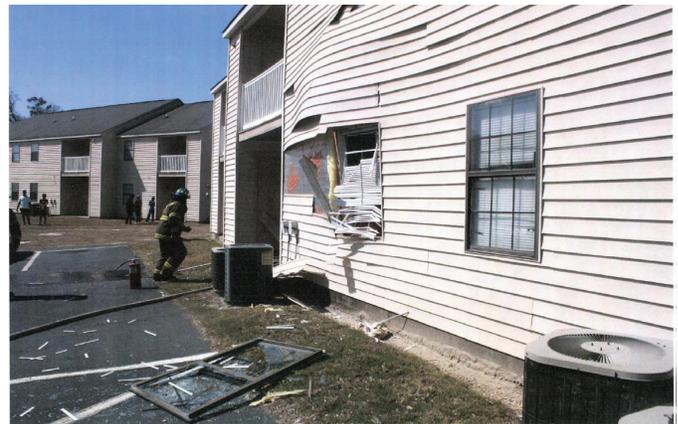
Figure 8

Building wall structures and components were primarily intact although cracked, bulged, and displaced due to overpressure. Windows and doors were broken, dislodged, and displaced over short distances. The damages were consistent with low-order explosion damage, as characterized in NFPA 921 Section 23.3.1¹. **Figures 8** through **13** depict typical overpressure damages observed to the building.

Exterior walls bulged. Window blown out.

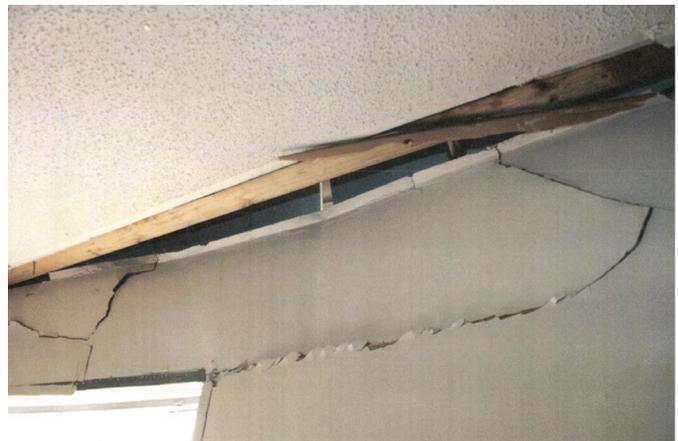
Figure 9

Wall / ceiling joint separation.

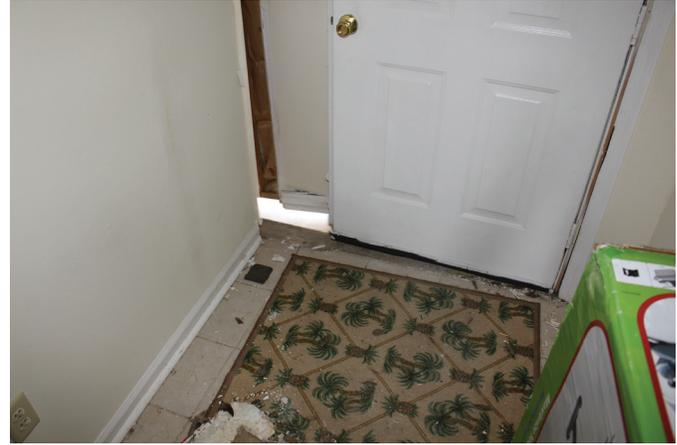
Figure 11
Exterior walls dislodged.

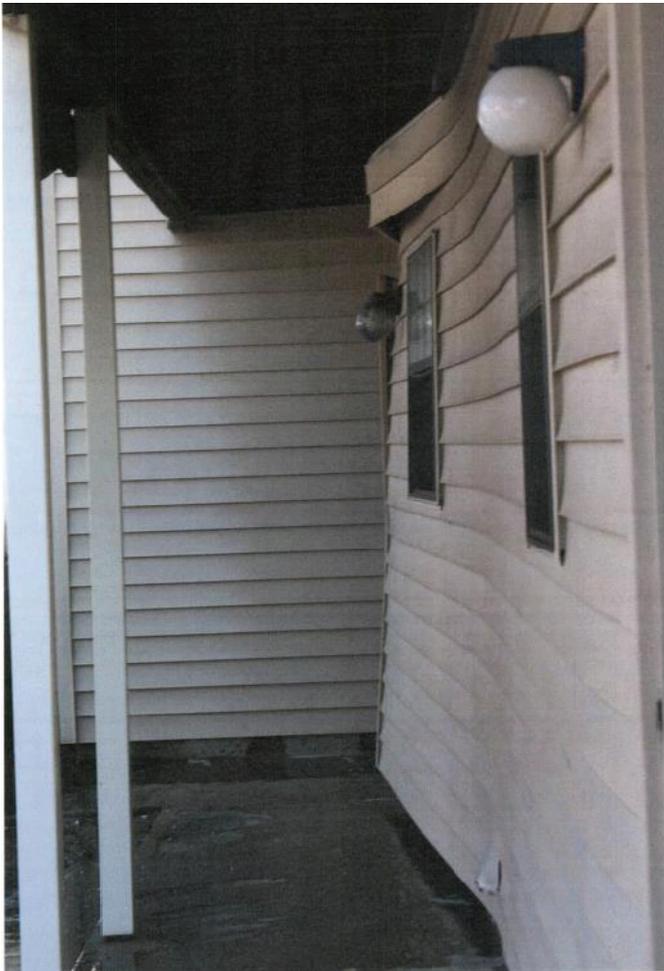
Figure 10
Exterior walls dislodged.

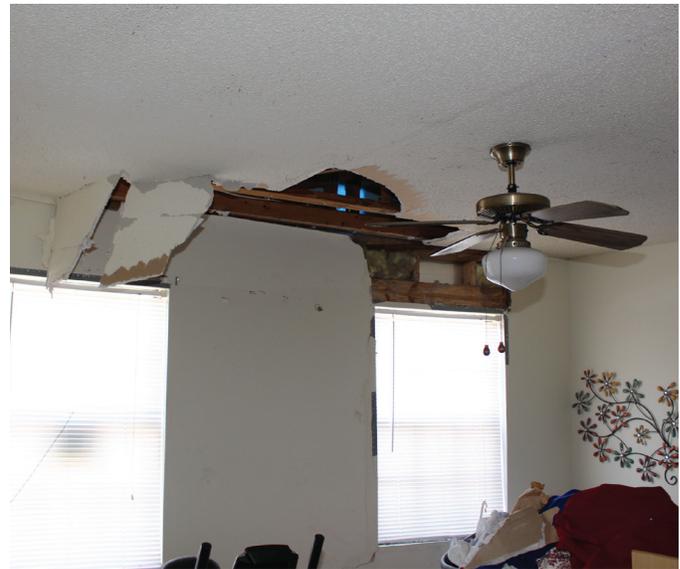
Figure 12
Interior and exterior walls separated from ceiling structures — windows intact.

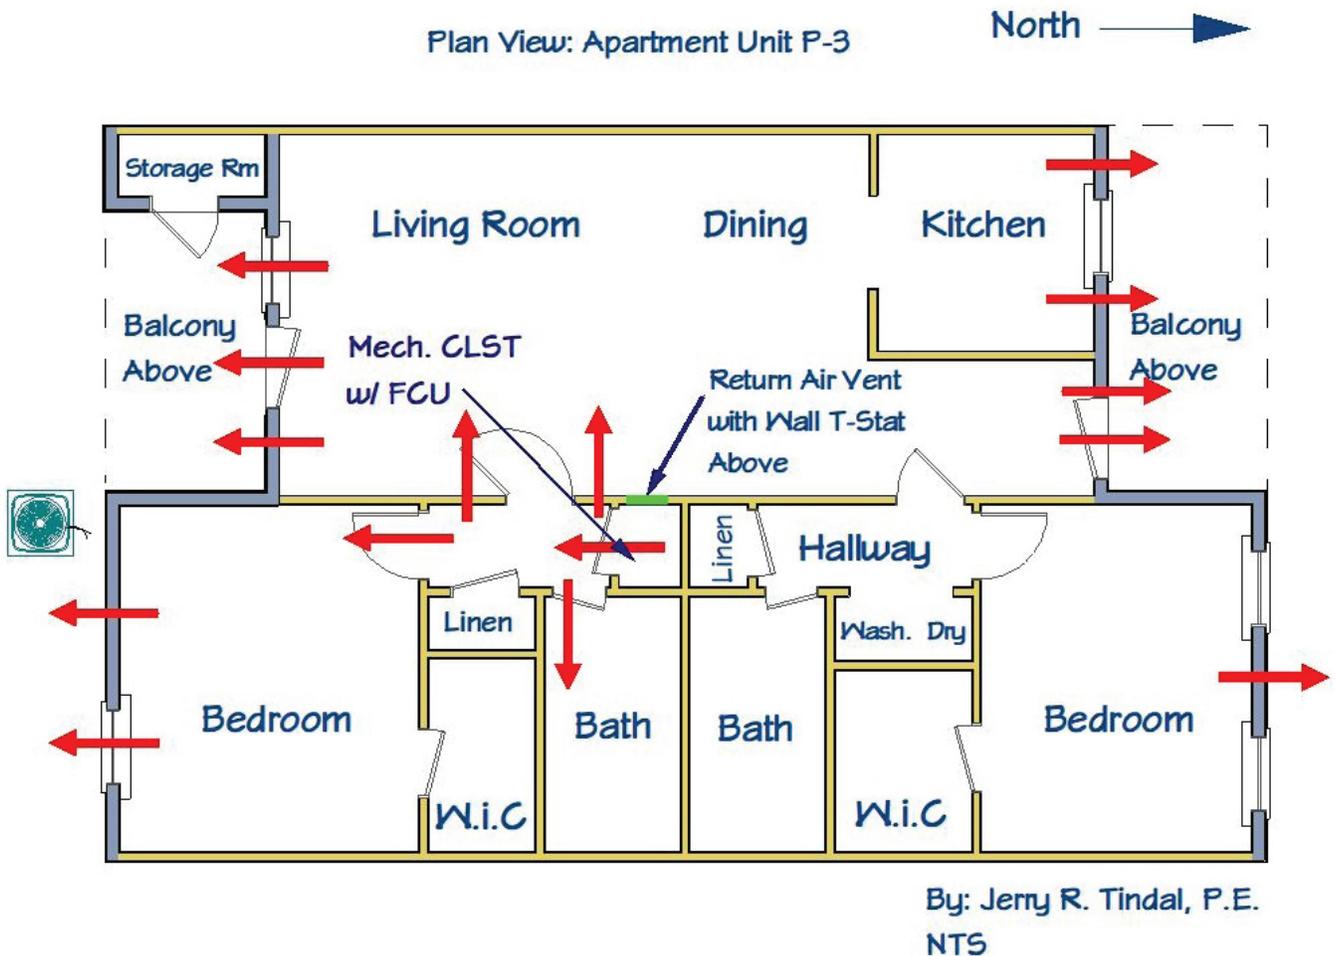
Explosion vector diagrams provide a useful tool for explosion dynamics analysis, origin identification, and illustration, as explained in NFPA 921 Section 23.15. An explosion vector diagram was constructed based on the blast patterns observed during scene examination. Blast patterns, fire patterns, and witness observations were consistent with an explosion originating in, or immediately adjacent to, the mechanical closet of P-3. **Figure 14** shows the explosion vector diagram.

Figure 14
Explosion vector diagram.

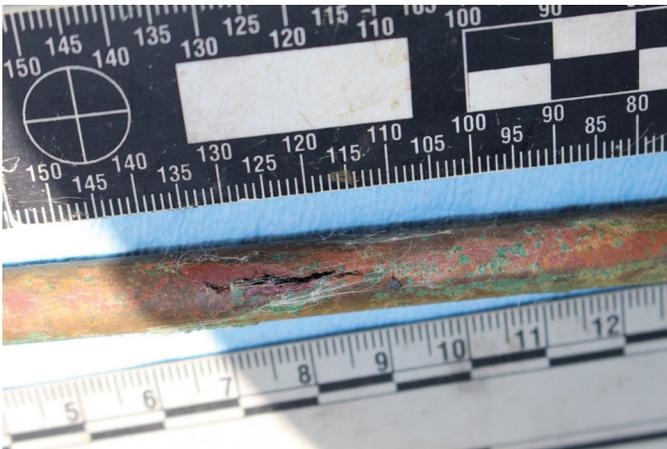
During excavation and extraction of the refrigerant line set, a single failure point in the liquid line piping was located inside the PVC conduit a couple of feet north of the exterior south wall. The failure manifested in the form of a bulging split or rupture in the wall of the piping, running parallel to the pipe axis. There were no other leaks or points of damage observed in the liquid line other than the single rupture point. In addition, there was no observed evidence of kinking, twisting, or bending that could potentially have been caused by explosion forces. The refrigerant lines were primarily located inside of a protective PVC conduit and below the building concrete slab. No evidence of any substantial movement of the FCU or the refrigerant lines by the explosion was observed. The failure in the pipe was

not likely caused by explosion forces.

The bulge in the pipe wall opening indicated the refrigerant line was under internal pressure at the time of the pipe failure. The internal pressure created a localized bulge in the pipe wall as the pipe failed at that point, split open, and released the refrigerant. **Figures 15 and 16** depict images of the failure point. Extensive metallurgical testing was not completed to determine the exact cause of the failure; however, such failures in refrigerant piping are engineering-foreseeable occurrences. Mechanical systems, including HVAC systems and their components, are subject to wear, tear, corrosion, and therefore eventual failure. Components, including piping, routed in the ground or through open conduits in the ground are subject to water submersion, salts, lawn chemicals, and other chemical contaminants.

Figure 15
Failure point in liquid line.

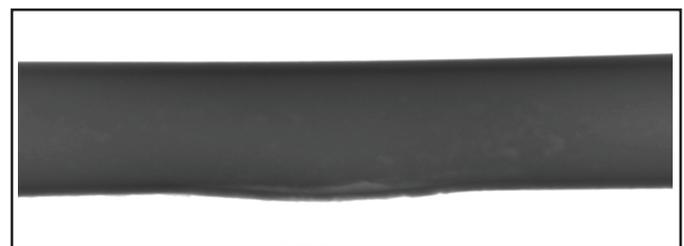
Figure 16
X-ray image of failure point bulge.
