Journal of the  
**National**  
**Academy** OF  
**Forensic**  
**Engineers**<sup>®</sup>

Vol. 35 No. 1 June 2018

# Forensic Engineering Analysis of an Electrical Substation Fire in a Manufacturing Plant in Brazil

By Mauricio Cueva-Eguiguren, PE (NAFE 776S)

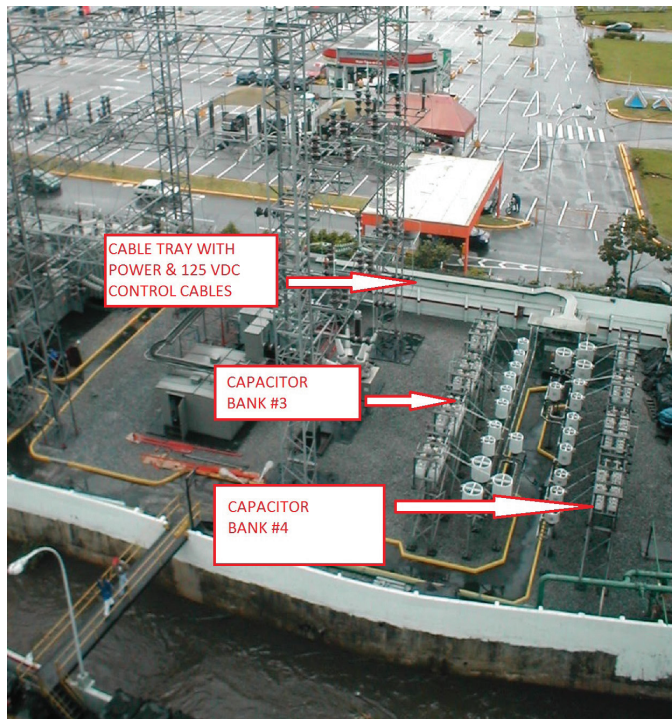
**Figure 4**  
Relocated capacitor Bank #3 and #4.

Transformer No. 5 (**Figure 4**). The power cables in the trays were spliced with additional cables to reach the relocated capacitor banks (**Figure 5**).

When the 4.16kV, 6 MVAR capacitor banks were relocated to make room for the new Transformer No. 5, the circuit breakers associated with the capacitor banks were also relocated close to the capacitor banks, approximately 100 meters away from their original location.

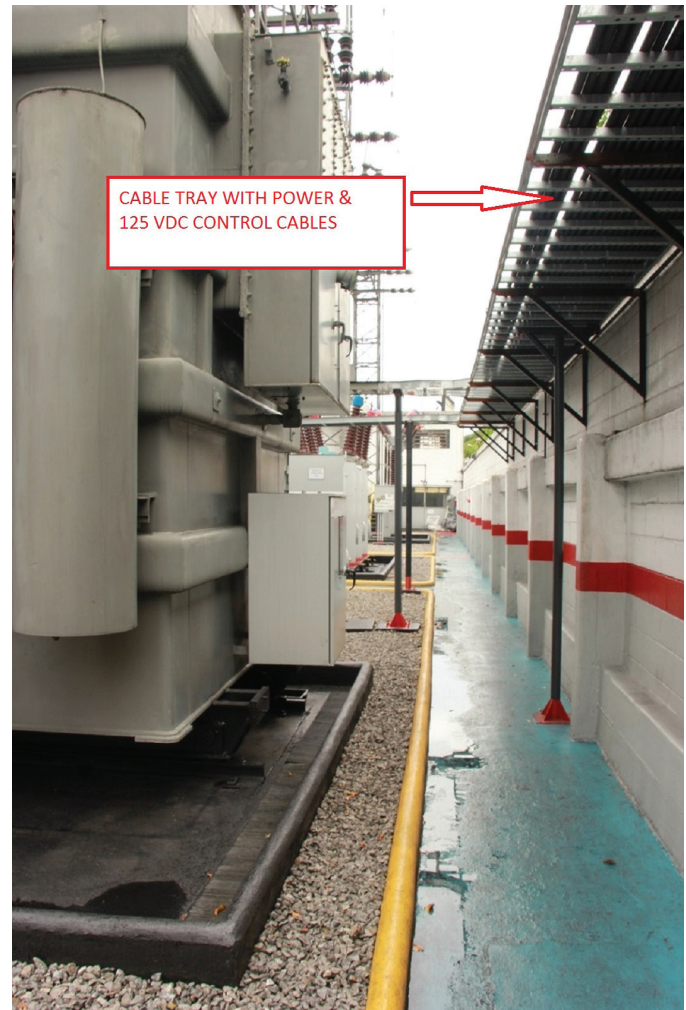
The power cables for the capacitor banks were spliced in the cable tray, which was located on the outside wall along the property line. This cable tray also contained 125 VDC control cables used for the protection and control of the 6.0 MVAR, 4.16kV capacitor banks.

The electrical power for the 4.16kV, 6 MVAR capacitor banks was derived directly from the 4.16kV busbars in the substation. In light of this, the spliced power cables (from the 4.16kV substation busbars to the relocated circuit breakers and capacitor banks) were not protected by the 4.16kV distribution system in the substation, since the spliced power cables became an extension of the substation 4.16kV busbars.

**Figure 5**  
Cable tray for capacitor bank cables.

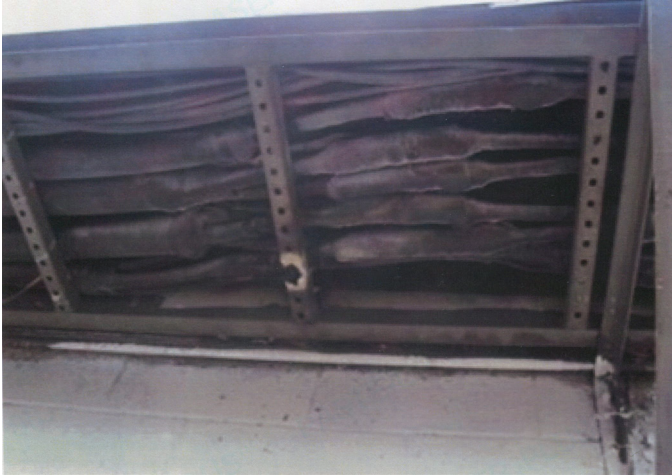
In the spring of 2015, a second cable splice failure occurred in one of the power cables associated with one of the capacitor banks. The cable splice failure caused a short circuit and a fire in the cable tray where the power and 125 VDC cables for the capacitor banks were located (**Figure 6 through 9**).

**Figure 6**  
Capacitor bank cable splices.

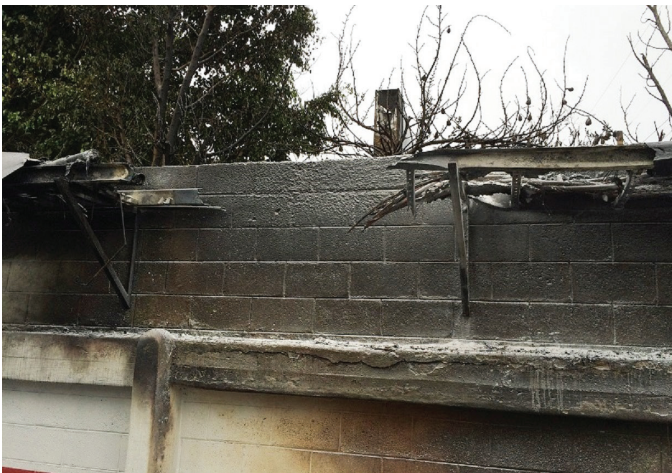
The fire in the cable tray caused the catastrophic failure of the entire 125 VDC control system in the substation. This prevented the 88kV and 4.16kV circuit breakers in the substation from providing the protection and control for all the equipment in the substation. The only

**Figure 7**  
Cable tray with cable splice failure.

The state-of-the-art cable installation practices for 4.16kV power and 125 VDC control cables require that these cables be installed in separate cable trays or with metal barriers separating the power and control systems in order to prevent failures such as those described above.

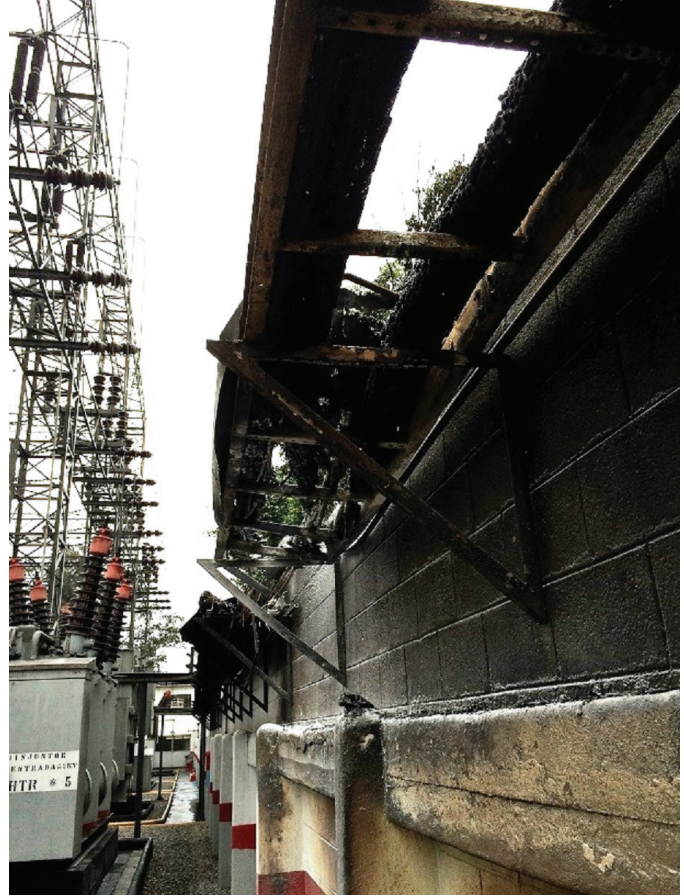
**Figure 8**  
Cable splice failure.

The cable splice failure and fire occurred at night when daytime weather featured scattered clouds with temperatures reaching 90°F. The temperature at that time was reported as approximately 72°F with a relative humidity of 89% and a barometric pressure of 29.93 inches. Since the cable splice was consumed by the fire, a detailed failure analysis of the components could not be performed.

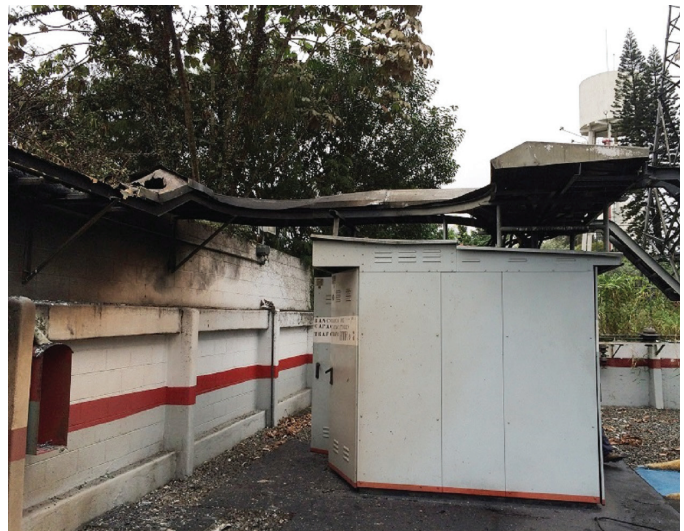
**Figure 9**  
Cable tray with cable splice failure.

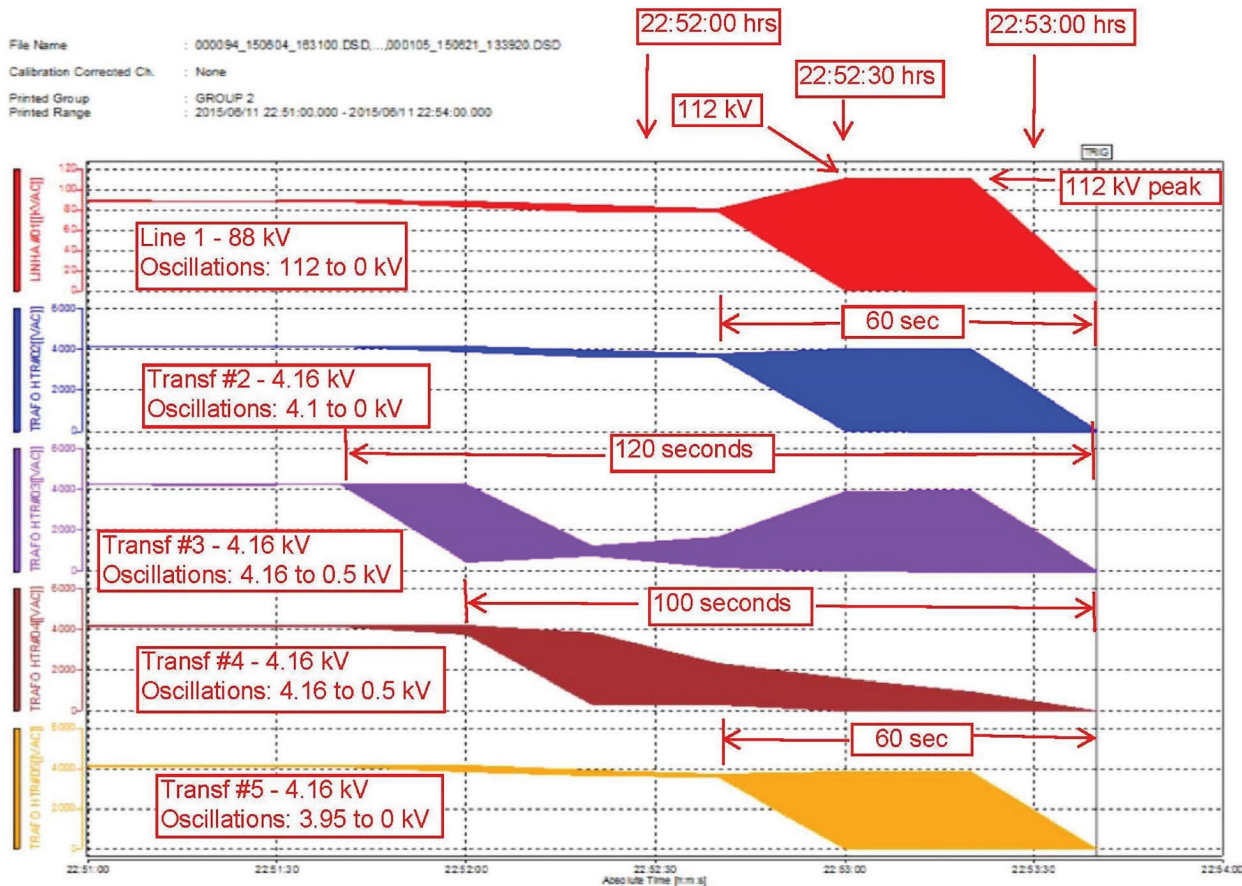
Figure 10

Recorder graphs — 88kV utility overhead line and customer Transformers 2 through 5.

Given the fact that overvoltages of as much as 27% occurred in the 88kV incoming power from the utility, it is very likely that the cause of these overvoltages was the result of a ferroresonance<sup>1,2,3,4</sup> condition produced by the electrical transients in the substation after the splice failure.

The voltage graph of the secondary winding of Transformer No. 2 recorded by the voltage recorder during the fire shows that Transformer No. 2 went into oscillations for approximately 60 seconds. The voltage oscillations ranged between 0kV and 4.16kV (**Figure 10**).

In addition, the voltage graph of the primary winding of Transformer No. 2 (88kV) recorded by the voltage recorder during the fire shows that the primary winding voltage went into oscillations for approximately 60 seconds, ranging from 0kV to 112kV for approximately 60 seconds or as much of as 27% of its rating (**Figure 10**).

The voltage graph of the secondary winding of Transformer No. 3 recorded by the recorder during the fire shows that Transformer No. 3 went into oscillations for approximately 120 seconds. The voltage oscillations ranged between 0.5kV to 4.16kV (**Figure 10**).

In addition, the voltage graph of the primary winding of Transformer No. 3 (88kV) recorded by the voltage recorder during the fire shows that the primary winding voltage went into oscillations ranging from 0kV to 112kV for approximately 60 seconds or as much of as 27% of its rating (**Figure 10**).

The voltage graph of the secondary winding of Transformer No. 4 recorded by the voltage recorder during the fire shows that Transformer No. 4 went into oscillations for approximately 100 seconds. The voltage oscillations ranged between 0.5kV to 4.16kV (**Figure 10**).

In addition, the voltage graph of the primary winding of Transformer No. 4 (88kV) recorded by the voltage recorder during the fire shows that the primary winding voltage went into oscillations ranging from 0V to 112kV for approximately 60 seconds, with overvoltages of as much of as 27% of its rating (**Figure 10**).

The voltage graph of the voltage recorder shows that while the short circuit was occurring in the cables of Capacitor Banks #3 and #4, the voltage in the secondary winding of Transformer No. 5 went into oscillations ranging from 3.95kV to about 0kV for approximately 60 seconds (**Figure 10**).

In addition, the voltage graph of the primary winding of Transformer No. 5 (88kV) recorded by the voltage recorder during the fire shows that the primary winding voltage went into oscillations ranging from 0kV to 112kV for approximately 60 seconds with overvoltages of as much of as 27% of its rating (**Figure 10**).

The voltage graph of the 88kV line 1 recorded by the voltage recorder during the fire shows that the 88kV line 1 went into oscillations 60 seconds after the short circuit occurred in the cable splices, and such oscillations remained for approximately 60 seconds. The voltage oscillations first went up from 88kV to approximately 112kV, then leveled off at 112kV for about 20 seconds, and then went down to 0kV in the next 20 seconds. The voltage oscillations coincided with the start of voltage oscillations in Transformer Nos. 2 and 5, which is an indication that the voltage disturbances in the utility 88kV system directly affected Transformer Nos. 2 and 5 (**Figure 10**).

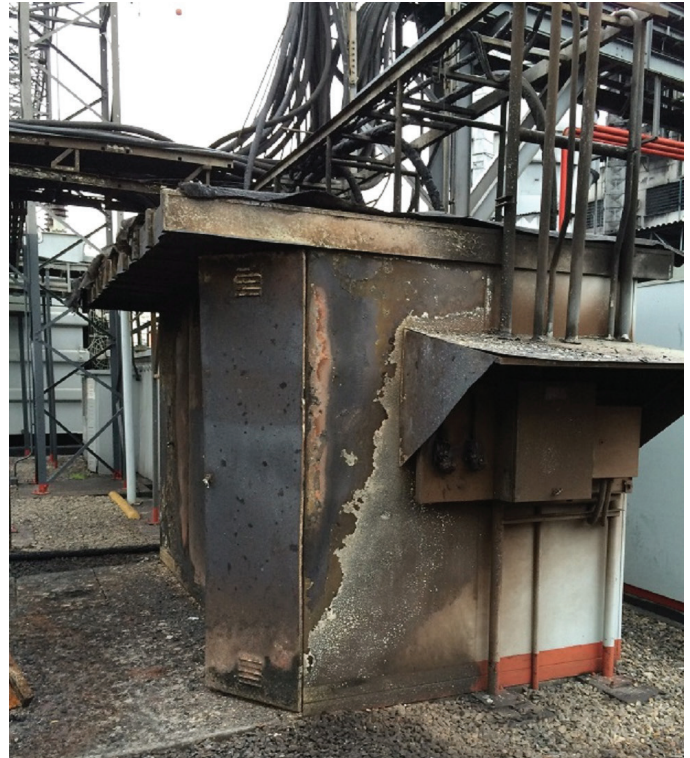
Since four of the 88kV – 4.16kV transformers and their associated switchgear were energized during the fire, they were exposed to high short-circuit currents and electrical voltage transients. In addition to the short circuits that occurred in the cable tray where the power and control cables for the 4.16kV capacitor banks are located, other short circuits occurred in the 4.16kV switchgear Nos. 3 and 4, resulting in fires around them and damaging these 4.16kV switchgear and cables around them (Figure 11 through 16).

**Figure 12**  
4.16kV switchgear fire damage.

Due to the need to restore the electrical power for the plant to continue operating, temporary repairs were performed to the 88kV and 4.16kV substations in order for the plant to return to service within approximately 29 days. The temporary repairs included installing new cables, cable trays, replacing one of the 4.16kV switchgear, and repairing the other damaged 4.16kV switchgear.

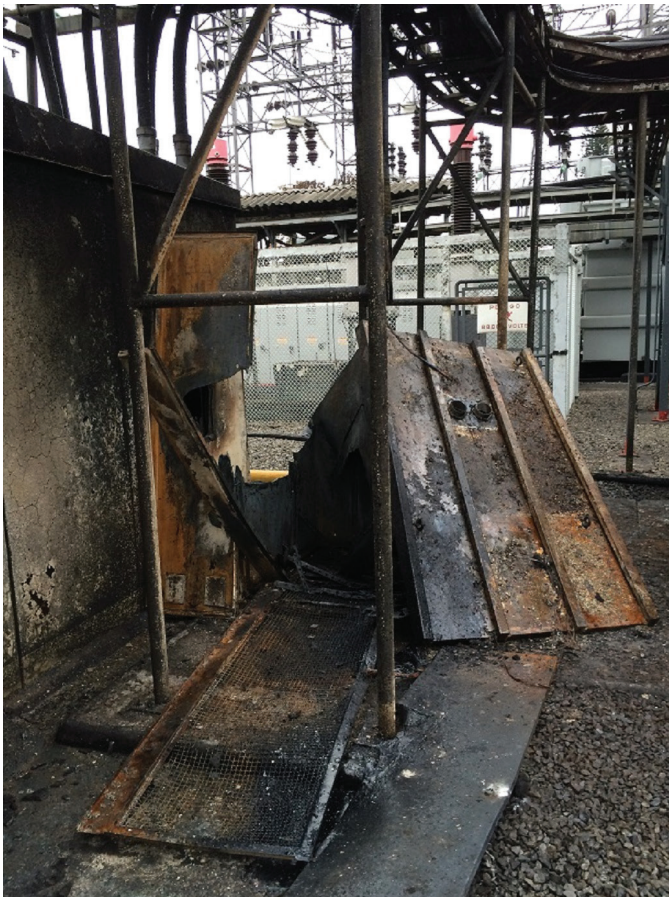
**Figure 11**  
Cable tray fire damage.

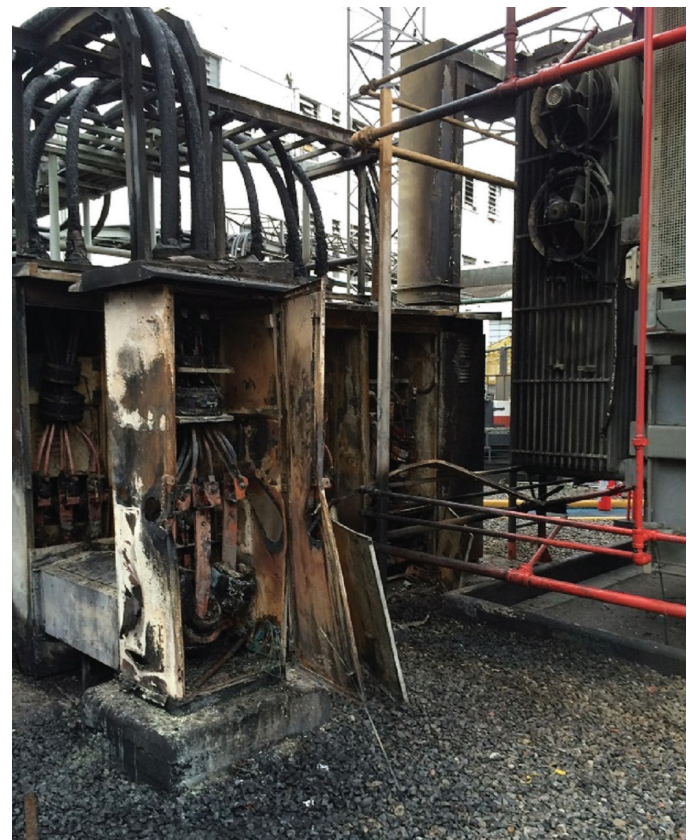
**Figure 13**  
4.16kV switchgear damage.

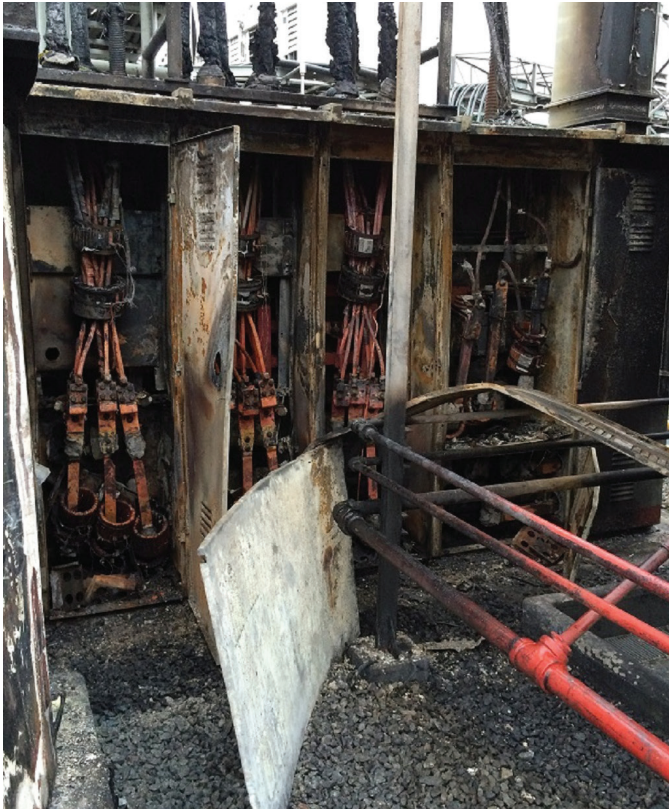
**Figure 14**  
4.16kV switchgear fire damage.

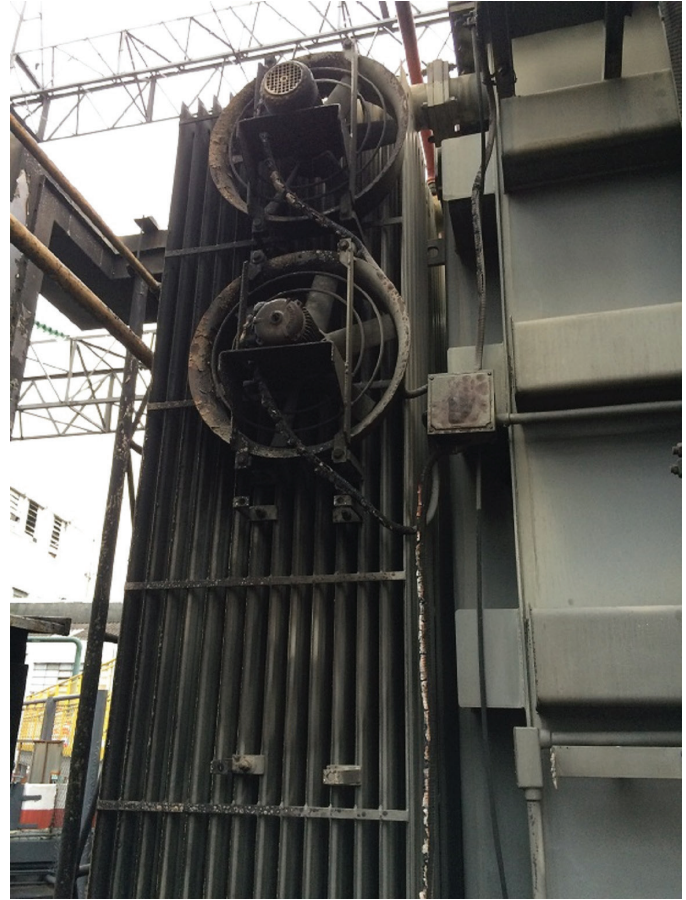
**Figure 16**  
88kV - 4.16kV transformer damage.

Transformer No. 3 also experienced short circuit currents of as much as 31,600A for as long as 120 seconds. These high short circuit currents caused high electromagnetic forces in the primary and secondary windings overstressing the mechanical supports of the transformer windings and core.

Transformer No. 4 also experienced short circuit currents of as much as 28,500A for as long as 120 seconds. These high short circuit currents caused high electromagnetic forces in the primary and secondary windings, overstressing the mechanical supports of the transformer windings and core.

Since the 88kV circuit breakers in the utility 88kV overhead transmission system did not trip for the first 120 seconds after the cable splice failure, the four 88kV – 4.16kV stepdown transformers were exposed to very high short circuit currents and electromagnetic forces damaging these transformers.

in service. See **Figure 2** for the transformer oil sample results. The oil in Transformers 2, 3, 4, and 5 tanks was replaced prior to returning these transformers to service.

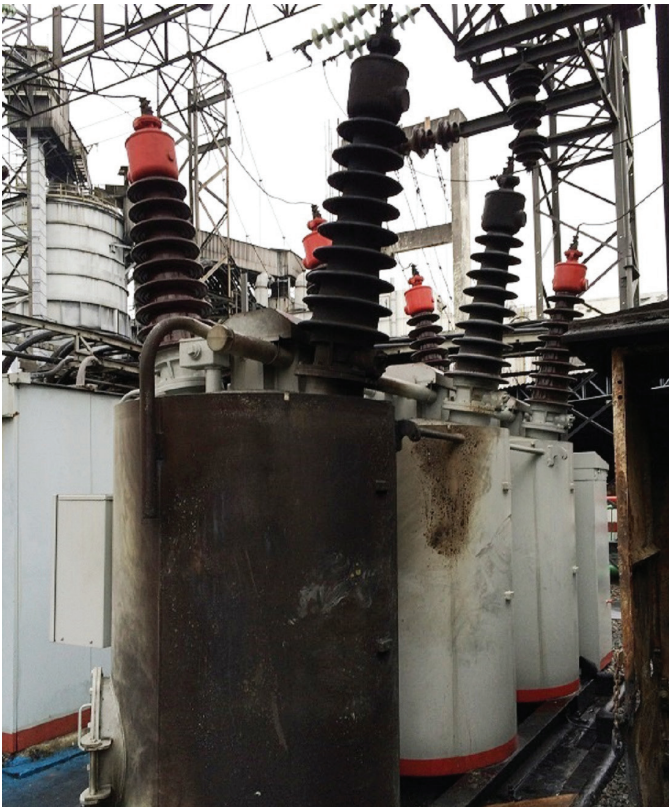
**Figure 15**  
4.16kV circuit breaker damage.
