Vol. 35 No. 1 June 2018

# Forensic Engineering Metallurgical Analysis of PTO Air Compressor Rupture and Fire

By Raymond G. Thompson, PhD, PE (NAFE 763F) and Dustin Nolen, PE

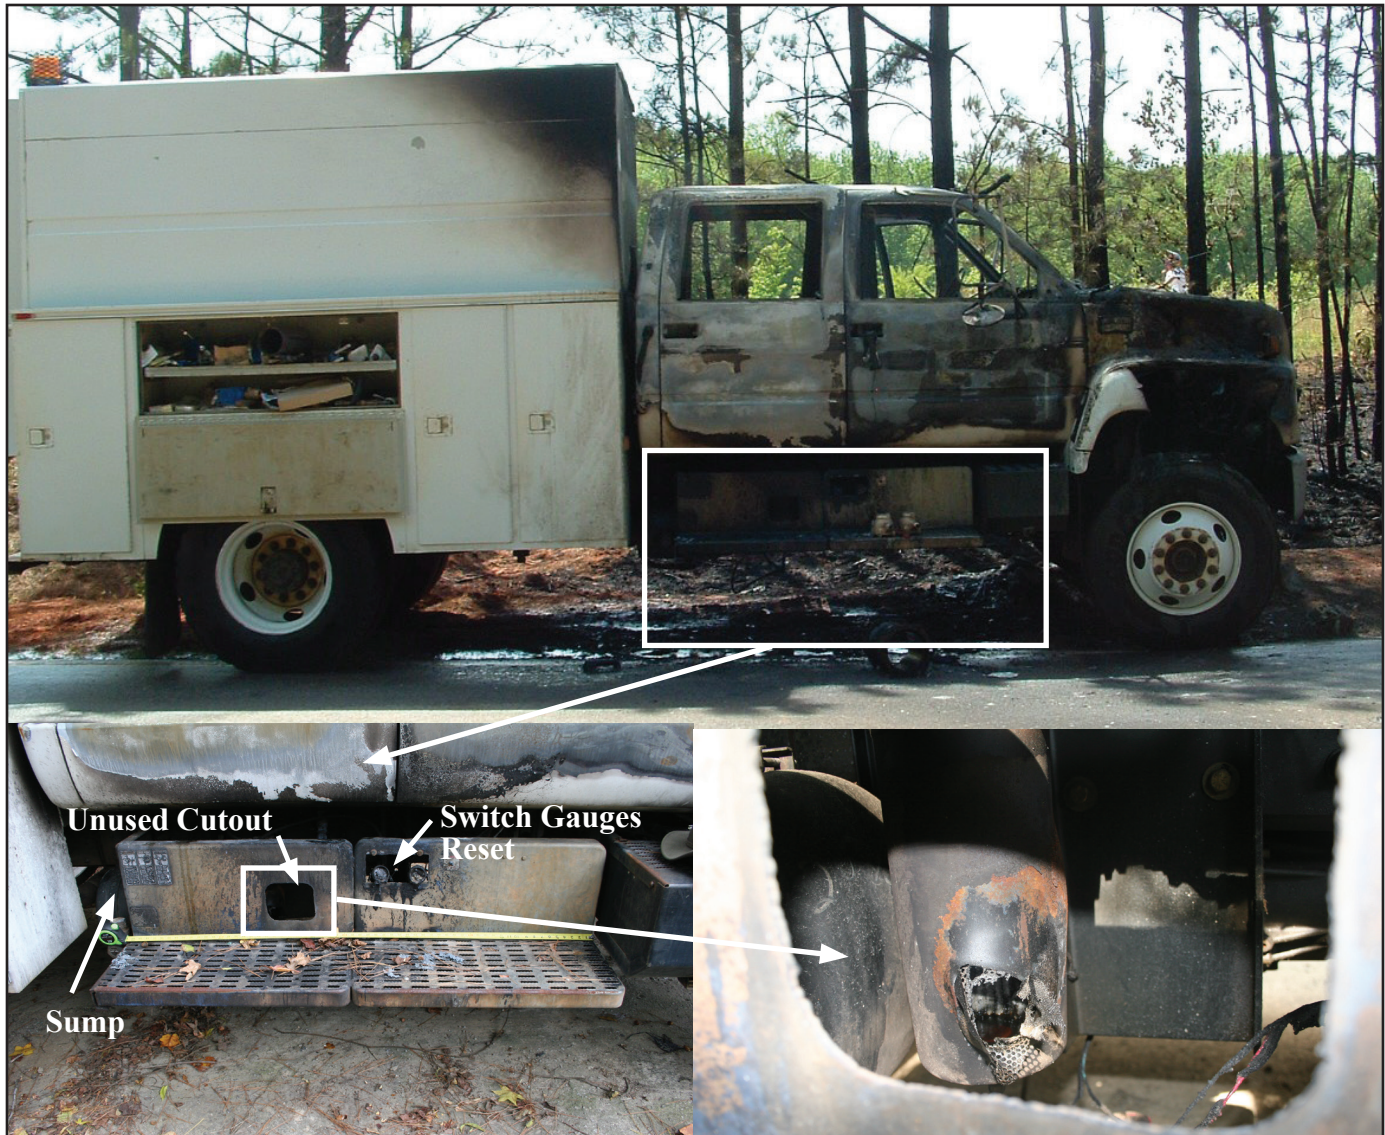
**Figure 2**

Pictures showing relationships between truck, step, reset button, gauges, and coalescer.

Coalescer perspective is what the operator would see when in position to restart the air compressor system.

The passenger-side step had two holes cut; one for the gauge cluster and another for unspecified reasons (**Figure 2**). The open cutout happened to be located at such an angle to the coalescer that the rupture direction aligned with it.

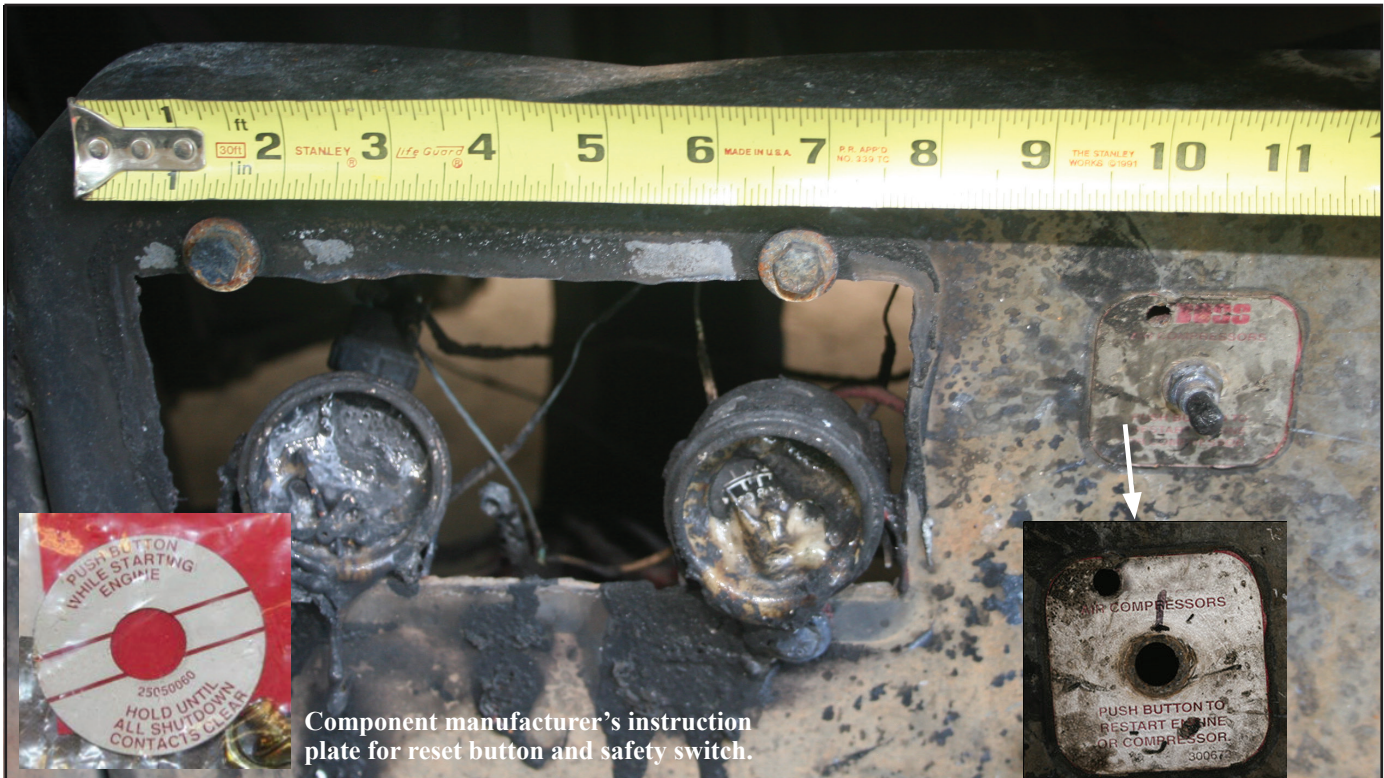
Figure 3

Component manufacturer's instruction plate for reset button and safety switch.

Damaged temperature and pressure switch gauges. The reset button switch is shown to the right mounted 2½ inches from the switch gauge cluster. Note instructions. Manufacturer names are hidden.

The manufacturer never evaluated or considered the consequence of the reset button energizing the air compressor. The language on the reset button shown in **Figure 3** even invites the operator to attempt to restart the air compressor regardless of the present state of the system's temperature and pressure. The subject reset button instructions are different from the component manufacturer's instructions (**Figure 3**). However, the component manufacturer's instructions are even more inviting to hold the reset button. It is not operator error to perform a

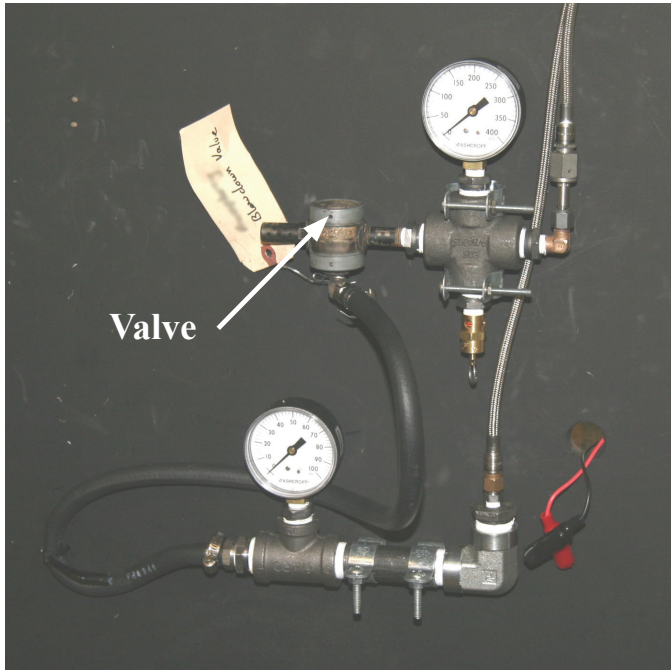
The purpose of the automatic blowdown valve was to relieve pressure from the system when it was shut down. **Figure 4** shows the testing apparatus used for testing pressure-related components such as the automatic blowdown valve. It proved to be operating as designed.

Test apparatus used to test the automatic blowdown valve and the pressure switches. The system is shown with the automatic blowdown valve installed.

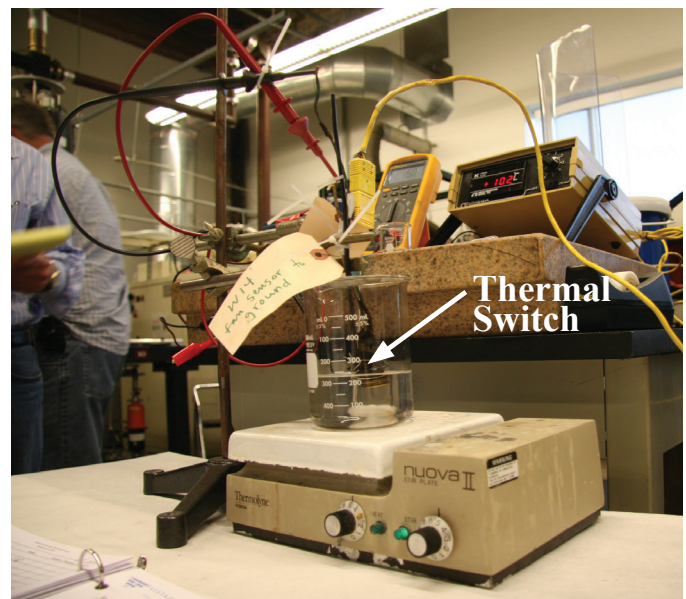
The thermal switch was tested by immersing in silicone oil and progressively heating until the contact closed. **Figure 5** shows the test setup. The temperature was monitored using a K-type thermocouple connected to an Omega Model 120 thermocouple display. The closing temperature was recorded by monitoring the continuity through the switch. The heat was removed from the system, the oil was allowed to cool until the switch opened, and the opening temperature was recorded. The testing

Test apparatus to measure the high and low temperature threshold of the thermal switch used to energize the relay controlling the heat exchanger fan motor.

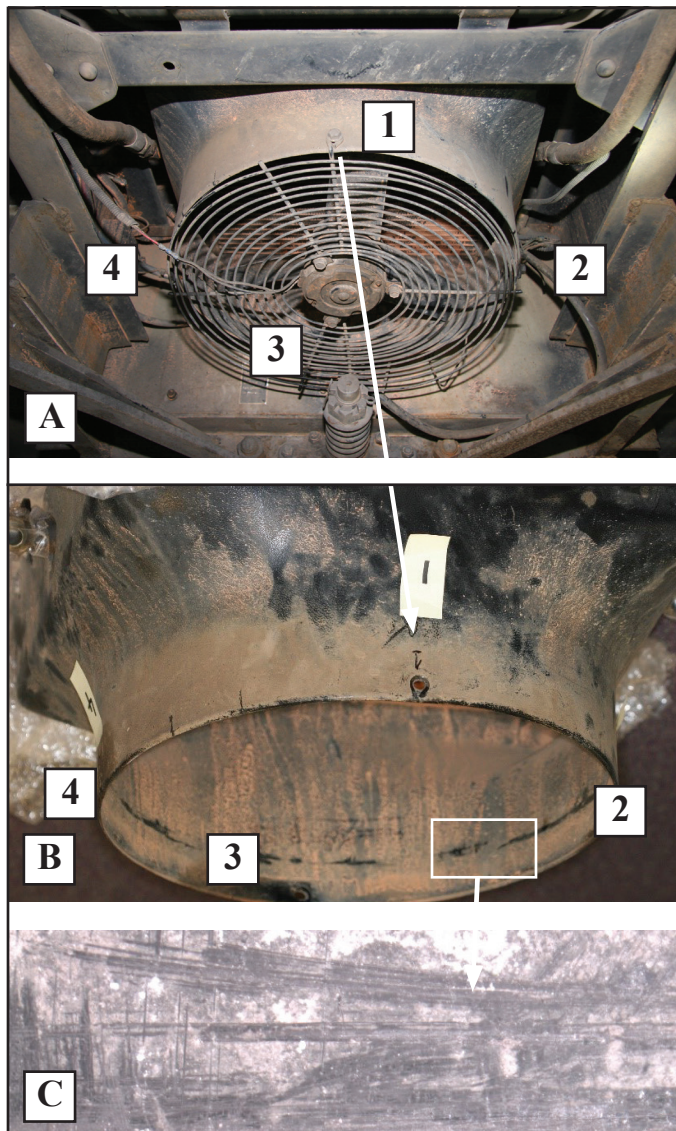
**Figure 7**

controlled by the combination of the thermal switch and a 12V relay; both were shown to be functional. Inspection of the fan and fan grill showed that the fan grill had suffered damage by an outside source, such as road debris. The fan blades and motor are attached to, and supported by, the grill, which is attached to the heat exchanger shroud by four grill wires. Three of the four grill support wires had suffered fatigue failure. The broken support wires allowed the fan to fall downward, pinning the fan blades against the shroud. The fan, in the final resting position, is shown in **Figure 7**.

Subject fan shown at top (A) with its four grill support wires identified as shown (1 – 4). Witness marks on the inside surface seen in B and C of the heat exchanger shroud showing that the fan ran against the shroud for short time before binding. The grill was held in place at wire [1] which was not broken.

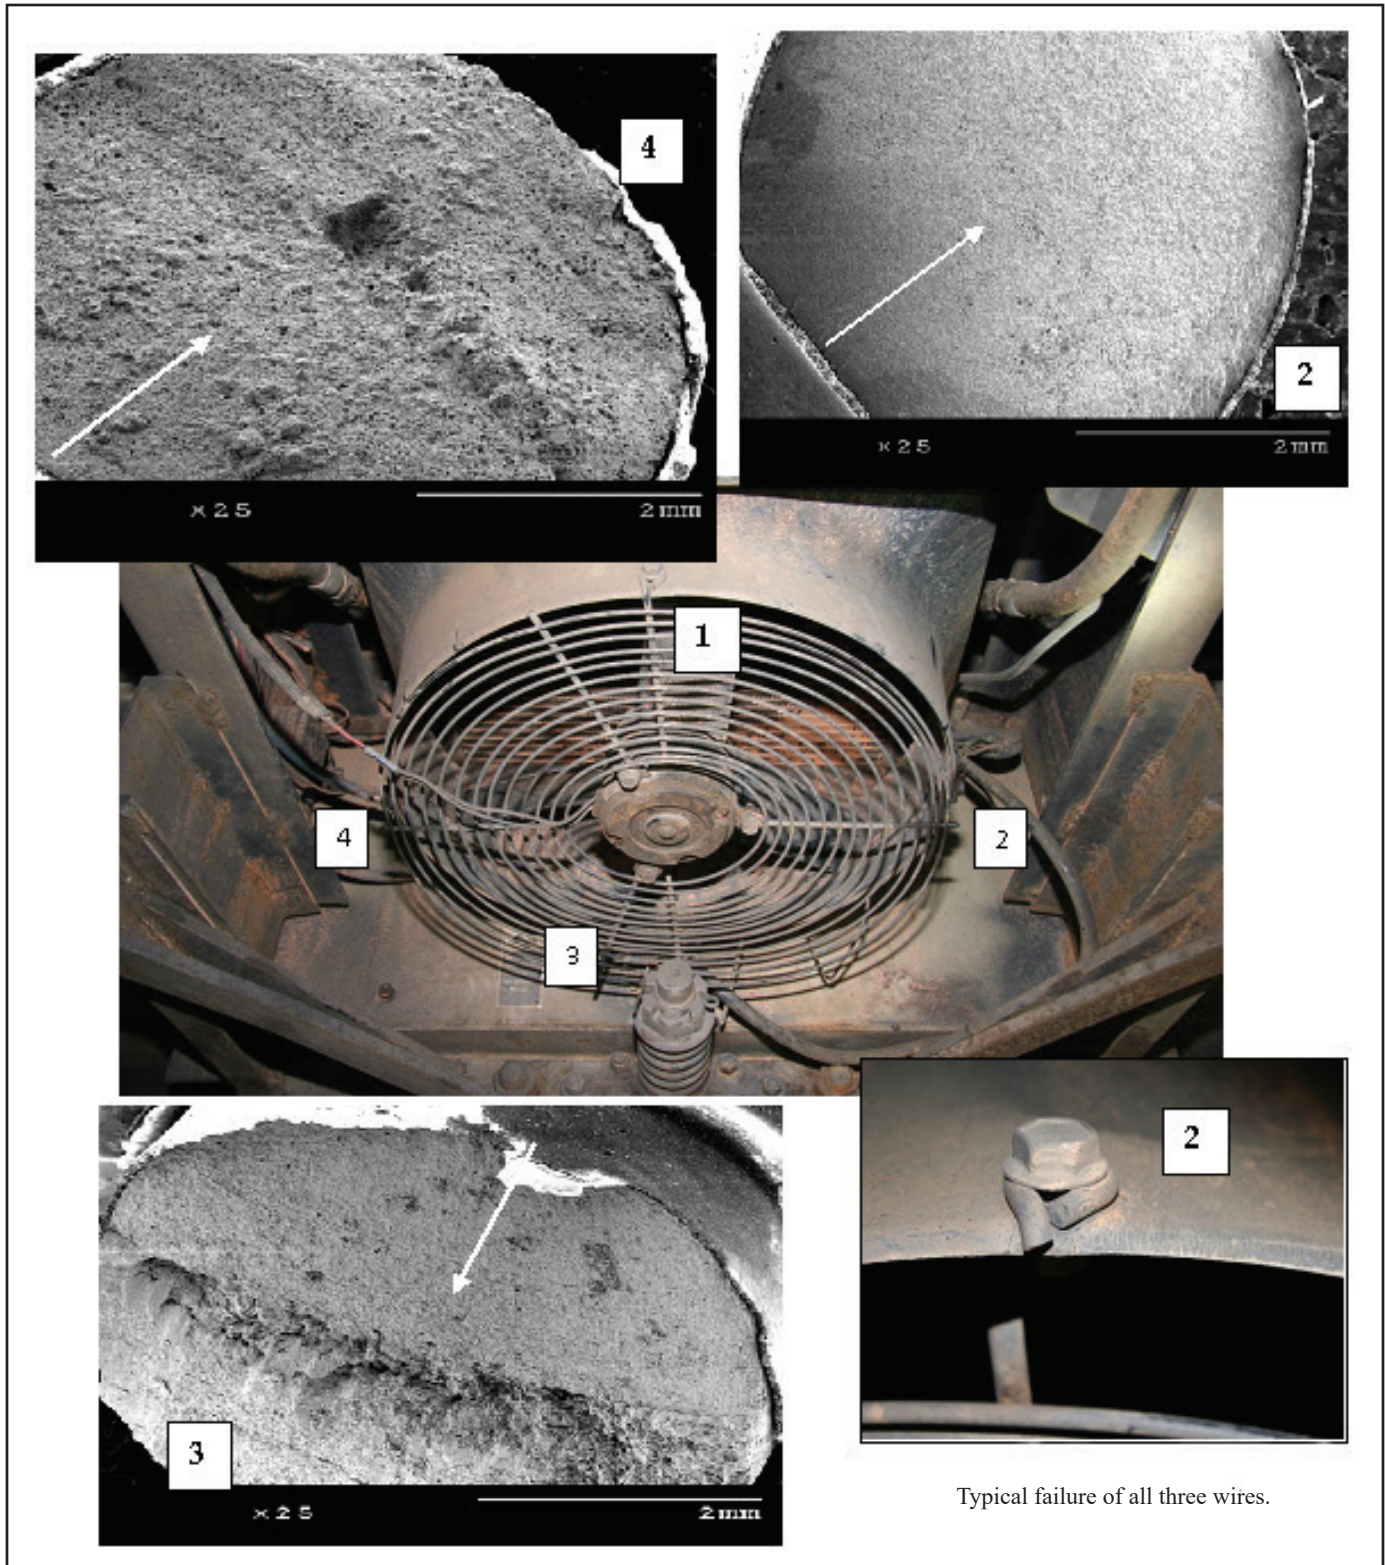
**Figure 8**

Scanning electron microscope (SEM) examination of the broken wires showed they had failed in fatigue — and failed progressively in order 2 – 4 – 3 (**Figure 8**). The root cause of the fan failure was fatigue of the grill support wires. The wires were overloaded by the weight of the fan motor and blades when they were subjected to vibrational loading from the vehicle while installed in its horizontal orientation. A single impact from roadway debris did not cause failure of the grill.

The fact the wires failed in fatigue<sup>3,4</sup> (and failed sequentially) suggests that there was a time when the fan grill could have been identified by inspection as “going bad” before it fell down, causing the fan to bind.

Subject fan shown in center with its four grill support wires identified as shown (1 – 4). SEM pictures of the fractured wires show their progression of failure by fatigue. Wire 1 is unbroken. Wire 2 broke with a flat fracture surface, indicating it broke first under the lowest load. Wire 4 exhibited the next most uniform fracture, indicating it failed second and wire 3 showed a fracture with higher loading and less uniformity, indicating it failed last after 2 and 4 were broken. The progression of failures suggests that maintenance had an opportunity to find the problem grill before it suffered its final failure.

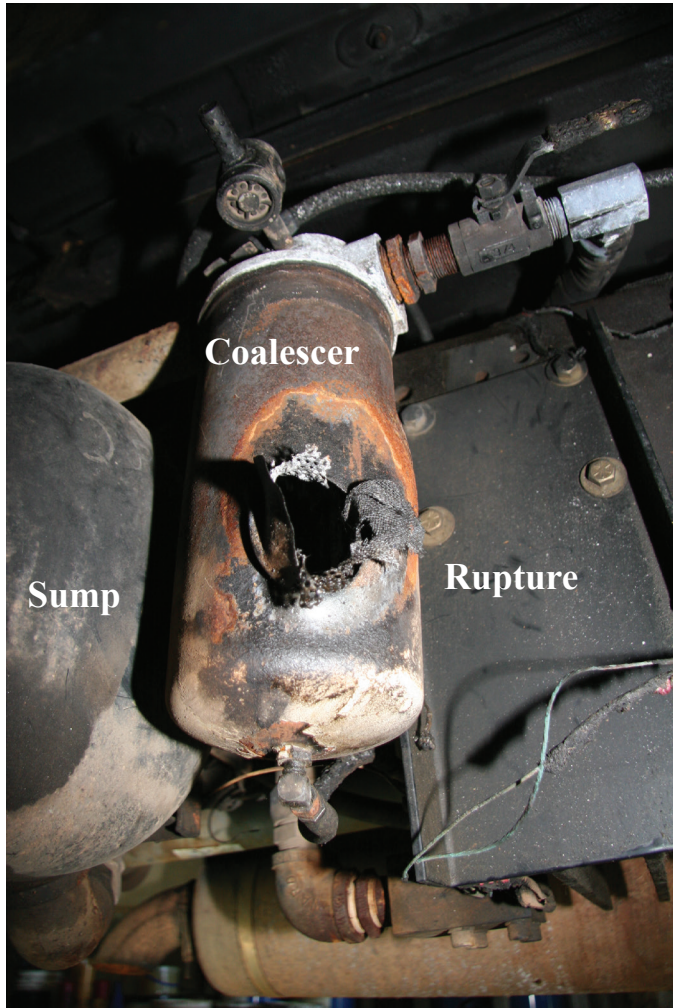
**Figure 9**

Image of the coalescer ruptured after the step was removed. The coalescer is located forward of the sump directly behind the rear hole in the passenger side step.

a coalescer to remove oil vapor from the air supply upon exit and return the reclaimed oil to the compressor. The coalescer contained a large rupture, as shown in **Figure 9**, which allowed rapid depressurization and the instantaneous release of burning oil at high pressure. The location of the rupture aligned with the release of burning oil in the direction of the operator. The coalescer was examined by visual inspection, X-ray inspection, and CT inspection. The properties of the metal were examined metallurgically and by microhardness testing.

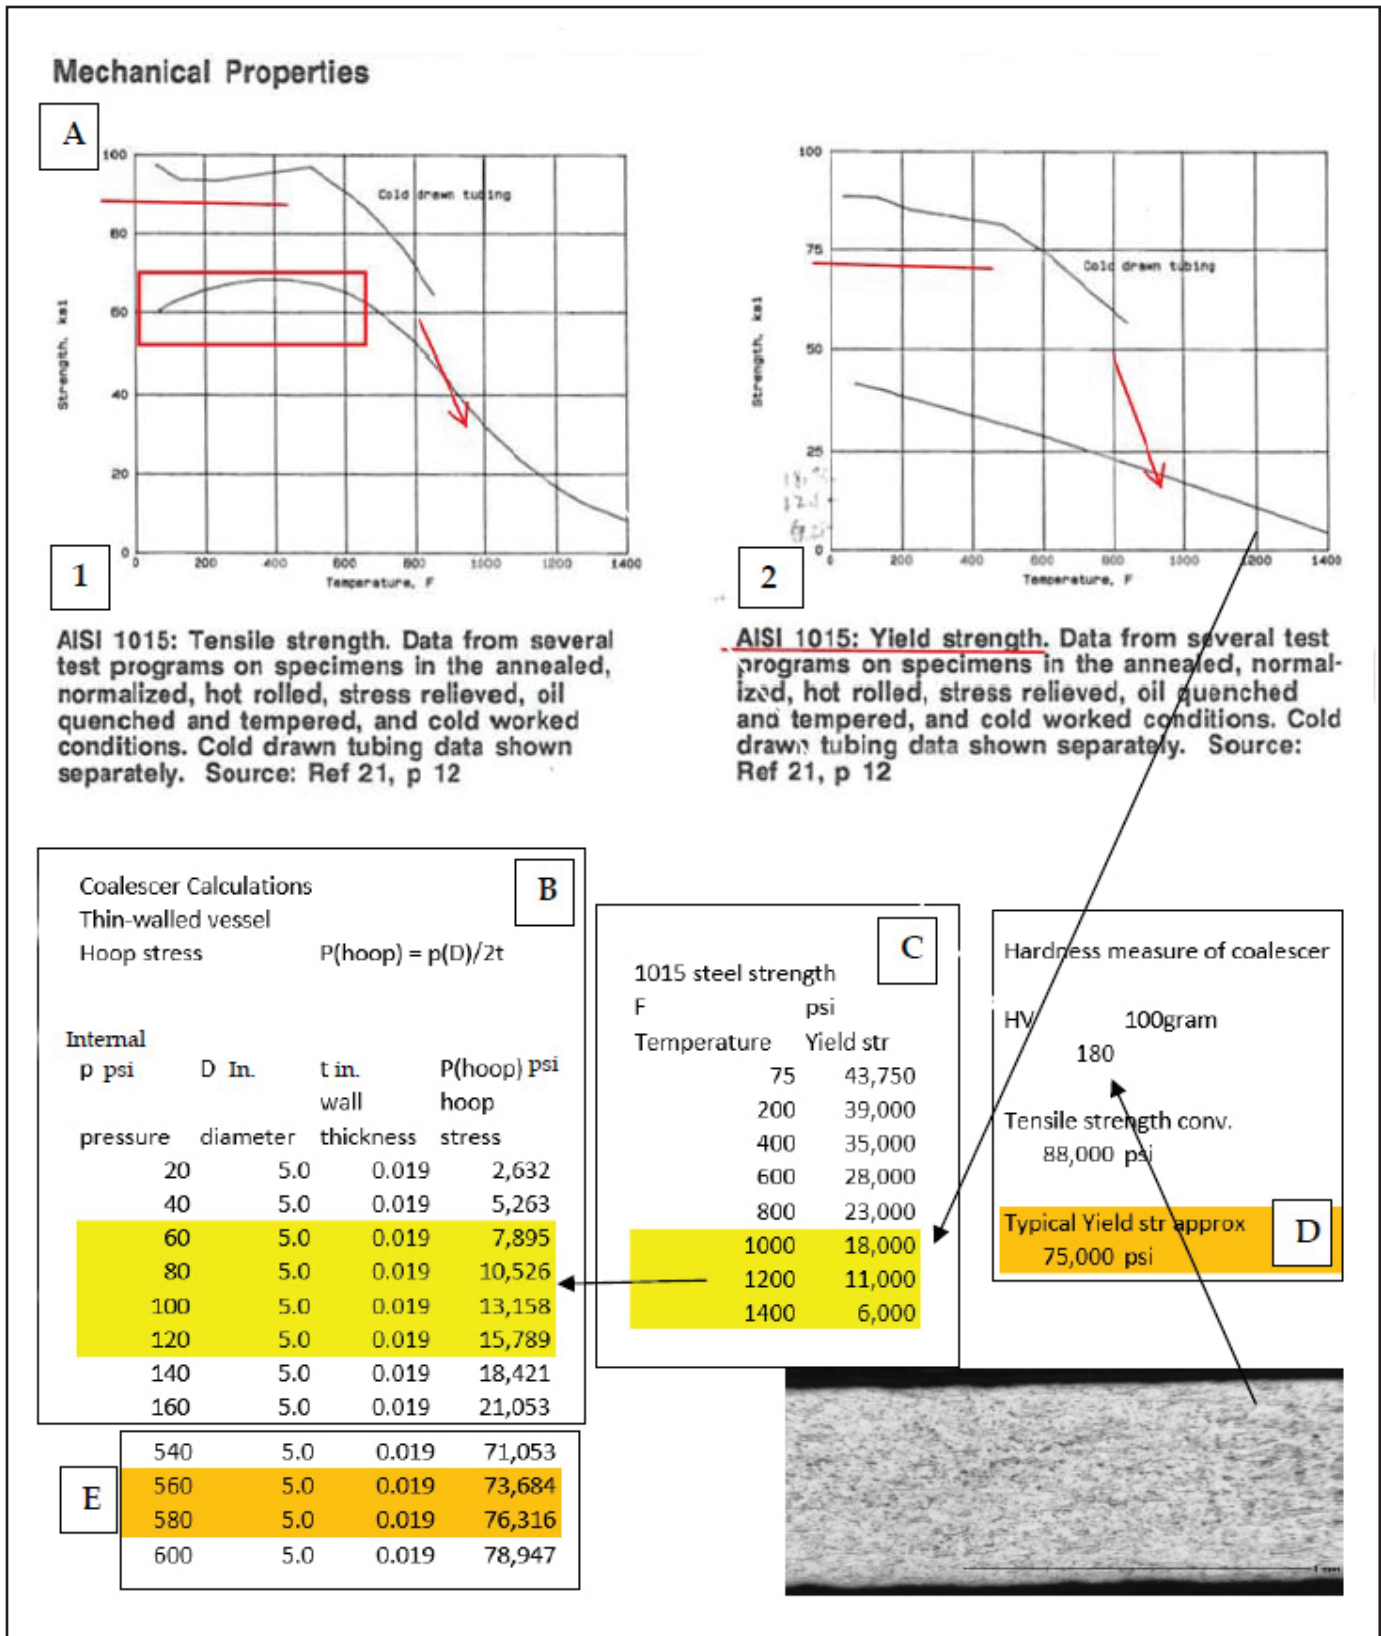
Figure 11

air compressor pressure up to about 400°F (**Figure 11**). However, at temperatures in the range of 1,000 to 1,400°F, the subject coalescer would exceed its yield strength, allowing the coalescer to bulge<sup>5</sup>. The next step would then be rupture as the temperature increased still further and damage accumulated from yielding of the metal.

Subject coalescer had an as-manufactured hardness of 180 HV corresponding to a tensile strength of over 80,000 psi (D). The hoop stress on the coalescer (B, E) as a function of the compressor pressure shows a safety factor of 2-4 at temperatures up to 400°F. At temperatures of 1000 - 1400°F (A, C, B) the coalescer will plastically yield (bulge) and rupture within the normal operating range of the compressor (B).

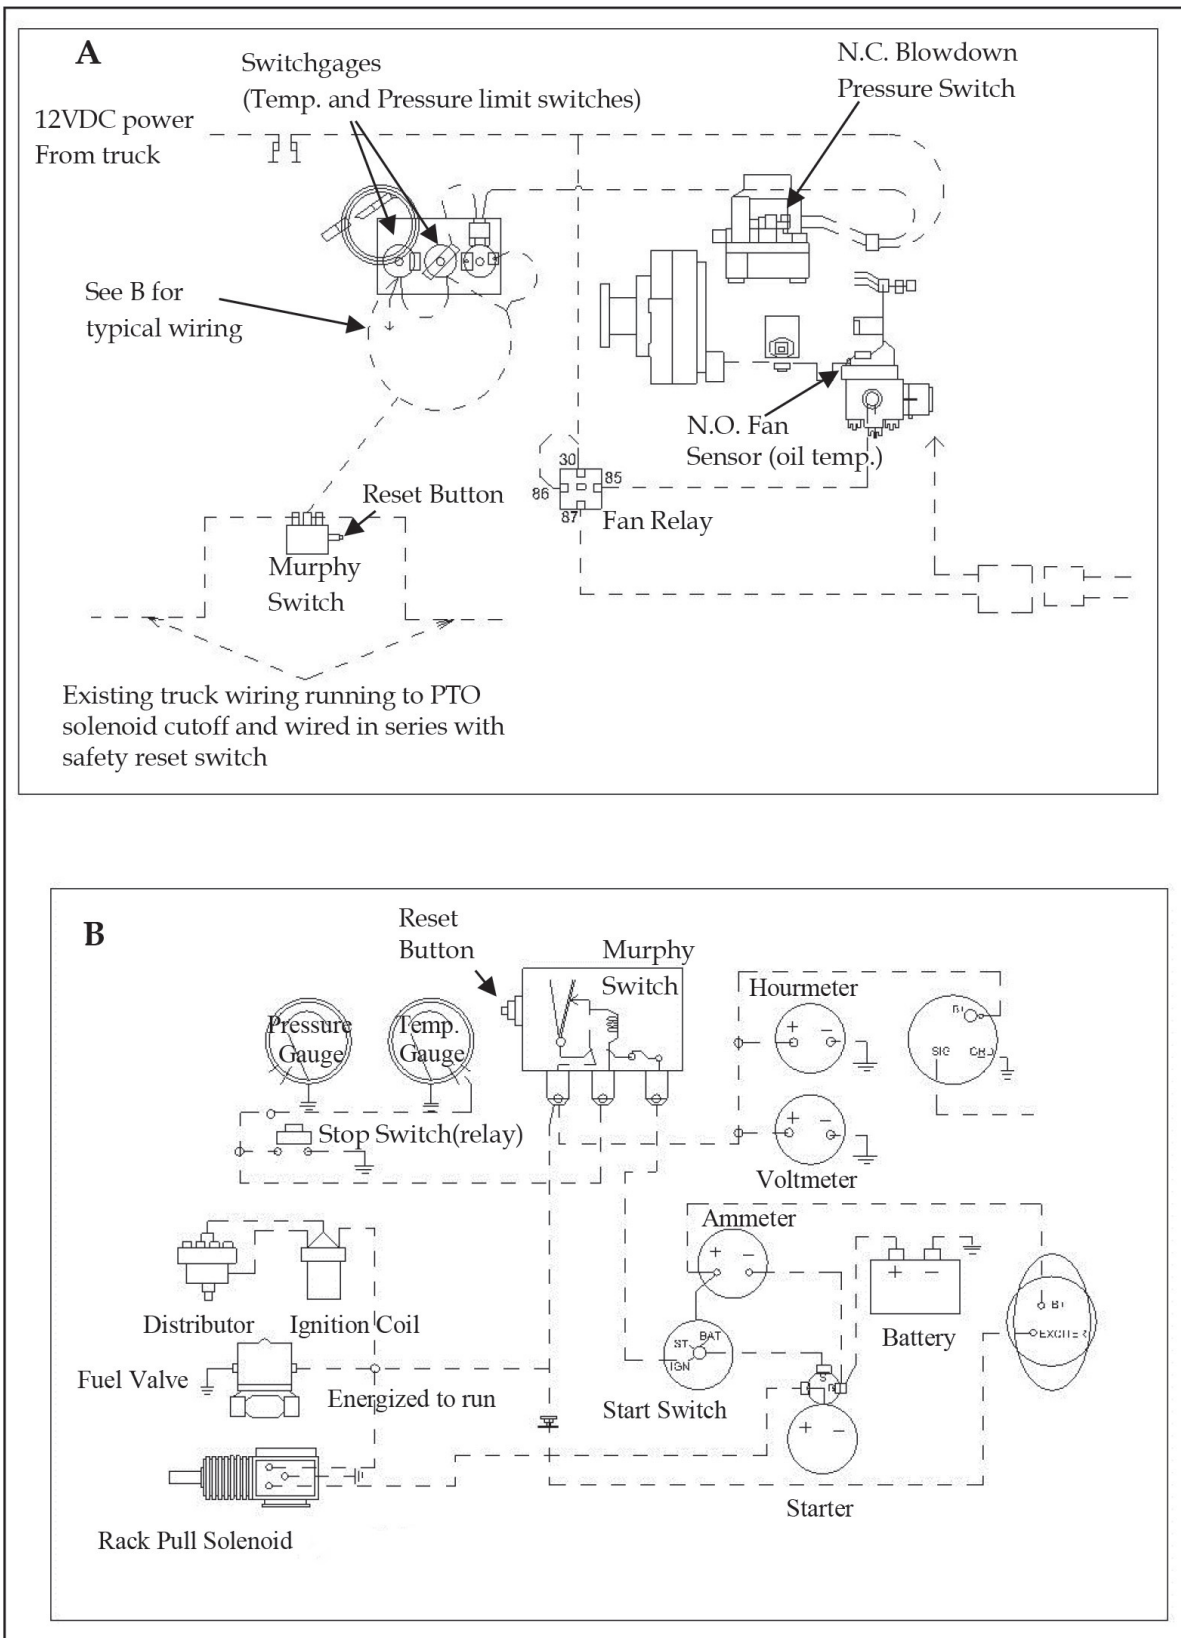
**Figure 12**

A. Diagram showing the air compressor manufacturer's subject safety shutoff circuit that allows the operator to manually override the out-of-limit condition and continue operating the air compressor system. B. Component manufacturer's design of a typical circuit (stop switch [relay] and reset button) resulting in same override outcome.

The inherent danger in this flaw is that while the air compressor is operating in an already dangerous condition, the condition can get worse<sup>2, 7-9</sup>. In this case, it was found that the broken fan on the heat exchanger allowed the oil temperature to continue to increase when the compressor was actuated with the reset button. The high oil temperature led to the flash fire in the coalescer, causing it to rupture.

This finding led to a redesign of the subject control circuit that would prevent the restart of the air compressor while it is out of its intended operating parameters. Again, a schematic of the subject electrical circuit is shown in **Figure 12**. The control circuit was redesigned using a 12-volt relay and two suppression diodes. The revised design allows the system to shutdown at an over-limit condition and prevents the operator from restarting the system until the over-limit condition has reversed (i.e., temperature and/or pressure is back in operating range).

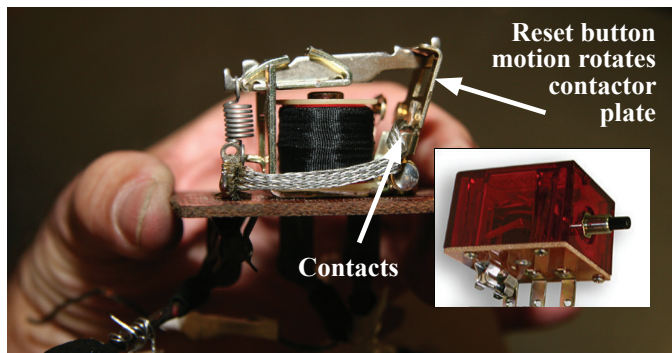
The subject safety shutoff switch in the unlatched position. To reset, push the spring-loaded contactor to the left and lock it in place on the hook. When the electromagnet is energized, the hook is pulled down, causing the contact linkage to unhook and rotate to the unlatched position (system out of limit condition).

through the temperature and pressure gauges at the second pole. **Figure 13** shows the device with the outer housing removed to show the internal electromagnet and latching device. Upon actuation of the electromagnet by a gauge over-limit condition, the electromagnet mechanically unlocks the latching mechanism by pulling the hook arm down and releasing the contacts to open and the system to shut down. Pressing the reset button forces the contacts closed, which engages the air compressor whether or not the electromagnet is active.

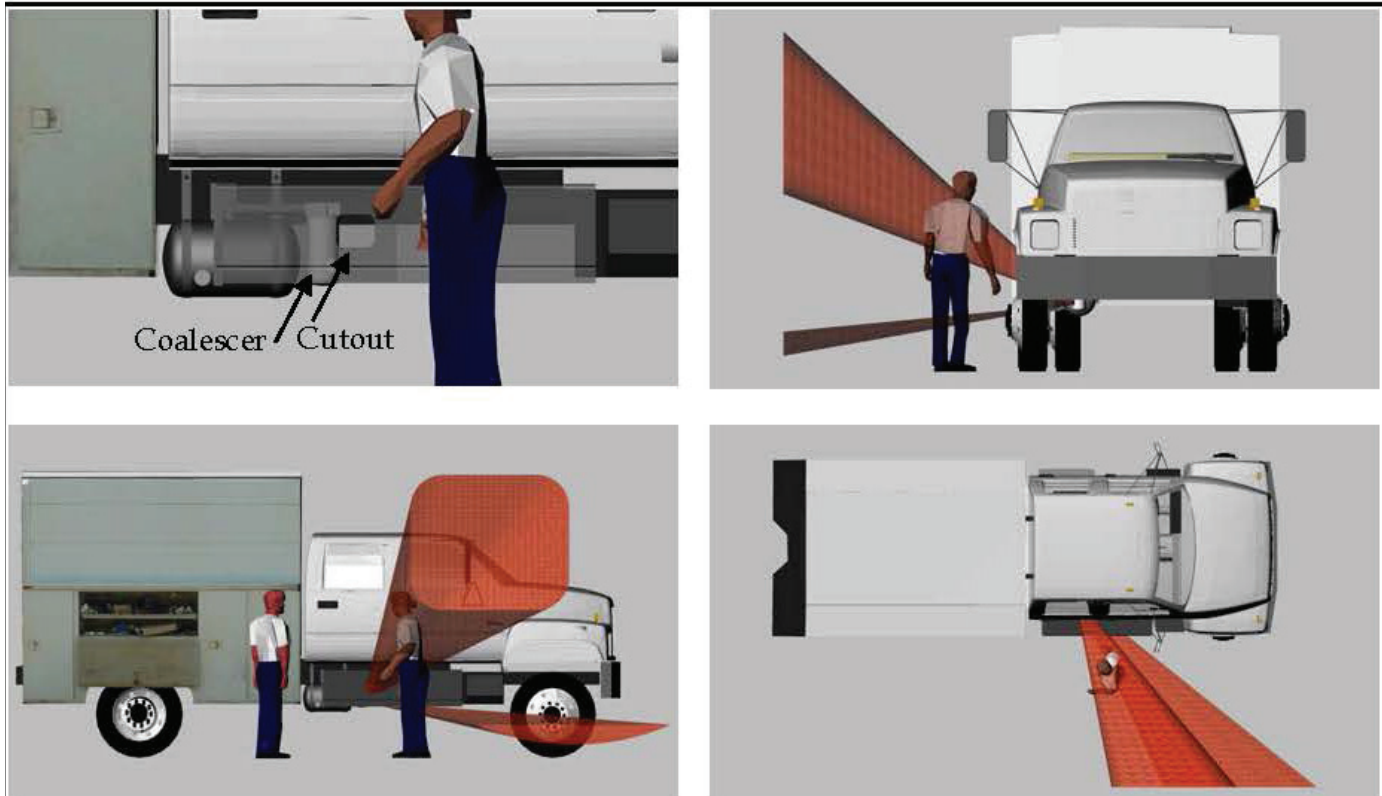
Figure 16

The open hole proved to be the opening that the burning oil needed to exit the truck and strike the operator over a large part of his body (**Figure 16**). The path of the oil, from the rupture through the open hole, was analyzed and shown to be consistent with the injuries in the case. A root cause of the injuries suffered was the open cutout in the step.

Operator at location required to operate reset button. B-D. Perspectives of fluid spray from coalescer.

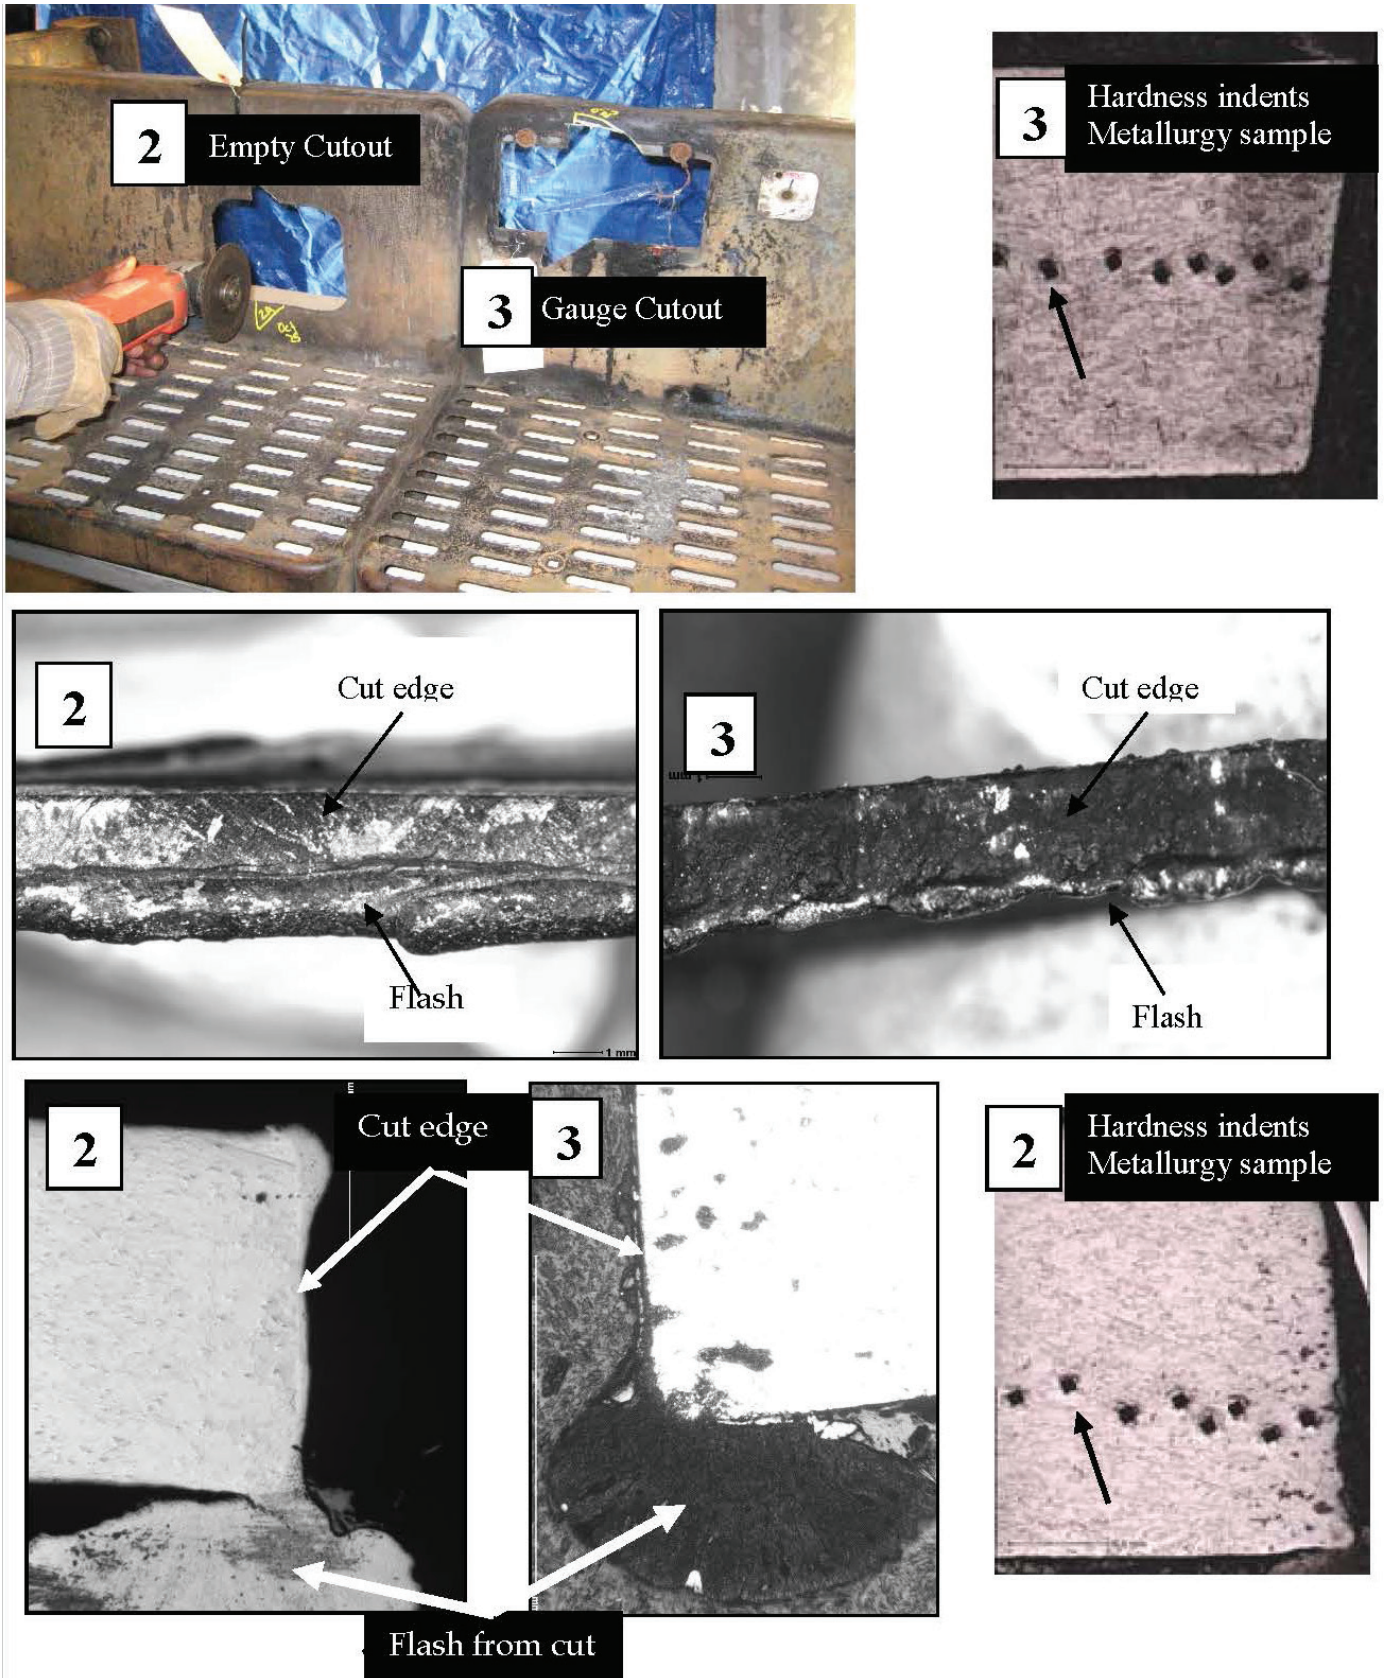
Figure 17

Samples taken from cutouts in step. 2. Cutout #2 is the empty cutout. 3. Cutout #3 is the gauge cluster cutout. The cut edge with metal and oxide flash was found to be the same in each cut. The hardness and metallurgical heat zone were found to be the same in both cuts.

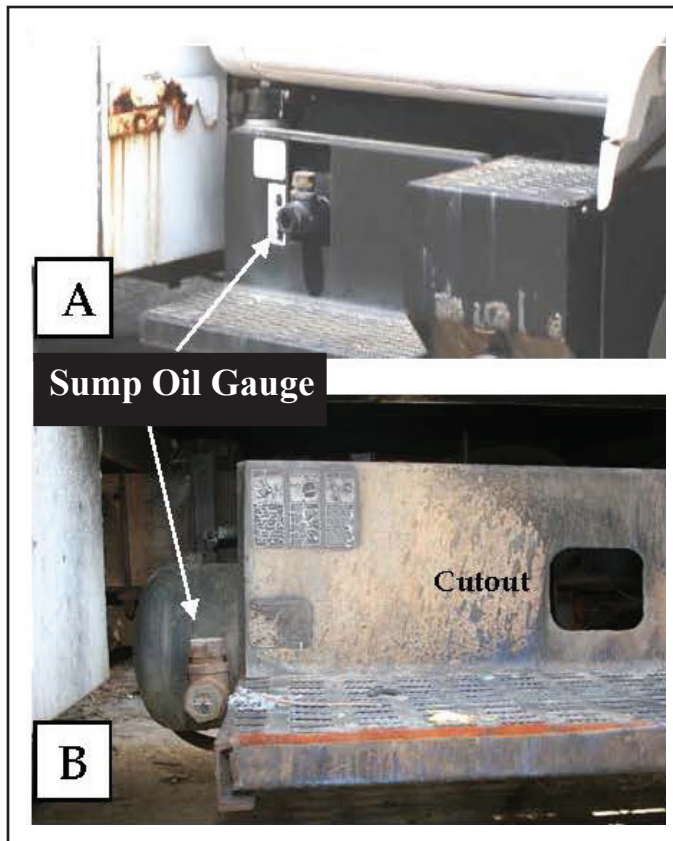
**Figure 18**

Exemplar truck oil gauge location. B.  
Subject truck oil gauge location and open cutout.
