Vol. 35 No. 2 December 2018

Forensic Engineering Investigation of a Fatal Farm Tractor Incident

By Daniel P. Couture, PEng (NAFE 951M)

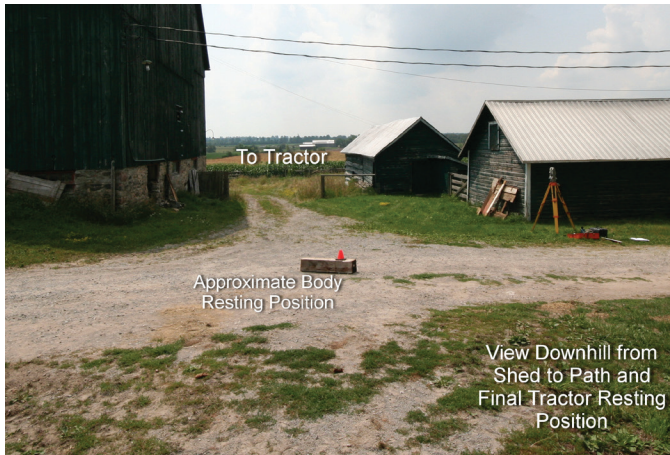
Figure 2

View downhill from shed at farm site.

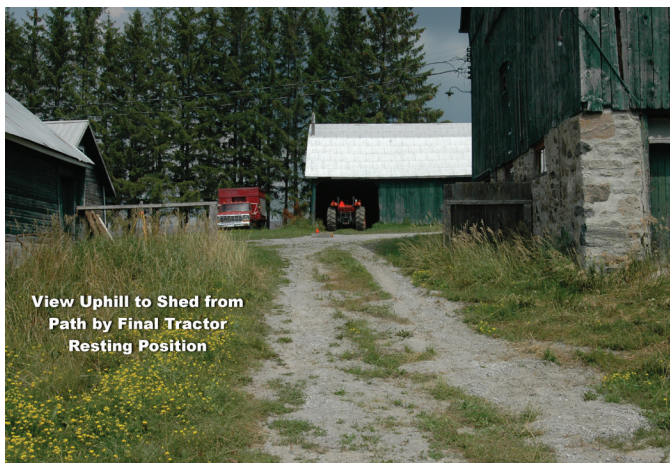
Figure 3

View uphill to shed from path.

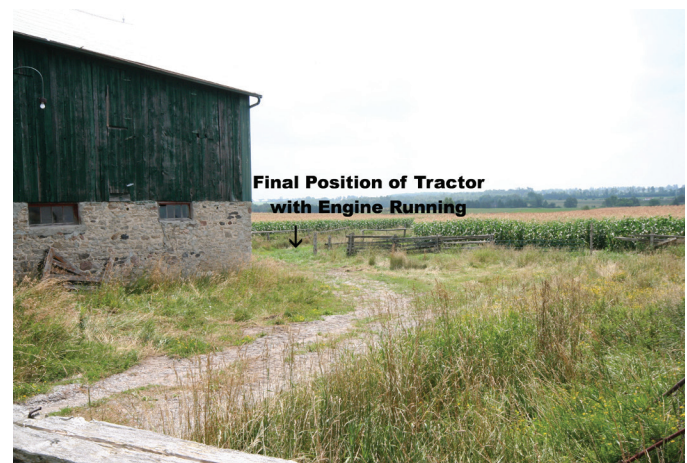
Figure 4

Final position of tractor with engine running.

Recalling that the tractor transmission was found after the incident in neutral (with the engine running), it was inferred to have been that way at the time of the incident. With the local slope conditions contributing to creep of the tractor backward, the tractor parking brake was either not engaged at the time of the incident involving Mr. W, or it was engaged and had become disengaged. The possibility of the latter provided the impetus to continue the second phase of the investigation.

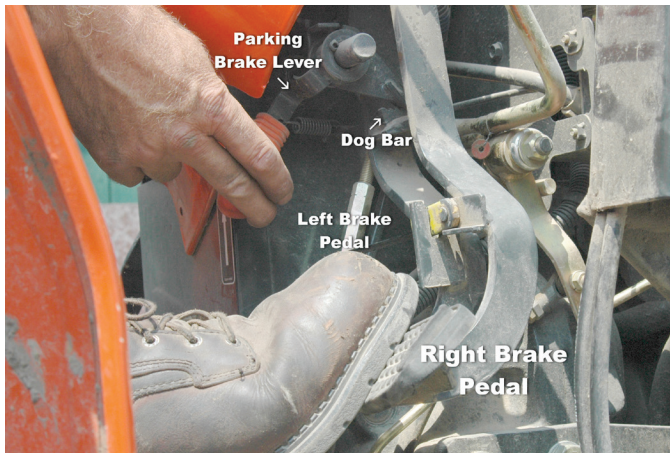
The tractor braking system comprised independent mechanical wet disc brakes for the right and left traveling brakes. Separate pedals were provided for the right (outboard side) and left (inboard side). Depressing the pedals and pulling the parking brake lever locks the traveling brakes, and results in the same state as that obtained when the brake pedals are pressed. The inboard and outboard pedals can be split, but only the inboard pedal is required to be depressed to engage the parking brake, as shown in **Figure 5**.

Figure 5
Parking brake configuration.

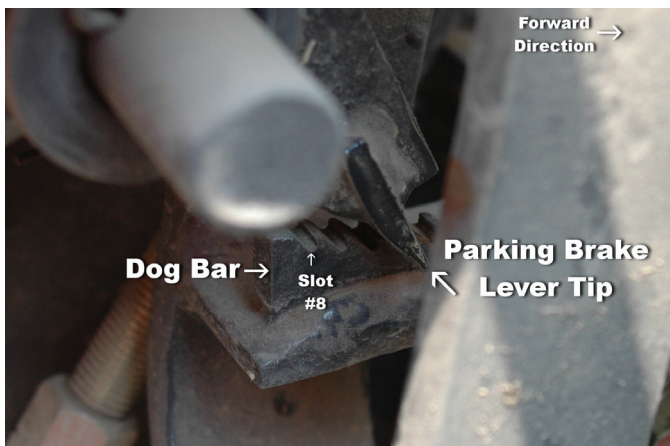
the end tip of this bar dropped at an acute angle into one of a series of transverse tooth-shaped slots (**Figure 6**) cut across another bar (“dog bar”) welded horizontally to the upper side of the inboard pedal.

The dog bar grooves were shaped such that the pedal return action engaged the flat bar tip edge, catching it and locking the brake pedal at that position. There were eight slots in the dog bar over its length from leading to trailing ends. The dog bar and the flat bar were composed of steel, and appeared to have been painted dark grey originally. The paint on the front leading edge of the flat bar had been worn away, and the underlying metal had rusted.

During the interaction between the flat bar and the grooves, it could be seen that the shape of the upper portion of the dog bar at the first and second slots was rounded, rather than sharp. Furthermore, the depth of the grooves appeared insufficient to provide contact forces to reliably engage the brake pedal and hold it depressed.

Figure 6
Dog bar and tip interaction.

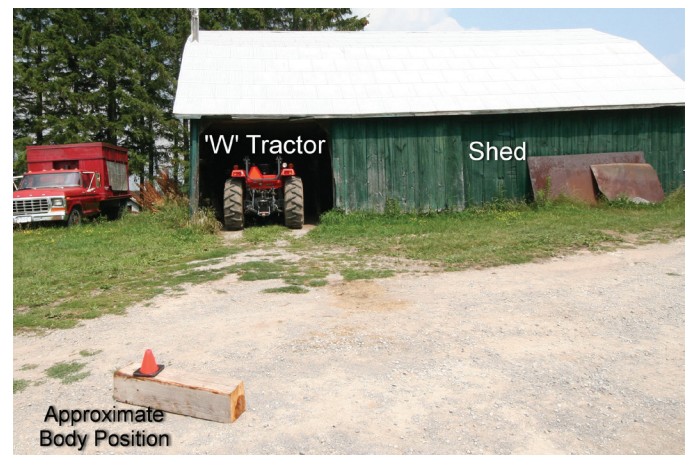
The tractor transmission was set in neutral with the engine running, without the parking brake engaged, at the edge of the shed, as shown in **Figure 7**. With the rear tires on a projected line on the ground below the eaves, the tractor was witnessed creeping backward out of the shed into the driveway. The 3.5-meter-long tractor backed out, gradually increasing in speed, and exited the shed in about 15 seconds. Further tests demonstrated that creeping would occur even with the engine stopped and the transmission in neutral.

Figure 7
Position of the tractor for neutral drifting test.

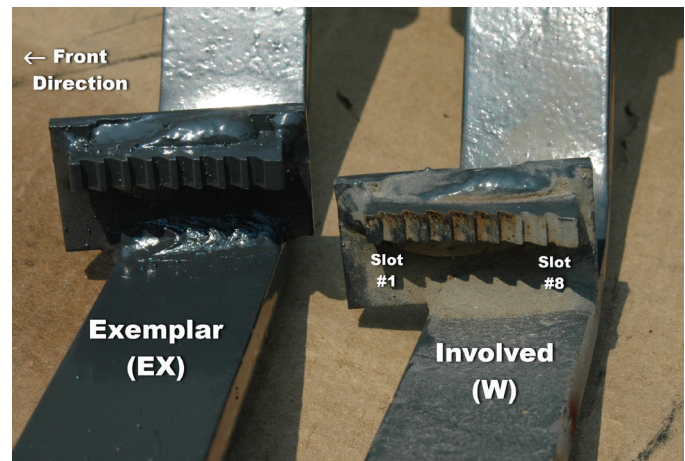
The exemplar and the W (hence forward referred to as “EX” and “W,” respectively) brake pedal dog bar welded positions were visibly different (**Figure 10**), when the front edge of the brake pedal was used as a reference point. On the W dog bar, the wear pattern was concentrated on one side — and on the first six teeth only — as shown in **Figure 11**.

Figure 10
Exemplar (EX) and involved (W) dog bars.

of a lateral offset between the tip and the teeth of the dog bar, as seen in **Figure 10**.

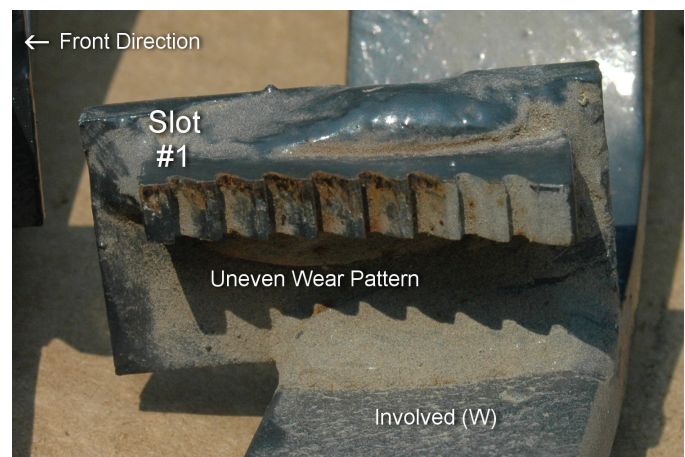
Figure 11
The wear pattern on the involved dog bar was uneven.

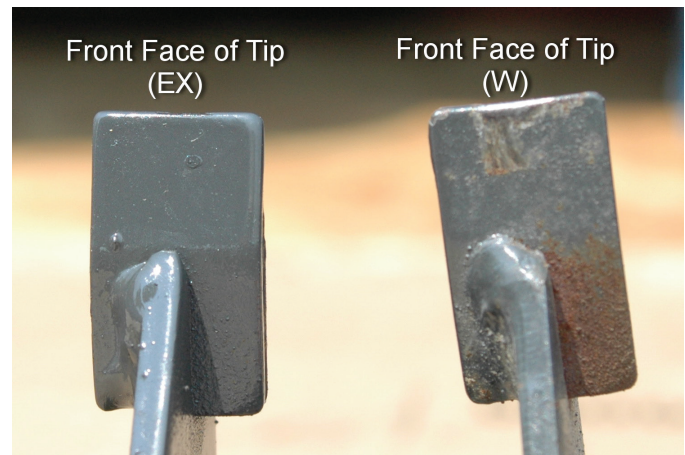
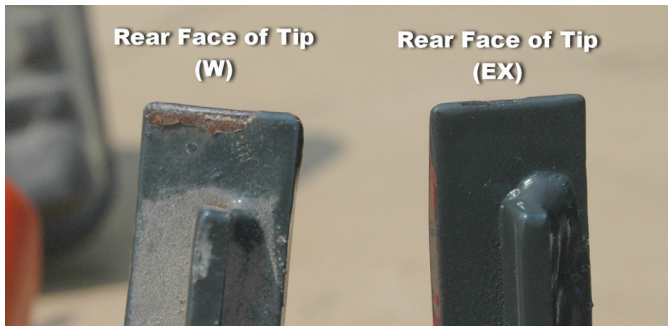
As shown in **Figures 12** and **13**, there was a trapezoidal shape of the wear pattern to the paint on the W parking brake lever tip, while on the obverse the paint coating was missing on the W lever tip, covering about three quarters of the width to a depth of 1.5 mm. The uneven wear pattern seen in **Figures 12** and **13** at the tip was suggestive of a lateral offset between the tip and the teeth, matching the uneven pattern as seen in **Figure 11**, possibly indicating incorrect fit.

The uneven wear pattern seen at the tip was suggestive

Figure 12
Front faces of the tips of the exemplar (EX) and involved (W).

Figure 13
Rear faces of the tips.

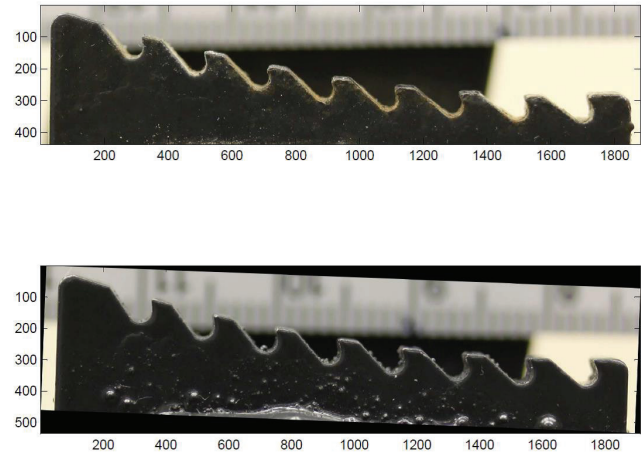
Figure 14
Tooth profiles for W (top) and EX (bottom) dog bars.

differences. Close-up digital SLR photographs of each profile were performed using a 50-mm macro lens (**Figure 14**). In Adobe Photoshop, the photographs were superimposed by overlaying a transparency of EX over top of W — the EX profile was uniformly scaled until both EX and W dog bar lengths were equal. The profiles were subjectively assessed and found to be identical.

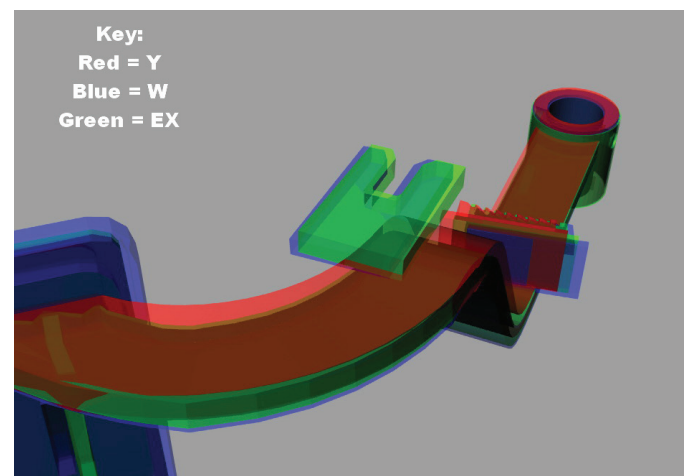
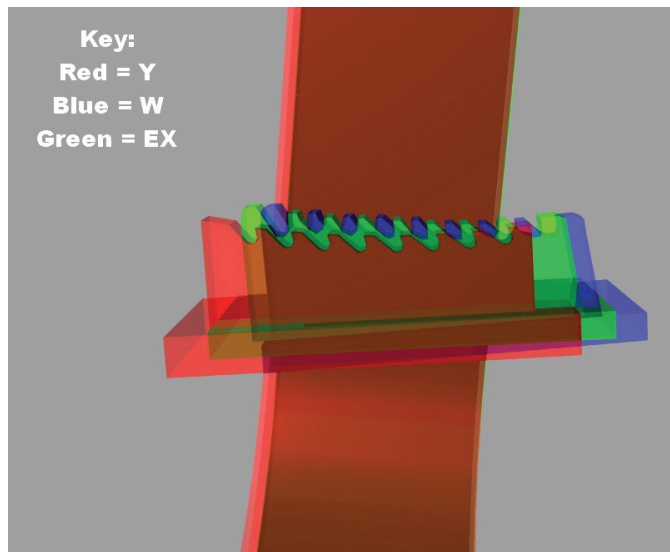
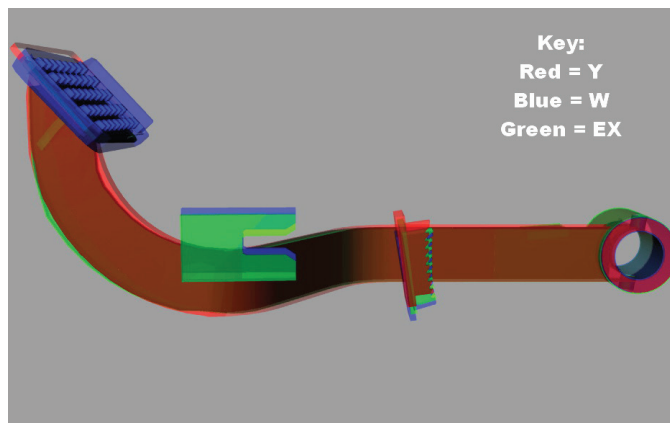
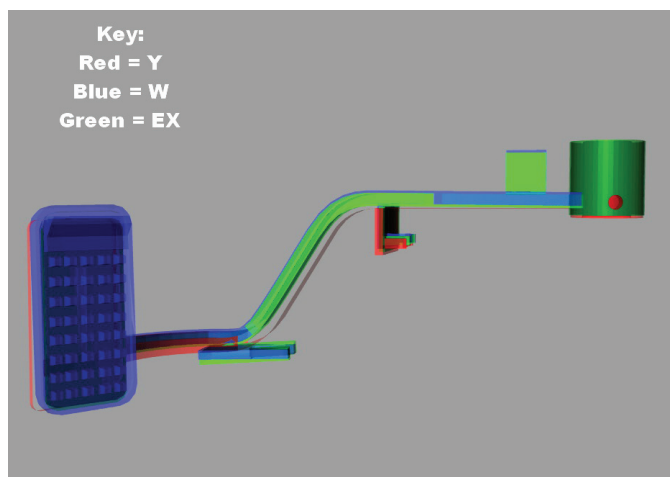
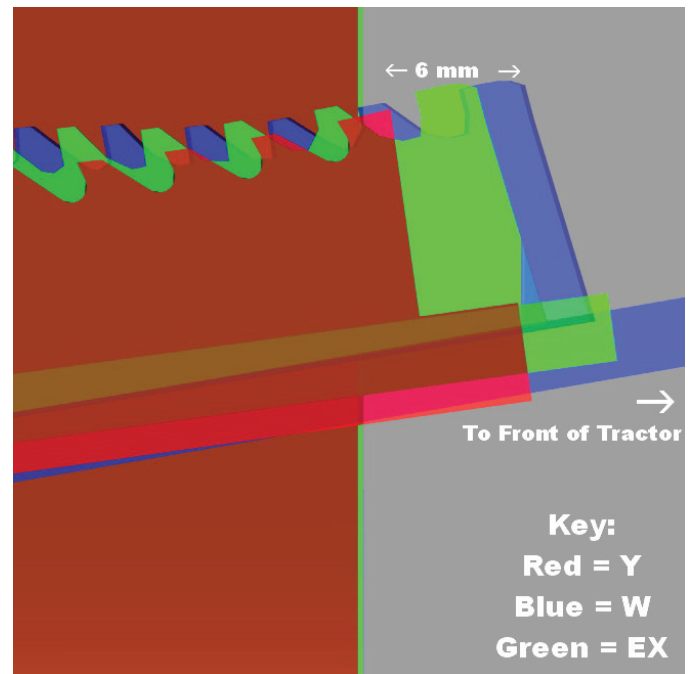
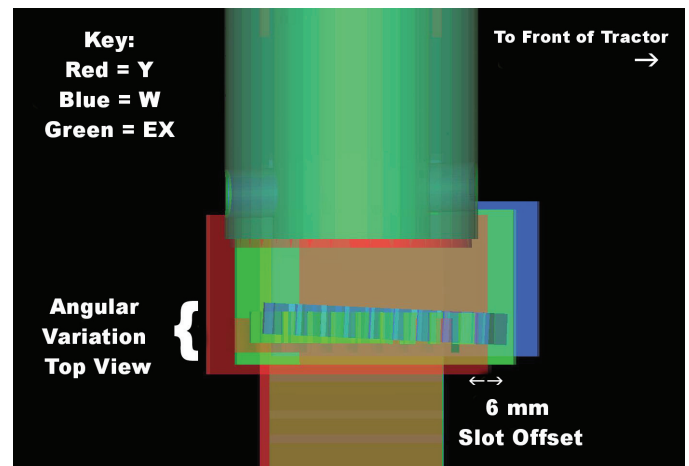
When compared in three dimensions, using a common reference origin with respect to the blueprint dog bar orientation and dimensions, it was determined that W dog bar had an offset of 6.3 mm, and rotation of its side, top and front by 1.8, 2.6 and 5.8 degrees, respectively. The

EX dog bar had an offset of 4.2 mm, and rotation of its side, top and front by 0.2, 0.4, and 0.2 degrees, respectively.

When the three are set at the common center of rotation and overlaid in color (red for Y, blue for W, and green for EX), the positions and orientations are very different, as depicted in **Figure 22** and **Figure 23**. The blue portion lies at an angle to the red, and at the forward edge, the separation between the supposed position of the first tooth on Y and that of the W is about 6 mm (about $\frac{1}{4}$ inch). This offset is 133% of the 4.5-mm slot center-to-center

distance on the dog bar toward the front of the tractor.

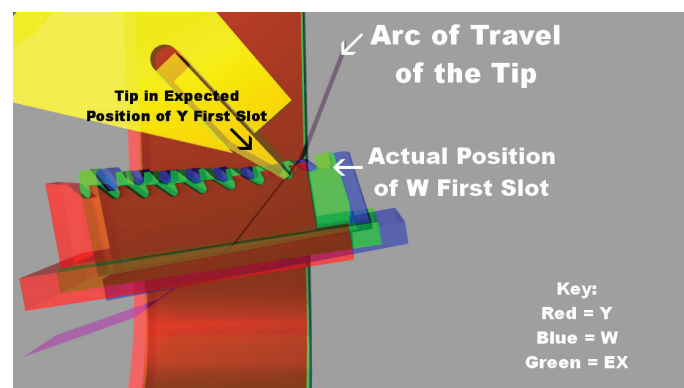
Figure 24

The intersection of the arc of travel of the lever tip and the dog bar no longer lay at the expected location in space after assembly, as shown in **Figure 24**.

The 6 mm ($\frac{1}{4}$ inch) displacement and relative rotation of the W components accounted for the change of behavior noted during the first and second phases of the investigation, in which the slot bar edge tip would not remain within the teeth of the dog bar. As mentioned, this distance was 133% of the slot center-to-center distance on the dog bar — a misalignment of more than one tooth.

Expected and actual positions of the tip at dog bar first slot.
