Forensic Engineering Experience with Electrically Ignited Fires

By Roger L. Boyell, P.E. (NAFE 696F)

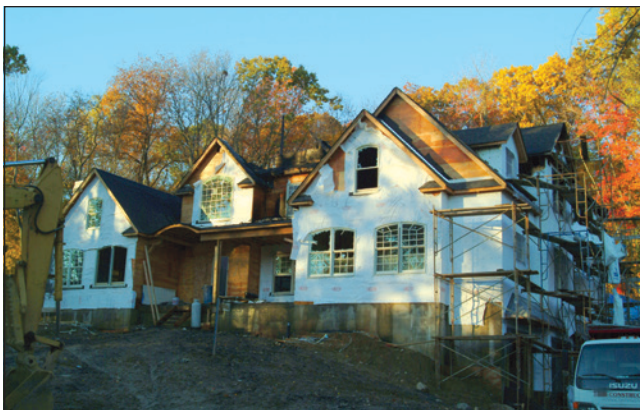
Figure 1

House under construction at the time of the fire.

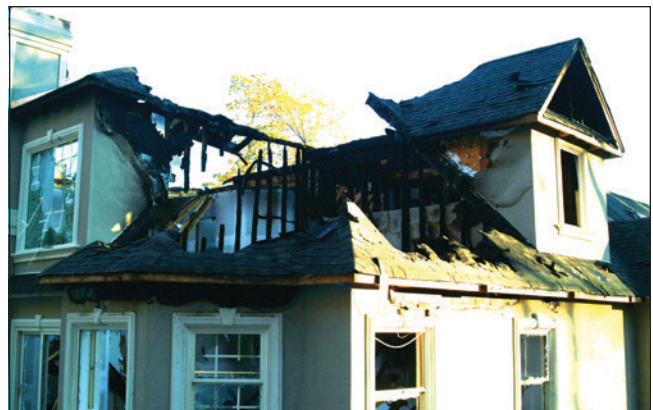
Figure 2

Fire inside broke through the roof.

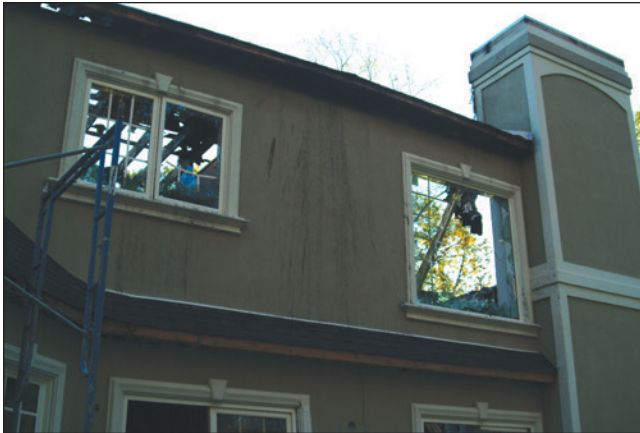
Figure 3
Interior heavily damaged.

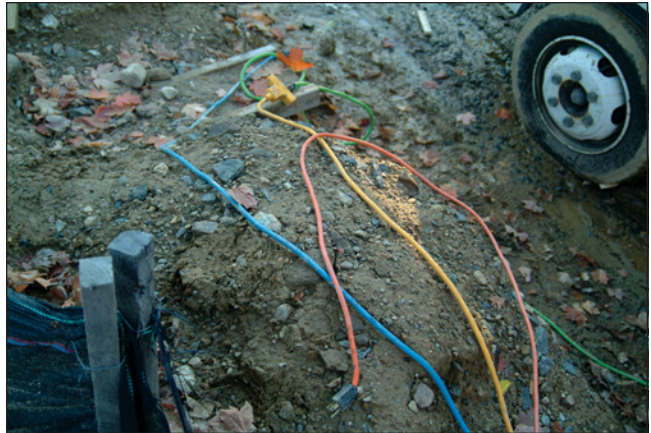
Figure 4
Various contractors' extension cords.

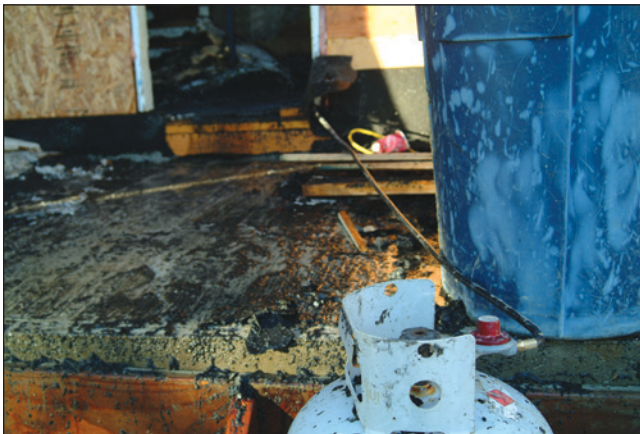
Figure 5
Propane tank and hoses.

The extension cord and work light were attributed to one of several contractors who had been working at the site. However, that contractor's fire investigator identified other potential non-electrical causes. For example, he claimed that fire patterns showed the origin of the fire to be at the downstairs level (where propane heaters had been operating) and that the extension cord was merely a victim.

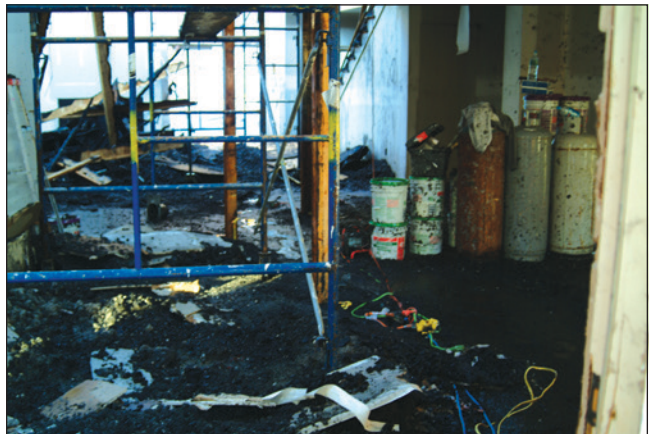
Figure 6
Paint cans and propane tanks.

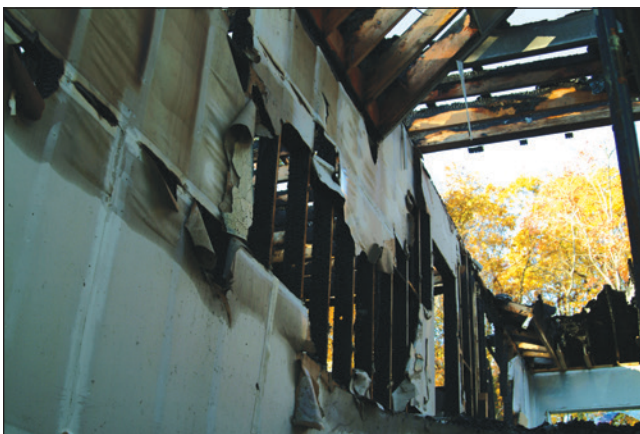
Figure 7
Fire damage from ground floor through roof.

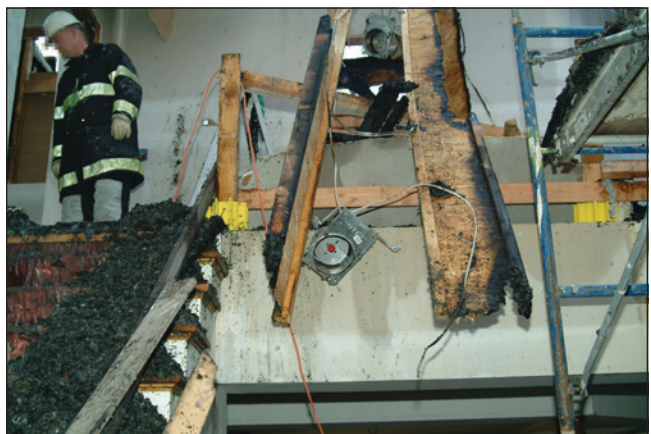
Figure 8
Orange extension cord of particular interest.

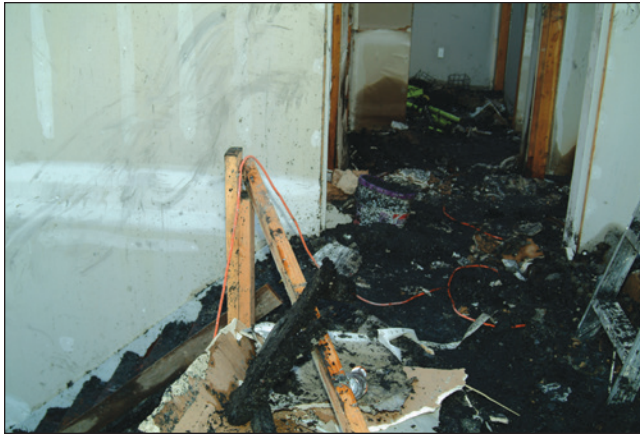
Figure 9
Extension cord leading into area of heavy damage.

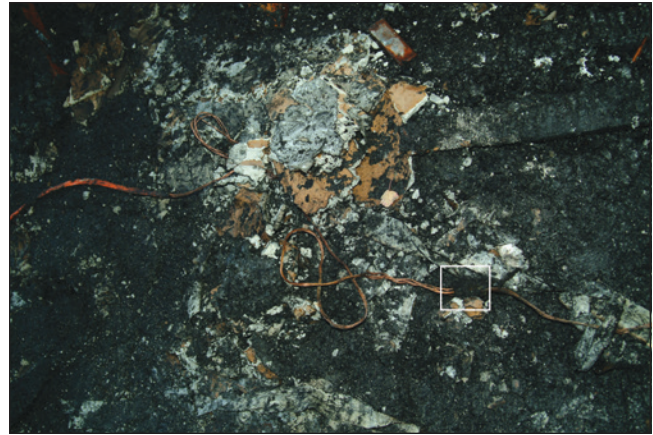
The orange jacket of the extension cord had been burned away near a plug-and-socket junction with a black power cord (lower right of **Figure 10**). The junction was encrusted with debris (right side of **Figure**

Figure 10
Plug-and-socket junction (at lower right of center).

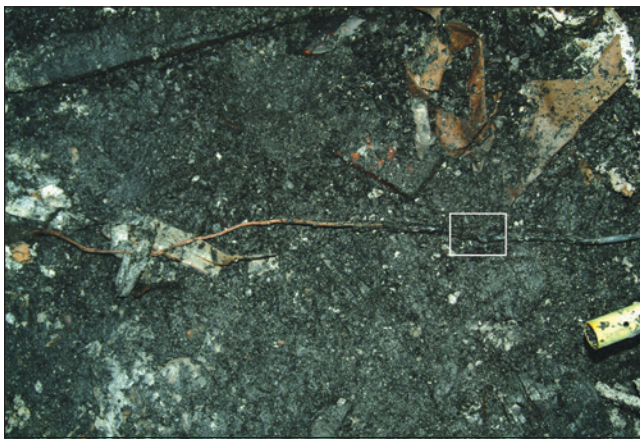
Figure 11
Plug-and-socket junction encrusted with debris.

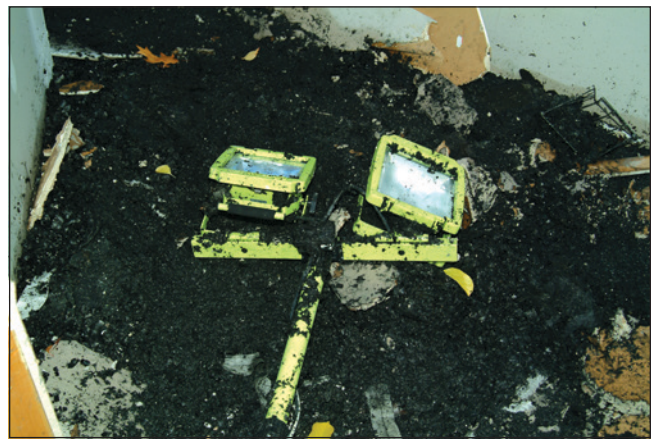
11), and the power cord was found to originate from a dual-head halogen work light (**Figure 12**), which later was found to draw 1,000 watts of power.

Figure 12
Work light that was plugged into the extension cord.

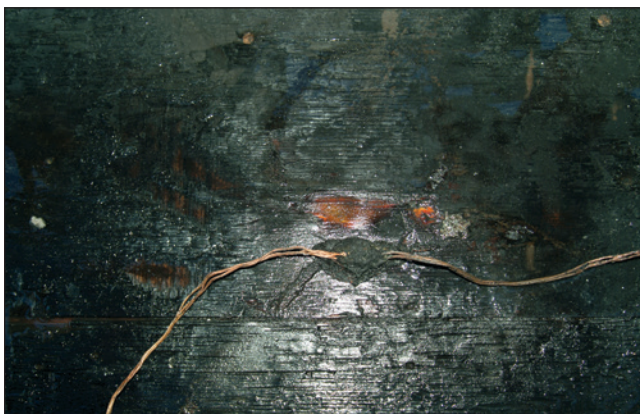
Figure 13
Extension cord (on the left), work light cord (on the right).

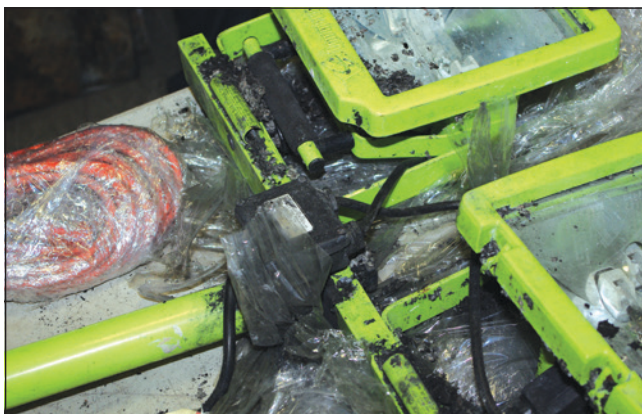
Figure 14
Evidence when first opened for examination.

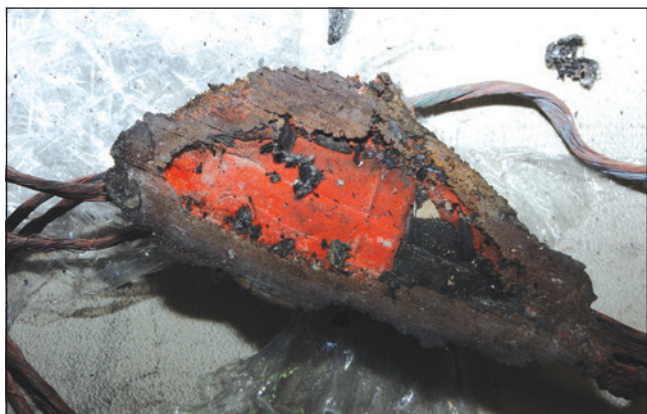
Eventually, the physical evidence was to be made available for examination. When the big day came, the extension cord and work light were unwrapped (**Figure 14**), and the first peek at the allegedly burned electrical junction (**Figure 15**) showed it to be intact and unburned. The debris that encrusted the junction seemingly protected it from damage during the fire. Engineers retained by the accused contractor opined that this physical evidence indicated the contractor's electrical equipment was not responsible for the fire.

Figure 15
Plug (black) and socket (orange) showing minimal damage.

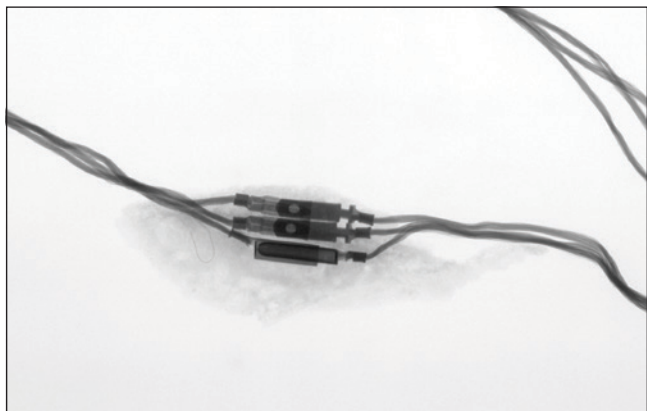
Not being deterred, the property owner's expert insisted that X-rays would show there was arcing or some other electrical damage at the junction. As a result, more time and money were spent obtaining high-resolution X-rays. Nevertheless, inspection of the resulting radiographs of the evidence (**Figure 16** and **Figure 17**) showed that the electrical connections between the plug and the socket were perfectly normal

Figure 16
X-rays of power cords forming the junction.

Figure 17
Enlargement showing no electrical defect.

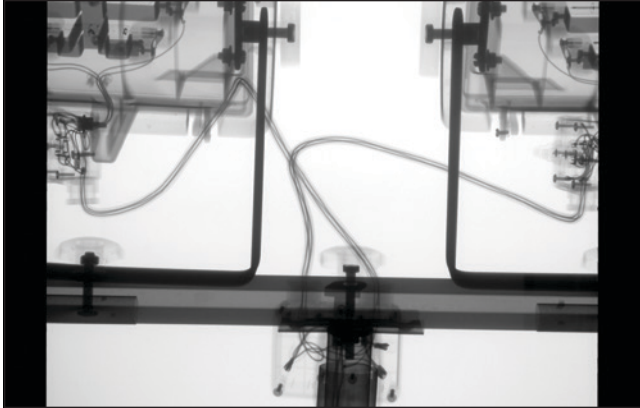
Figure 18

X-ray of work light showing no electrical abnormality.

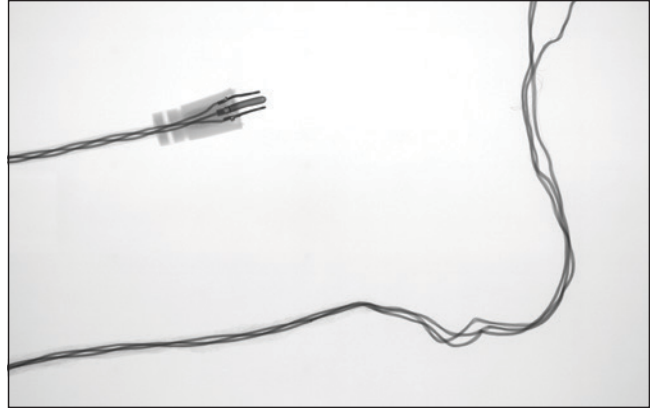
Figure 19

Extension cord plug also showing no electrical abnormality.

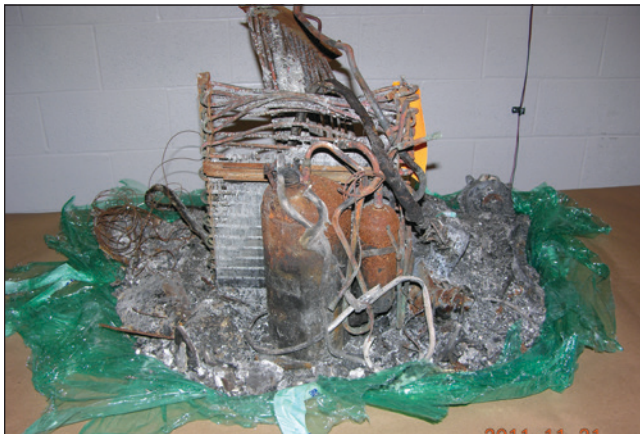
Figure 20

Front view of remains of room air conditioner.

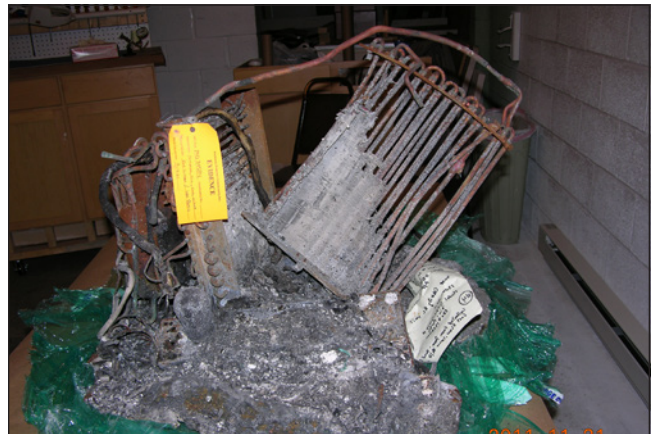
Figure 21

Side view of remains of room air conditioner.

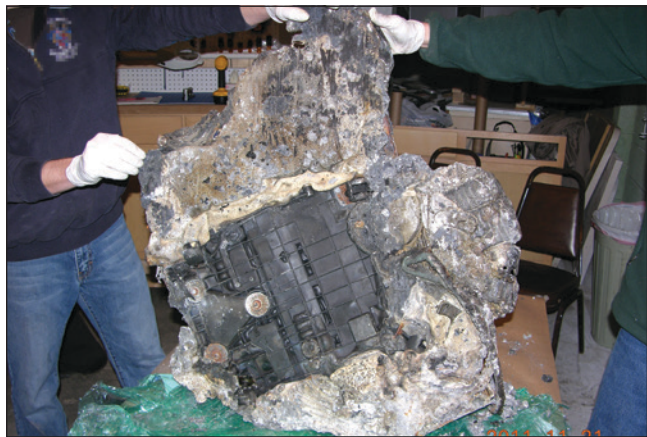
The exemplar exhibits electrical wiring, a compressor motor, and fan motors (**Figure 24**), all of which can be compared with the evidence unit to locate the presumed defect or malfunction. Upon investigation, such comparison revealed that the bottom of the evidence unit was surprisingly intact (**Figure 25**), considering that the fire was said to have begun there.

Figure 25
Underside of evidence unit showing little damage.

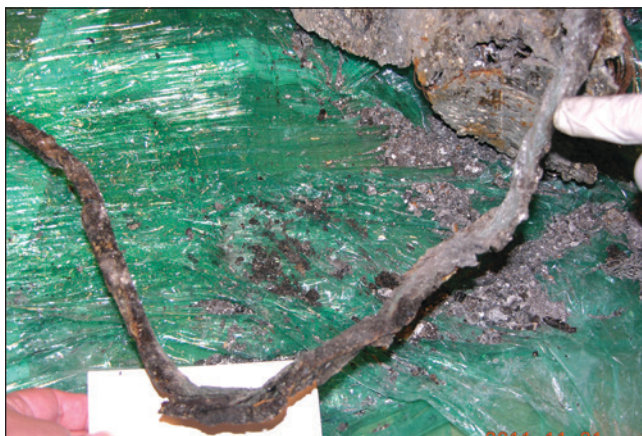
Figure 26
Power cord insulation burned away.

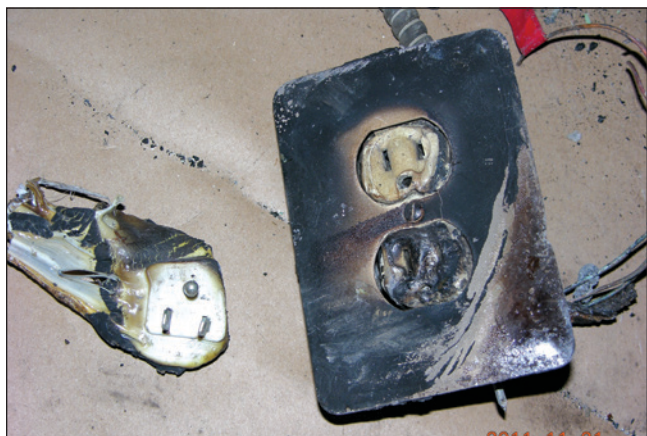
Figure 27
Plug and receptacle burned from outside in.

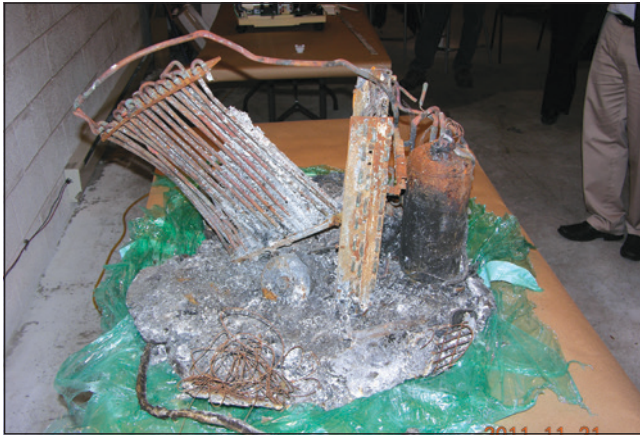
Figure 28

the air conditioner ignited first and spread to the rest of the room. It was curious, however, that the retained evidence was so thoroughly destroyed (**Figure 28**). It appeared as if a blowtorch had been applied to the unit rather than it being consumed in a plastic or wood fire. There was no damage pattern typifying a localized electrical event. Perhaps the air conditioner was merely a victim of the fire that had started elsewhere.

Evidence of intense fire consuming the entire unit.

While an electrically ignited fire usually shows a localized area of most intense destruction, this air conditioner exhibited uniform damage. That would be consistent with fire attacking the unit from the burning material circulating within it.

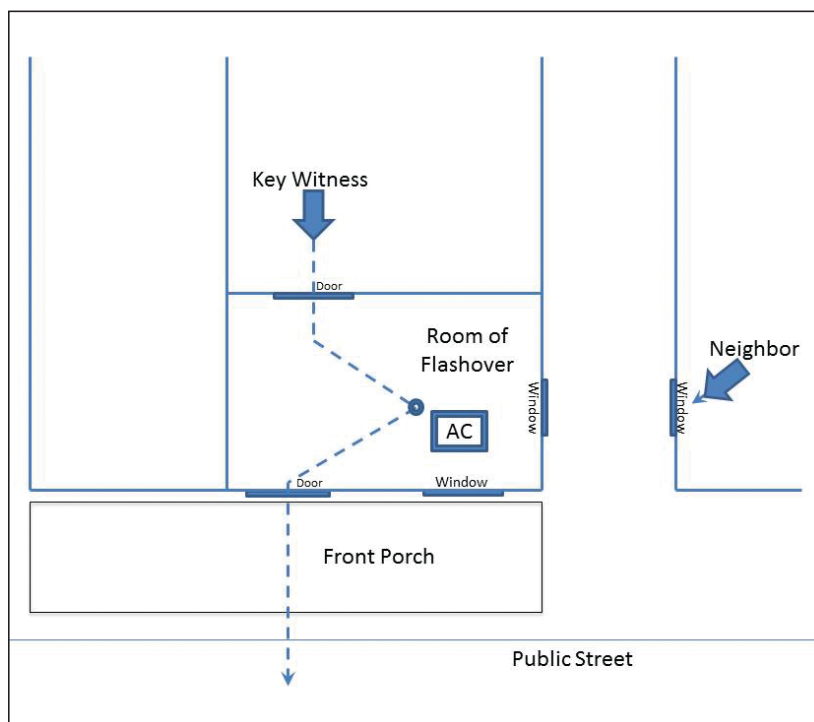
Figure 29

Information was pieced together from many witnesses. Everyone said the fire started near the front corner of the house. The layout of the premises is shown in **Figure 29**. The portable room air conditioner had been running to cool the room. The unit obtained its intake and exhaust from the front window.

The key witness said he entered the room and walked to the air conditioner as shown in **Figure 29**, seeing the flame begin there. Before he could do anything, the unit became engulfed in flames, and he ran out the front door to the street.

Layout of the house showing witness path.

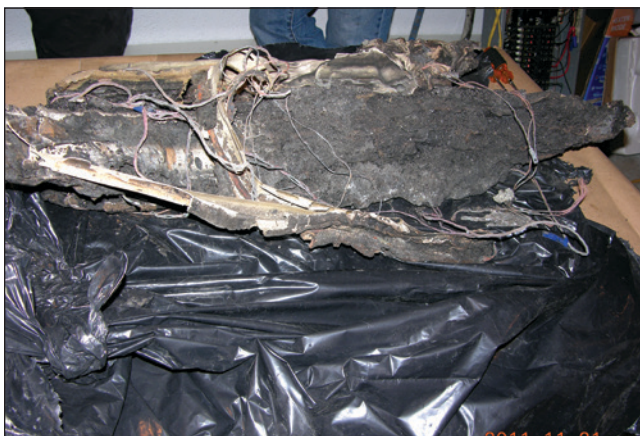
Figure 30

Inadequately preserved debris from front window.

This alternative hypothesis of the air conditioner being the victim could not be disproved, because investigators on the scene had not considered the origin to be on the porch. Little material was retained from outside the window of the room, and that material was not well preserved for examination (**Figure 30**).
