Vol. 35 No. 2 December 2018

# Forensic Engineering Analysis of Fire Caused by Control Failure Due to Deviation from Patented Design

By John Certuse, PE (NAFE 708F)

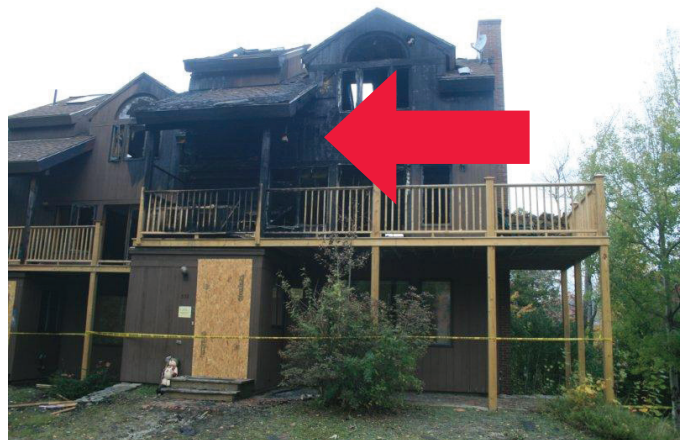
**Figure 1**

In October of 2010, a fire occurred in a condominium at a New England ski resort, resulting in a total loss of the subject and adjacent condominium units (**Figure 1**). This condominium included a four-person hot tub spa that was installed on the second-floor exterior porch of the 900-square-foot property. The hot tub spa was installed in 1997, and past service work included the installation of a new electric spa heater and circulating pump in 2003. The spa heater was again replaced in 2006.

Location of fire indicated by arrow.

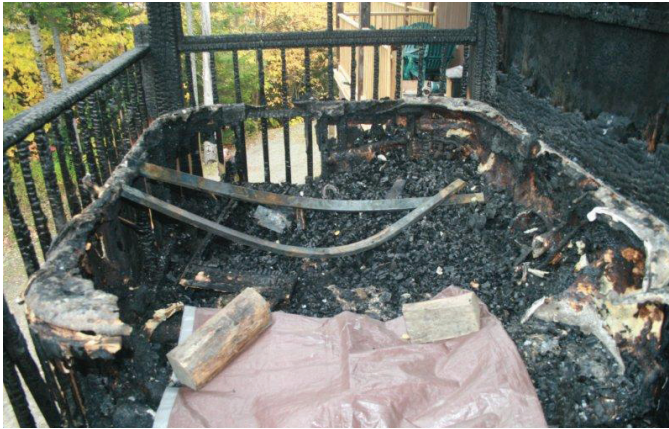
**Figure 2**

Spa as seen. Fire patterns and other fire investigation techniques identified it as the origin of the building fire.

Fire investigators determined that the fire originated from the hot tub spa located on the porch of the second floor (**Figure 2**). All other sources of the fire were eliminated both through visual examination, arc mapping, and fire pattern analysis. Part of the investigation included identifying parties that had access to or involvement with the condominium unit and spa including distributors, the manufacturer, ongoing maintenance repair technicians, as well as spare parts providers. Aside from the focus on the manufacturing and repair of the spa (and associated parts), the investigation also included recent carpentry work, because the second-floor porch where the spa was situated had recently been rebuilt. All parties were afforded the opportunity to conduct a fire scene examination. With winter weather conditions approaching — and in the interest of preserving the evidence from the fire scene — the spa and all electrical components were retained by the condominium owner's expert for later analysis.

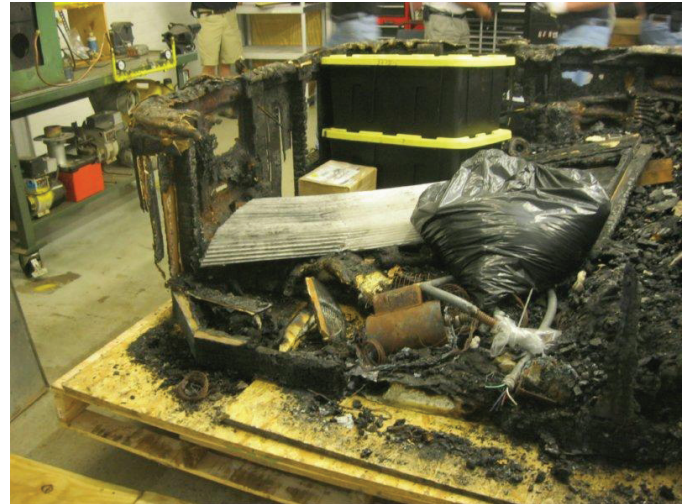
**Figure 3**

Spa and evidence in forensic laboratory.

Once the hot tub spa became the focus of the cause, the wiring and components of the tub that had not been rendered unidentifiable by the fire were examined and analyzed. Major components of the spa were examined for evidence of heat generation, consumption, and arcing to identify any involvement in the fire (**Figure 3**).

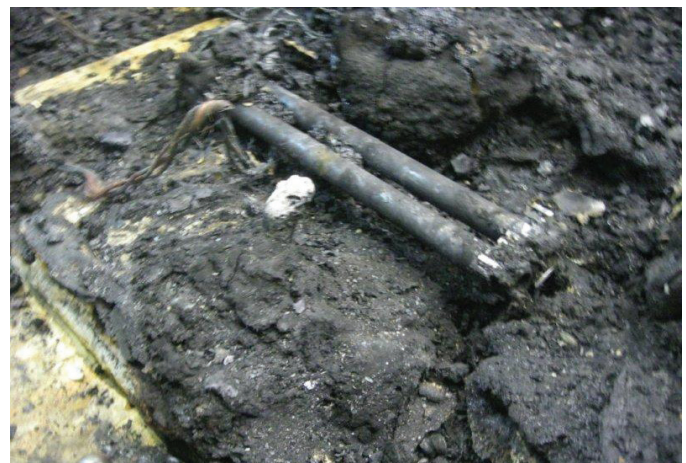
**Figure 4**

After major components were identified within the mass of melted foam and fiberglass, X-ray and computed tomography (CT) scanning were performed to identify features not initially visible (**Figure 4**). Examination of the heater identified electrical activity consistent with a malfunction and arcing event.

After debris removed, spa heater located.

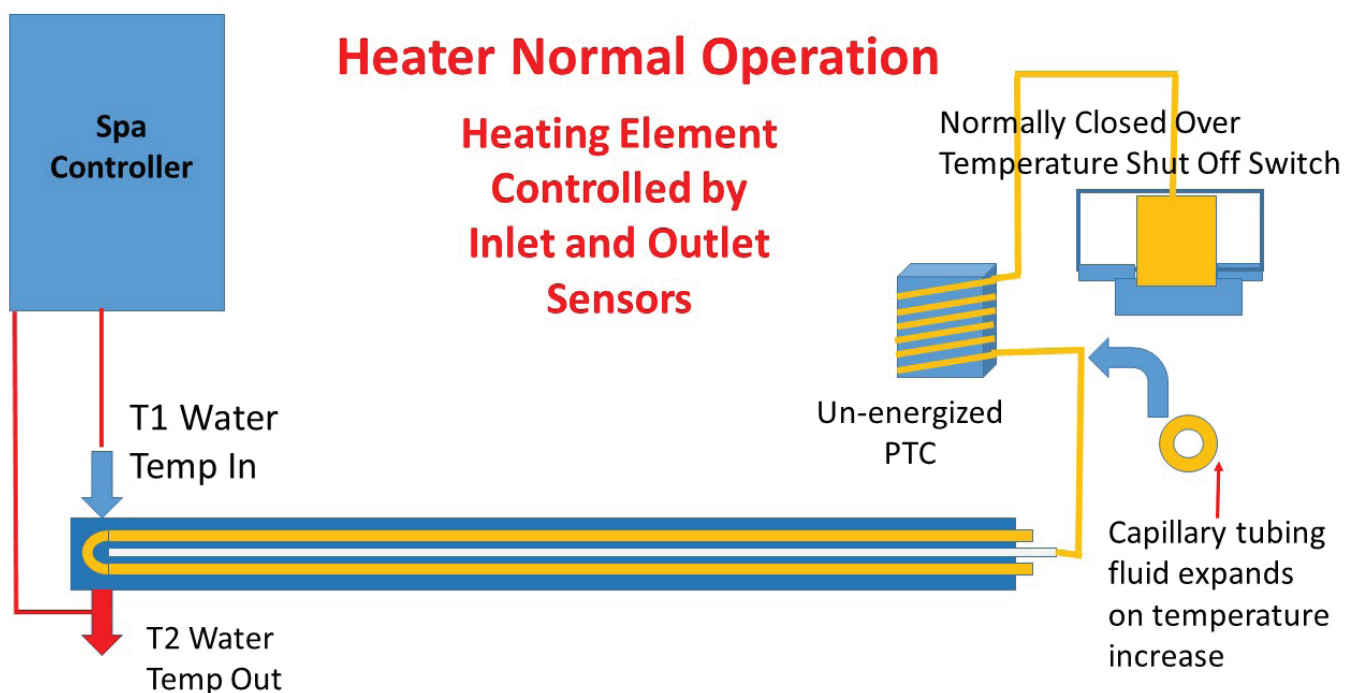
Figure 5

A second feature of the control — designed to prevent the sensing bulb from cooling and then allowing the over temperature shutoff switch to re-energize the circuit and start the overheating cycle again — was to use a positive temperature coefficient (PTC) heater. This heater, if configured in accordance with a patent referenced on the heater control’s enclosure, was intended to be encircled by a number of turns of capillary tubing to heat the capillary tubing and its internal fluid. This appears to have been an intentional design feature to enhance heat transfer from the PTC heater to the capillary tubing and the over-temperature control switch (Figure 5).

Drawing showing orientation of heater, sensing bulb and over-temperature shutoff switch.

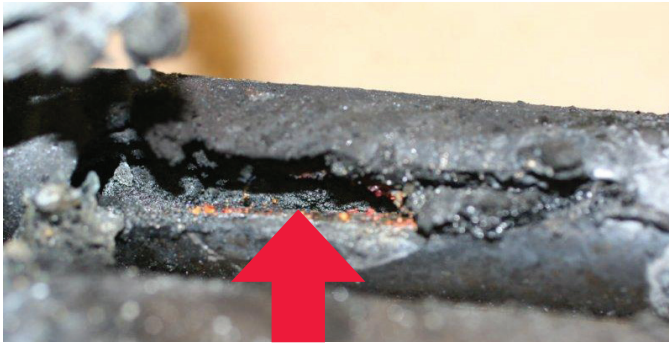
**Figure 6**  
Arcing damage found to heater vessel.

Examination of the control unit identified that the heater vessel was damaged by arcing, which burned through the vessel over a length of approximately 3 inches (Figure 6). No other electrical activity was found on any wiring, spa control, or component. As such, the heater was identified as the point of origin of the fire within the spa. Examination of the heater identified that the heater element was melted and damaged as a result of uncontrolled electrical application. The end of the element coinciding with the arcing through the heater vessel was missing due to consumption.

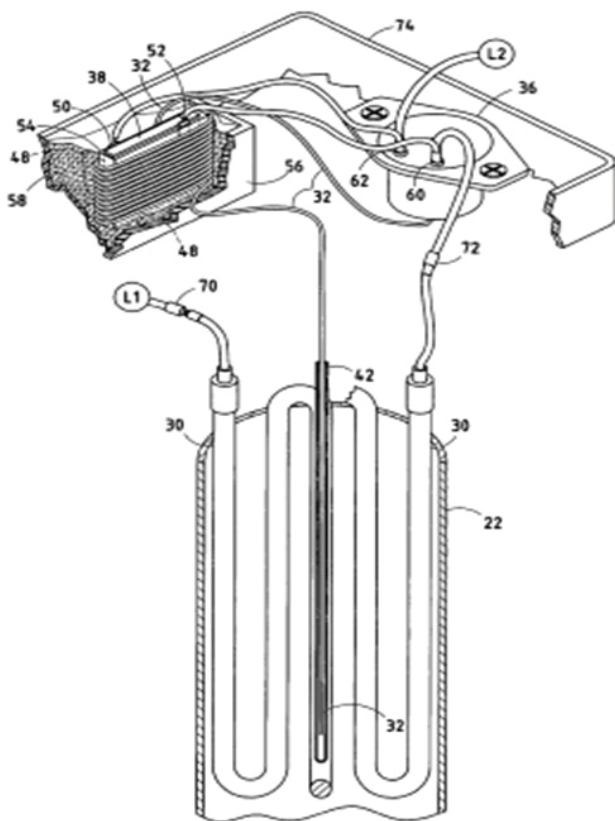
**Figure 7**  
Drawing from heater patent filing.

The patent (with images) for the subject heater was identified, and the features of the patented design were compared to the subject heater as well as a recently purchased exemplar heater (**Figure 7**). In comparison to the patent's Detailed Description of the Preferred Embodiment of the design, a major deviation on the subject and exemplar heaters was identified. The patent design of the overheating protection circuit and controls featured a heat generating positive temperature coefficient PTC heater that was designed to be encircled with capillary tubing, leading to the over-temperature shutoff switch.

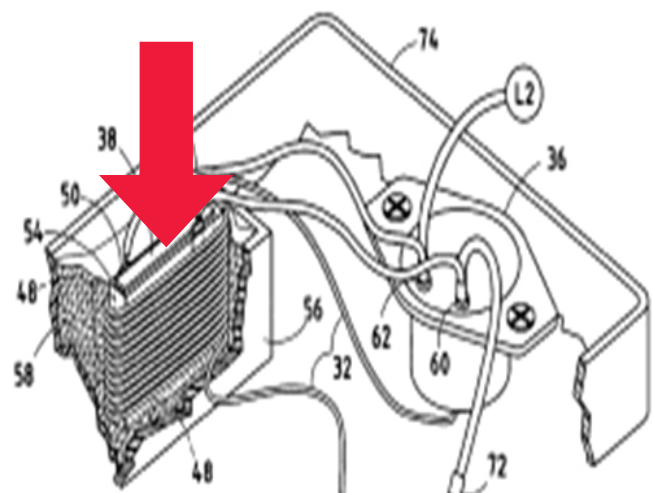
**Figure 8**  
Number of turns as described in patent drawing.  
Item 38 is the PTC with capillary tubing wrapped around it (see red arrow).

This design would keep the over-temperature shutoff switch in the open position and prevent the heater from being energized until power was removed to prevent continuous OFF-ON cycling of the heater. Additionally, the patent design documentation was quite specific in that it directed that the PTC heater be encircled by a specific number of turns of capillary tubing, to provide a thermal coupling (as shown in **Figure 8**).

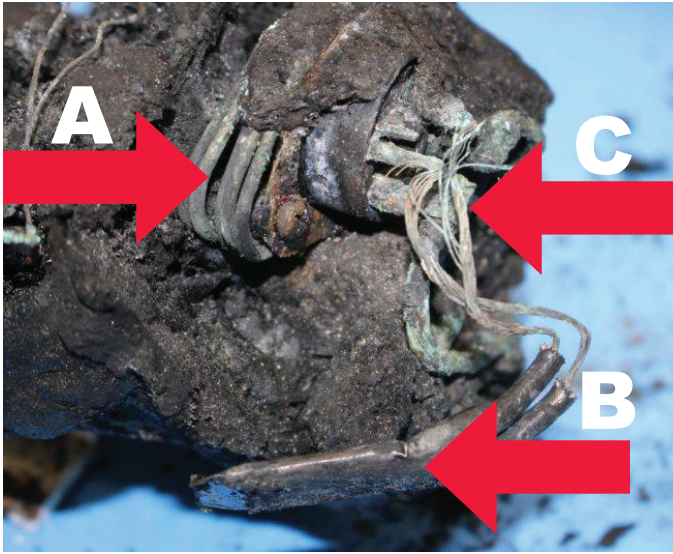
**Figure 9**

Over-temperature protection components of the heater as seen in fire debris: A – capillary tubing, B – PTC heater, C – Over-temperature shutoff switch.

patented design, was not encircled by capillary tubing in the manner shown in the patent documentation (**Figure 9**). Speculation was generated regarding whether this was the result of the fire. This led to further nondestructive tests, including X-ray and CT scanning examinations of the suspect components.

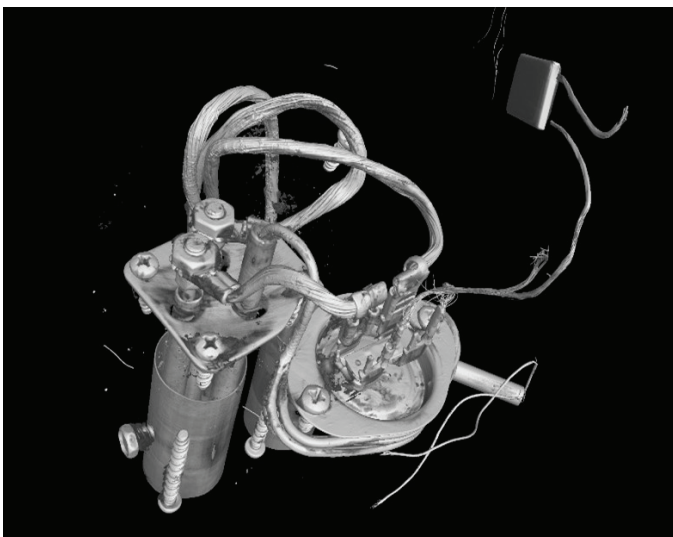
**Figure 10**

CT scanning and other means of evidence examination confirmed that the PTC heater was not encircled by the capillary tubing in the manner shown in the patent documents (**Figure 10**). Additionally, in the exemplar heater purchased, the same configuration (as the subject

CT scan showing PTC heater and capillary tubing.

heater) confirmed that the capillary tubing merely passed by the PTC heater in its path between the thermal sensing bulb within the heater vessel and the over-temperature shutoff switch. The deviation from the design shown in the patent resulted in a reduction in surface area between the capillary tubing and PTC heater, which would serve to diminish heat transfer between these two components and reduce control performance and effectiveness.

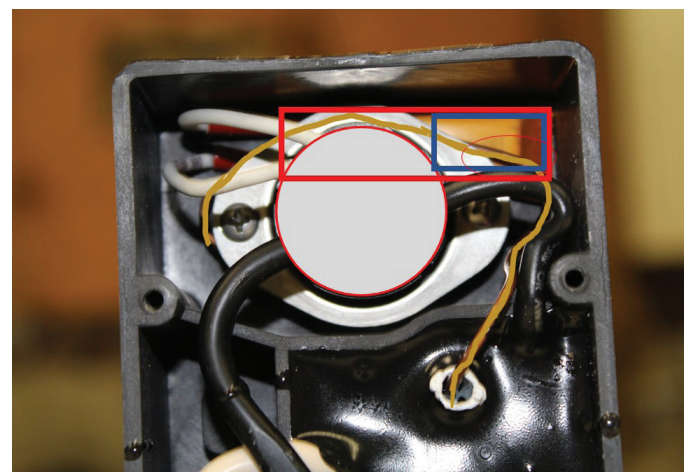
**Figure 11**

In the examination of the exemplar heater, the PTC heater was a “standalone” component not encircled with capillary tubing — contrary to patent documentation (**Figure 11**).

The securing of the PTC within the control box was not affixed and was free to move within the enclosure. Furthermore, contact with the capillary tubing, if any, was minimal — with only one segment of the capillary tubing (less than an inch long) being in direct contact with the heater. This comparatively reduced surface area between the PTC heater and capillary tubing would likely cause a proportionately different change in reaction time and performance. The author opined that this deviation between the patent design and the production components may have been a cost-driven manufacturing alteration.

Examining exemplar heater to locate placement of PTC and other components. Blue rectangle shows placement of PTC behind switch. Yellow line depicts capillary tubing NOT encircled around PTC.

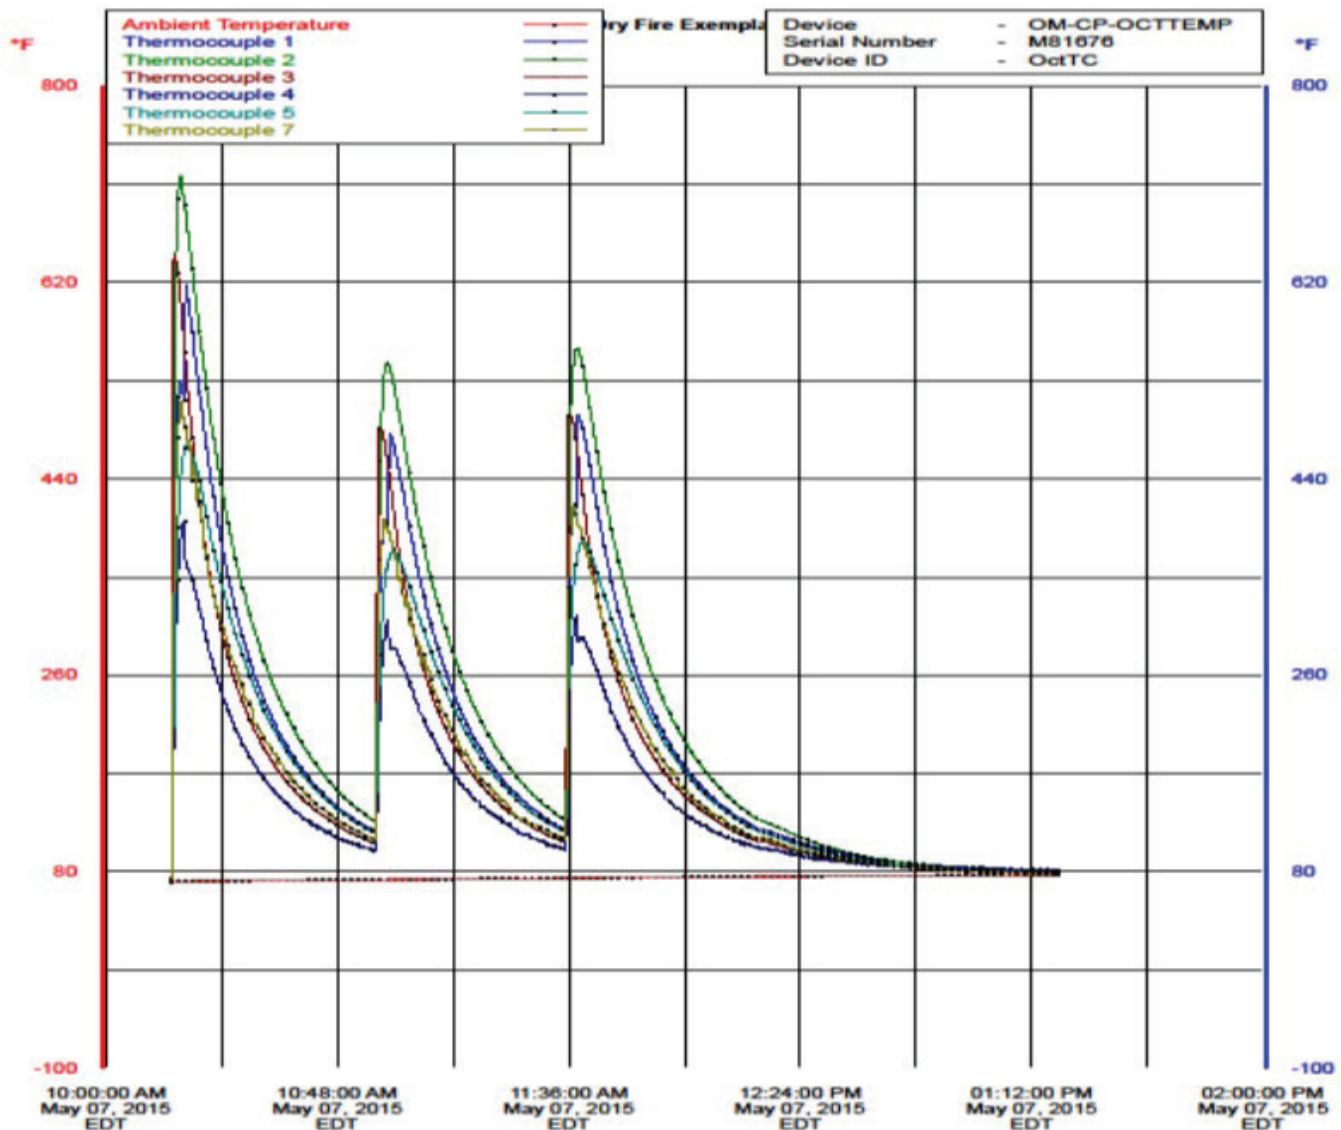
**Figure 12**  
Temperature data logging of heater in operation.

As opposed to a lockout condition of the over-temperature switch occurring as intended, cyclic heating and cooling resulted, allowing the heating element to be continuously and repeatedly exposed to heating and cooling cycles. The resulting temperatures (in the exemplar testing) were higher than what would have been experienced

during normal operation (**Figure 12**). Nevertheless, this repeated short cycling of the over-temperature shutoff switch would induce accelerated operational cycles, leading to more rapid switch failure and potential overheating and arc welding of the contacts. Additionally, the continuous heating and cooling could have the effect of inducing heater element damage and thermal sensing bulb leakage, which would make this position of the heater incapable of transmitting an increased internal pressure due to increased temperature within the heater.

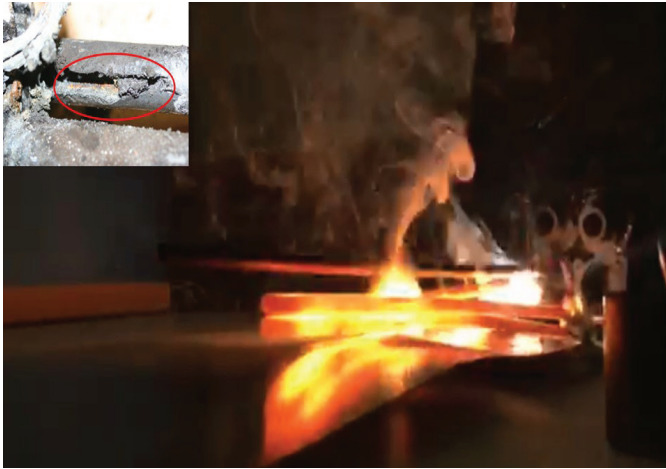
**Figure 13**

Heater arcing due to overheating damage.  
<https://youtu.be/KJ8sIBma22o>

Exemplar testing of an unsubmerged heater element resulted in arcing, flames, and molten steel, all of which would be easily capable of igniting combustibles within the control cabinets, such as the wooden cabinetry and instruction manual typically left in this area of the spa (**Figure 13**).
