Vol. 37 No. 1 December 2020

Forensic Engineering Analysis of Fatal Overhead Crane Accident

By Richard M. Ziernicki, PhD, PE, (NAFE 308F) and Ricky Nguyen, MS, PE

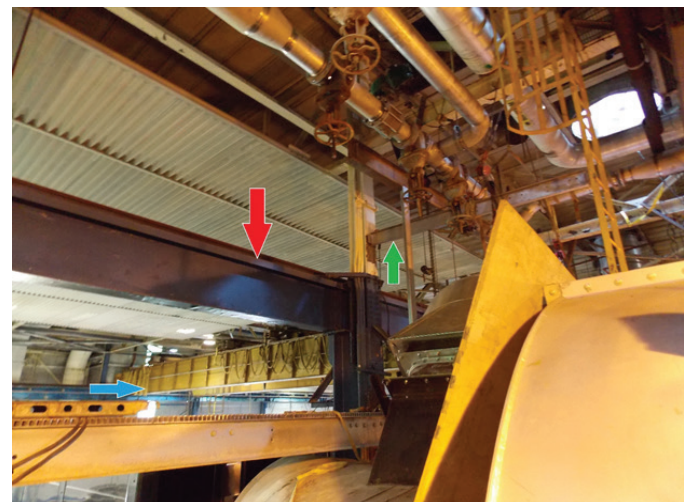
Figure 1

Accident location. Cross-beam to be removed pointed out with a green arrow. Overhead crane in the background pointed out with a blue arrow. Overhead crane rail pointed out with a red arrow.

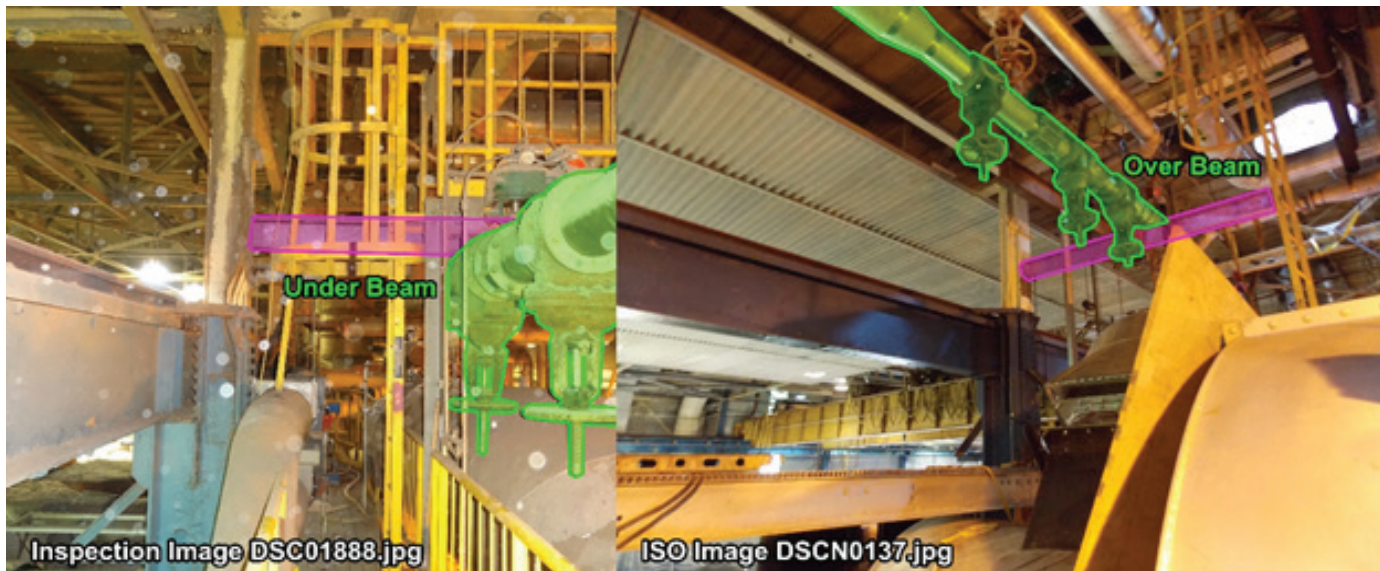
Figure 2

Photographs comparing the location of the pipework and cross-beam after the pipework was relocated (left) and before the pipework was relocated (right). Cross-beam is highlighted in pink; pipework is highlighted in green.

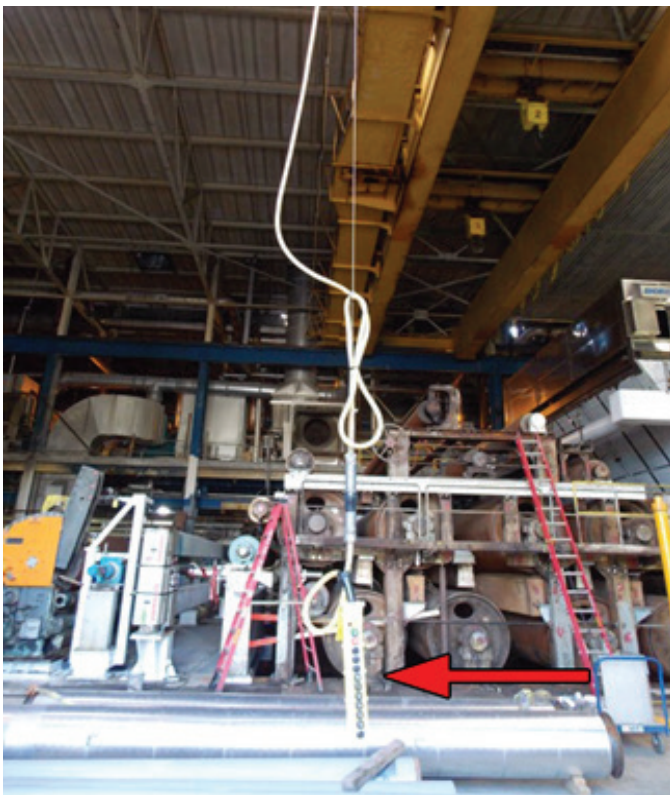
Figure 3

The overhead crane in question was controlled with a remote pendant that extends down from the crane (**Figure 3**) and allows the operator to control the crane from the floor of the plant (also referred to as a "floor-operated" crane). Since the pendant is directly connected to the crane, the operator is required to walk with the crane as the crane is traveling inside the plant. At the same time, the decedent was working 36 ft above the floor.

Provided photograph of the overhead crane and remote pendant (pendant point out with a red arrow).

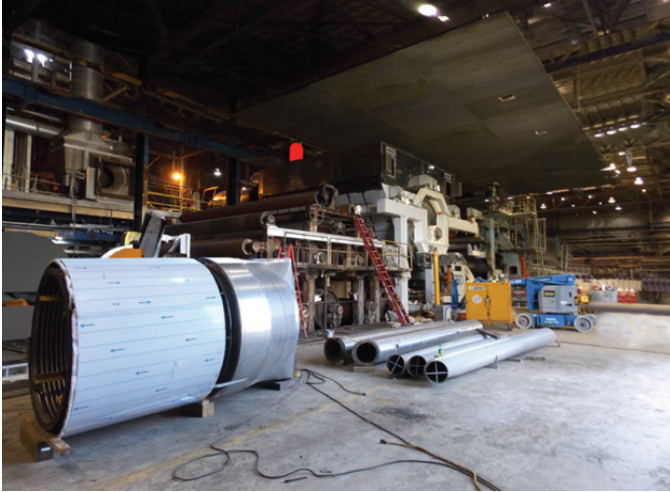
Figure 9

After reconstructing the accident scene, the location where the decedent was crushed was determined by analyzing evidence found in photographs and the plant's building plans. Photographs taken immediately after the accident showed evidence of blood on the support column. The location of the support beam in photographs taken immediately after the accident and during the forensic inspection were analyzed to determine the location in the building plans. Principles of photogrammetry were then used to determine the location of the decedent in the 3D virtual model of the reconstructed accident scene (**Figure 9**).

The location where the decedent was crushed, highlighted in red in the reconstructed accident scene.

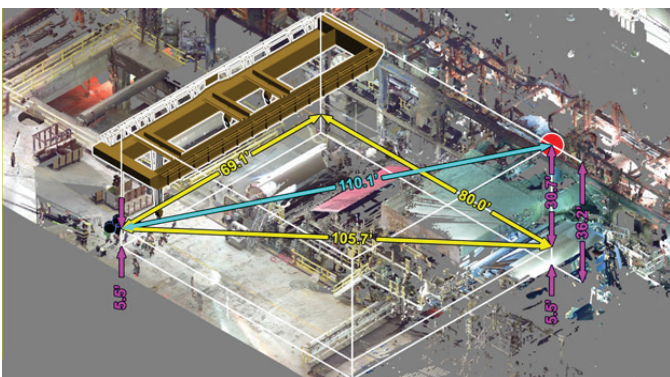
Figure 10 demonstrates the position of the crane operator and crane, relative to the decedent at a specific point in time. From the line-of-sight study, it was determined that the crane operator would have been able to see the decedent, had the crane operator checked for personnel near the crane’s travel tracks/rail before and during crane operation, as required by the ANSI B30.2 standard, the crane operator’s manual, and the plant policies.

Graphic showing the spatial analysis for the line-of-sight study at a specific point in time. Analysis to determine where the crane operator was spatially located to the decedent.

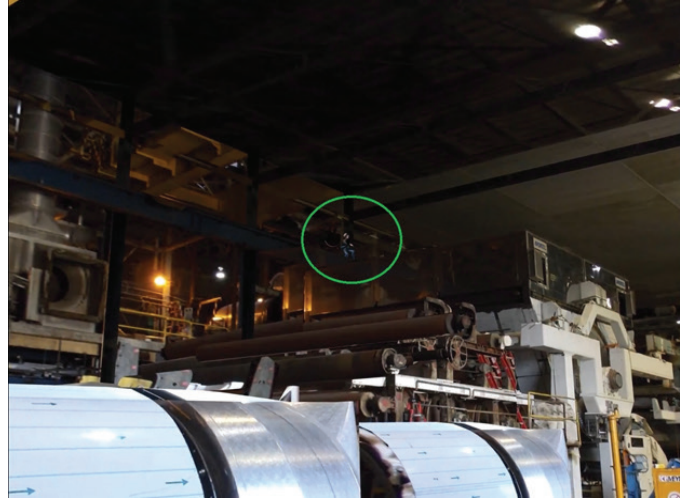
Figure 11 is a graphic of the reconstructed accident scene from the point of view of the crane operator, showing the decedent was visible to the operator before he operated the crane and for at least 21 seconds before the decedent got crushed, assuming the operator was traveling at an average walking speed. From the line-of-sight study, it was determined that had the crane operator checked for personnel near the crane’s travel track/rail, he would have seen the decedent near the crane’s travel track/rail,

Graphic showing the reconstructed accident scene from the point of view of the operator 30 seconds before the decedent got crushed. The decedent circled in green.

he would not have operated the crane until the decedent was no longer near the crane rail, and the accident would not have occurred.
