Journal of the
National
Academy OF
Forensic
Engineers[®]

Vol. 38 No. 1 June 2021

The Applications of Matchmoving for Forensic Video Analysis of a Fatal Sprint Car Accident: Part I

By Richard M. Ziernicki, PhD, PE, (NAFE 308F), Martin E. Gordon, PE (NAFE 699F), Steve Knapp, PE (NAFE 819S), and Angelos G. Leiloglou, M. Arch. (NAFE 956C)

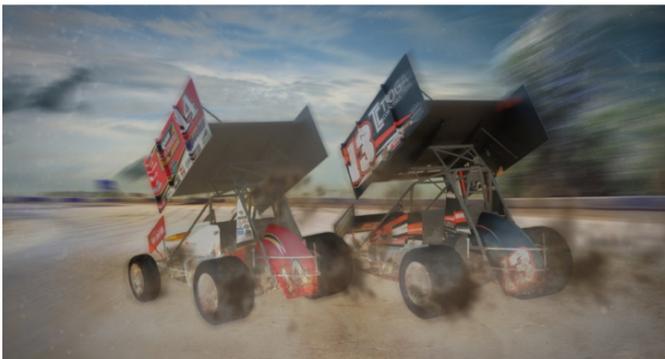
Figure 1

Visualization of SC#13 and SC#14 entering turn 1.

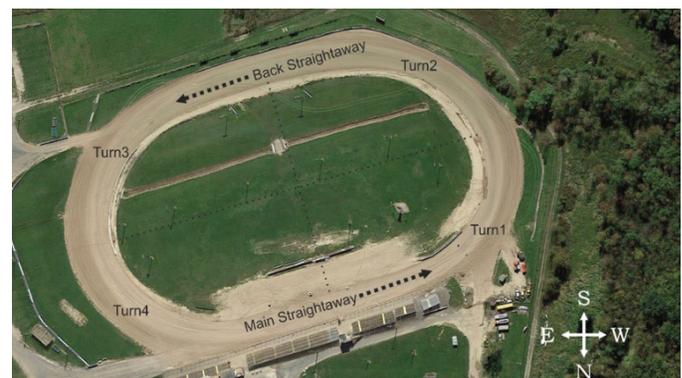
Figure 2

In, 2014, a fatal incident occurred where the decedent was participating in a Sprint Car Race (SC#13) on a low-banked dirt oval track with the straights running southwest and northeast. The grandstands are positioned on the north side of the track. The track corners are divided into quadrants (1 to 4) with the cars racing counterclockwise. Turn 1 is the first turn after passing the grandstands on the main straightaway (as shown in **Figure 2**).

Google image illustration of the racetrack where the incident occurred.

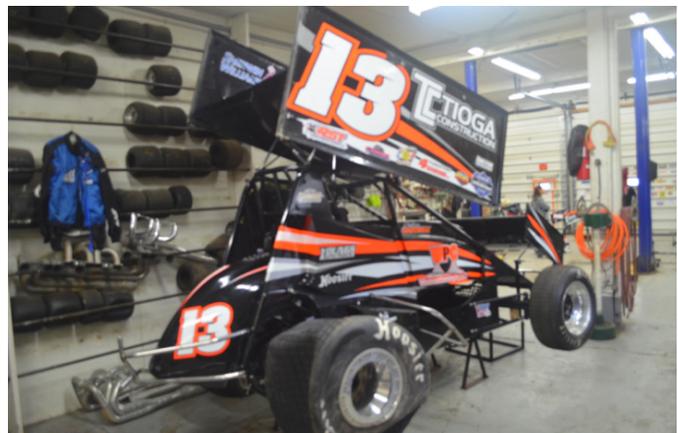
The Sprint Car being driven by the decedent on the night of the subject incident was examined and photographed, as shown in **Figure 3**. The right rear tire of the car is flat and had not been repaired since the incident.

Figure 3
Image of decedent's Sprint Car.

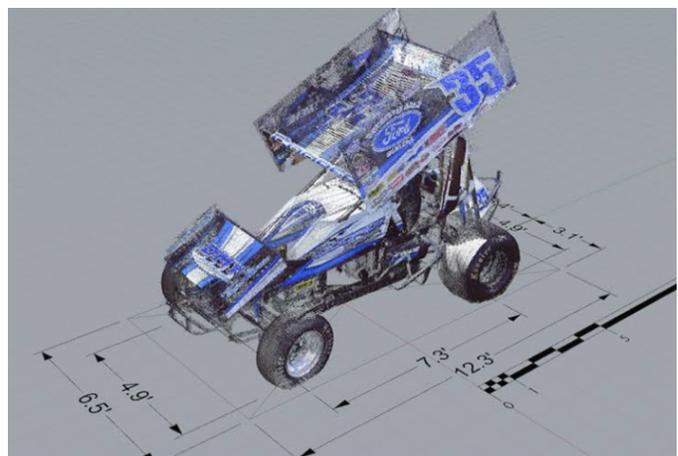
An exemplar Sprint Car was scanned in 2016. The Sprint Car was being prepared for sale and did not have an engine at the time of inspection. Additionally, the wing actuators (device used to move the large wing on the Sprint Car) had been removed. Otherwise, the vehicle had the same dimensions as both SC#13 and SC#14 at the time of the subject collision. The 3D scan collected approximately 390 million data points. An image of the scanned exemplar Sprint Car is presented in **Figure 4**.

Figure 4
Scanned exemplar Sprint Car with dimensions.

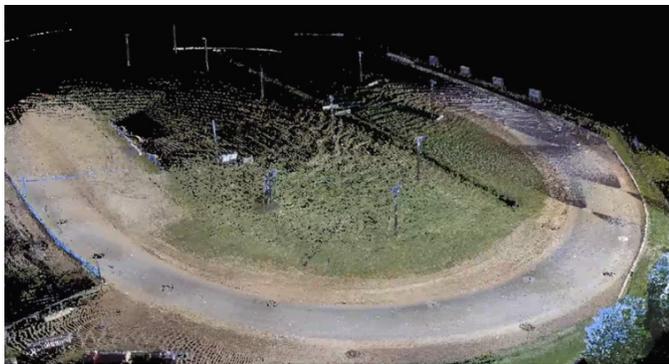
Figure 5
Aerial view of the scanned Sprint Car track.

The racetrack venue where the incident occurred was scanned for the purpose of documenting relevant areas of the track and grandstands. 3D scanning during the inspection produced approximately 860 million data points. The scans were captured using a Faro Focus 3D X330 Laser scanner and registered together to produce a 3D “point cloud” of the racetrack. Each data point in the point clouds is defined by its three-dimensional coordinates (x, y, z) and is accurate to within a few millimeters. Neither the track geometry nor the grandstand geometry appeared to have changed since the date of the incident. An image of the scanned subject Sprint Car track is presented in **Figure 5**.

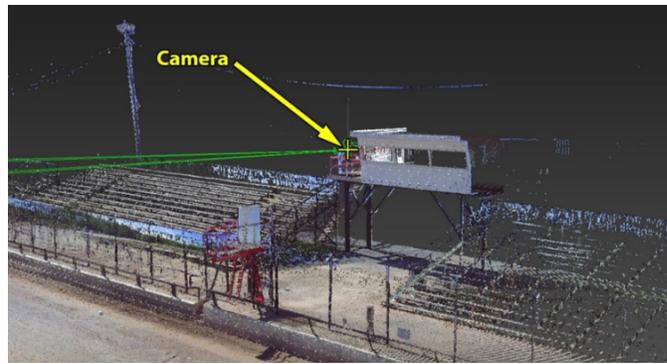
Figure 6
Perspective view of grandstands showing the location of the camera that captured video of the incident.

The subject incident was captured by three video cameras. Two of the available videos were captured by spectators with cellular phones located in the grandstands. The third video camera was positioned on the east side of the announcer’s box, as shown in yellow in **Figure 6**. The camera captured the incident event with video footage recorded at 29.970 frames per second.
