Vol. 38 No. 1 June 2021

Interdisciplinary Forensic Engineering As a Result of Substantial Completion Request: A Case Study

By Edward L. Fronapfel, PE (NAFE 675F)

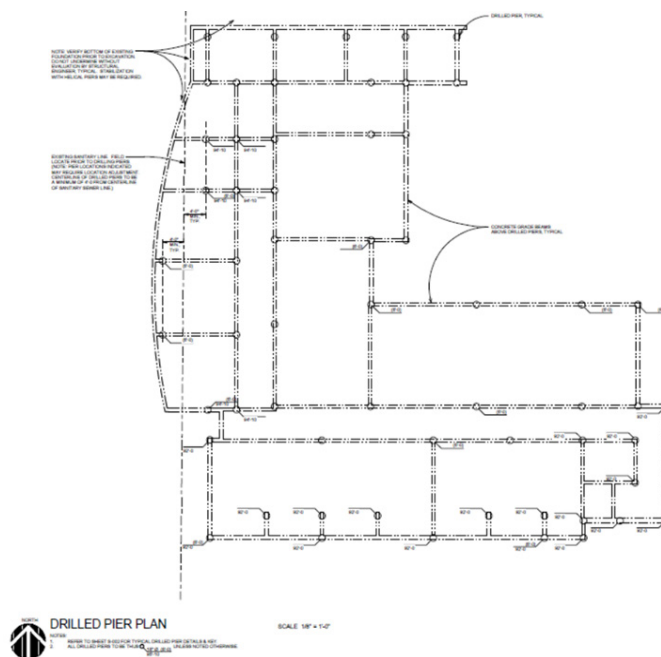
Figure 2

The original foundation system at the subject site (as shown in **Figure 2**) originally included deep-drilled cast-in-place concrete piers. The uplift of the expansive soils in the active zone required that the lower concrete shafts be keyed into the claystone bedrock. This is not a typical design for two-story buildings and likely did not match the original building, which was founded on spread footings. During the cost review, a decision was made to change the foundation system to spread footings and a slab supported on ground. This change clearly reduced the cost of the project; however, the costs associated with the upkeep

The original project documents included a foundation design using shear ring piers, which was consistent with the geotechnical report. An addendum changed the foundation to spread footings. No documentation exists evidencing the owner was apprised of the change in risk tolerance to the finish materials and structure due to the change in foundation type.

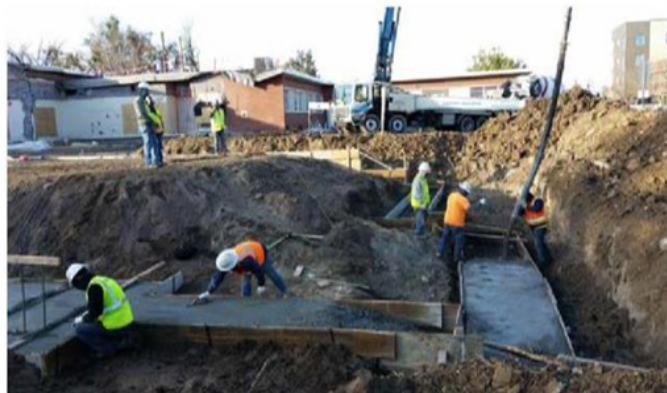
Figure 3

Owner-provided photograph (Nov. 6, 2015), showing concrete placement for footings. Note that the dowels necessary to connect the footing to the foundation walls are not in place prior to the pour. The stabbing of dowels is a violation of the code, and was strictly forbidden by the structural engineer of record.

shall be accurately placed and adequately supported prior to concrete placement (no wet stabbing) per IBC Section 1907.5.”² Since there is not sufficient lateral load issues on this foundation system, it would be expected that no second-prong damages associated with this poor workmanship were observed or expected, thus no costs to cure this issue were assigned to the claim. The issue was used, however, in establishing an opinion of the overall quality of work provided by the general contractor.

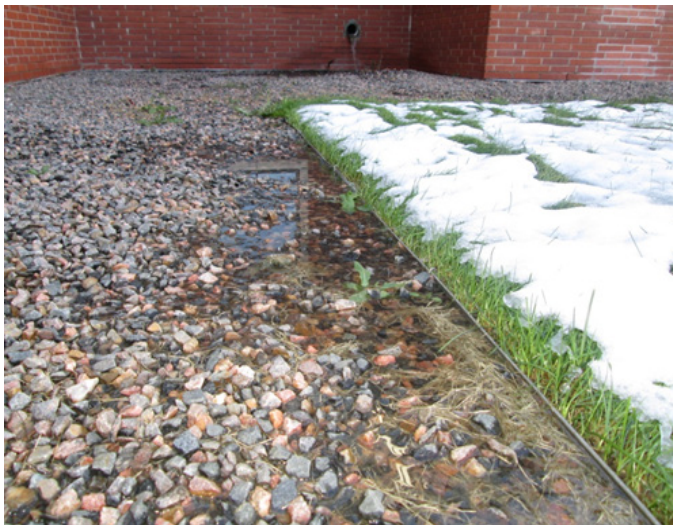
Figure 4

The site drainage plan was provided by a civil engineer under contract through the architect. The builder, architect, and engineer all had the opportunity to understand the potential associated effects that are the result of poor drainage around the building, and the change of foundation and floor types increased those associated risks. The site observations conducted during the substantial completion revealed two primary conditions with the grade: the first was the lack of effective slope within the backfill zone, also referred to as the “protective zone;” the second condition was ponding water near the building’s foundation (as shown in **Figure 4** and **Figure 5**).

Substantial completion observation (July 24, 2018) showing storm drainage water accumulation at the backfill zone of the foundation.

owner be willing to accept deficient, non-conforming work without cost reduction in the GMP and that the owner be willing to accept additional risks associated with water migration toward the structure and site. Building code and the geotechnical report both required that 5 percent minimum grading be maintained for 10 feet from the foundation perimeter⁵. This slope is visually apparent as 6 inches of fall in 10 horizontal feet, and the use of a perforated landscape edge is easily recognizable.

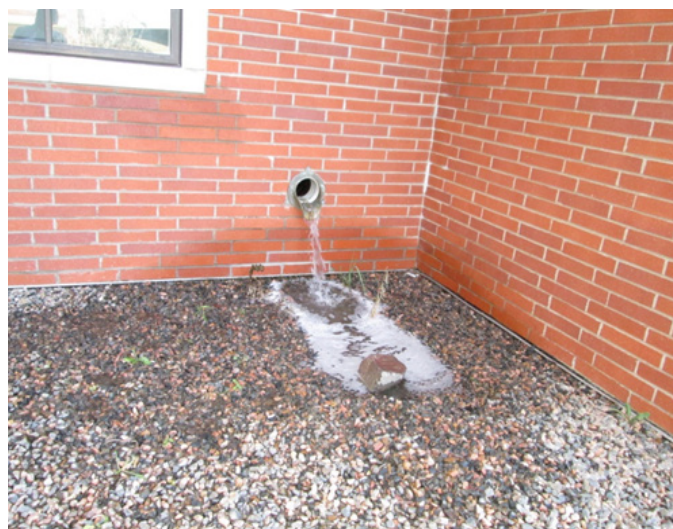
Figure 5

Substantial completion observation (July 24, 2018) showing storm drainage water accumulation at the backfill zone of the foundation.
