Vol. 37 No. 1 December 2020

# Forensic Engineering Analysis of Projectile Thrown from Phantom Vehicle

By Richard M. Ziernicki, PhD, PE (NAFE 308F), William H. Pierce, PE (NAFE 846C),  
and Angelos G. Leiloglou, M Arch., (NAFE 956C)

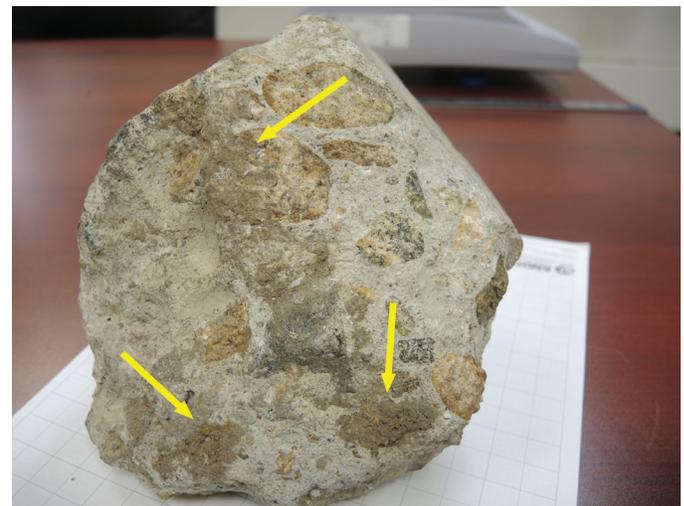
Figure 3

Soil embedded on the face of the projectile concrete.

The presence of soil on only one of the concrete's faces is evidence that the face had initially been resting on soil, and a force was applied on the projectile to embed the soil onto the surface of the concrete. Black residue was also observed on two sides of the concrete. The black residue was primarily found on the two faces that formed a wedge shape opposite of the soil (**Figure 4**).

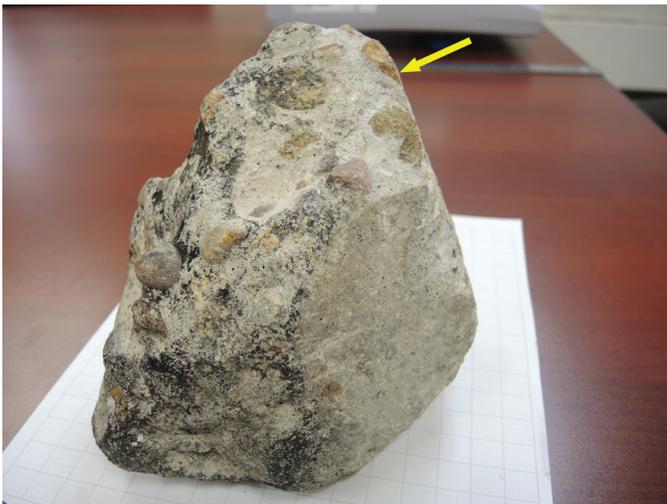
**Figure 4**

Black material observed primarily on two faces of concrete projectile opposite of soil (yellow arrow points to general side of embedded soil).

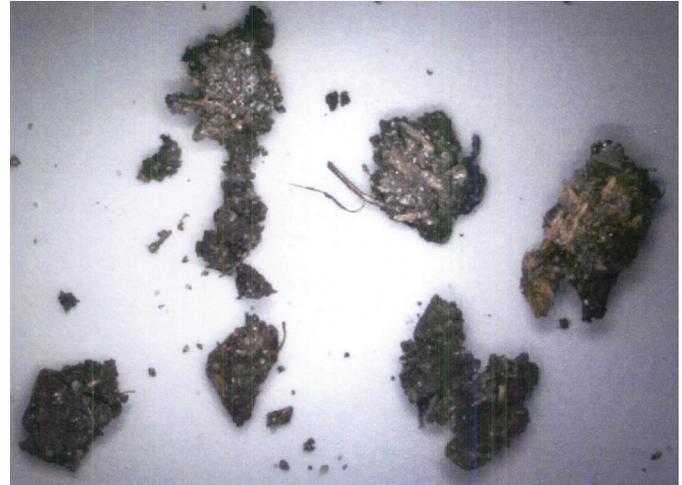
**Figure 5**

A digital microscopy image of the black material is shown in **Figure 5**. The lab analyst visually observed "black material, semi-translucent crystal, and fibers." The lab determined the black material likely contained styrene butadiene rubber, which is a typical elastomer used in the manufacture of tires<sup>2</sup>. The lab also determined that the fibrous material displayed chemical similarities with a compost sample, which was the same type of compost delivered to the park by the two dump trucks on the day of the incident. Therefore, the lab testing showed that there was material that had chemical similarities to tires, and the compost that had been delivered on the day of the incident to the park via dump trucks. A geometric analysis was performed.

Digital microscopy of the material.

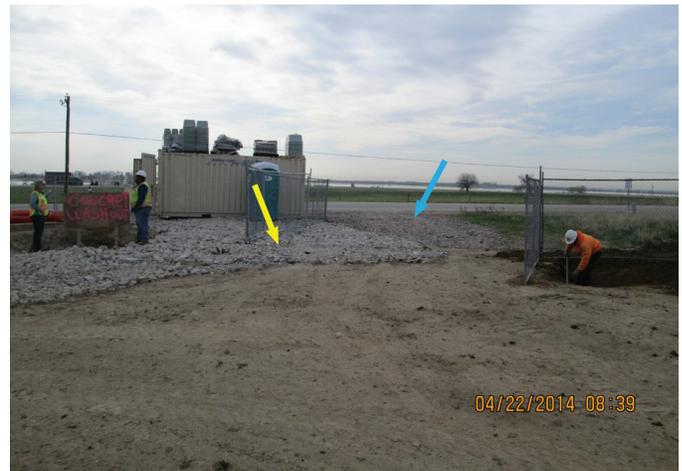
**Figure 6**

The photographs show that, in general, the recycled concrete in the SSA is larger than the material installed on the VTC. However, the photographs also show that recycled concrete from the stabilized staging area overlapped a large portion of the VTC. Therefore, as trucks entered and exited the site, they would have likely run over the larger pieces of recycled concrete from the stabilized staging area that overlapped the VTC.

Photograph of vehicle tracking pad (VTC) and stabilized staging area (SSA) at the park taken by city inspectors, approximately two weeks prior to incident. Yellow arrow shows material in concrete washout area; blue arrow shows material on VTC.

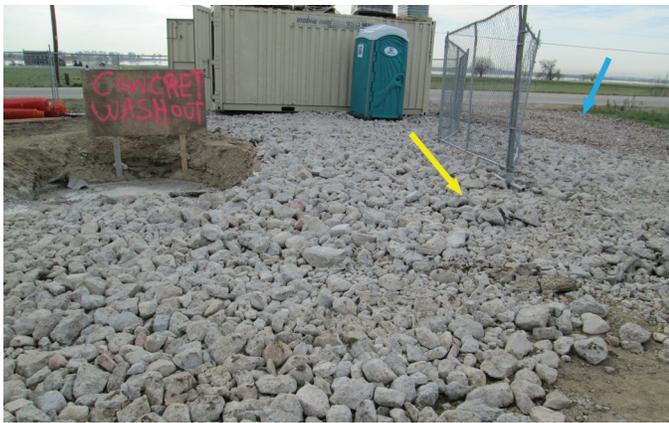
**Figure 7**

Photograph of concrete washout/SSA and VTC taken by city inspectors on April 22, 2014, approximately two weeks prior to incident. Yellow arrow shows material in concrete washout area; blue arrow shows material on VTC.

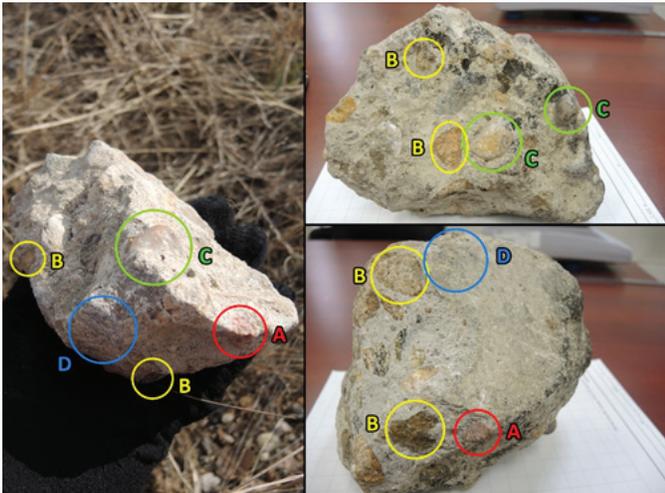
Figure 14

Near the entrance, there were some protruding sections of recycled concrete embedded within the soil. Our firm observed one piece of recycled concrete above soil level. The aggregates observed on the surface of the recycled concrete sample were of various colors. The authors visually compared the aggregate within the sample piece of recycled concrete and the aggregate within the projectile concrete using inspection photographs. **Figure 14** shows that the aggregate found on the sample's surface was visually similar to the aggregate found on the concrete projectile's surface. Therefore, the recycled concrete found at the accident site had visual similarities to the concrete projectile.

Visual similarities between sample recycled concrete found during inspection (left) and the concrete projectile (right). Colored circles identify areas of visual similarity.

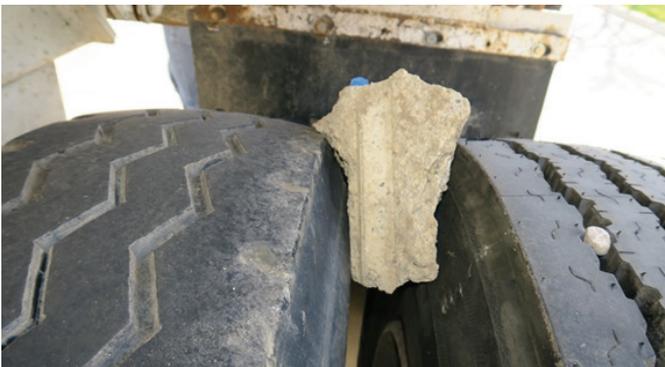
Figure 15

The defendant's dump trailer was documented using photography and HD scanning. At the time of the inspection, for demonstration purposes, a concrete of similar size and shape to the projectile concrete that was obtained at the park was embedded in the trailer's rear left set of dual tires to show that the concrete fit very well in the set of dual tires (Figure 15).

Concrete of similar size and shape as projectile concrete obtained from the park embedded within the defendant trailer rear left set of dual tires.

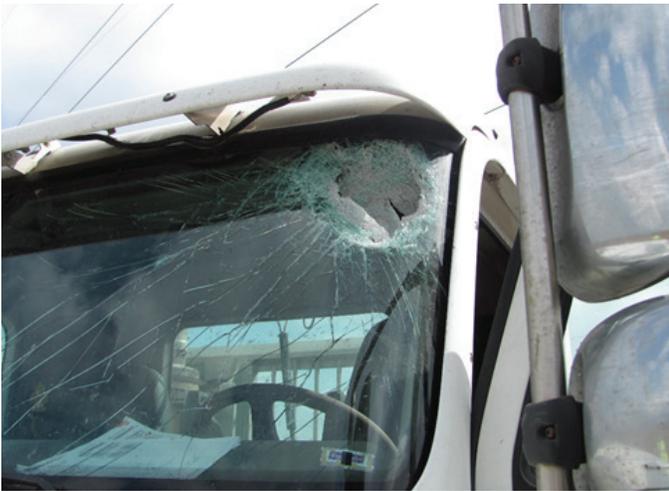
The truck's windshield was severely damaged during the incident. The damage was concentrated near the upper-left most corner of the windshield (Figure 19). The damage to the windshield included a hole that was consistent with a spheroid-like object striking and penetrating the windshield. The shape of the hole was generally consistent with the shape of the piece of concrete projectile that fell out of the cab when the witness opened the cab door.

**Figure 19**  
Damage to windshield consistent with projectile concrete impact (scene photograph).

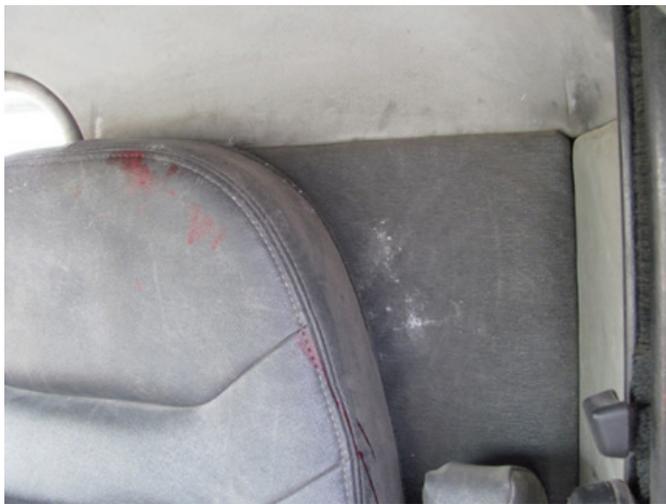
There also were concrete fragments found on the rear cab wall (**Figure 20**), and the rear cab wall was dented, consistent with the concrete striking the rear cab wall after striking the windshield and the plaintiff.

**Figure 20**  
Concrete fragments along panel behind driver's seat.

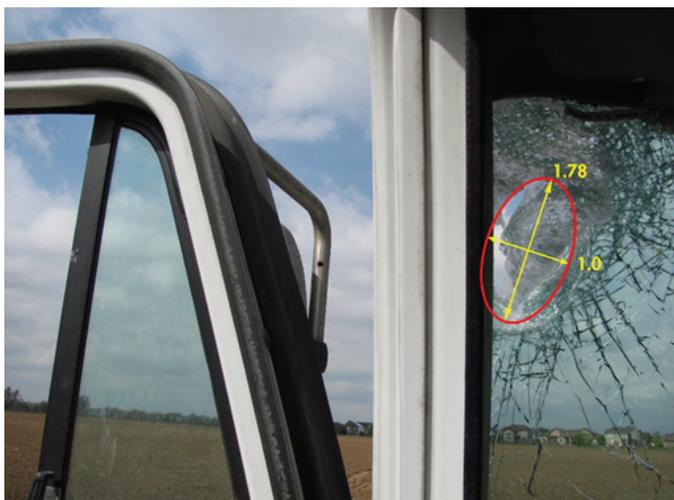
Figure 24

The windshield damage pattern and entry hole form a diagonal oval that extends from the left, upward to the right. The oval has a length to width ratio of 1.78 to 1 (Figure 24), which is a higher ratio than concrete projectile's length to width ratio. Therefore, the oval in the windshield is elongated compared to the shape of the concrete projectile. The angle, size, and shape of the oval provide insight to the direction that the projectile entered the windshield.

Elongated oval-shaped opening in windshield from left to upper right. Oval length to width ratio is 1.78 to 1.

This shooting reconstruction method was applied to the physical evidence in the subject incident. The entry oval in the windshield is substantially longer than the longest dimension of the concrete projectile (similar to a cylindrical bullet forming an elongated oval when shot at an angle), and the elongated oval distinctly forms an angle from the left upward to the right (Figure 24). Like the example shown in Figure 26, this elongated oval shape and angle is consistent with the concrete projectile entering the cab with a lateral velocity component from the left to right side of the cab.
