Journal of the
National
Academy OF
Forensic
Engineers[®]

Forensic Engineering Investigation and Analysis of Crack Formation in Acetal Resin Nuts Used for Water Supply Lines

By Edward S. George, PE (NAFE 621M), Donald J. Fournier, Jr., PE (NAFE 626S), Paul Eason, PhD, PE, and Charles R. King

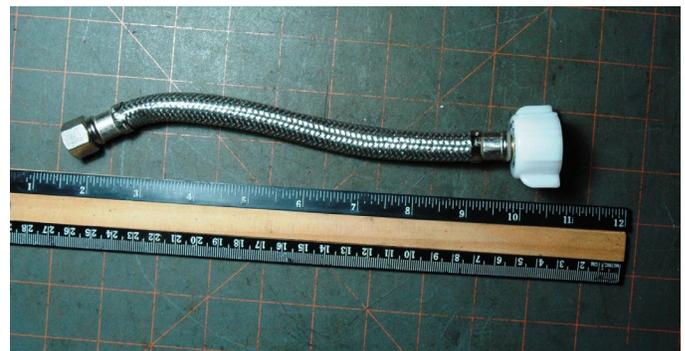
Figure 1

A plumbing contractor was sued by a homeowner related to the failure of an acetal resin nut that was part of a water supply line to the toilet tank (**Figure 1**). The plumbing contractor subsequently filed a third-party lawsuit against the supplier of the water line, alleging negligent design and manufacture of the acetal resin nut.

As-received photo of toilet supply line.

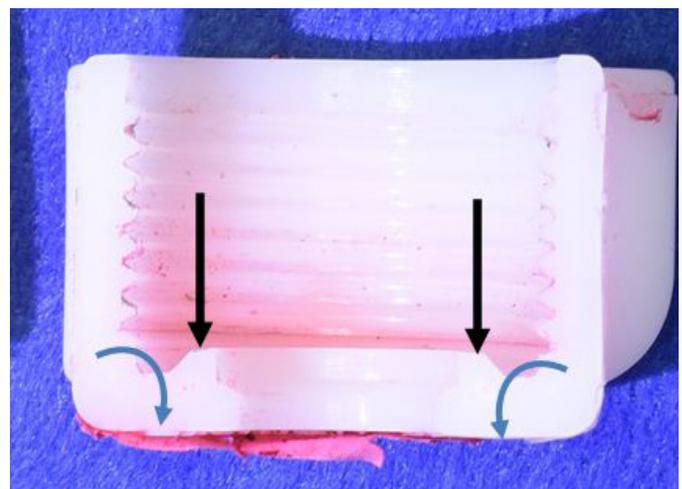
In use, the toilet connector threads onto a male pipe at the bottom of the toilet tank, compressing a rubber gasket between the interior surface of the connector and the end of the male pipe to prevent water leakage (**Figures 2 and 3**). The contact between the end of the male pipe and the connector creates an outward-directed longitudinal force on the interior surface of the connector. This force creates a shear stress and bending moment within the wall of the connector, with the highest stress located at the interior surface at the bottom of the wall (as shown in **Figure 4**). In addition, the threaded wall of the cap is subjected to a

Figure 4
Cross-section of nut with crack, showing force and bending moment at end-cap.

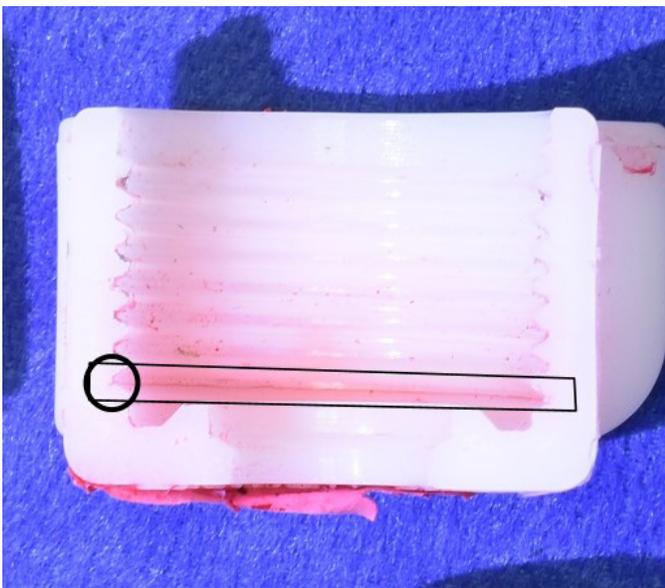
Figure 5

The interior thread extends to the base of the cap. The sharp-edged roots of threads are known as stress risers, which lead to local stress concentrations many times greater than the stress that would be present without the stress riser⁵. **Figures 5** and **6** show a cross-section of a nut examined during this investigation that revealed the presence of a crack that formed at the root of the base thread, as predicted by static analysis of the applied forces and illustrated in the output of FEA performed during this investigation (shown in **Figure 7**).

Cross-section of nut, showing crack at root of base thread.

During the first phase of the investigation, 43 fittings were cut in cross-section. Incipient cracks were present at the root of the base thread in 11 of these, as seen in the sample shown in **Figures 5** and **6**. The onset of cracks in 25 percent of the samples with no evidence of tool marks, along with the three prior known failures of the same parts associated with this installation, provided strong evidence of a design or manufacturing defect specific to this lot of fittings. At this point in the study, deposition testimony was provided by experts for the various parties, and the suits were settled.

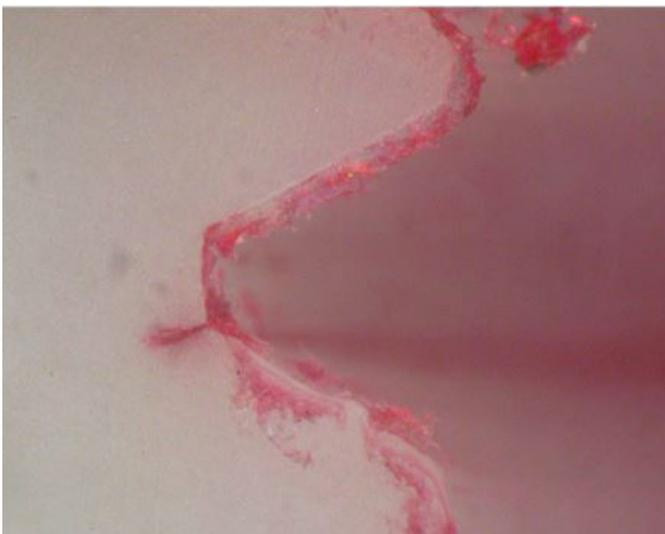
Figure 6

Close-up of crack in cross-section.

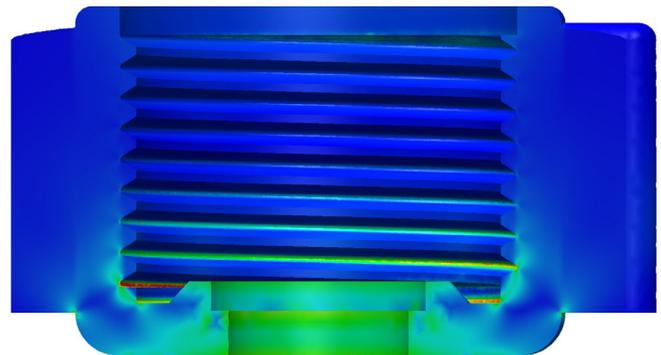
Figure 7

FEA analysis was performed using a standard simulation software. The geometry of the fitting was based on measurements of a cross-section. Material properties were obtained from material datasheets. A tensile force was applied to the base of the fitting. The goal was not to determine stress values but to identify the most probable location for stress risers in this type of loading. The static simulation performed on the resulting model revealed a stress riser in the root of the base thread of the nut (**Figure 7**), consistent with both the physical findings and predictions based on engineering mechanics.

Qualitative FEA image, showing peak stress at root of base thread in red.

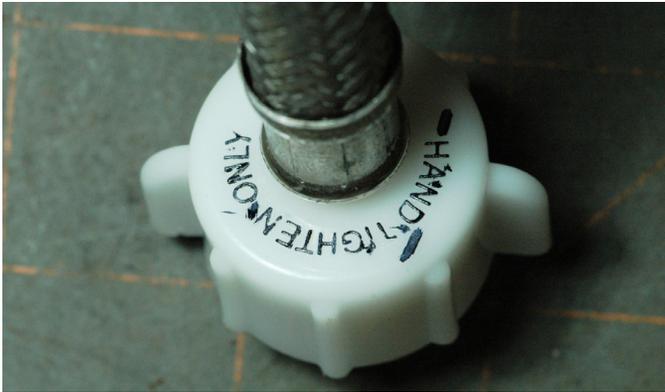
Figure 8

End of nut embossed with instruction to “hand tighten only,” which has been colored for this photograph.

The subject nut in the original case appeared to have tool marks on the outer surface. Experts opined that the nut had been over-torqued, causing creep to occur and leading to the failure. Raised lettering on the end of the nut cap stated “HAND TIGHTEN ONLY” (**Figure 8**). However, this is not a reliable or accurate torque specification. Several studies have identified many factors that determine torque when hand tightening a nut^{3,4}, including age, gender, strength of the individual doing the tightening, and the location of the nut being tightened. Arguably, this means there is no torque specification for these nuts.

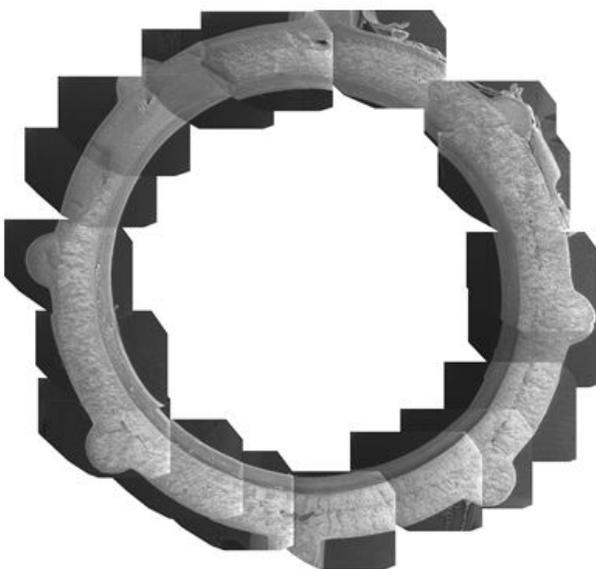
Figure 9

Composite photograph of cross-section of subject nut; interior thread ends at a notch in the upper left of image.

The subject nut was examined by experts retained by the parties involved. The joint examination included visual examination under optical microscope and SEM. **Figure 9** is a composite photograph of the fracture surface of the subject nut. Failure initiated at the notched end of the interior thread at the base of the fitting, consistent with the location of the highest stress as shown by FEA.

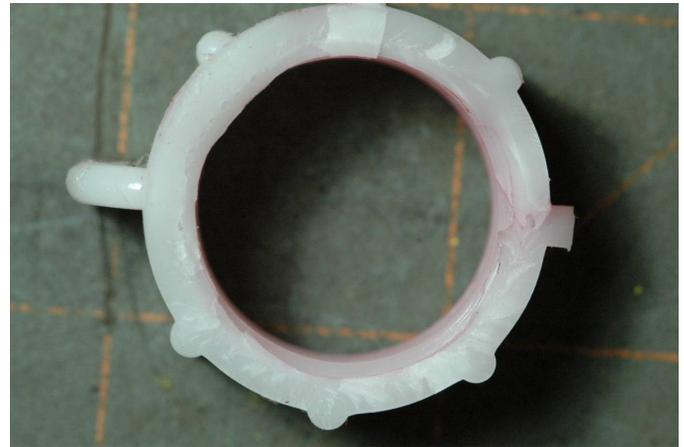
The thread base of an additional 100 supply line nuts was then examined microscopically to determine if any cracks had started over the two-year in-service period. These nuts had no signs of tool marks. As shown in **Figures 13 and 14**, Sample #17 had red dye penetrant on the inside of the fracture surface, indicating the presence of a crack. Of the 100 parts examined in this phase, 10 were found with cracks at the base of the last thread, corresponding to a crack formation rate of 10 percent.

Figure 13
Fracture surface of Sample #17.

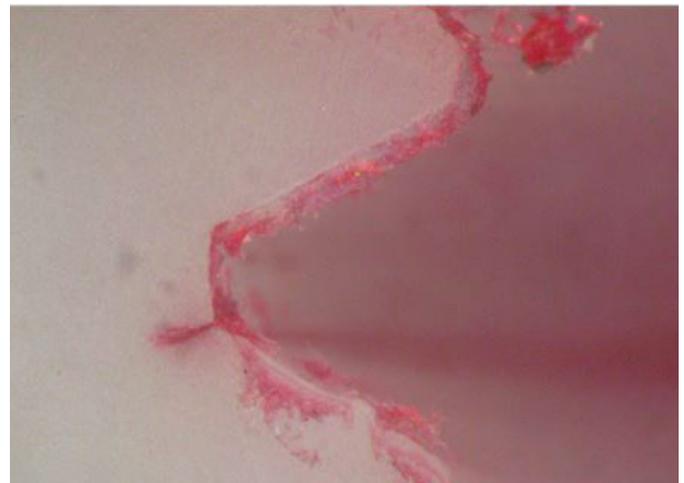
Figure 14
Red dye penetrant in crack on the fracture surface of Sample #17.

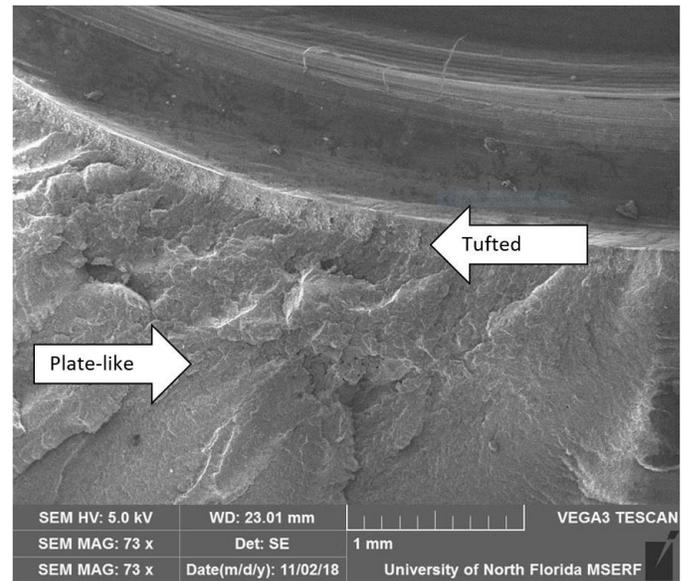
The SEM images after gold coating clearly show two different types of fracture morphologies present in the surface of the same sample. One has plate-like fracture zones corresponding to a fast overload fracture achieved with the torque wrench, while the other (crack that visually showed as red in color) has a tufted appearance associated with sustained loading over time, resulting in creep rupture morphology. See **Figures 16** through **20**. Under sustained

Figure 17
Medium magnification, Sample #17, gold coated showing fracture morphologies.

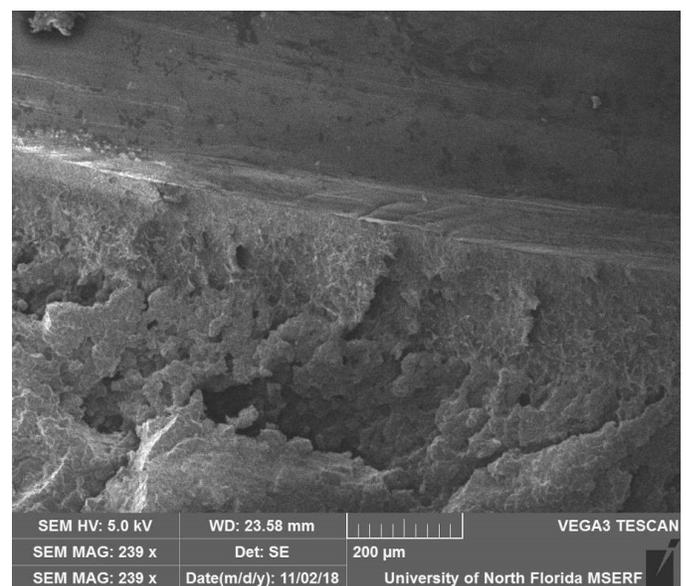
Figure 18
Higher magnification, Sample #17.

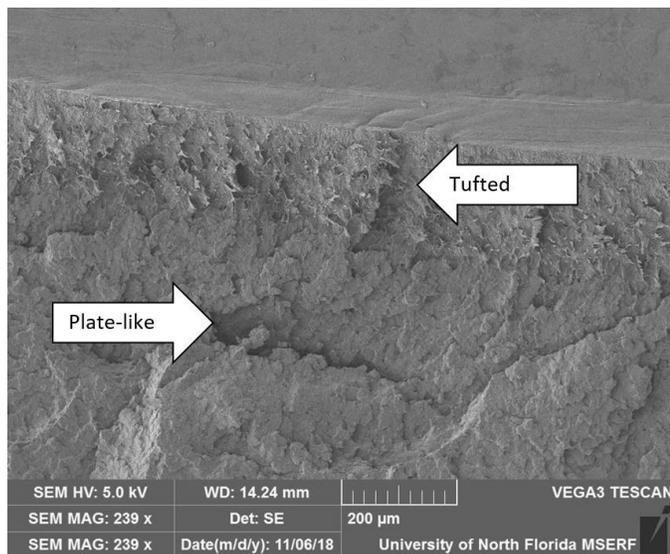
Figure 19
Higher magnification, Sample #17,
gold coated showing fracture morphologies.

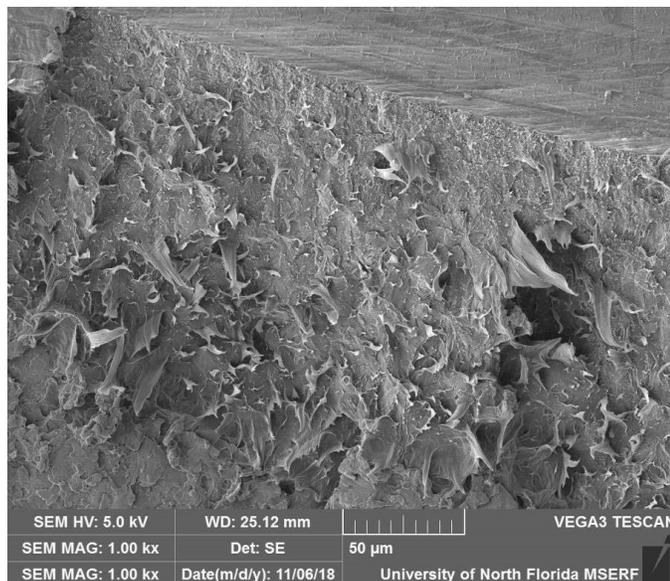
loading, this material undergoes slow, stable crack extension, resulting in the development of a tufted fracture surface appearance. These tufts represent fibril extension and subsequent rupture in various polymers⁹.

Figure 20
Even higher magnification, Sample #17,
gold coated showing tufted appearance of fracture surface.

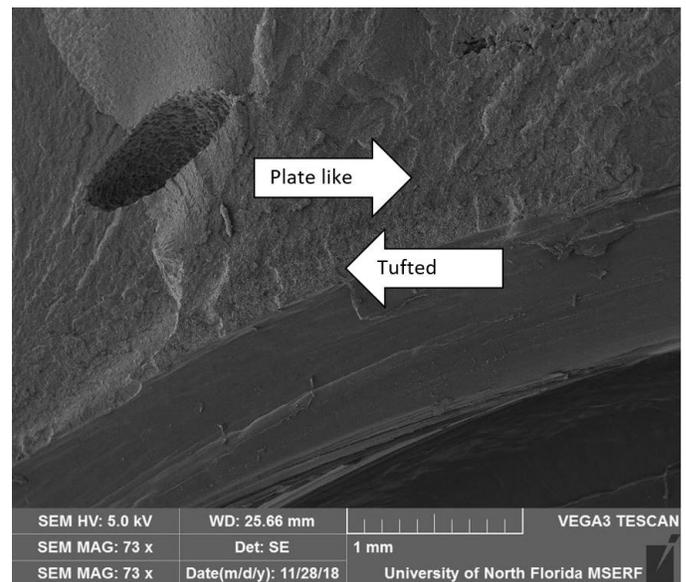
SEM was also performed on two more cracked parts, Sample #9 and Sample #27, which were picked at random from the 10 parts with visible cracks. The SEM photographs for these two samples reveal the same two types of fracture morphology (plate-like and tufted), as described above and shown in **Figures 21** through **24**.

Figure 21
Sample #9, medium magnification.

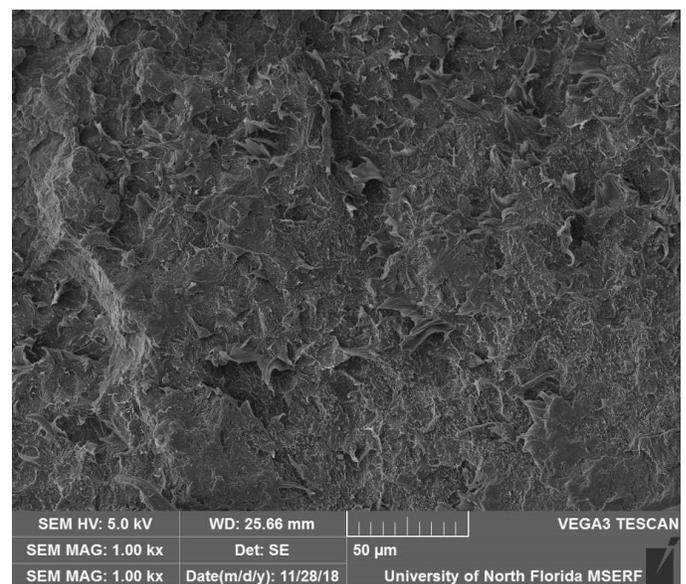
Figure 22
Sample #9, higher magnification of tufted area.

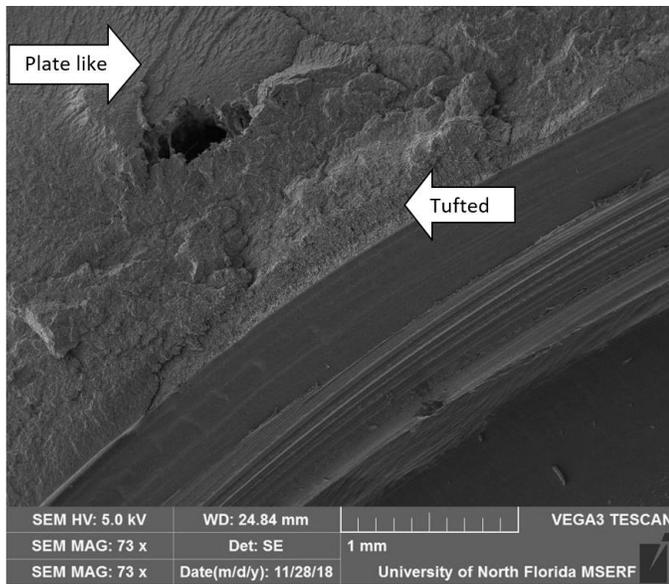
Figure 23
Sample #56 with two fracture morphologies.

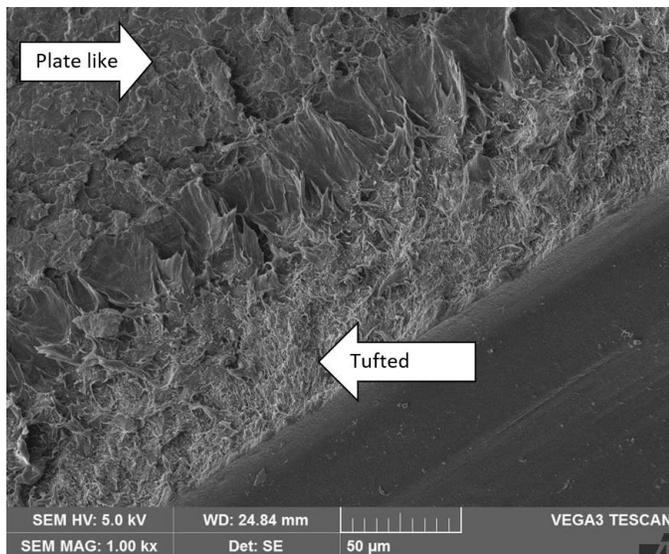
Figure 24
Sample #56 at higher magnification.
