Vol. 36 No. 1 June 2019

FE Evaluation of Hillside Excavation for a Construction Contract Dispute

By Rune Storesund, DEng, PE, GE (NAFE 474S)

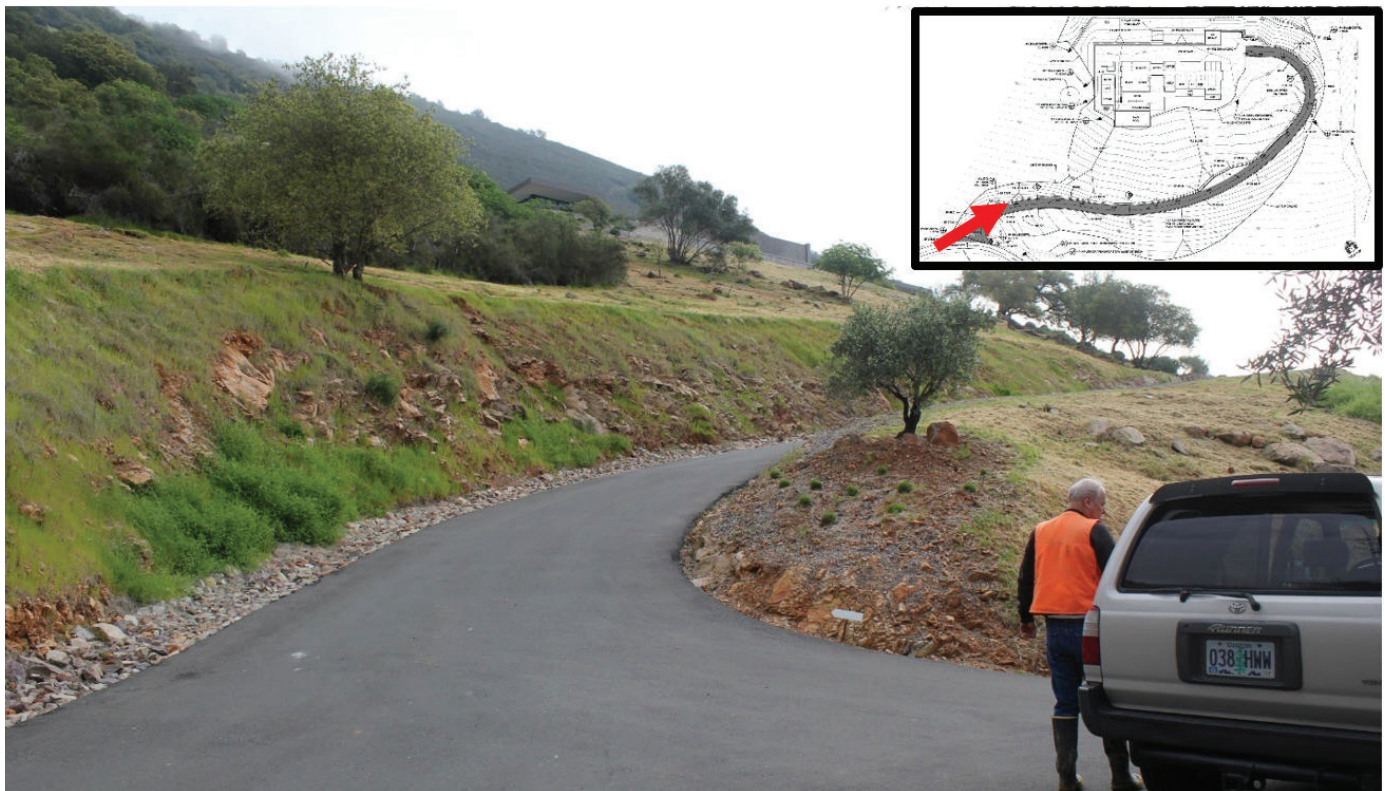
Figure 4

View at lower end of grading area, looking up the new driveway, which was within the plaintiff's work area (Source: R. Storesund).

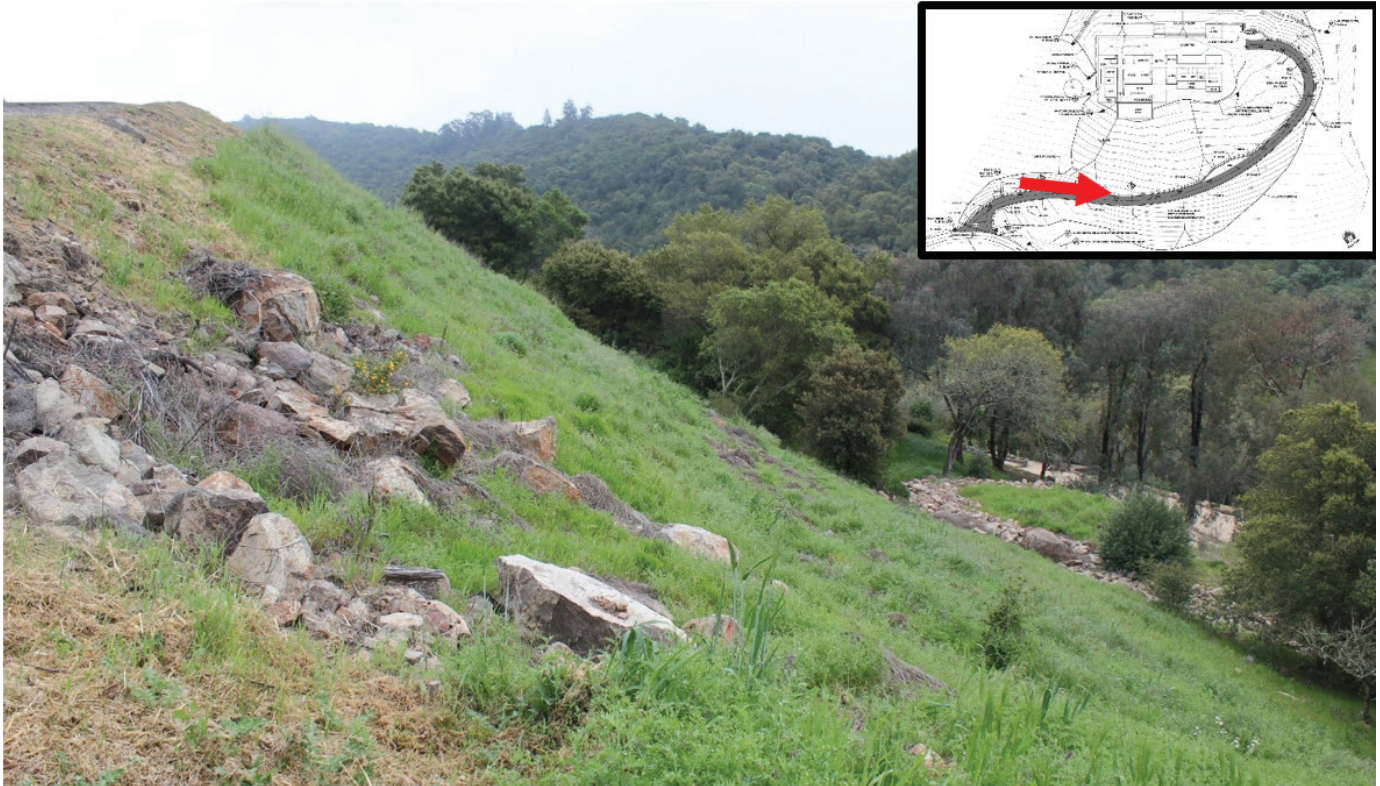
Figure 5

View of hillside slope where plaintiff performed some grading operations.
This area was re-constructed by the second grading contractor (Source: R. Storesund).

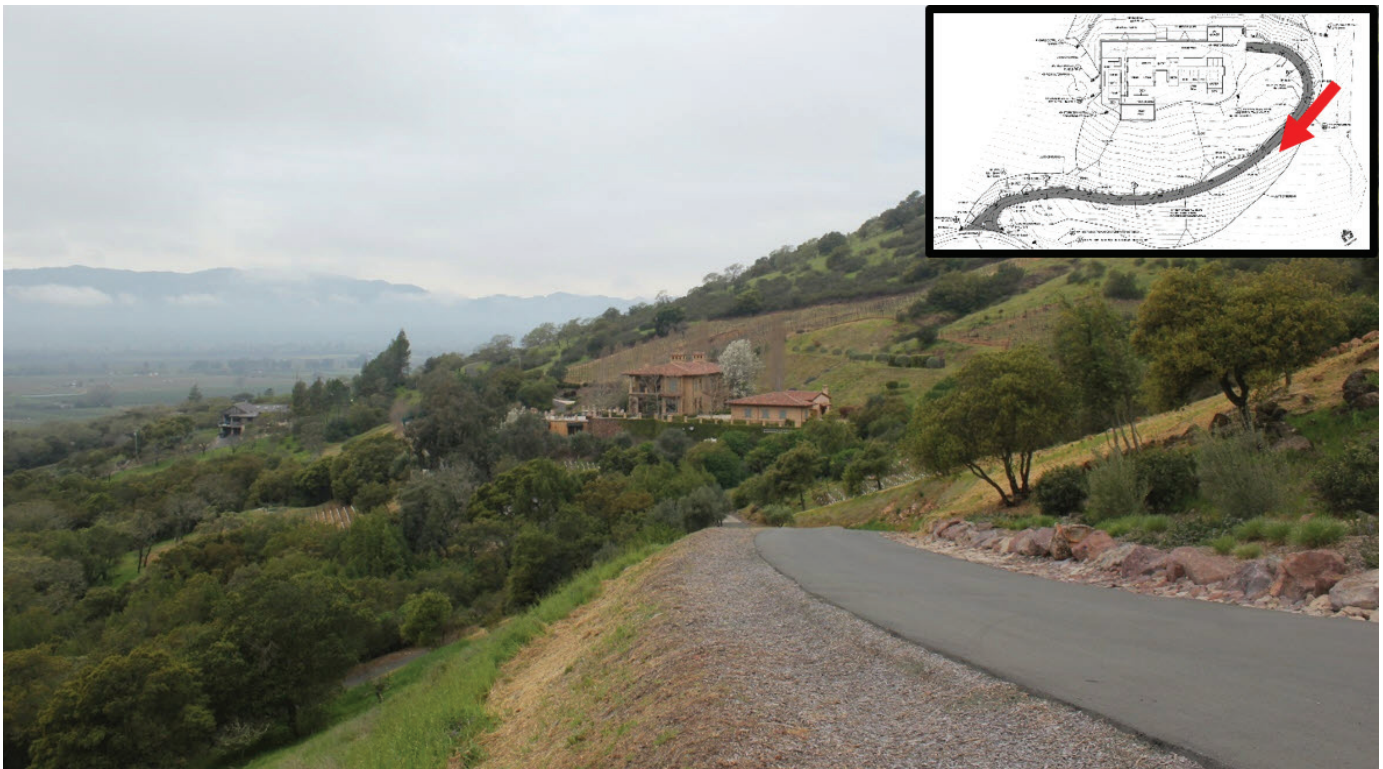
Figure 6

View looking down the driveway. This is outside the grading limits of the plaintiff.
This work was completed by the second grading contractor (Source: R. Storesund).

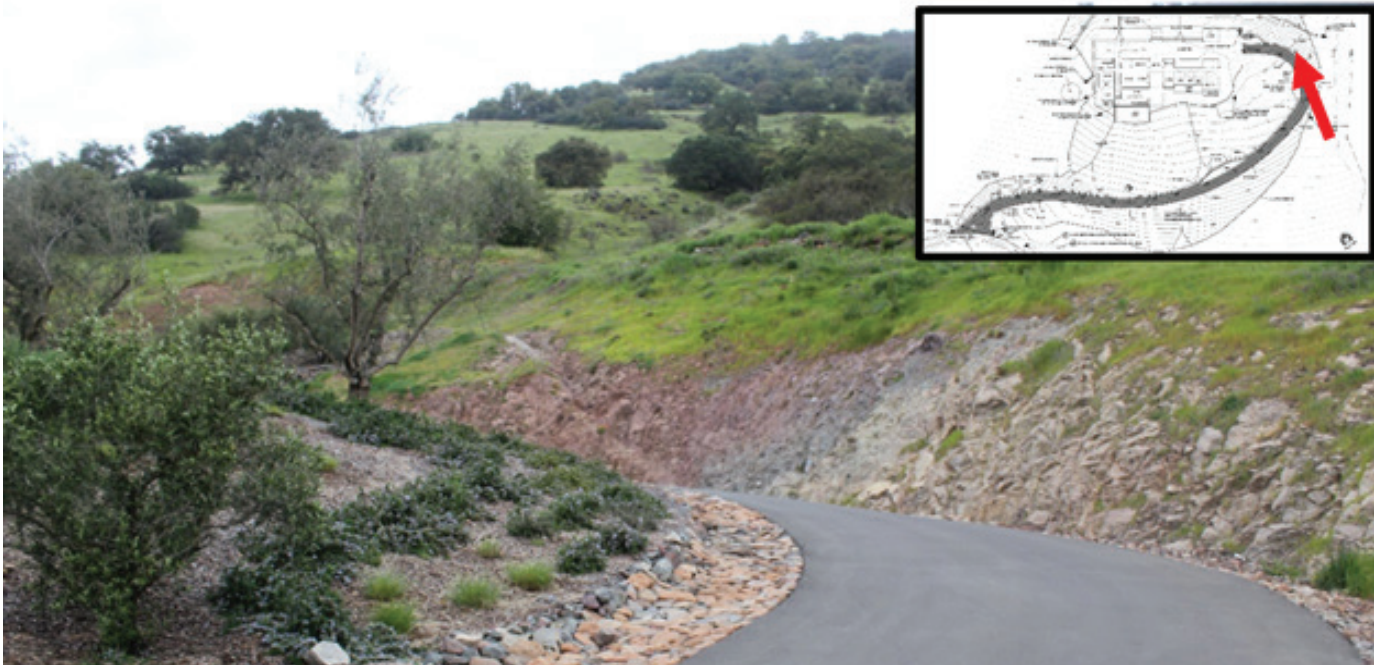
Figure 7

View in the driveway looking up toward the hillside pad cut for the new residence. This work was completed by the second grading contractor (Source: R. Storesund).

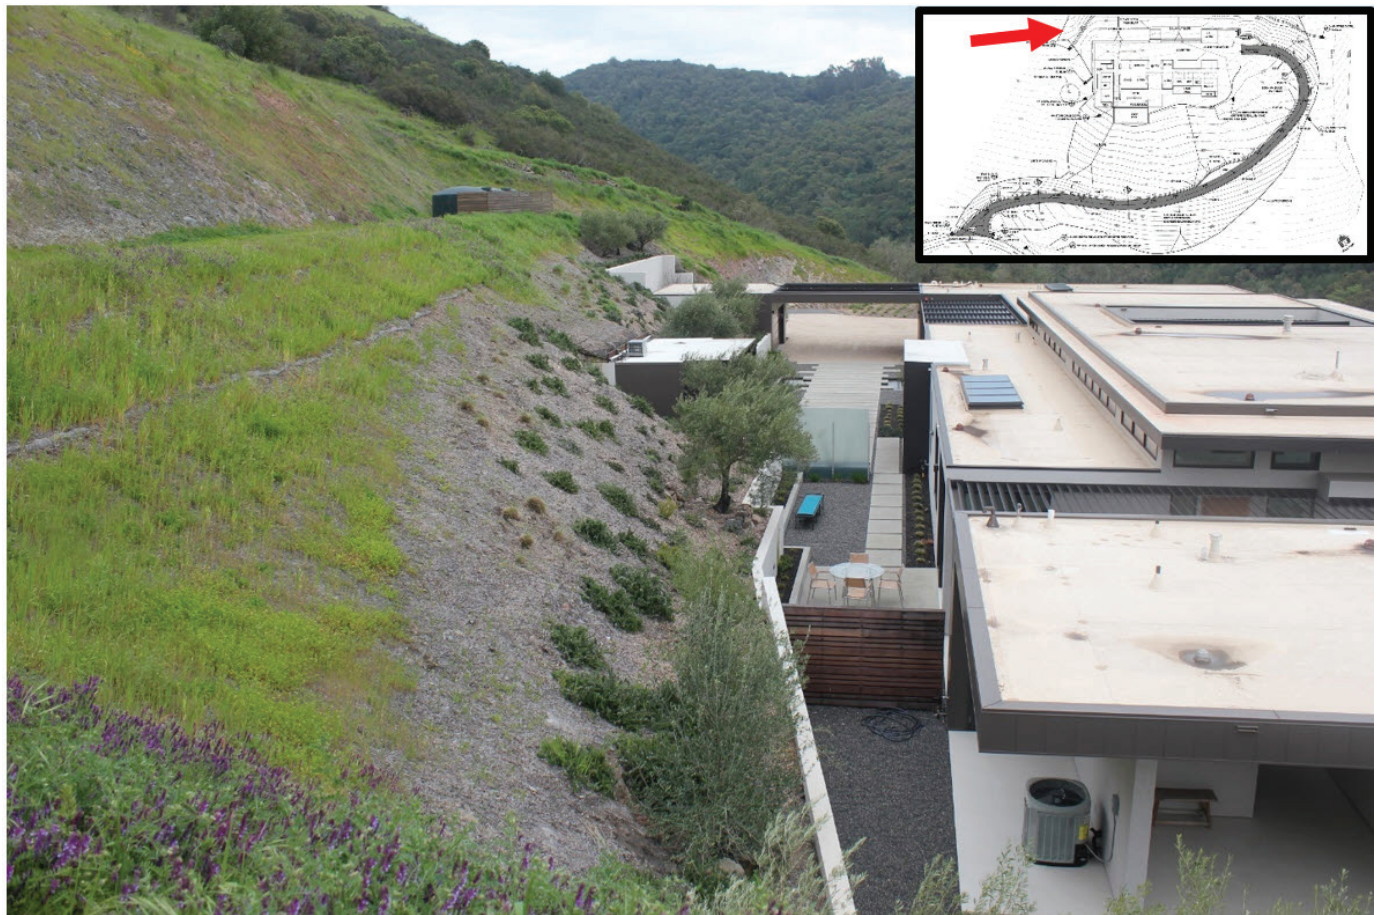
Figure 8

View of the hillside cut behind the new residence. This work was completed by the second grading contractor (Source: R. Storesund).

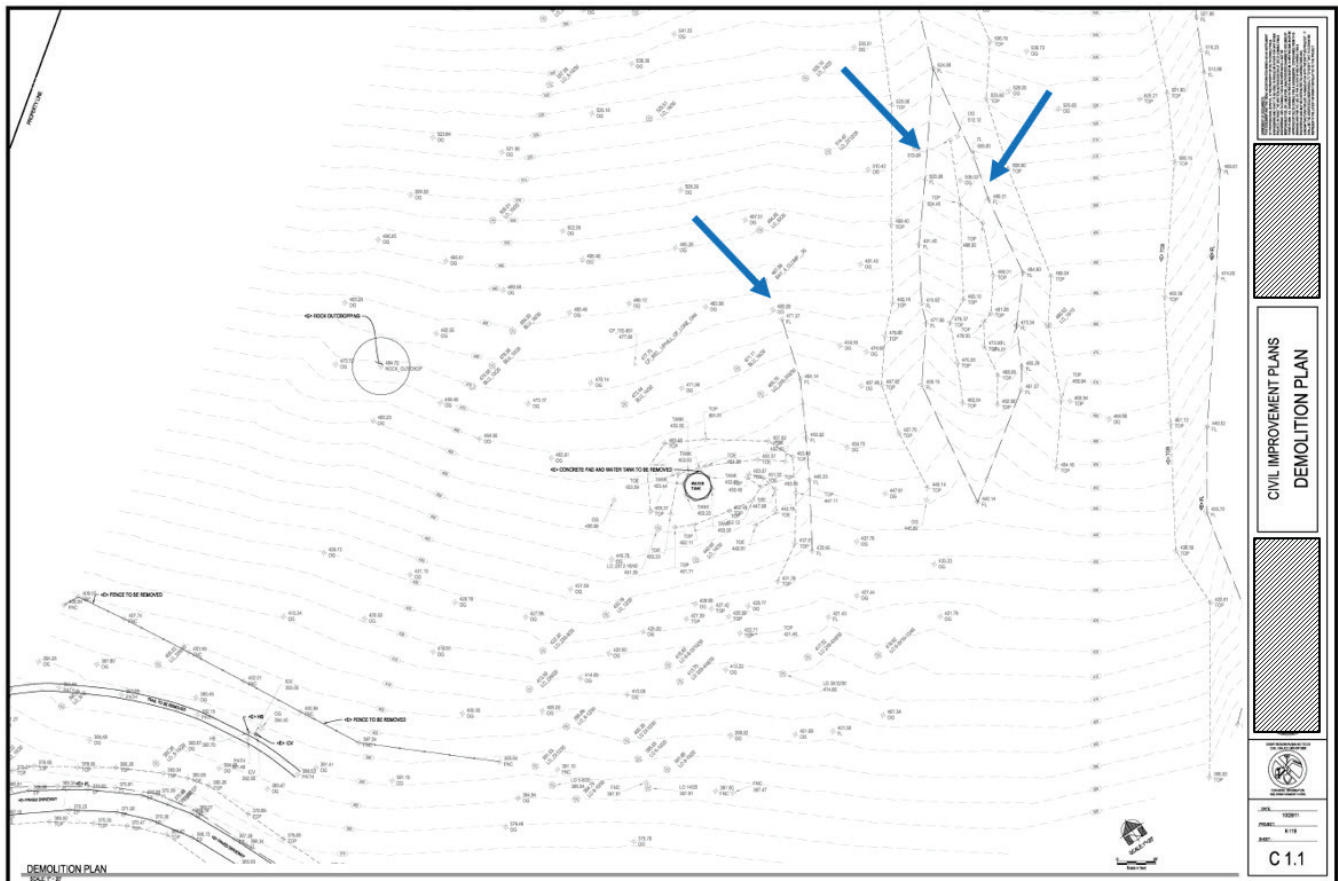
Figure 9

There are apparent drainage channels on the eastern portion of the project site that are situated on a thin veneer of soil, which overlies the volcanic bedrock. The channels become less steep as one moves from the top of the mountain to the base of the mountain because sands and gravels collect at the base of the drainage channel. One would expect water flow to be visible in the upper portions where the water flows on top of the shallow bedrock and then “sink” into the collection of sands, gravels and trapped fine-grained soil (clays and silts) as you move toward the

Demolition plan (Sheet C1.1) showing pre-project conditions, including presence of drainage channels, highlighted by blue arrows. (Source: Project plans)

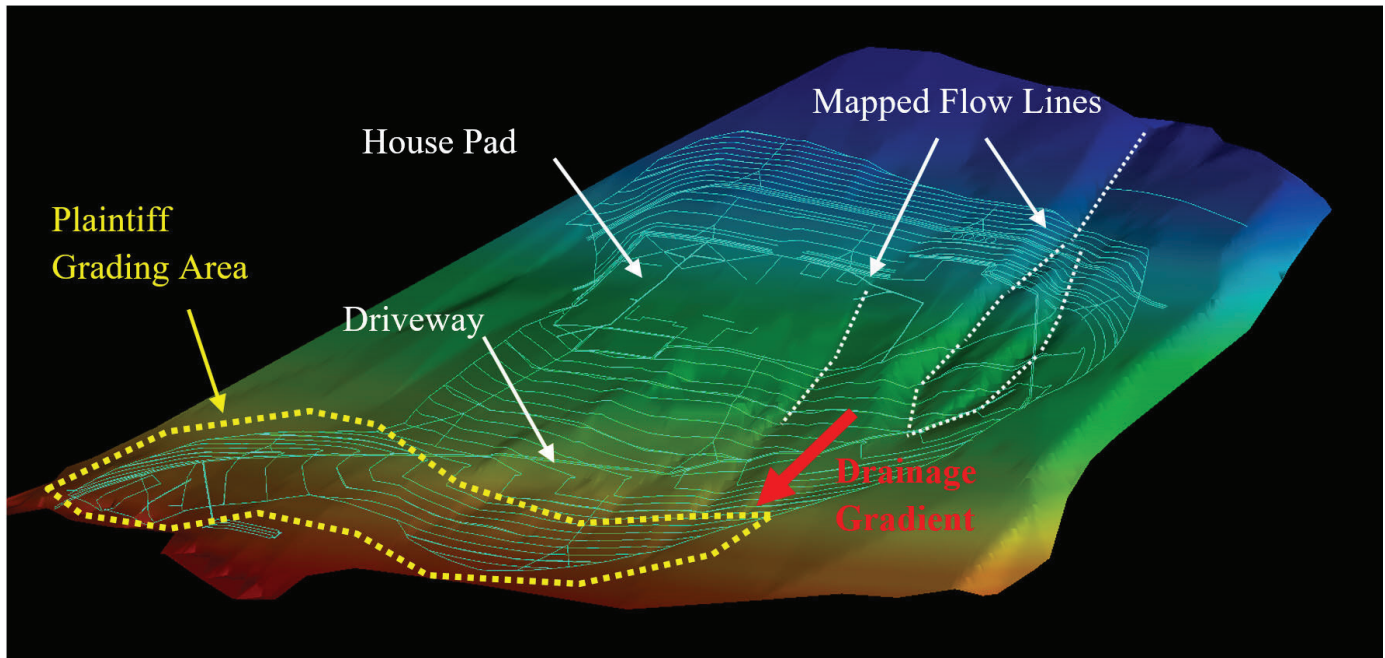
Flow lines of the streams identified on Sheet C1.1 (white dashed lines) relative to the proposed site grading.
Note: These drainages are concentrated on the east side of the property.

Figure 10 shows the proposed grading in relation to the flow lines mapped onto a 3D Digital Terrain Model (DTM). The general drainage gradient is toward the eastern portion of the planned keyway. **Figure 11** on page 18 is an exhibit from the plaintiff's deposition, where the plaintiff drew two green parallel lines to indicate the "wet" material he observed on the eastern side of the excavation (and corresponding to the area of "changed" conditions). This is consistent with the mapped drainage courses identified in the plan set (Sheet C1.1). This is also consistent with the photographs supplied during the plaintiff's construction activities where the surficial soils have caliche staining, as shown in **Figure 12** on page 18.

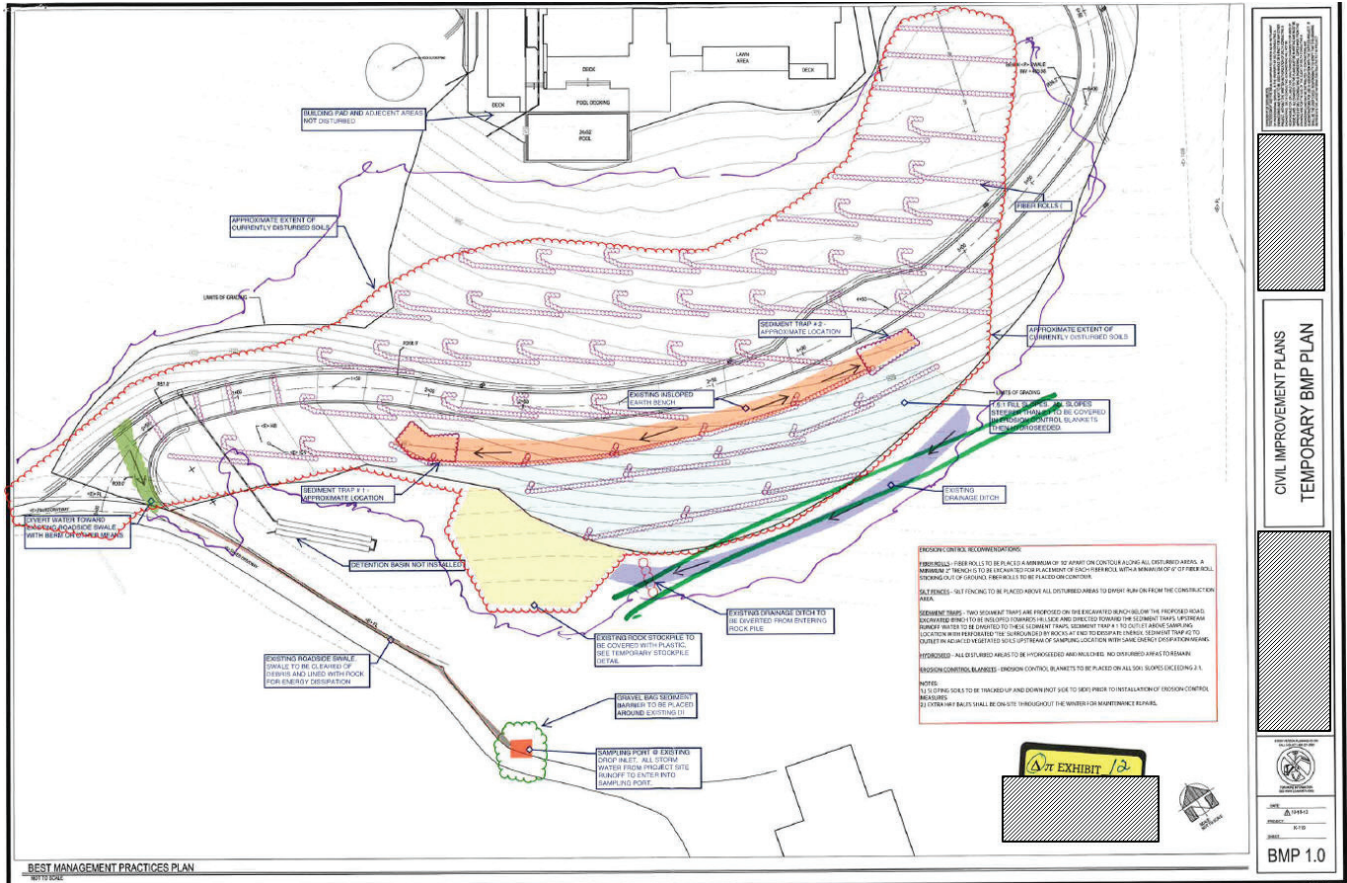
Figure 11

Parallel green lines delineating of zone of “unexpected” material (Exhibit from the plaintiff’s deposition). These green lines are coincident with the natural on-site drainage.

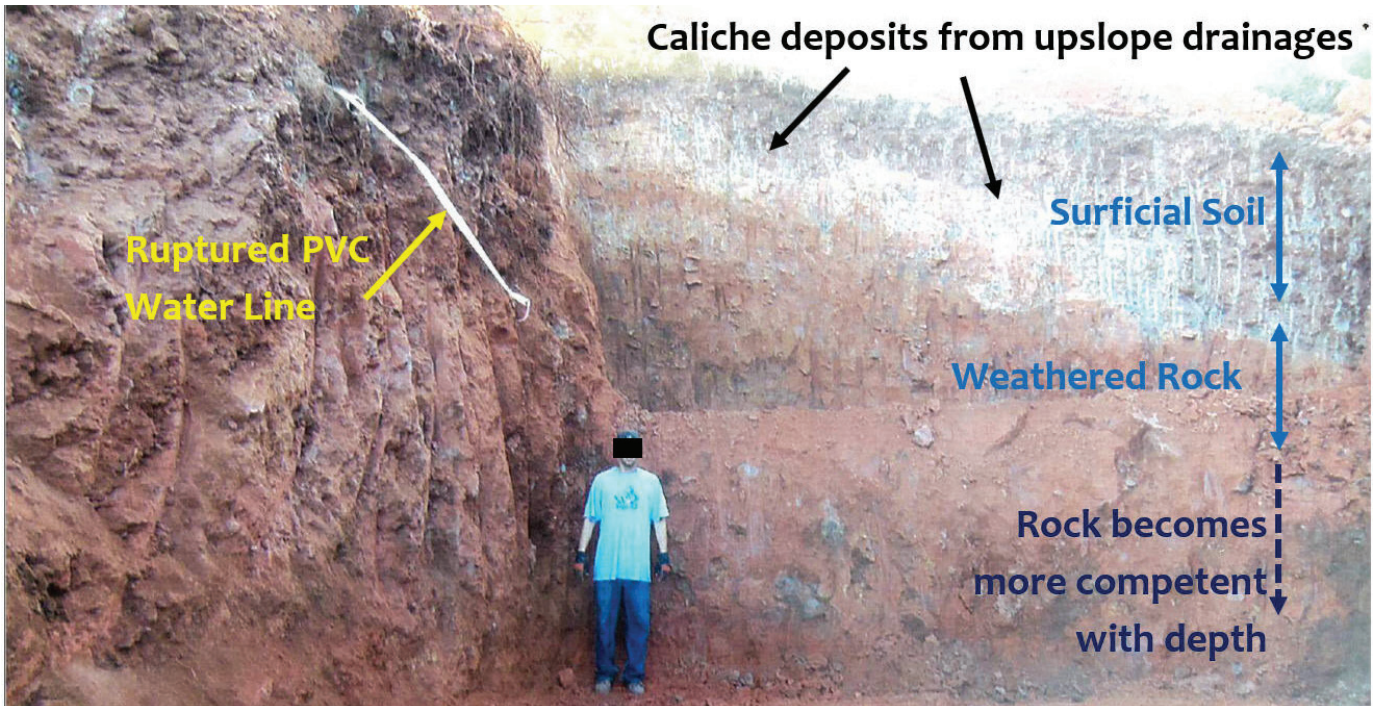
Figure 12

View (looking eastward) of the eastern end of the keyway (Source: plaintiff photo, annotations by author).

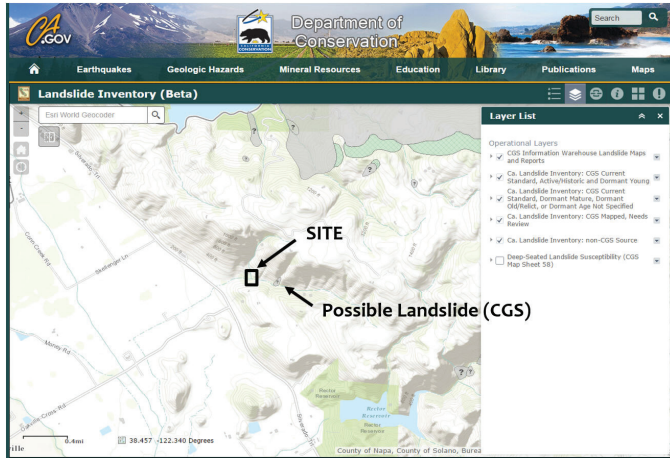
Figure 13

Possible landslide mapped by CGS2 to the east of the project area.

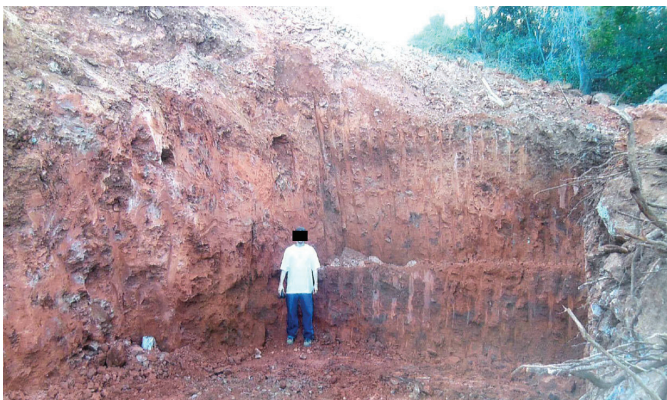
Figure 14

A review of the photographs taken by the plaintiff during the course of his construction work provide visual exposures of the cut slopes in the grading area. All of these photographs are consistent with the mapped geology. No faulting is apparent in any of the plaintiff-supplied photographs, as demonstrated in **Figure 14** and **Figure 15**.

Exposure of cut-slope (left hand side of photo) shows no faulting, and the exposed material is likely near optimum moisture content (Source: Plaintiff photo).

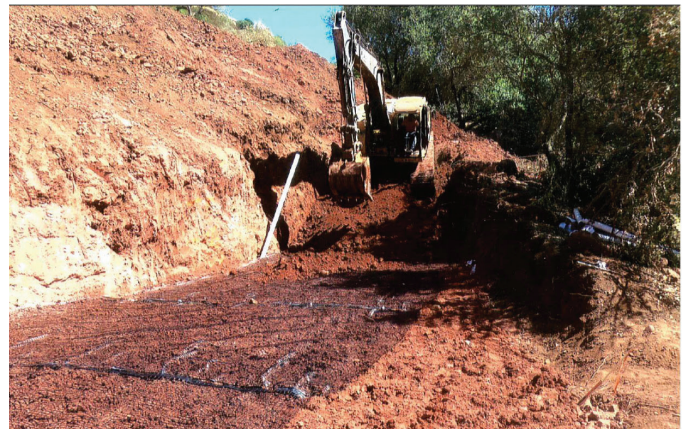
Figure 15

Another photo taken during construction where the exposed cut slope shows no signs of faulting (Source: Plaintiff photo).

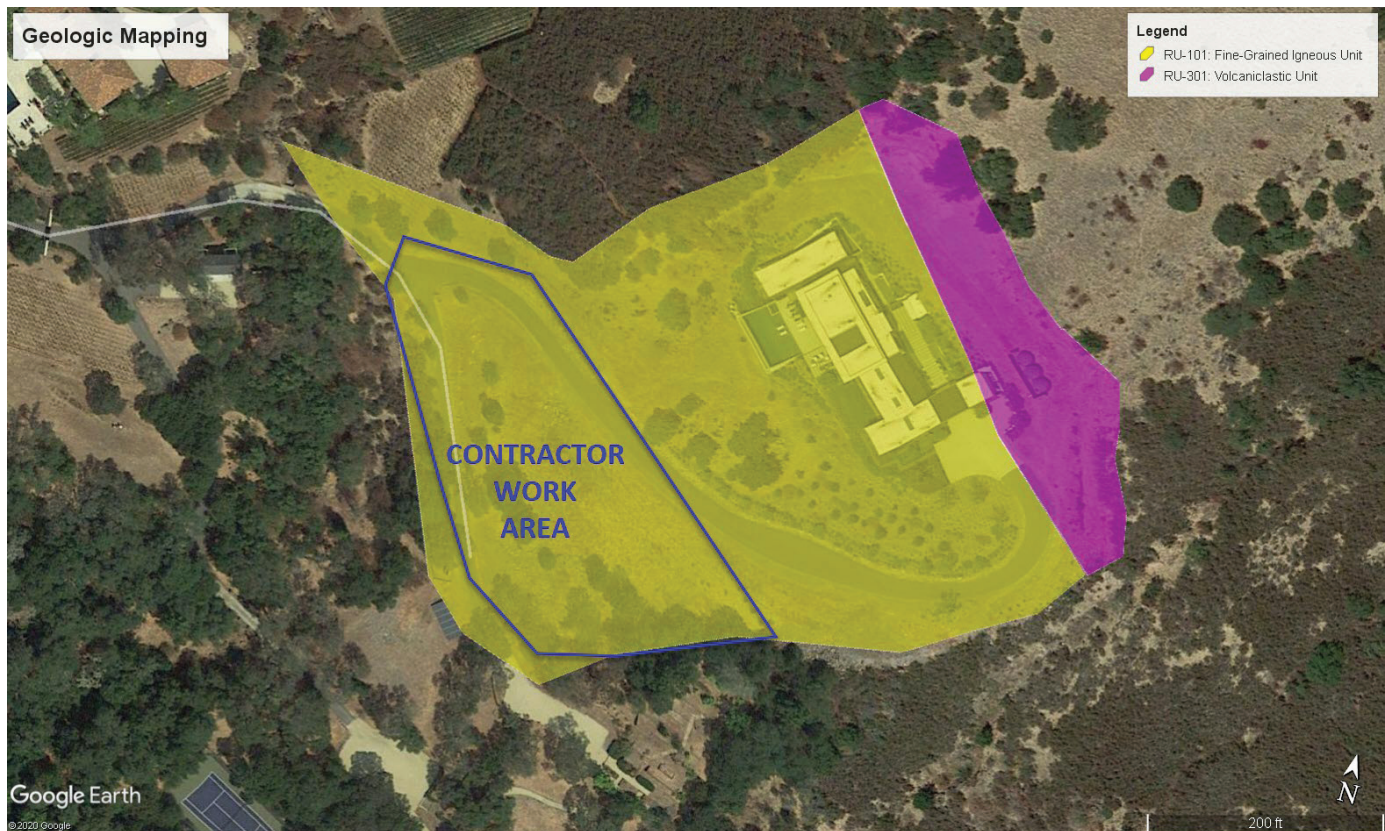
Figure 16

Geologic mapping based on site reconnaissance found no faulting in the contractor’s work area.

the site was mapped. A geologic contact was observed at the top of the driveway between two distinct onsite geologic units — a volcaniclastic unit and a fine-grained igneous unit (**Figure 16**). This contact was not situated within the work limits of the plaintiff and had no impact to the plaintiff work area. No evidence was observed that this fault was active (activity within the last 10,000 years).

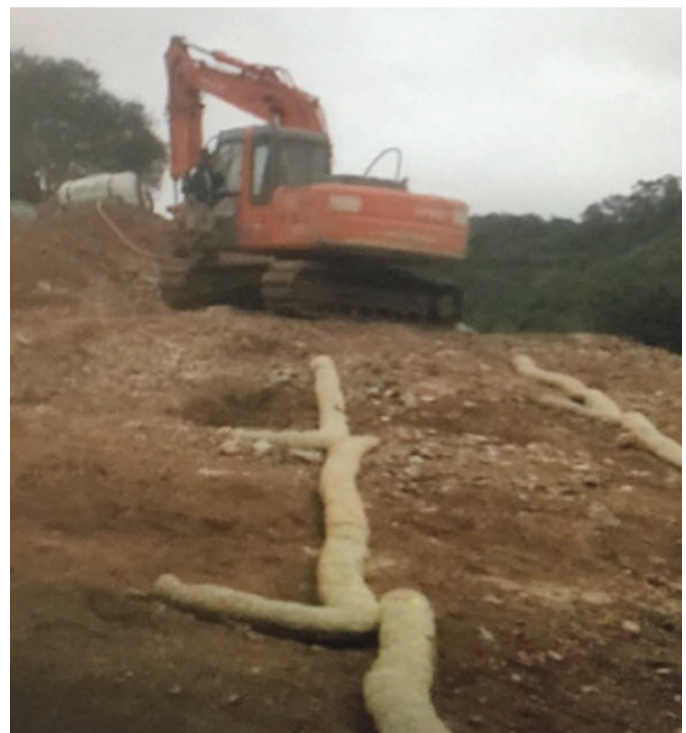
Figure 17

Deployment of straw wattles for erosion and sediment control (Source: Plaintiff photo).

Examples of the identified erosion and sediment control can be seen via the site construction photos, such as **Figure 17** taken by the plaintiff and **Figure 18** and **Figure 19** taken by representatives documenting BMP implementation at the time of termination of the plaintiff. The installation of these erosion and sediment controls were part of the grading scope of work as delineated by the project plans.

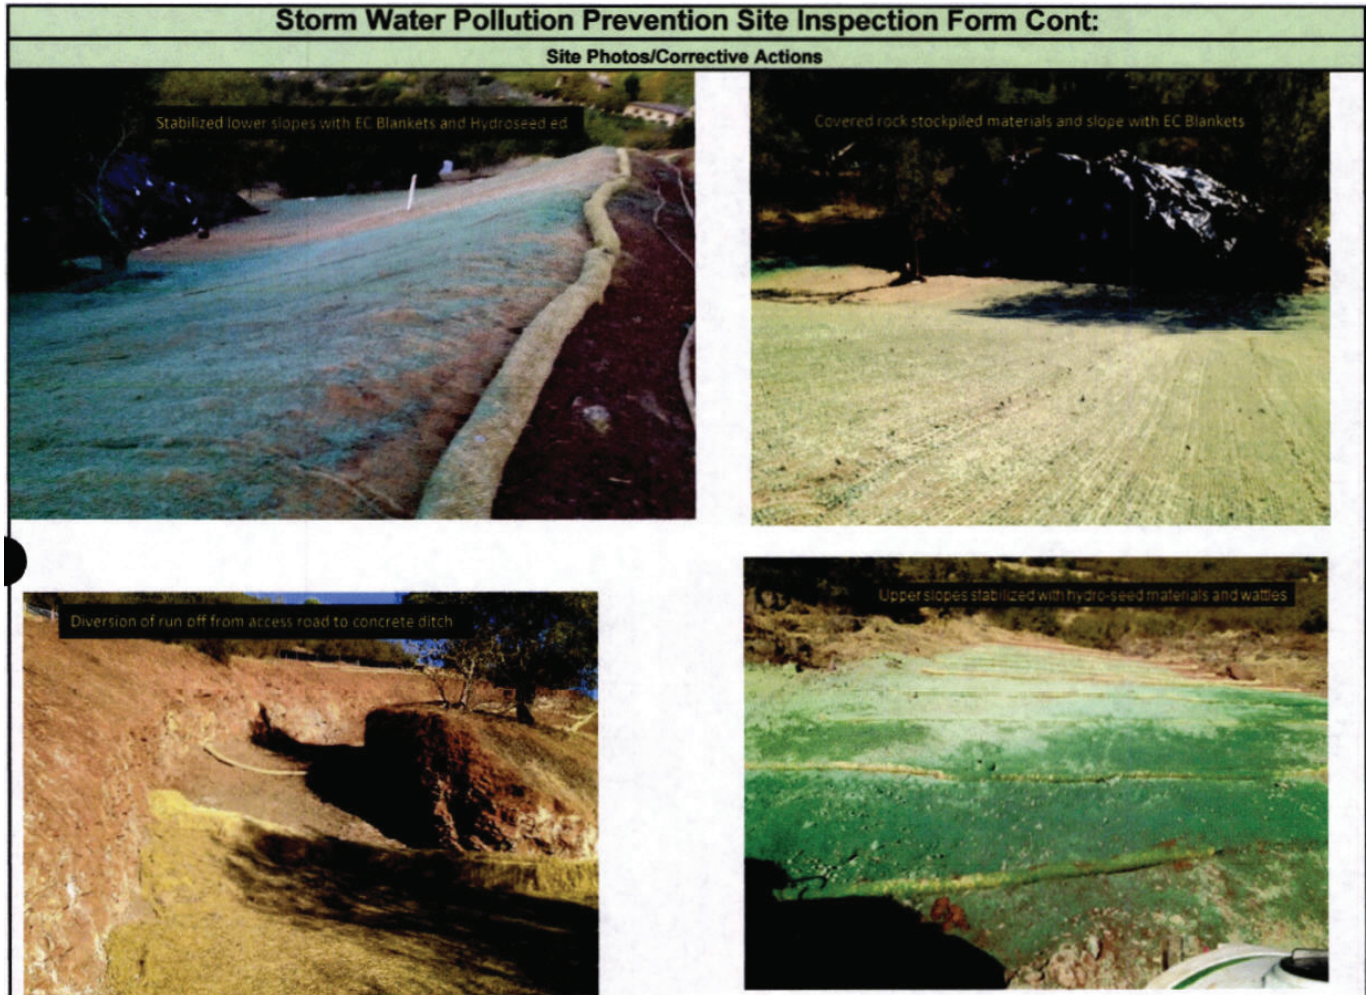
Figure 18

Photo documentation following installation of erosion and sediment control devices. All devices are consistent with the notes and details in the project plans (Source: Project SWPPP consultant).

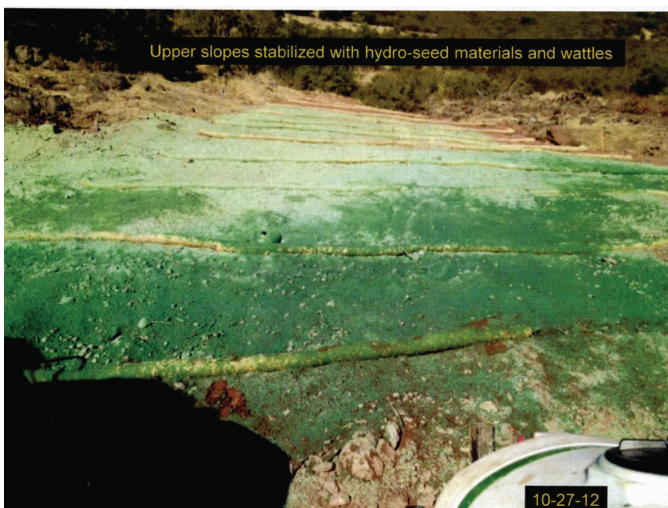
Figure 19

Photo documentation following installation of erosion and sediment control devices. All devices are consistent with the notes and details in the project plans (Source: Project SWPPP consultant).

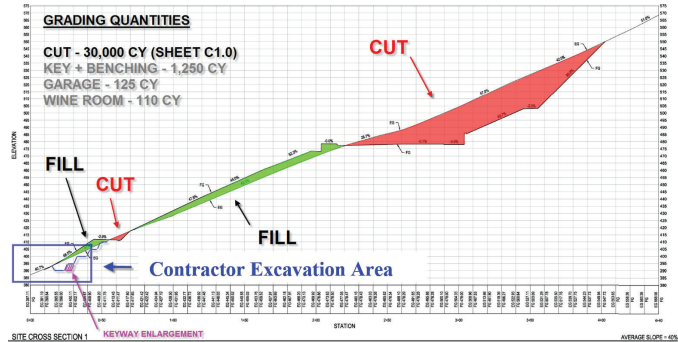
Figure 22

Contractor's work area in relation to overall project cut and fill. Note that the keyway and benching is not a significant (>20%) portion of the site work (Source: Cross-section from project plans).

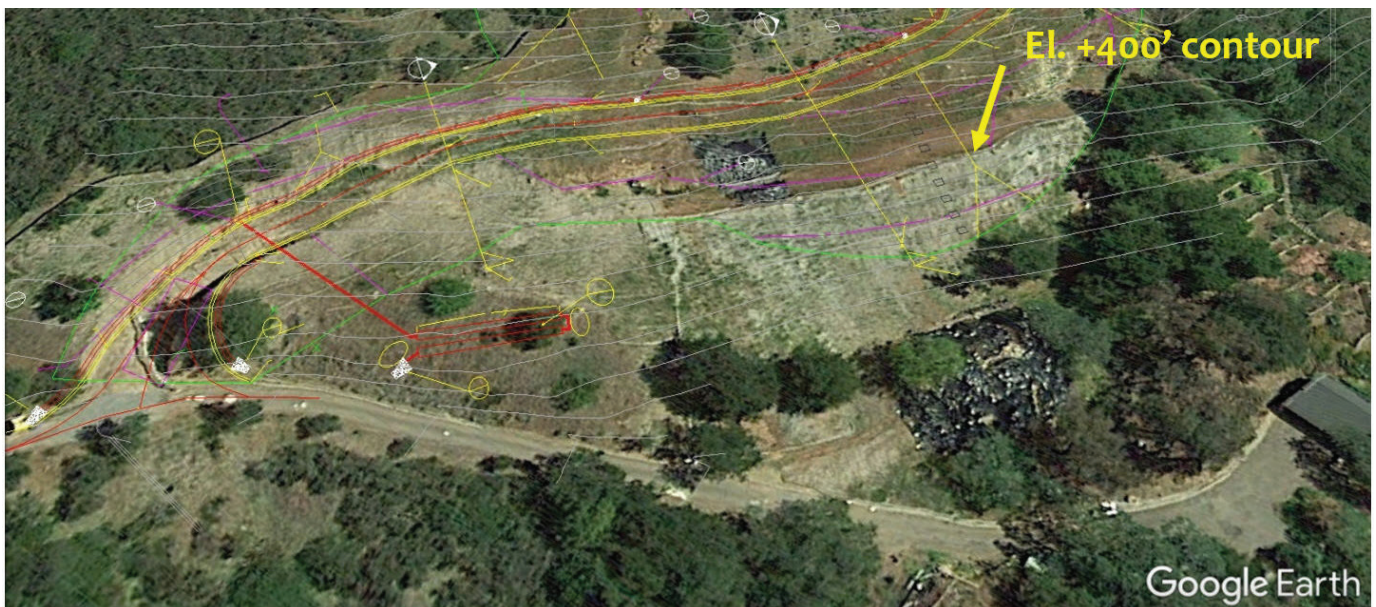
Figure 24

Close-up of where the plaintiff performed grading in fall of 2012. Note the top of the roadway embankment is at approximately El. +400 ft.

embankment in the spring of 2013. It is inferred that this condition is very similar to the condition at the end of site operations in October 2012. Note that the top of the berm is situated just under El. +400 ft.

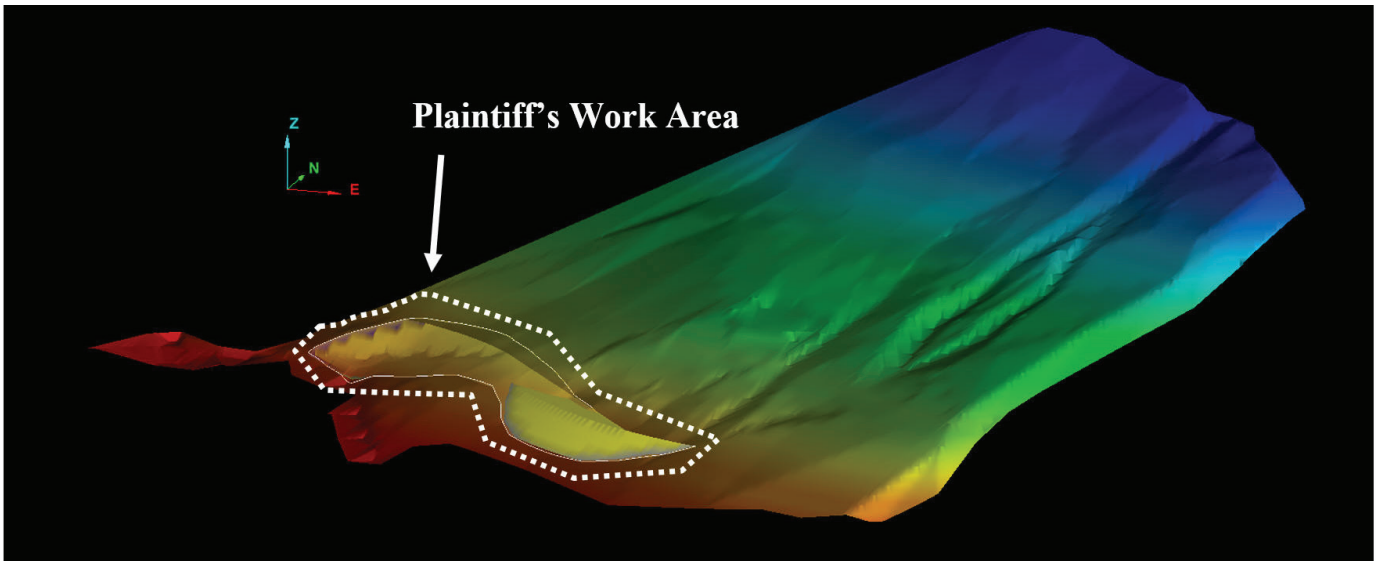
Figure 25

shown on the “grading plan.” The project cut quantity corresponding to the contract cut with proposed grades developed to El. +400 ft was approximately 3,800 CY. **Figure 25** through **Figure 27** show aerial oblique views of the volumetric analysis performed to compute the estimated cut volume completed by the plaintiff. No topographic data was collected during the course of the plaintiff’s work to corroborate the analytic results; however, the subsequent

Aerial oblique view of volumetric analysis performed to compute cubic yards (CY) of excavation performed. White line delineates interpreted extents of plaintiff’s work.

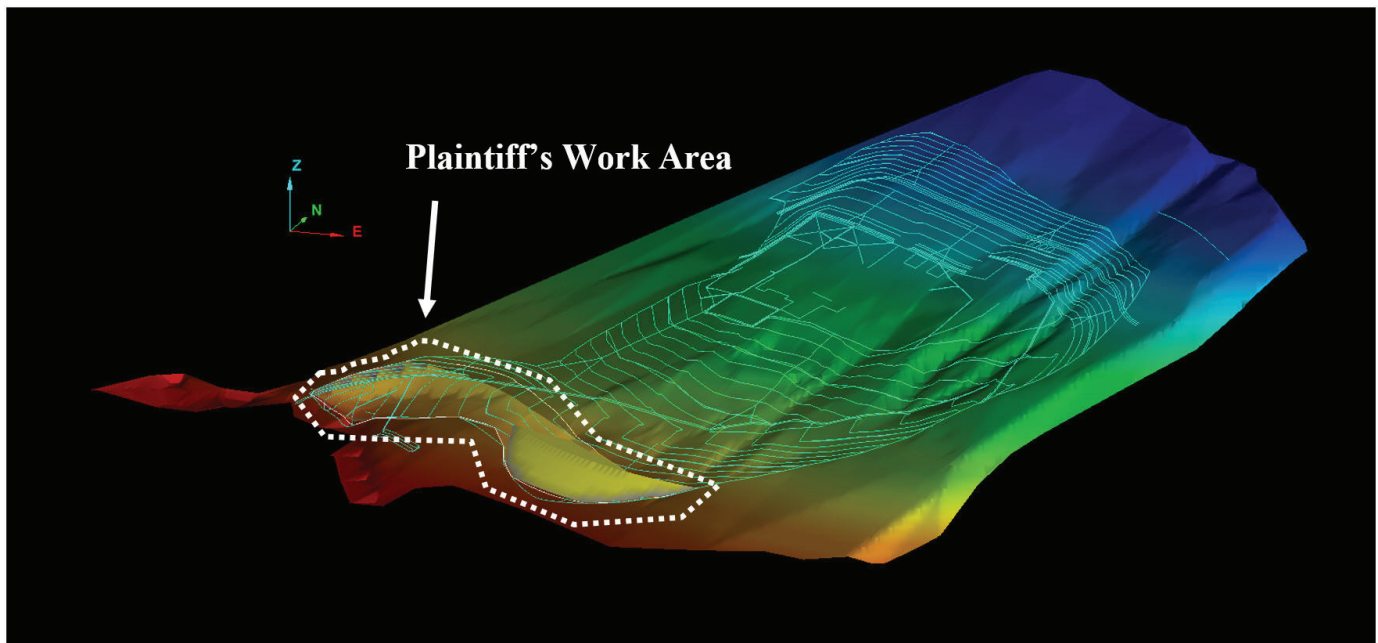
Figure 26

Aerial oblique view (Northwest) of volumetric analysis performed to compute cubic yards (CY) of excavation performed with overlay of project plans. White line delineates interpreted extents of plaintiff’s work.

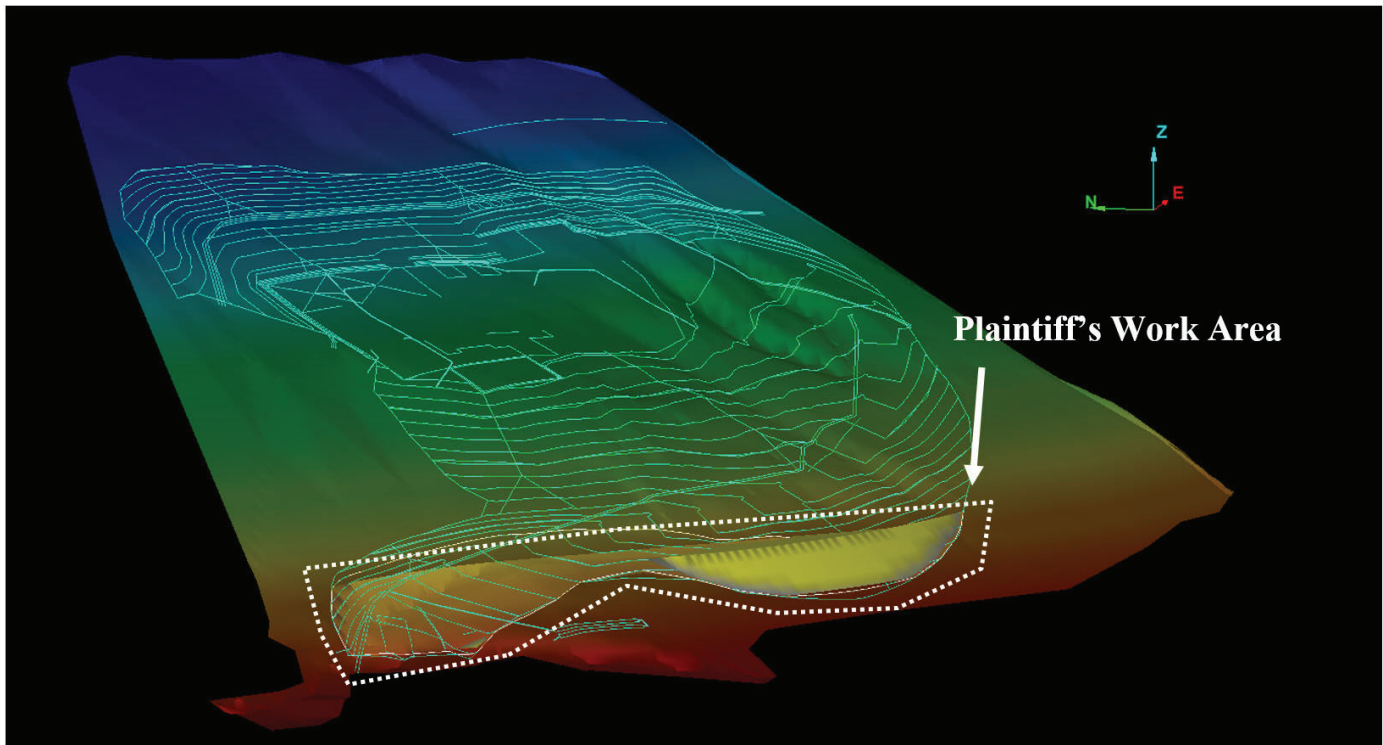
Figure 27

Aerial oblique view (northeast) of volumetric analysis performed to compute cubic yards (CY) of excavation performed with overlay of project plans. White line delineates interpreted extents of the plaintiff's work.
