Vol. 41 No. 1 June 2024

# FE Evaluation of Pedestrian and Worker Fall Incidents — the Evolution of Analysis Techniques and Safety Requirements

By Christopher B. Shiver, PE, DFE (NAFE 661S)

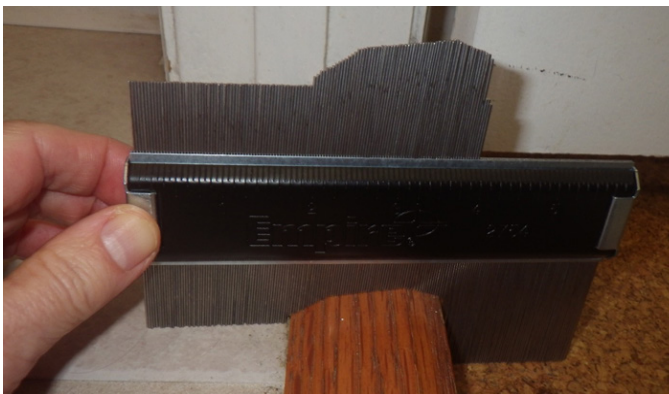
**Figure 2**

With “flat” walkways, the primary details to document are any elevation changes as well as clear width. Sloped surface grades and lengths between grade changes should be recorded. Additionally, document heights or profiles of any abrupt elevation changes, including doorway thresholds or trim strips between differing floor surfacing materials (for these types of investigations, a carpenter’s or machinist’s profile gauge may be useful), as shown in **Figures 2** and **14**.

Use of profile gauge to measure elevation change details.

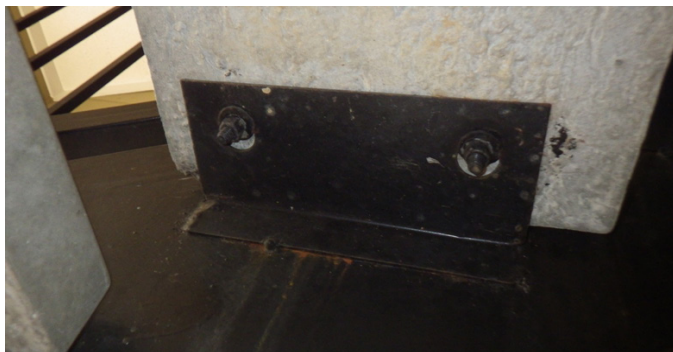
**Figure 3**  
Concrete stair tread attachment to steel frame.

ers may loosen, resulting in treads that shift under a user’s weight (**Figure 3**). Therefore, in cases where it was alleged that a user lost balance due to movement of the staircase or treads, careful examination of the entire structure (including the treads) for signs of damage, deterioration, or non-rigid conditions is critical. Carpet-covered stairs can pose additional visualization and footing challenges, particularly if the carpet fit is loose. Those details should also be documented.

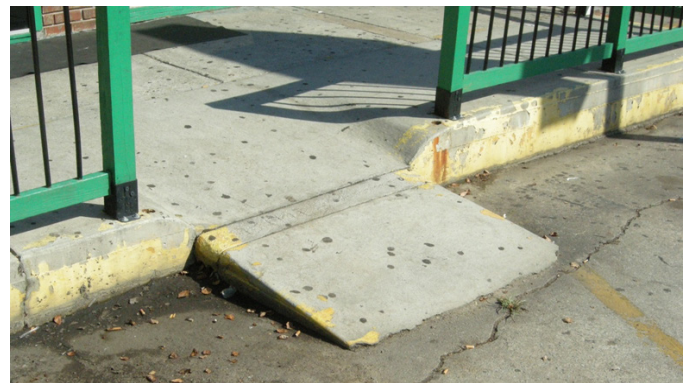
An increasingly widespread type of exterior ramp is a curb ramp, which provides for elevation change access across a curb. They are of two types: ramps formed or cut into the curb and sidewalk (standard type) or extended (built-up) curb ramps that are built out from a curb onto the lower elevation paving (**Figure 4**). Curb ramps

**Figure 4**  
Combination standard and extended curb ramp. Lack of side flares on the extended portion presents a trip hazard to pedestrians approaching laterally.

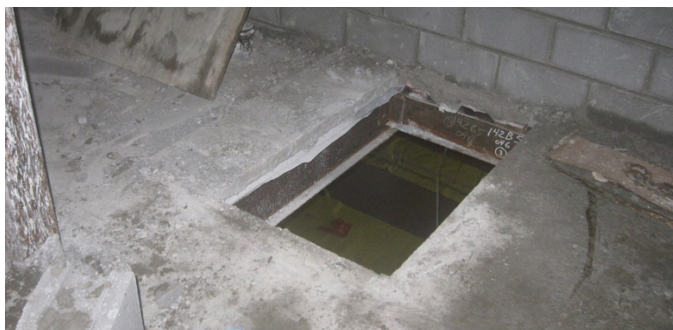
**Figure 5**

Temporary floor opening at construction site requiring fall prevention features, such as covers or barricades per OSHA and ANSI requirements.

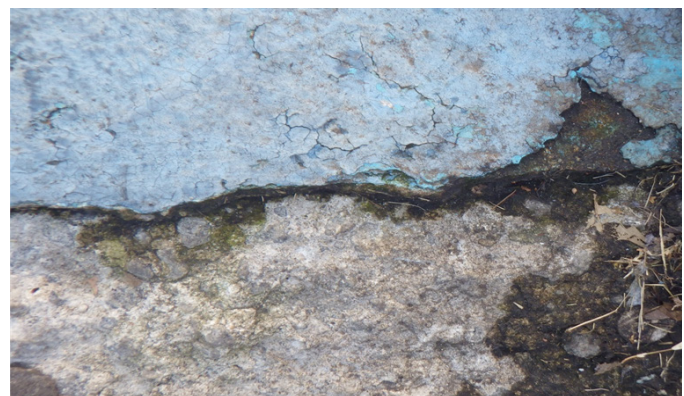
**Figure 7**

Where side flares are provided with a ramp, the typical code requirement is (and has been) that the slope not exceed 1 in 10. Deterioration of ramp surfaces is addressed similarly by the applicable maintenance code (including the IPMC where implemented) as a type of walkway surface. Extended (or built-up) curb ramps, in particular, are susceptible to edge damage where their material is at its thinnest, which can result in abrupt change in elevation trip hazards (**Figure 7**).

Extended curb ramp edge material loss potential trip hazard.

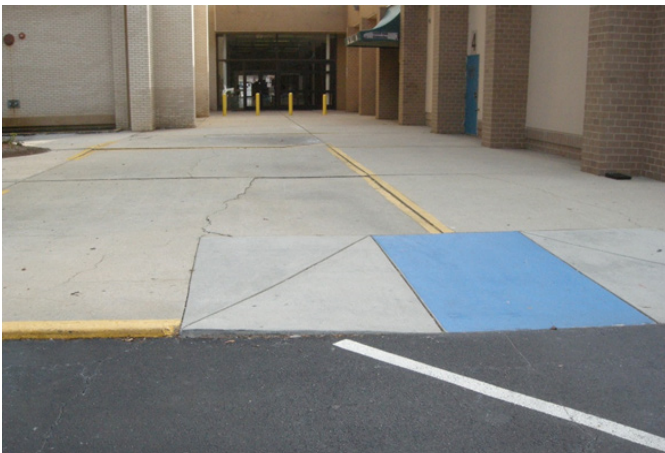
**Figure 8**

Mall entry walkway and curb ramp — note yellow striped joints.

route, including a curb ramp from marked ADA parking spaces. Based on the documented facility construction and renovation dates, appropriate editions of the LSC and ADA facilities requirements (including a state-mandated accessibility code) applied. These required that walkway elevation changes exceeding  $\frac{1}{2}$  inch be accomplished with a compliant ramp. The IPMC also was in effect for this facility and required that the walking surfaces be maintained in a safe condition. The inconsistent striping of joints with trip hazards potentially increased the risk of a pedestrian tripping on the unmarked joints with abrupt elevation changes.

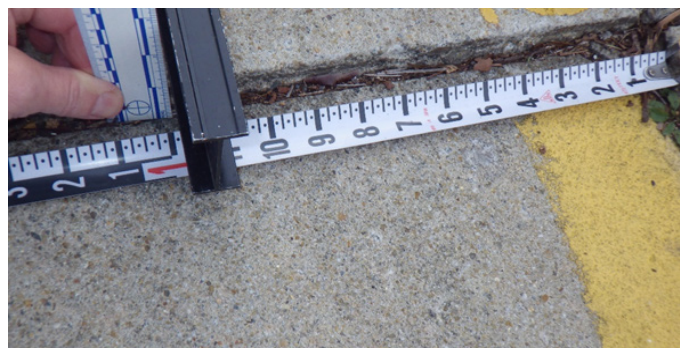
**Figure 9**

One of the main entries for a shopping mall building included concrete exterior approach walkways providing parking area access. This pavement had been poured in sections separated by visible joints. At many of these joints, differential settlement of the adjacent paving sections had occurred, resulting in sudden vertical elevation changes that (at some locations) exceeded  $\frac{1}{4}$  inch or even  $\frac{1}{2}$  inch. Some of the joints that had elevation changes above these values had been striped with yellow paint, reportedly to indicate potential trip hazards to pedestrians. However, other joints with elevation changes above these values had not been striped with yellow paint, and, in some cases, the unpainted joints had greater magnitude sudden elevation changes than painted joints (**Figure 8**). A pedestrian tripped and fell while reportedly passing across an unpainted joint with an elevation change ranging from  $\frac{5}{8}$  to  $\frac{3}{4}$  inch (**Figure 9**).

Measurement of incident location elevation change height.

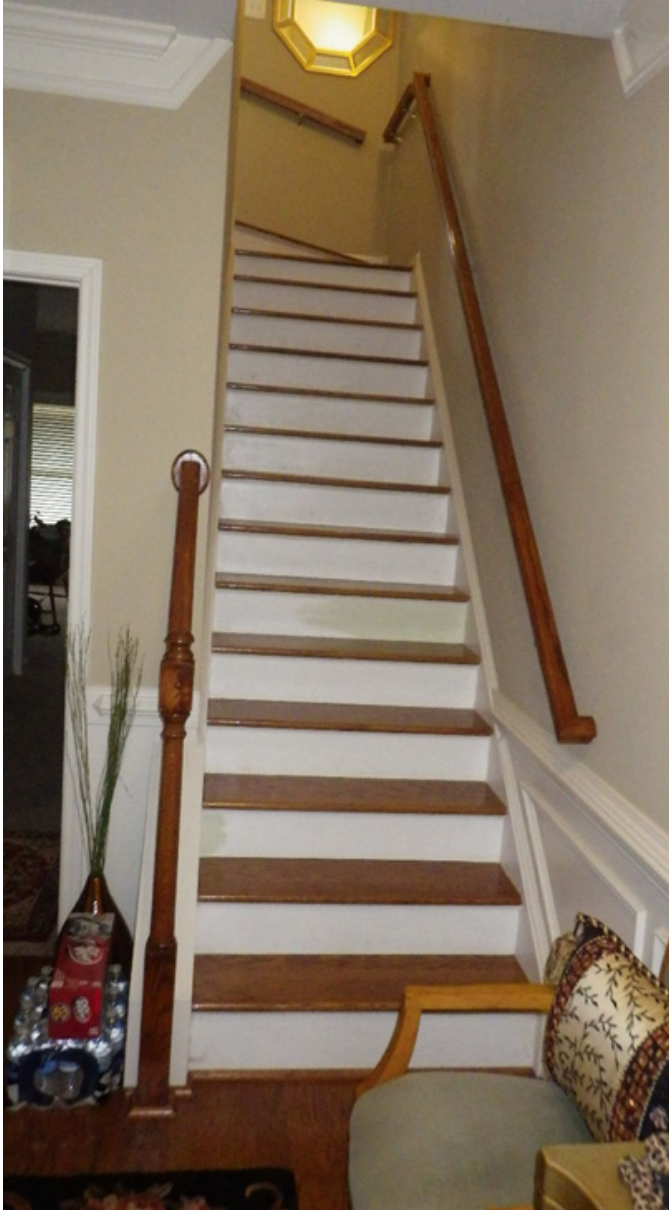
**Figure 10**

The injured pedestrian reported falling from near the top of this staircase, which included a right angle turn accomplished with two diagonal treads. The pedestrian further reported that handrails observed during the inspection, within this corner portion of the staircase, were added by the property owner after the incident (**Figures 10 and 11**). A dimensional study of the staircase revealed riser heights well over 8 inches, tread depths less than 9 inches, variations in these features exceeding 2 inches, handrail heights varying between 31 and 42 inches, and handrail wall clearances less than  $1\frac{1}{2}$  inches (including for the more recently added handrails).

Townhouse staircase lower portion and corner.

part of the staircase rather than as a landing indicated that the staircase overall had been built in an overly steep configuration to fit the limited space within this townhouse. These overall conditions would not only increase the risk of a fall but would also increase the potential that a fall might result in a pedestrian tumbling down the full stairway. **Figure 12** is an example of how to present staircase inspection findings in comparison to code requirements as part of an expert report.

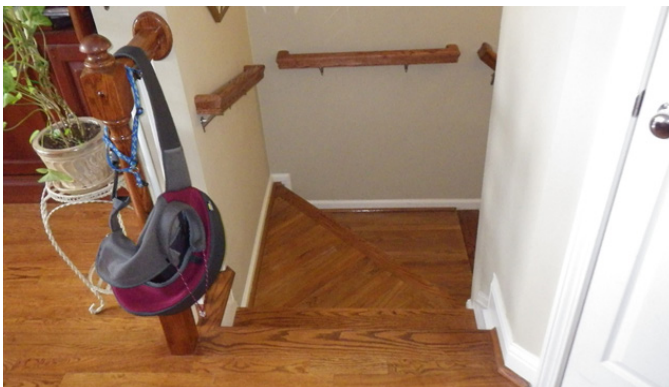
**Figure 11**

Townhouse staircase upper portion and corner, including handrails added after incident.

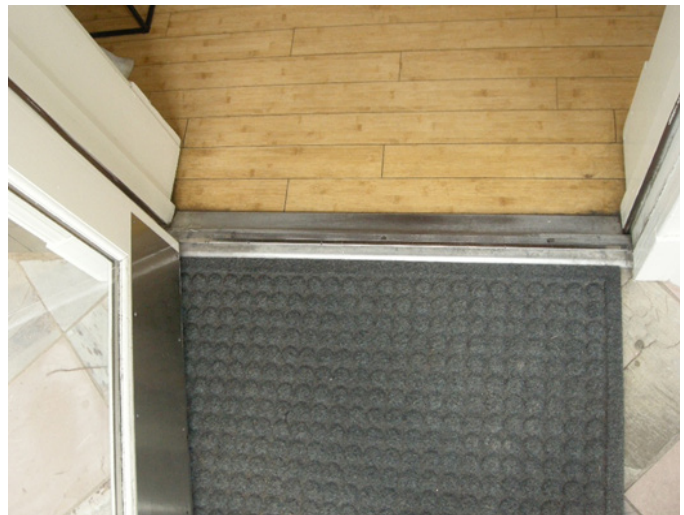
**Figure 13**

The main entry doorway for a walk-in business included a manufactured metal threshold installed under the swinging type standard width door (**Figure 13**). Reportedly, a patron entering the business tripped on that threshold, which evidenced several elevation change features and a maximum height above the floors on either side (which themselves were at elevations differing by approximately  $\frac{7}{8}$  inch) exceeding  $1\frac{1}{2}$  inches. Use of a profile gauge was valuable for documenting the actual threshold dimensions (**Figure 14**). The gauge study

Doorway threshold insert.

Based on the facility construction and renovation dates, the IBC and LSC were applicable to the subject doorway. The threshold profile was not in compliance with the doorway elevation change specifications in those codes. The subject threshold presented a much more vertically aggressive profile than the author has typically observed. It was hidden from the view of pedestrians until they opened the door — even then, they could only view it from almost directly above, presenting minimal opportunity to properly view this trip hazard.

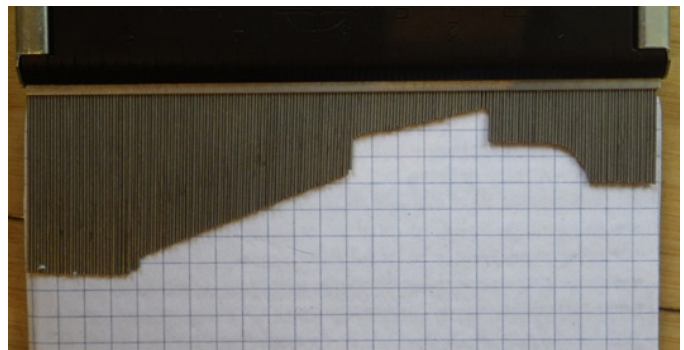
**Figure 14**

Threshold insert profile — each square equals  $\frac{1}{4}$  inch.

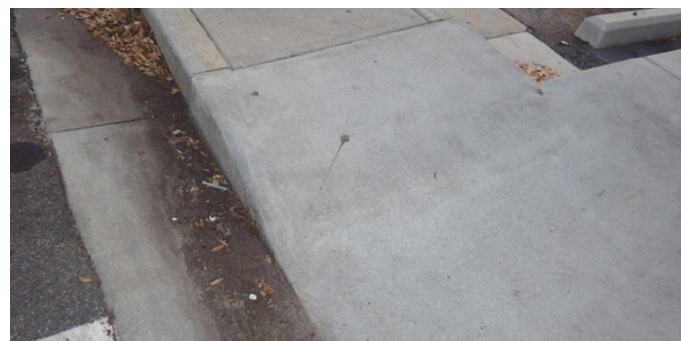
**Figure 15**

Curb ramp flare with excessive slope.

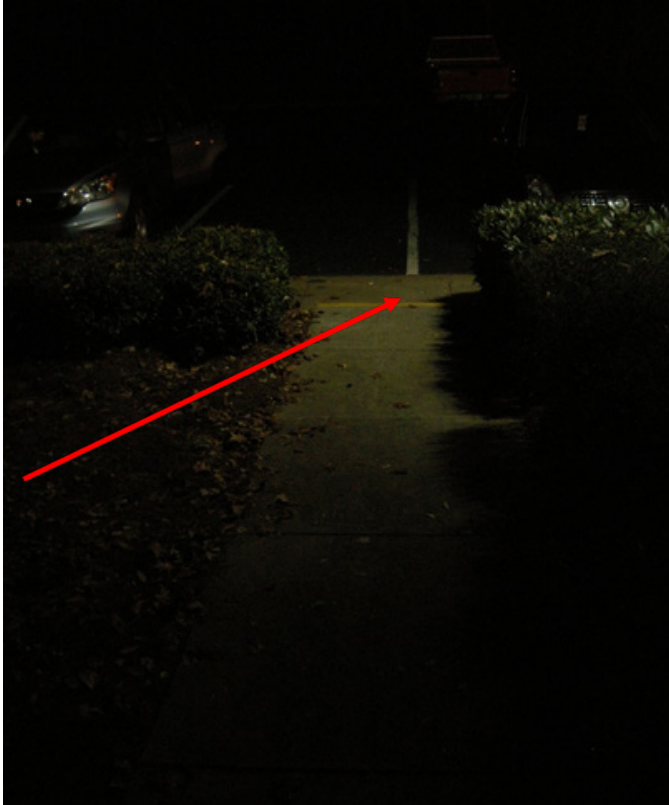
**Figure 16**  
Walkway at night looking toward  
single step down (indicated by arrow).

crossing sidewalk where it approached the parking area. A visitor did not visualize this feature at night and lost balance, crossing it from above (**Figure 16**). Illumination during nighttime inspection was documented to differ from the time of the incident — namely that new fixtures had been added, and non-functional fixtures had been restored to service (**Figure 17**). An illumination study at the walkway level indicated that in areas shadowed by adjacent shrubs and/or the walkway elevation change that lighting levels were less than 0.13 fcd with all lighting functioning. Temporary removal of that reportedly added illumination resulted in measured lighting levels below 0.06 fcd. At the inspection, the elevation change was striped yellow, although it was documented that this striping was not present on the incident date.

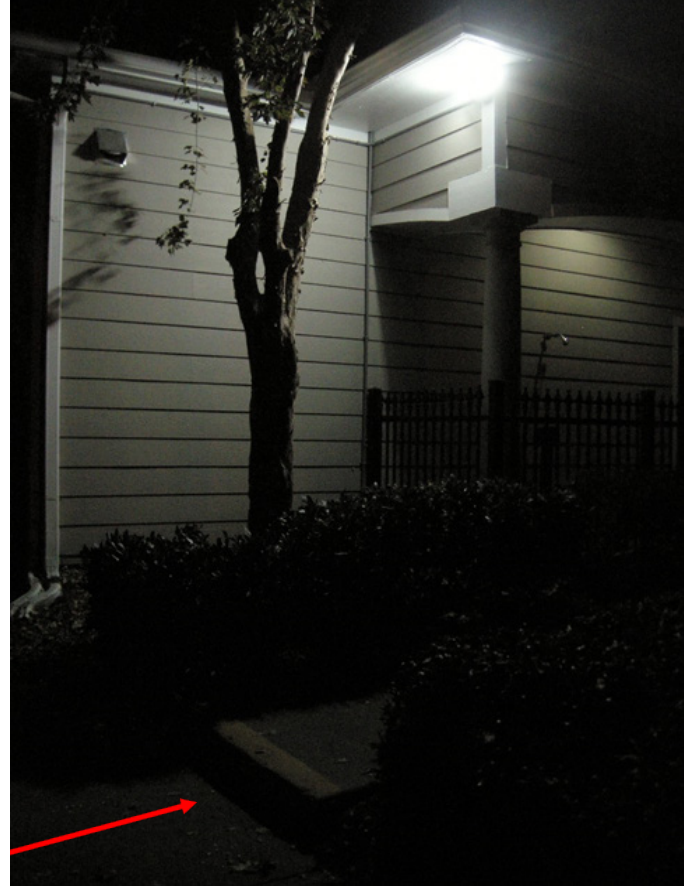
**Figure 17**  
Primary illumination for walkway step  
down (arrow) at time of inspection
