Electrocutions and Downed Powerlines: a Forensic Electrical Engineering Analysis of Causes, Reasons, and Effects

By Helmut G. Brosz, PEng (NAFE 1029C)

Abstract

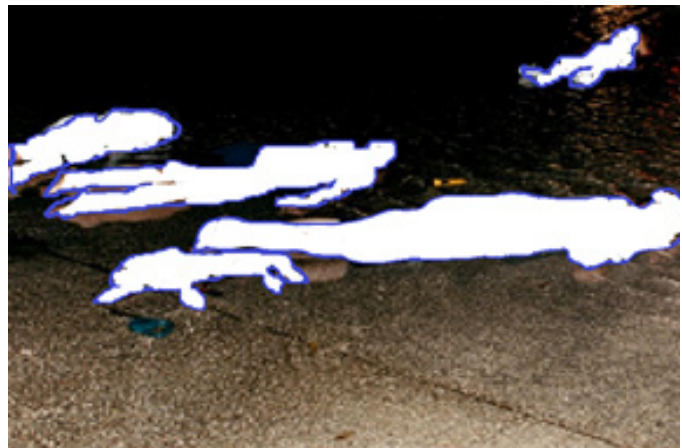
Figure 1

In October of 1999, after a storm reportedly produced winds of approximately 70 mph, a mother took her two sons, their friend, and the family dog out for a walk in the dark. The individuals approached a giant puddle covering the T intersection on the road. The two brothers decided to walk through the pool barefoot, their mother went around the puddle with shoes on, and their friend entered the puddle after taking off his running shoes (followed by the dog). Upon noticing the brothers, the friend, and the dog lying in the puddle unconscious, the mother turned around and entered the puddle as well. All were electrocuted by an energized 480-Volt (V) downed streetlight conductor found lying in approximately 4 inches of water. The heads of the three deceased males were located about 1 foot from the underwater streetlight conductor. The female's feet and head were approximately 25 feet from the other side of the conductor (**Figure 1**).

Location of victims observed in the puddle of water after electrocution.

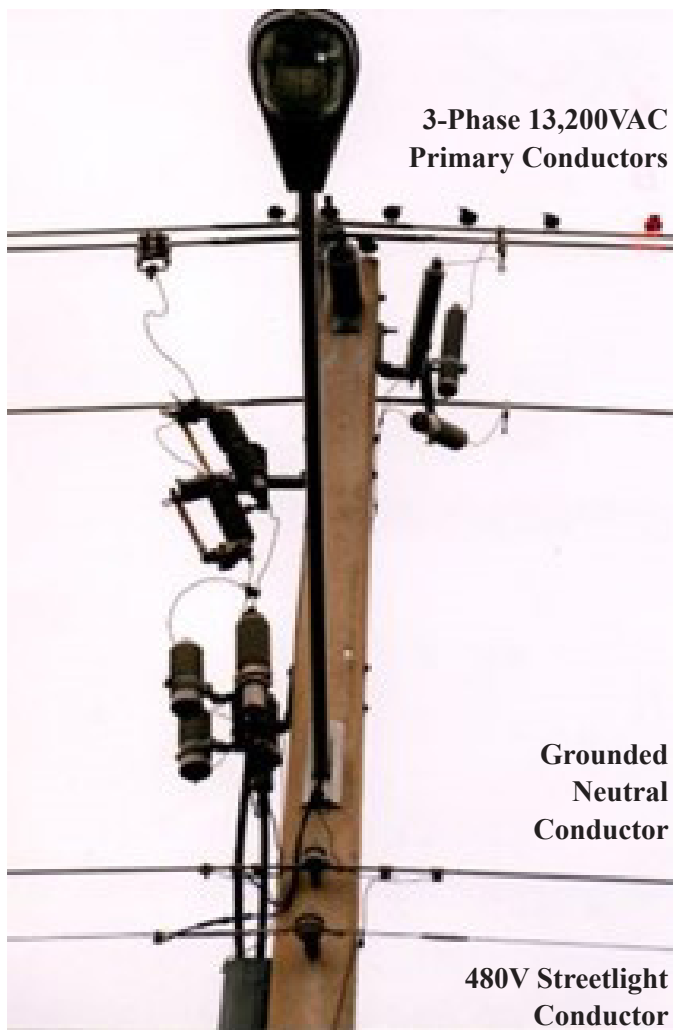
Figure 2
Streetlight conductor configuration.

north side of the street. A neutral conductor (3/0AWG AAAC) was underbuilt. The #4 AWG AAAC streetlight conductor was mounted 1 foot below the neutral at each concrete pole (**Figure 2**).

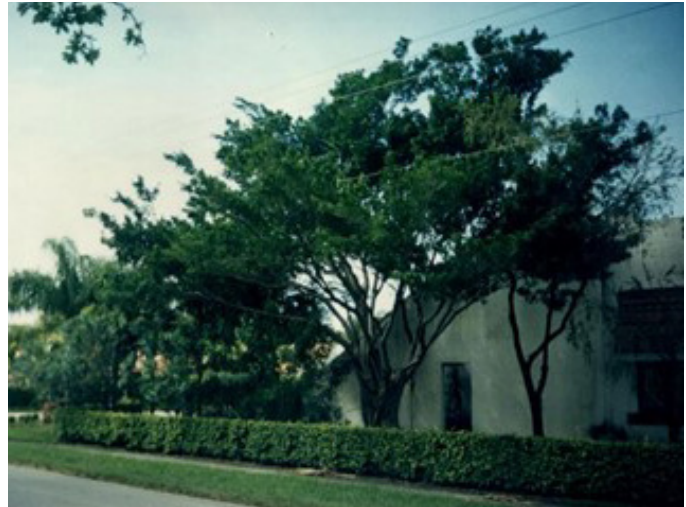
Figure 3
Neutral conductor in the Ficus tree after the incident.

in contact with a Ficus tree, among other trees and bushes displayed in **Figure 3**.

- d. The primary cause factor for the short-circuit event was due to the lack of vegetation maintenance. The vegetation was not appropriately managed in maintaining a 6-foot clearance between powerlines and trees. According to the utility standards, appropriate vegetation management requires to maintain a clearance of 6 feet between power lines and trees⁵. This distance was not met and was a large factor in causing the short-circuit event.
- e. Short circuits caused by conductive flying objects were ruled out due to the lack of flying conductive objects found, seen, or reported. Furthermore, the momentary contact would not be long enough to produce the damage observed.
- f. Sustained contact with branches alone at 480VAC would not draw sufficient current to produce the arcing damage observed — only corrosion evidence is attributed.

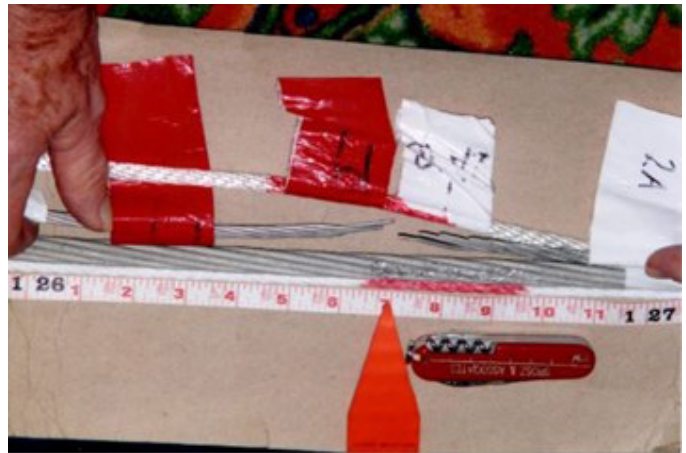
Figure 9

Severed streetlight conductor.

- a. Close visual and optical examination of the neutral and streetlight conductor revealed a short circuit occurred between the two at the 126-foot location and at other locations. The seven strands (7 x 0.0843 inches) of the #4 AWG streetlight conductor were melted and severed (**Figure 9**). The larger neutral conductor was only one of its seven 0.1672-inch strands severed (**Figure 6**).

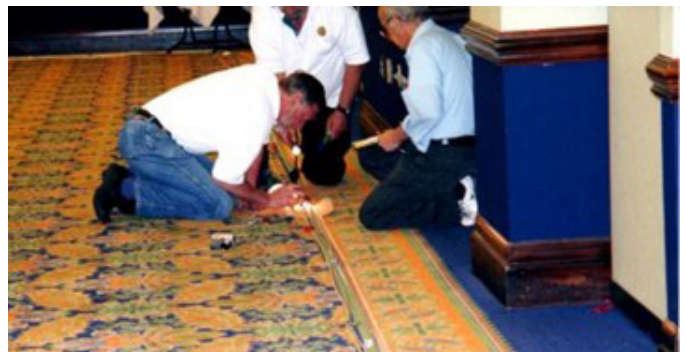
Figure 10

Examination of conductor.

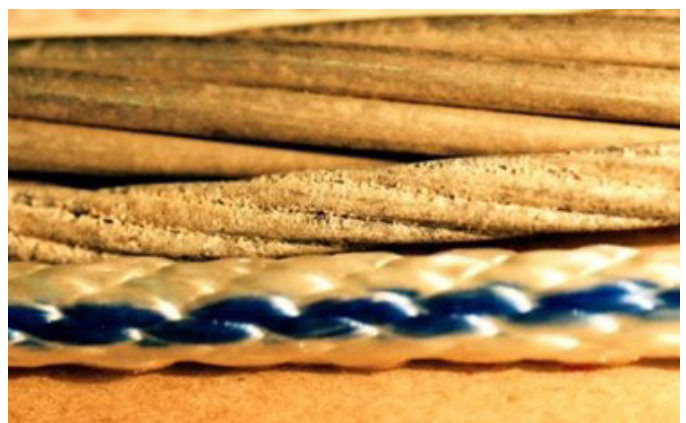
Figure 11

Rope copy of conductor with vegetation contact markings.

- b. On the severed conductor, evidence of long-term contact with vegetation (**Figure 11**) resulted in a form of corrosion. The survey was conducted six years after the event and tree trimming.

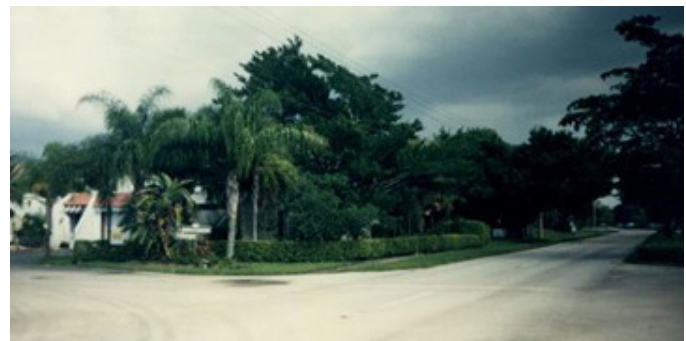
Figure 12

- c. New shoots emanating from the Ficus tree trimming cuts were observed. The diameter of the cuts ranged from 3 to 6 inches, corroborating the extent of branches in contact and in the vicinity of the open conductor. Production of documents revealed trimming had not occurred for at least six years prior to the electrocution. The tree

trimming cycle of three years (as set out in the utility standards) was missed at this location (**Figure 12**). Furthermore, the tree trimming cycle does not take into consideration the growth rate of the various vegetation species. A Ficus tree can grow up to 6 feet per year.

Ficus branches below neutral 3/0 and #4 streetlight conductor (removed) following the incident and prior to trimming.

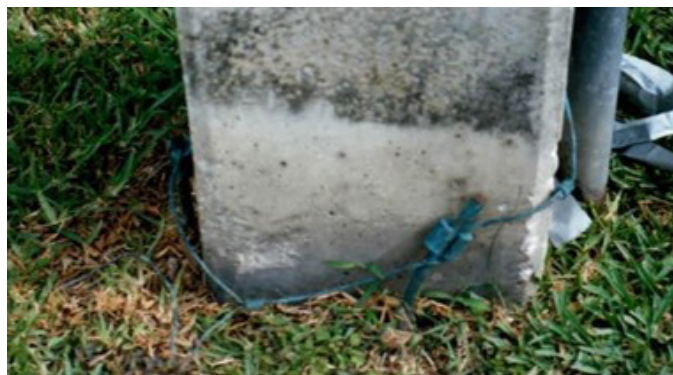
Figure 13

- c. When the still-energized west section of the #4 conductor fell into the puddle, the current path extended from the conductor through water, through the ground back to the grounding rod (Figure 13) at the base of the concrete transformer pole. From there, the current flowed up the solid copper #6 AWG bare conductor to the neutral of the streetlight transformer. The impedance of the circuit was high enough (and the current low enough) so as to prevent the transformer 6K fuse from operating on a 480V and less than a 225A fault.

Ground rod at the base of the transformer pole.
