Vol. 38 No. 1 June 2021

Pinched Power Cord is Latent Defect Causing Fire When Appliance Is Not in Use

By Michael D. Leshner, PE (NAFE 559F)

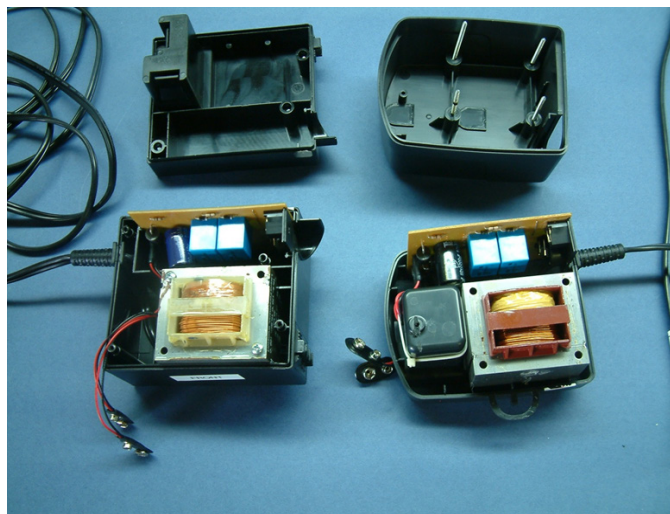
Figure 1
Power supply designs — old (left) and new (right).

was of the older design, based on the length of the power cord. The timing of the original purchase was also consistent with the older design.

Both designs were functionally equivalent, having the same transformer, circuit board, and connections. Revisions in the plastic enclosure provided more space for the wiring and a more direct path for the power cord. The short AC power cord and long DC cord reflected the altered location of the power supply. In the former design, the power supply was permanently mounted under the recliner. In the new design, the short AC power cord made it unlikely that the power supply could find its way under the recliner.

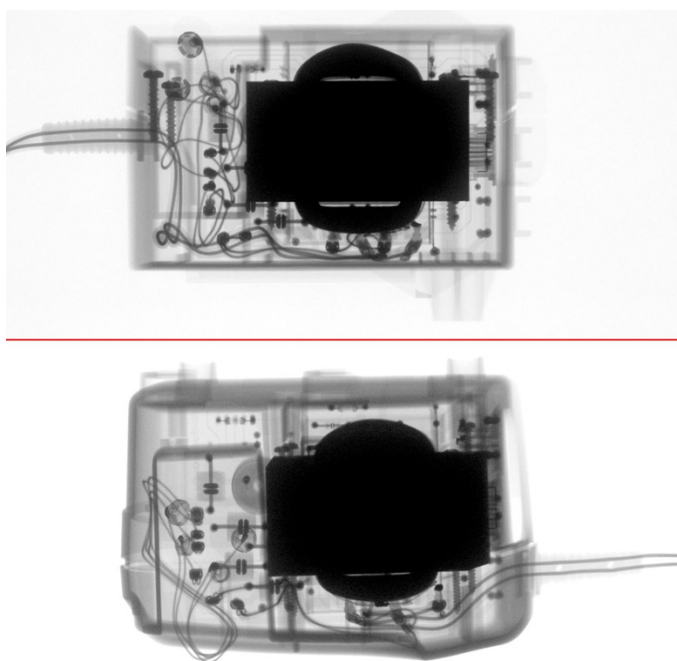
Figure 2

X-ray images of the old design (top) and new (bottom).

cord enters at a different location. All wiring is inspectable as the housing is assembled. **Figure 2** shows x-ray images of the power cord paths and the space between the transformer terminals and the side of the enclosure.

In the older design, the power cord took a tortuous path to the transformer and became compressed against the inside of the enclosure. In the revised design (lower image), the power cord took a direct path to the transformer and has adequate clearance to the inside of the enclosure.

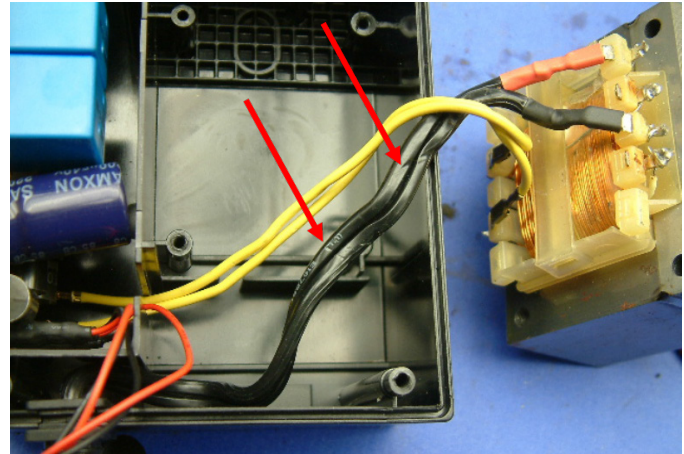
Figure 3 shows the wiring connections under the transformer. While attempting to carefully re-assemble the power supply, the transformer did not fully “nest” into position before the screws were tightened against the transformer. It felt like the wiring was in the way. To prevent damaging the wiring under the transformer by tightening the screws, the transformer was carefully removed again for a closer look at the wiring. **Figure 4** shows significant damage to the power cord insulation from being compressed against the transformer frame and terminals.

Wiring connections in the older design show evidence of external force (red arrows).

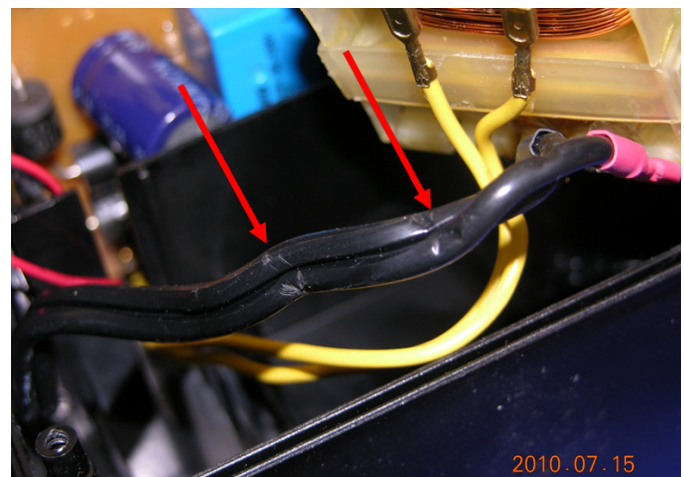
Figure 4

Damaged power cord within enclosure shows evidence of pinching against the transformer terminals (red arrows).

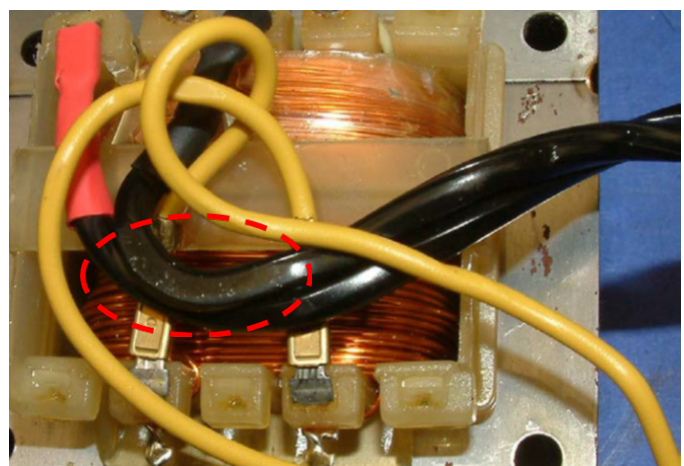
Figure 5

Measurement of the enclosure’s internal spaces revealed that there was insufficient space to accommodate the wiring connections without compressing and damaging the power cord insulation as the transformer screws are tightened during assembly. **Figure 5** shows the back of the power cord where it was flattened by compression against

The portion of the power cord inside the ellipse has been flattened from continuous pressure against the inside of the enclosure in a warm environment.

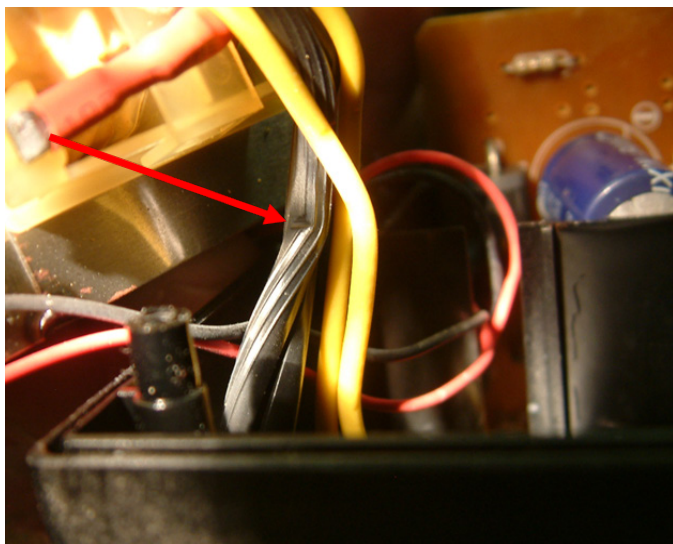
Based on the finding of a pinched AC power cord in a single exemplar power supply, another older exemplar was obtained. Another pinched power cord was found as shown in **Figure 6**. This result was expected because the older design electrical enclosure cannot be assembled without applying an external force the power cord, deforming the insulation.

Figure 6
Another exemplar shows evidence of a pinched power cord (red arrow).

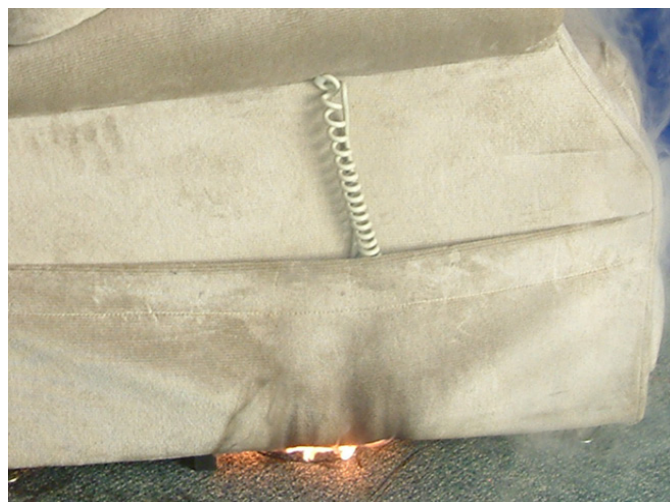
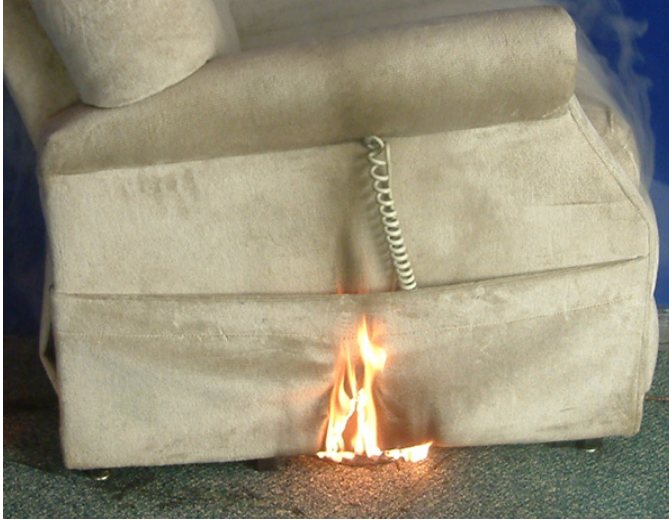
As shown in **Figures 7 and 8**, an exemplar power cord was positioned under the product and energized with 60 amps. The cord glowed orange and ignited the fabric within about 20 seconds.

Figure 7
Ignition of fabric by glowing power cord.

Figure 8
Propagation of fire to fabric.

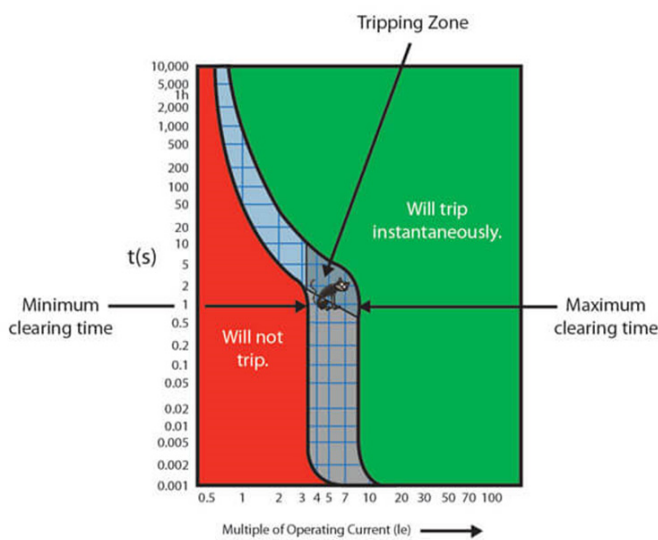
The circuit breaker on the branch circuit supplying the chair was a 20-amp breaker, and it was found to be tripped after the fire. It was not removed from the panel, and its specific model is unknown. However, the typical trip characteristics for a circuit breaker are shown in **Figure 9**. The typical trip curve indicates that a circuit breaker can sustain multiples of its rated current for 10 to 20 seconds or

Circuit breakers are designed to protect wiring in the building, and can tolerate many times their rated capacity for a short time. For example, as shown in **Figure 9**, a typical 20-amp circuit breaker can handle 100 amps for up to 5 seconds, or 40 amps for up to 30 seconds, before tripping. The specific performance curve for the 20-amp circuit breaker model supplying the branch circuit connected to the power supply was not available in the record. However, the fact that a circuit breaker was in the line cannot prevent a short-lived overcurrent in the power cord before

Figure 9
Representative circuit breaker trip curve indicating the time it will take to trip at multiples of its rated operating current². Image reprinted with permission from c3controls, Beaver, Pa.
