Vol. 36 No. 1 June 2019

# Forensic Engineering Investigation of a Furnace Oil Supply Line Fitting Leak

By Daniel P. Couture, PEng (NAFE 951M)

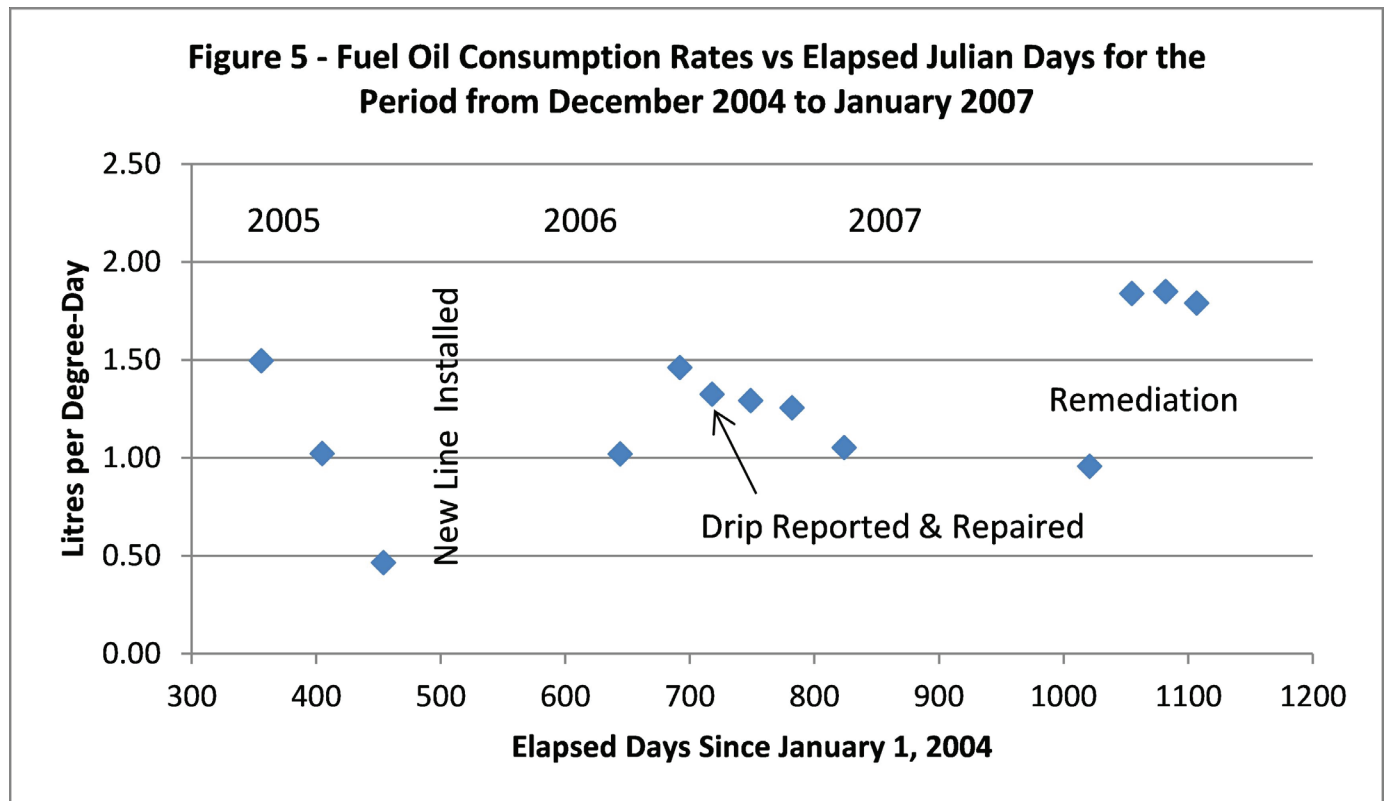
Figure 5

Historical heating season consumption rates were plotted against Julian Days elapsed since January 1, 2004 in **Figure 5**. They ranged from 1.0 to 1.5 liters per degree day in 2004, from 1.0 to 1.5 liters per degree day in 2005, and were steady at 1.8 liters per degree day in 2006. The off-season rate was no more than 0.8 liters per degree day in 2005 and 1 liter per degree day in 2006.

The consumption rates were effectively stable from the date of the installation of the new tank in May 2005 (Julian Day 513) until the beginning of the heating season. There was no increase after the reported discovery date by the homeowner in December 2005 (Julian Day 718) until the next fill date of January 19, 2006 (Julian Day 749), an interval that would have included the site visit by BURSCO personnel. The site excavation and remediation reportedly took place in the fall of 2006. There was a significant jump to 1.8 liters per degree day consumption rate in the 2007

Fuel oil consumption rates vs elapsed Julian Days since January 1, 2004 for the period from December 2004 to January 2007.

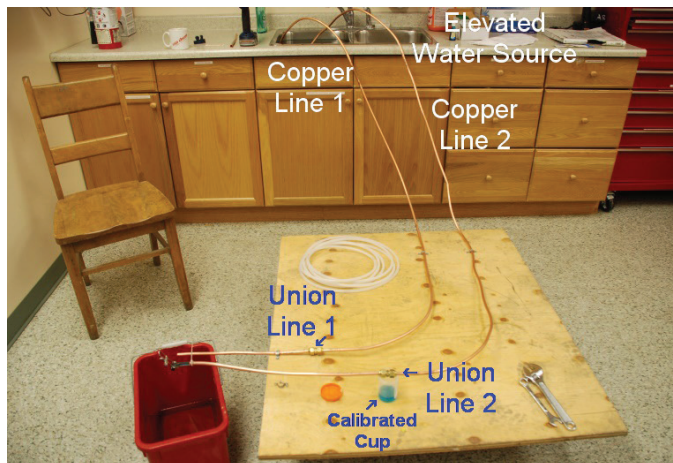
**Figure 6**

An overview of the experimental set-up, with collection bottle in the foreground. The effective head was 18 to 23 inches from the bottom of the sink full of water to the height of the plywood.

On April 15, 2011, a testing apparatus comprising a  $\frac{3}{8}$  inch copper line, mounted on a plywood sheet was devised (see **Figure 6**). The line was attached to the sheet with an anchor clip, then bent around a 14-inch (35 cm) radius, followed by a straight section into a  $\frac{3}{8}$  inch SAE 37 degree union fitting, and into another straight held in place by an anchor clip.

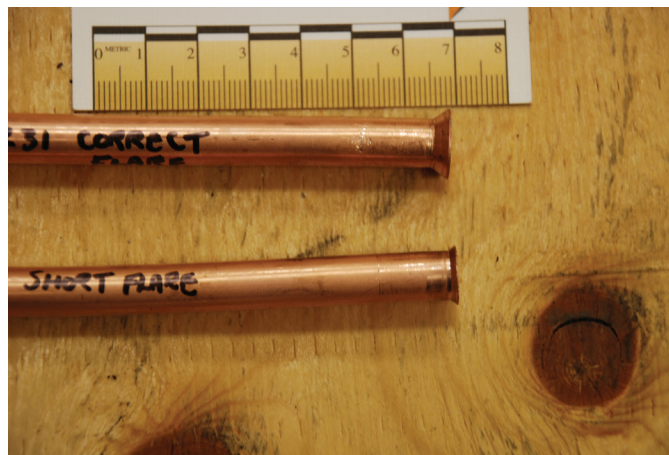
**Figure 8**

Correct and short flares in  $\frac{3}{8}$ -inch copper tubing.

The professional swaging fixture was designed to prevent oversized flares, which cannot be removed from the tool, and to minimize short flares swaged when the tube is not correctly inserted into the jig. There was no evidence in the file documents of incorrect flaring of the involved tubes. To the contrary, it was established that the same flares were successfully reused to redeploy the supply line

to the furnace. Had there been an incorrect flare present, the joint seal would have been immediately unstable, according to the laboratory results.

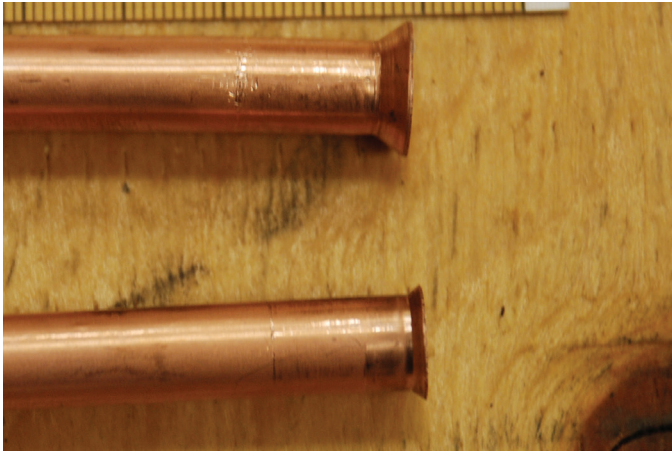
**Figure 9**  
Correct and short flares – magnified view.

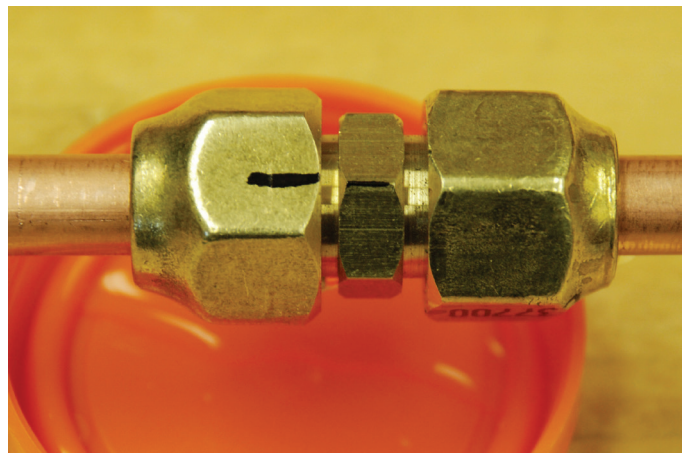
**Figure 12**  
Minimal relative movement of 1 mm after the finger-tight assembly was repeatedly kicked.

The experiment included an attempt to disrupt a tool-tightened union fitting by repeatedly kicking by a workboot worn by a 250-lb technician with the strike force directed at pushing the nut, over a period of 3 minutes. We also considered whether the burner pump vibration, from a distance of 8 feet away, could have had an effect, but it was presumed to be insignificant. These actions were unable to dislodge the fitting or tubing to create a leak. The same actions were performed on a finger-tight union fitting, but these actions could only move the nut 1 millimeter, as seen in **Figure 12**. No droplets were formed from the fitting after this interaction.

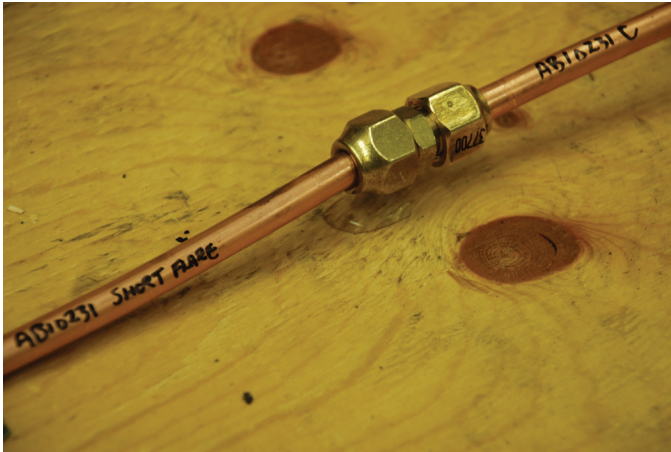
An improper “short” flare was created with the flaring tool and connected to the union with the nut. The seal that was produced was unstable such that small movements of the tubing on the short flare side immediately produced drops on the underside as shown in **Figure 13** on page 7. There were 10 drops produced in 40 seconds, with a total volume of 2.5 milliliters, as measured with a calibrated syringe. On the correctly flared union, conditions were set to mimic the one drip per second described by Mr. L and Mr. W, by arranging the relative position of the hex head and the nut at 6 to 7 mm from the tool-tight position, shown in **Figure 14** on page 7.

Short flare tubing joint was unstable and leaked immediately.

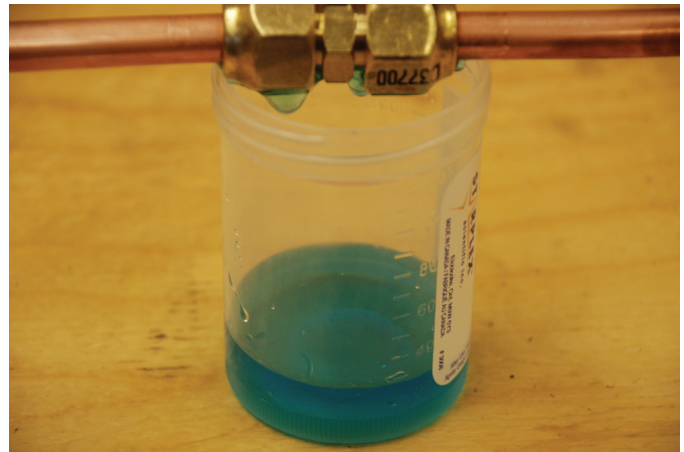
**Figure 15**

Active dripping from the 7 mm nut offset configuration.

observed in 60 seconds. A volume of 55 ml in a calibrated sample cup was produced in 10 minutes as seen in **Figure 15**.

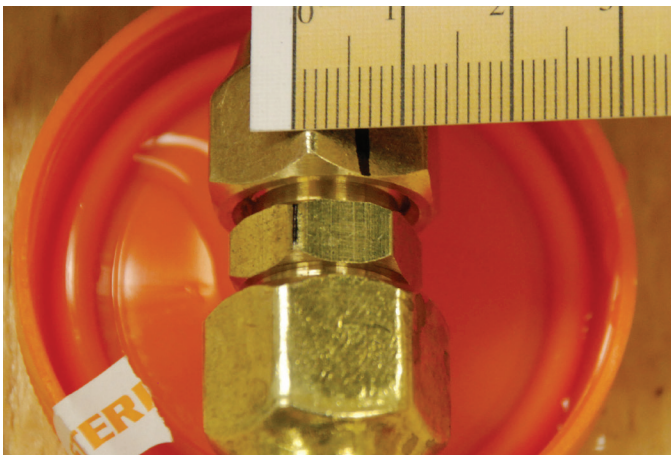
**Figure 14**

Relative rotations of the nut in the 7 mm test configuration.

Tool-tightened nuts have limited potential to loosen over time, if at all, without external intervention. A relative rotation of 6 to 9 mm (0.2 to 0.35 inches) was required to create dripping.

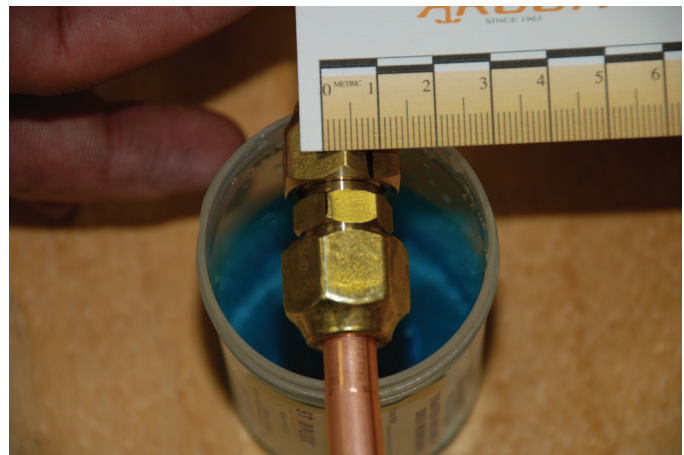
**Figure 16**

Nut offset for the 9 mm configuration during the test run.

The nut was rotated to the 9 mm relative position for the second run, yielding 73 drips per minute, with a slightly lower head of 15 to 20 inches of water. On this run, 66 ml were captured in 5 minutes, and the volume increased to a total of 100 ml in 9 minutes (**Figure 16** and **Figure 17**). As expected, the rate was most sensitive to the position of the tubing flare. The testing results are summarized in **Figure 18** and **Figure 19** on page 8.

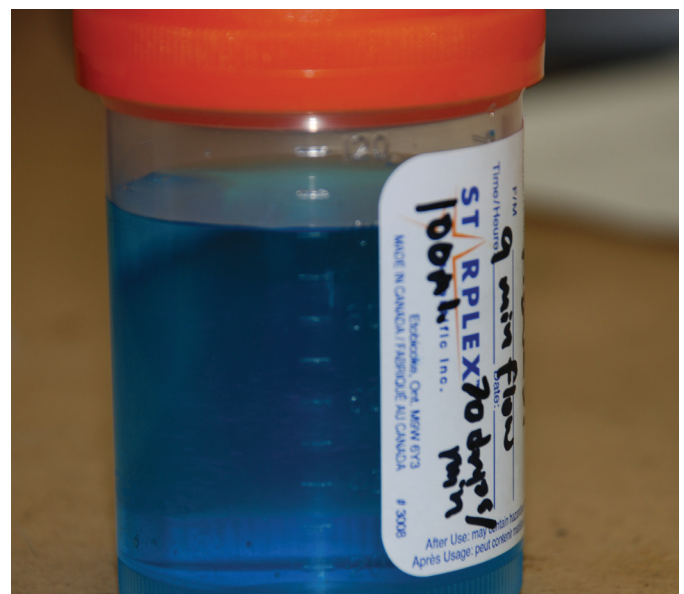
**Figure 17**

Calibrated cup after 9 minutes with 100 ml of water.

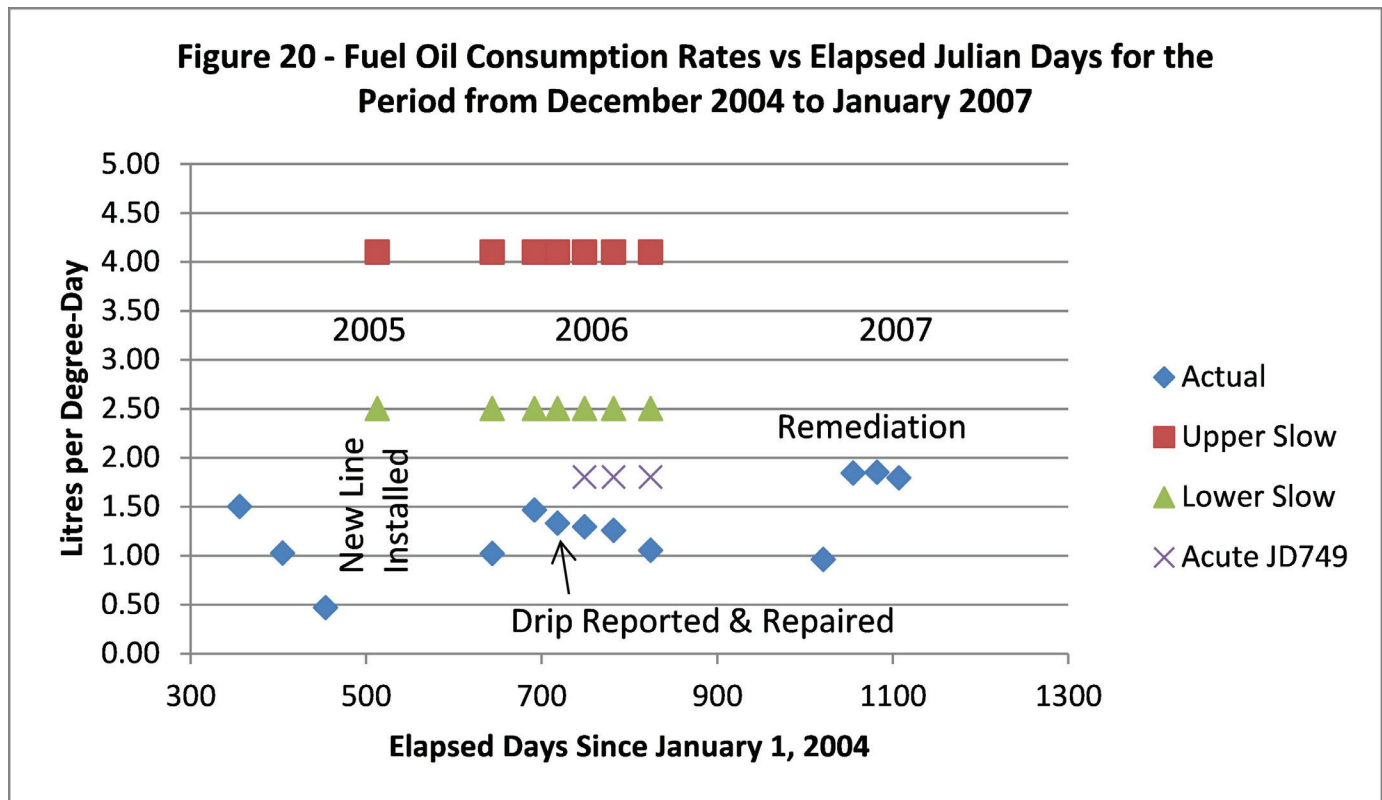
Figure 20

This volume would range from 8 to 16 liters (about 2 to 4 gallons) per 24 hour period, rates which could drain a full 240 gallon (910-Liter) tank in anywhere from 50 to 100 days. A leak of this quantity would not only be visible once underway but also certainly have a potent unpleasant odor.

Over the time period from installation of the new tank in late May 2005 to the apparent discovery in December 2005 (or the documented discovery by BURSCO in January 2006), a period of seven months, the projected quantity of the spill would be from 260 to 520 gallons (1,000 to 2,000 liters), without any consumption by the furnace. Had such a drip sequence started in May, the fuel tank would have been completely empty well before the start of the heating season in October. Therefore, the possibility of a disrupted union having been installed in the furnace supply line was so remote as to be dismissed. We considered whether running the burner pump would reduce the leakage while it was operating, but concluded that both the burner and the leak would account for a proportion of the lost oil. The consumption would lessen the escaped fuel amount, so the burner pump does have an effect.

Theoretical rate upper and lower ranges for one drip per second starting at JD 513 and acute drip starting on JD 749.
