Forensic Engineering Evaluation of Utility Compressor Truck Explosion/Fire

By Christopher B. Shiver, P.E. (NAFE 661S)

Abstract

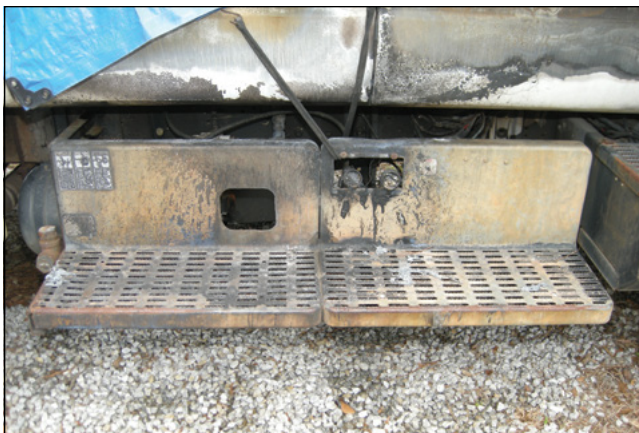
Figure 3

oil sump/receiver tank, and oil coalescer/separator were all installed from back to front, respectively, on the vehicle passenger side frame outboard side behind the cab access steps. Installed in a hole cut into the kick plate portion of those steps, just forward of the oil coalescer/separator, was the instrument cluster, which included the pressure/temperature gauges, limit controls, and manual reset switch (**Figure 3**). A separate hole with no apparent purpose was also present in the kick plate aft of the

Damage to passenger side steps and control gauges.
Note unused extra hole in steps.

Also noted during the evaluation was that the truck passenger side cab access step assembly had been cut out in at least one location to accommodate the location of the compressor control components. The locating of the controls in this position was not in accordance with potential locations recommended by the system manufacturer's installation manual. Further, at least one additional cutout had been made for reasons the equipment installer could not explain. The presence of this extra cutout and the controls in close proximity to the oil coalescer/separator contributed to the operator suffering serious injury when that component ruptured.

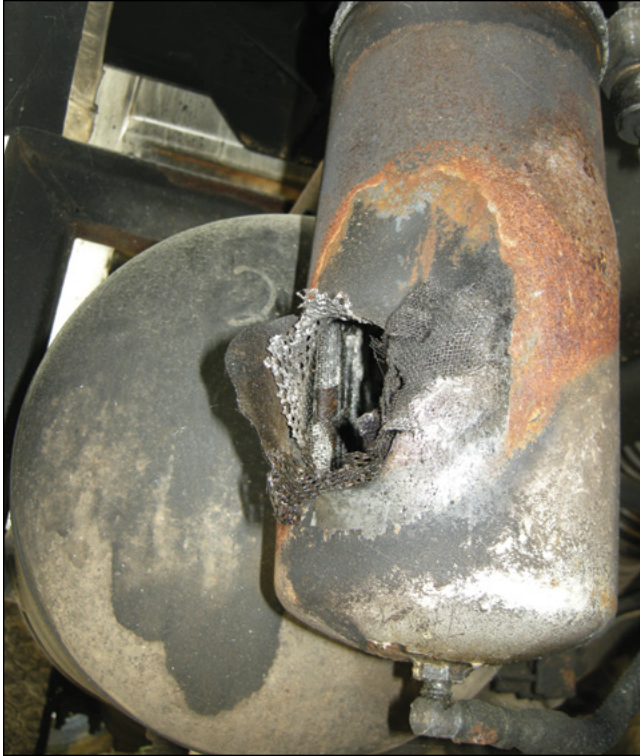
Figure 4

The burn damage to the truck and compressor system indicated that a limited explosion and fire had initiated between the truck passenger side frame rail and cab step in the vicinity of the oil coalescer/separator, which uses gravitational and inertial effects to separate the compressed air and oil. The cylindrical coalescer/separator's thin-walled metal casing evidenced a rupture due to internal overpressure on the side toward the vehicle front (**Figure 4**). Burning oil discharge toward the vehicle front and passenger side step was evident, which caused destructive fire/heat damage to the instrument cluster and passed outward through the cluster hole cut in the step's kick plate as well as the other nearby similar hole. Beyond the instrument cluster and coalescer/separator — and their hose and wiring connections — the compressor system was generally intact with limited or negligible fire effects.

Damage to oil coalescer/separator, including rupture.

Evaluation of the entire subject compressor system clearly indicated that a breach had occurred due to an over-temperature condition in the oil coalescer/separator. The damage observed to the compressor and truck further indicated that this breach had resulted in discharge of hot compressed air mixed with compressor oil into the area where the compressor controls had been located. The report that a system operator was manipulating those controls at that time is consistent with the reported severe burn injuries he reportedly sustained. The detailed examination performed on the ruptured oil coalescer/separator casing indicated that its rupture was due to normal internal pressurization in an overheated condition, and was not related to any material or fabrication defect in that component.

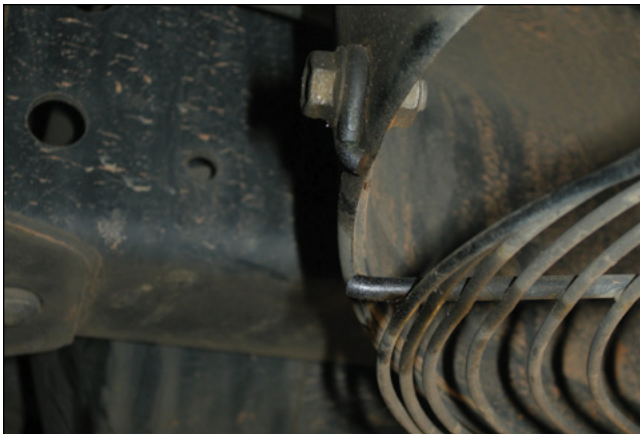
Figure 5

Inspection and testing of compressor system components also revealed that the mounting loops for the steel wire grill (located under the oil cooler fan) had fractured in three of four locations, causing the grill to sag downward (**Figure 5**). The center of the fan grill directly supported the fan motor such that this sagging was causing the fan blade tips to make contact with the fan shroud under the oil cooler. The blade tips and shroud evidenced abrasion damage from this contact. Detailed metallurgical examination of the failed mounting loops indicated fatigue fracture over time with possible initiating damage from road debris impacts.

Fan grill support fracture (one of three).

Functional testing of the oil cooler fan assembly was performed, including the shroud and grill with three out of four supports fractured. The testing demonstrated that the fan rotation was significantly impeded by the contact between the blade tips and shroud, with intermittent stoppage occurring. This contact and rotation interference was found to be affected by the changing vibration as the fan speed varied due to this

Inspection and testing of the subject compressor system oil cooler assembly indicated that several functional conditions likely impeded the cooler's performance. The cooler fan grill support fractures were resulting in probable intermittent slowing or stopping of the fan rotation. Analysis of these fractures indicated that thrown debris from the truck rear axle tires was a probable contributor — in combination with expected vehicle road vibration. Also noted in the installation manual for this system (provided by the manufacturer) was that the subject under-truck rear installation location for the cooler was one of several options for positioning it — with the other optional locations in areas less vulnerable to road hazards. In addition, during the cooler installation, incorrect wiring connections resulted in reverse rotation, which caused reduced air flow even when the fan was rotating unimpeded. Therefore, it was determined that installation deficiencies had resulted in compromise of the oil cooling system on the subject vehicle, which was the probable cause for the compressor system overheating, leading to the incident. In addition, the system design, which permitted installation in an area under the truck where damage due to road debris was an expected condition, was deficient and also contributed to the oil cooler conditions.

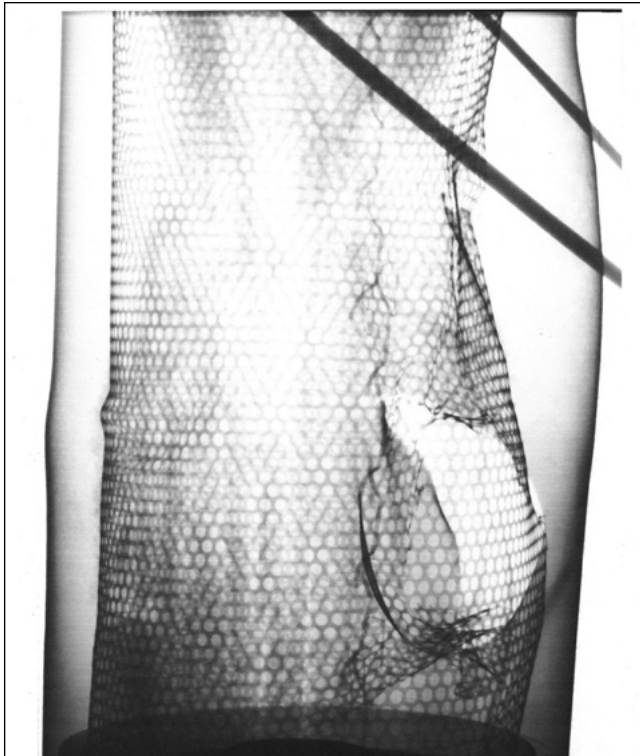
Figure 6

Metallurgical analysis of the ruptured oil coalescer/separator cylindrical shell was performed, including computerized tomography x-ray scanning and scanning electron microscope viewing of the failure region with energy dispersive analysis for materials characterization (**Figure 6**). The findings of this analysis revealed that the material had been overheated from within, resulting in rupture by normal operating pressure forces. In addition to the rupture location, the shell had also bulged outward in several other locations due to overheating while at or below system design pressure. It was determined that the system was below the design pressure based on no evidence of relief valve or high pressure shutdown control actuation prior to the coalescer rupture.

Oil coalescer/separator x-ray image in rupture zone.

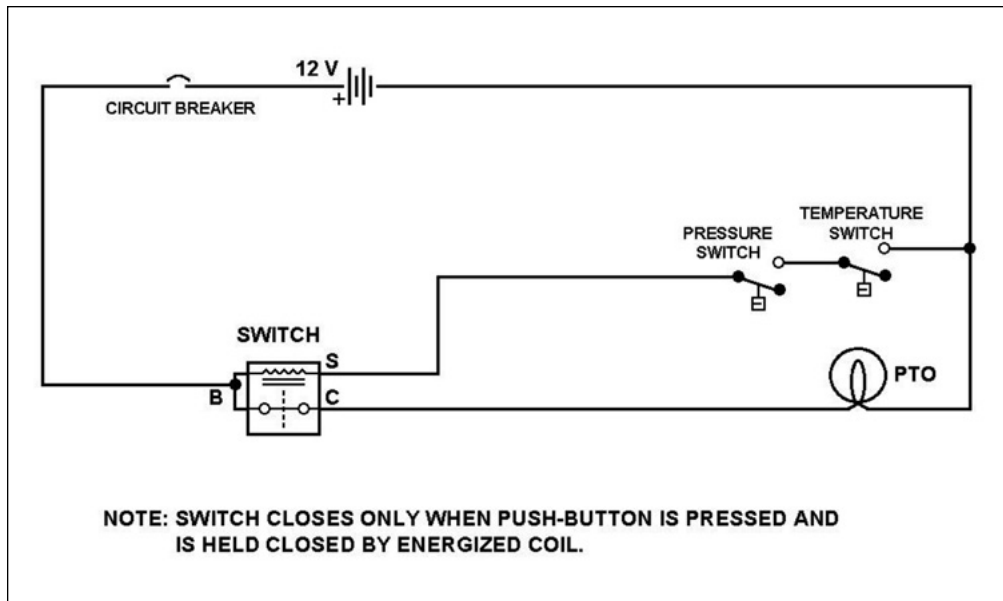
that the opening of either set of switch contacts on high pressure or temperature would have shut down the compressor. The compressor could be restarted after a shutdown by momentarily pressing the button on the reset switch/relay. However, if an excessive pressure or temperature condition had still been present, shutdown would recur upon release of the button. Testing of this control system using the same model of exemplar components in place of the damaged components indicated that holding down the reset button would allow continued compressor operation — even if one or both of the gauge switch contacts had opened in response to an excessive pressure or temperature condition. It was observed that the reset switch/relay installation on the subject truck included a still-legible compressor system manufacturer's label at the button stating: "Push Button to Restart Engine or Compressor" with no other instructions or warnings.

Figure 7
Original safety shutdown circuit.

The subject compressor system design and installation included automatic shutdown controls in the event of either an air/oil over-temperature or over-pressure condition. However, the control system also included a manual reset push button, which would allow the operator to not only restart the system if an over-temperature or over-pressure condition existed, but would also override those automatic shutdown

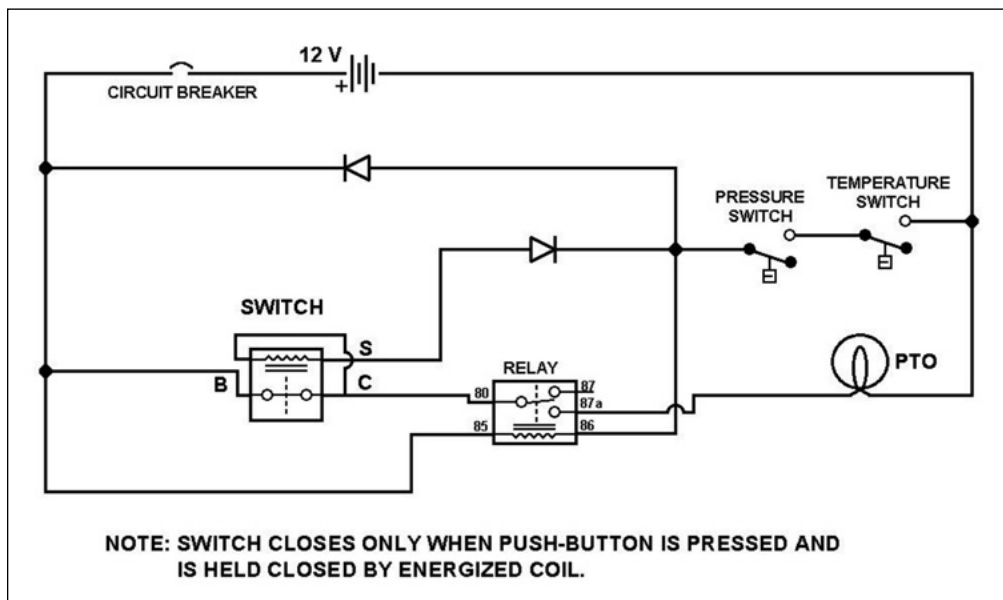
Figure 8
Modified safety shutdown circuit.

One of the parties in this evaluation proposed a modification to the electrical control safety shutdown circuit for the compressor system, which was intended to prevent the system from restarting or running with the reset button held down by an operator, if the system pressure and/or temperature was above the high shutdown limit values (**Figure 7**). Based on input from the other parties involved, the proposed control circuit was assembled using new exemplar components (same model components as specified by the compressor system manufacturer) for comparative testing to the original control circuit. The modified circuit included

addition of a single-pole/double-throw relay and two diodes as well some wiring connection modifications (**Figure 8**). The testing demonstrated that it was possible to have designed and installed an electrical control safety shutdown circuit on the compressor system that would have prevented the system from restarting or running with the reset button held down by an operator, if the system pressure and/or temperature was above the high shutdown limit values. The expense and effort required for this modification was determined to be negligible in comparison to the total system cost.
