Vol. 39 No. 1 June 2022

FE Use of Arc Mapping/Arc Fault Circuit Analysis in a Residential Kitchen Fire Investigation

By Jason McPherson, PE (NAFE 852M)

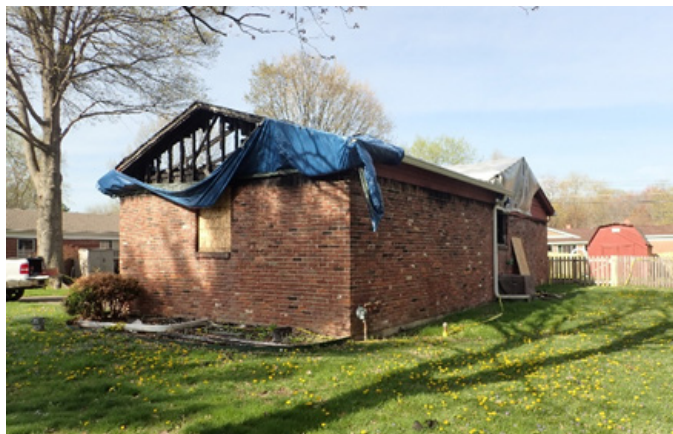
Figure 1

Exterior photograph of the residential structure.

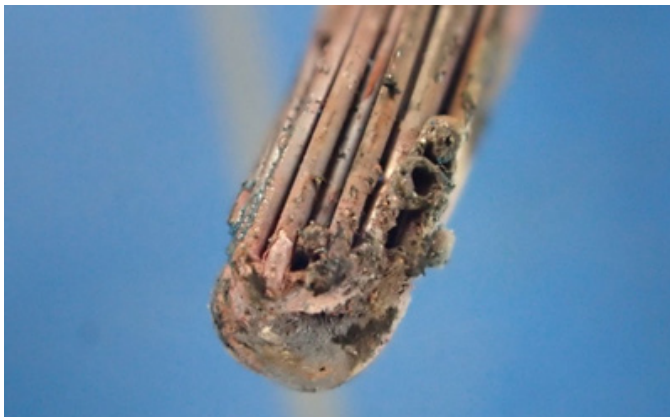
Figure 2
Arc site found at the fire scene.

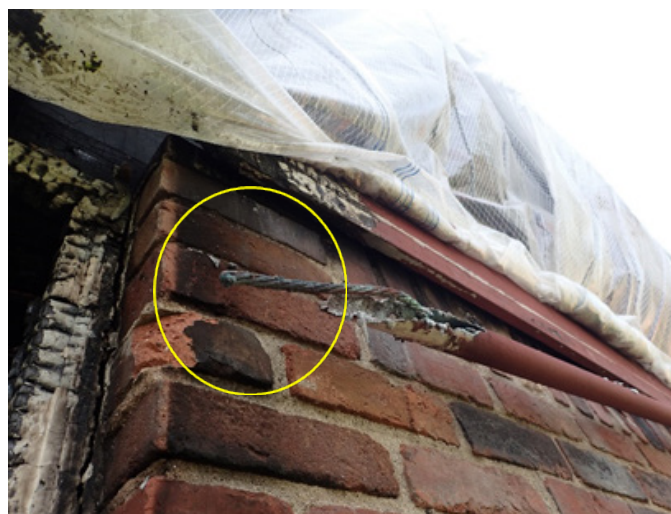
During the electrical survey, it was noted that an arc site was present on the service entrance conductors in the area of the west side of the kitchen window (**Figure 4**). This was the sole site in this area, meaning it was the only site on this section of the circuit. This provided the following information:

- The utility service consisted of enough available fault current to result in an arcing event that would leave physical damage to circuit conductors.
- At the time the wife utilized the garage vehicle door keypad to open the door, the fire had not yet breached the kitchen window and caused the service to fault.
- The west side of the kitchen window was the location where the fire first breached the kitchen window and service entrance.

Figure 4
Arc site found on service conductors.

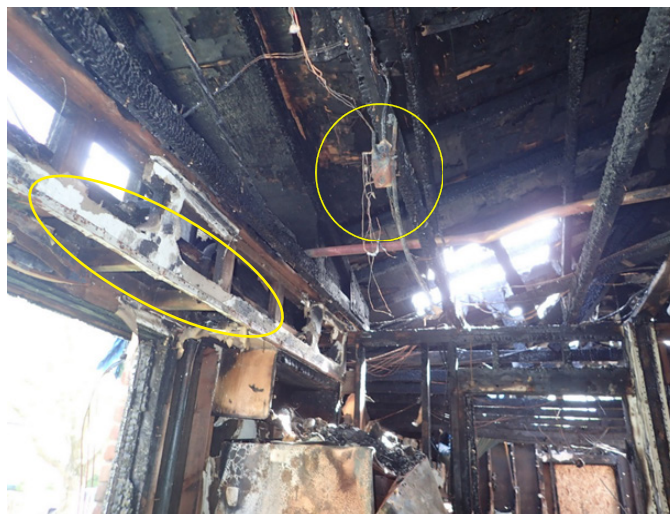
Figure 5

The electrical survey in the form of circuit tracing efforts revealed that the branch-circuit cable supplying the junction box that the ceiling light fixture was attached to consisted of a three-conductor with ground cable. From the ceiling light junction box (**Figure 5**), one section of two-conductor with ground non-metallic sheathed cable was routed to the surface-mounted fluorescent light fixture positioned over the kitchen sink. Further examination revealed that the branch circuit was constantly energized — and that the same section of branch circuit also supplied the range hood that was mounted above the stove.

Another section of two-conductor with ground non-metallic sheathed cable was routed from the ceiling light junction box to the west wall — where it was eventually terminated to the duplex receptacle that supplied the gas stove. Based on this information, it was logically inferred that the developing fire attacking one of these would result in an arc site that could be used to further define the area of origin and help to determine the path of fire travel.

Ceiling light junction box in relation to over-sink light fixture.

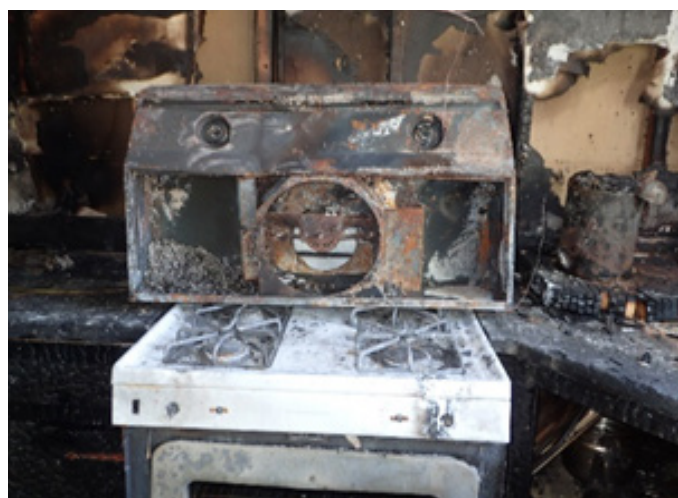
Range hood.

After the area of origin was narrowed down to the west side of the kitchen using the electrical system, fire investigators were able to utilize fire effects. Examination of the range hood revealed fire effects in the form of oxidation patterns on the surface that would have faced downward toward the cooktop. The range hood was more oxidized on the right side than the left side.

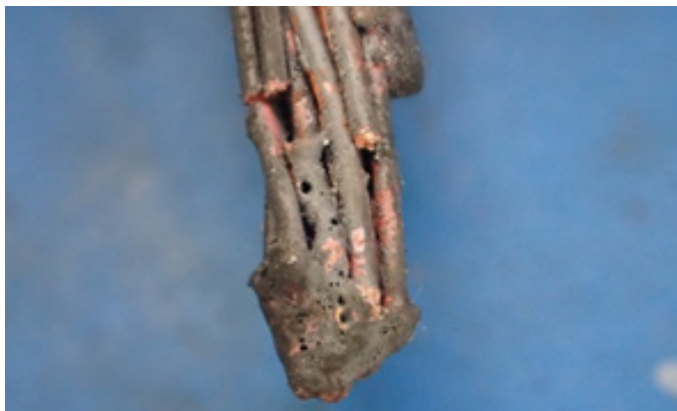
The location of the arc site on the service entrance conductors and lack of arc site(s) related to the over-sink fluorescent light fixture, ceiling-mounted light fixture, and associated wiring for both led to the determination that this, in fact, would be a strong indicator that the fire originated toward the west side of the kitchen. Attention then turned to the range hood (**Figure 6**). Since the range hood consisted of a metal enclosure, heat from the fire would easily be conducted through the metallic walls to the wiring. Examination of the wiring within the range hood revealed an arc site (**Figure 7**). Based on the understanding of the electrical system from performing an electrical survey, the arc site in the range hood, the arc site on the service entrance conductors, and lack of an arc site within

Figure 7
Arc site found on range hood wiring.

the fluorescent fixture wiring indicated that the fire had originated at the west side of the kitchen.

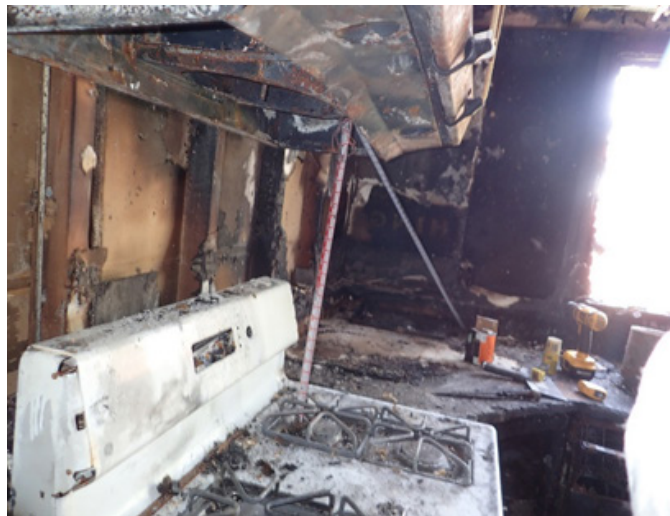
Remains of melted aluminum mesh were found on top of the right front burner grate (**Figure 8**). It was first thought that the remains consisted of the remains of aluminum filters from the range hood. By reconstructing the range hood position — and then using documentation techniques to determine if the filter material would drop onto the front burners or not — investigators determined this would not be the case (**Figure 9**).

Figure 8
Reconstructing the range hood.

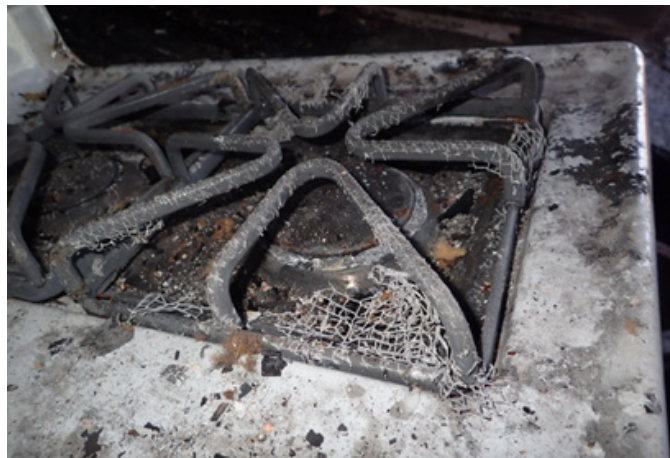
Figure 9
Mesh found on right-front burner.

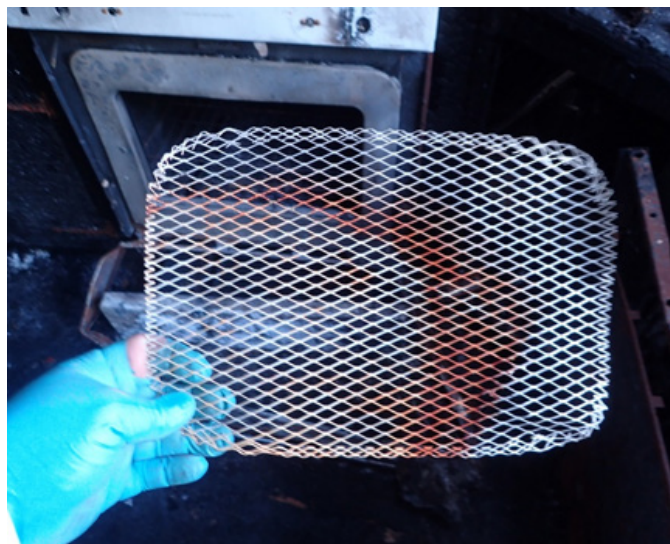
The wife was interviewed again regarding the use of aluminum mesh screens for cooking. She indicated that the husband liked to cook jalapeno peppers stuffed with cream cheese and wrapped with bacon on the grill, using a small aluminum mesh screen. She did not recall seeing the husband ever use the stove for that purpose. The kitchen area was searched, and additional aluminum mesh screens of the type that the husband would use were found (**Figure 10**). When compared with the remains found on the right

Figure 10
Exemplar mesh screen.

front burner grate, they matched.

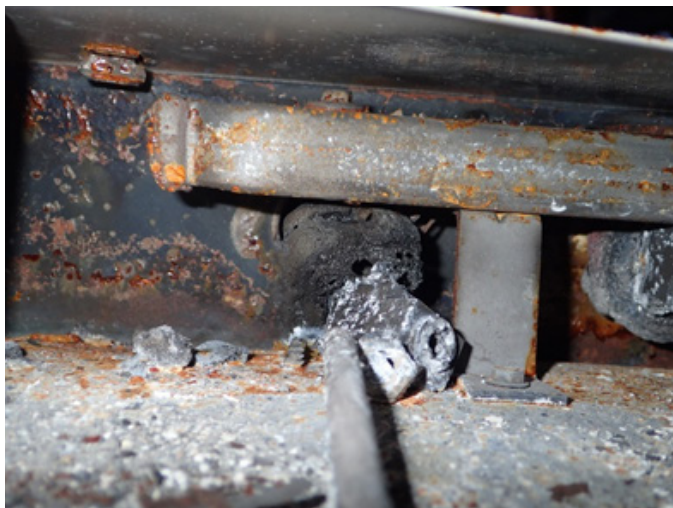
Figure 11

The cooktop was raised so the gas valve positions could be compared. It was determined that the right-front gas valve was slightly dislodged from its installed position (**Figure 11**). Further comparing it with the remaining three gas valves revealed that when the gas valve was rotated back to its installed position, the gas valve stem would still have been in a position other than OFF. It was estimated that the burner was at a medium-high setting (**Figure 12**).

As-found position of the right-front burner control valve.

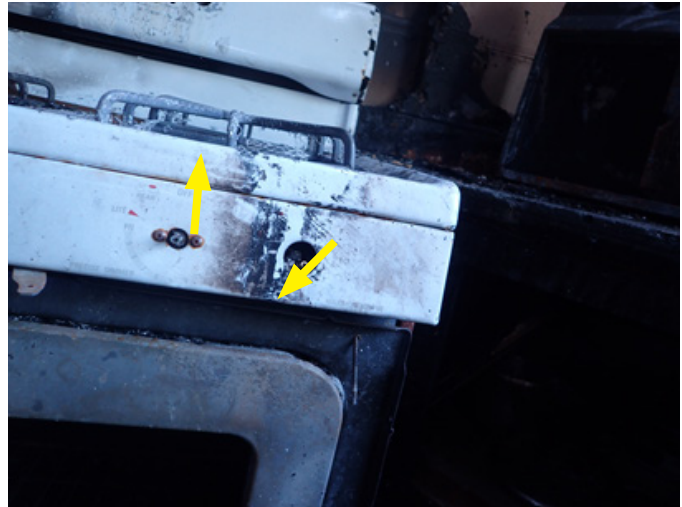
Figure 12

Based on the available data, it was determined that at some point the husband started cooking and fell asleep with the stove on with foodstuffs on the right front burner grate.

Estimated setting of the right-front burner control stem.
