Vol. 36 No. 1 June 2019

Forensic Engineering Investigation into Factors Contributing to Explosion of Consumer-Grade Tabletop Torch

By Jahan Rasty, PhD, PE (NAFE 768S)

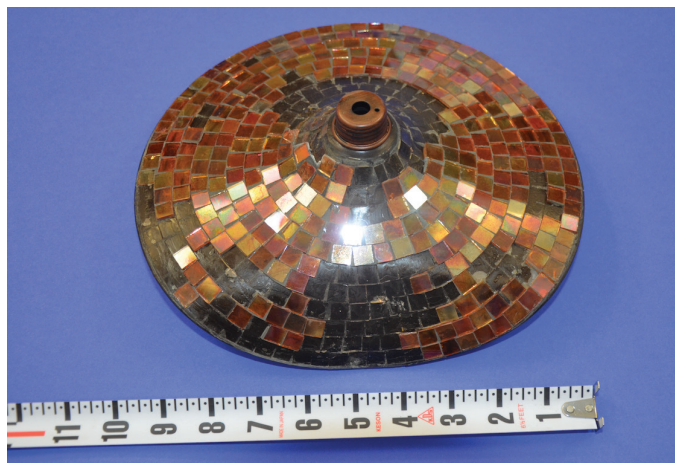
Figure 1

Upper section of the subject torch exhibiting bulging as a result of the explosion.

3. All exploded torches were subjected to an internal pressurization generated by a combustion event. Note: Some explosions, including the subject event, resulted in a sudden and violent complete separation of the upper and lower sections of the torch, with the upper section showing clear signs of outward bulging due to a sudden internal pressure event, as shown in **Figure 1**. Other less severe explosions resulted in sudden, forceful ejection of the wick and/or the screw-top cap, thereby depressurizing the torch and avoiding catastrophic explosion of the torch vessel.

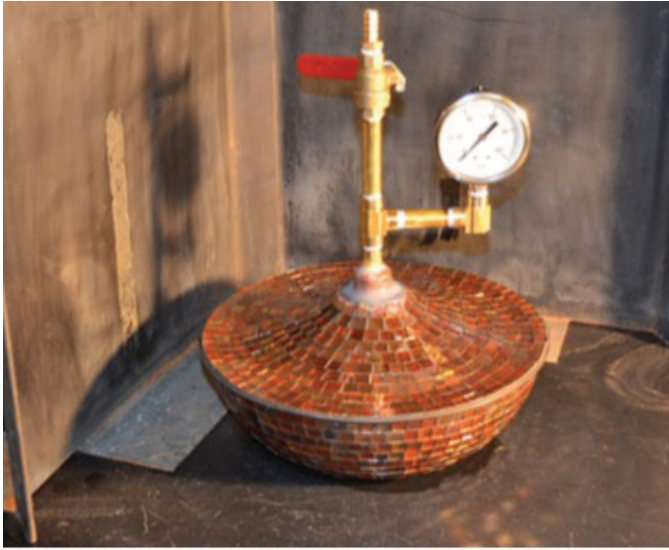
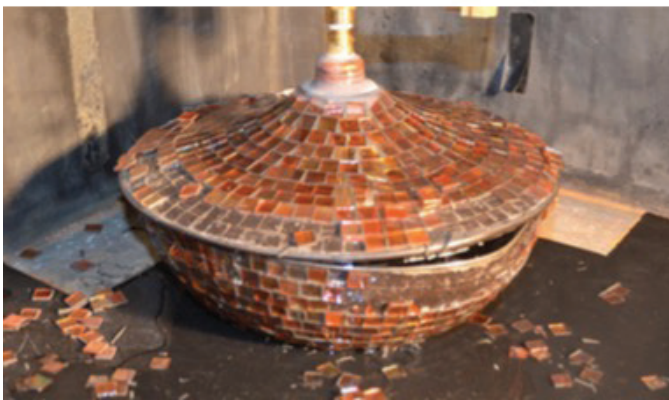
Figure 2

This test, which employs a slow pressure increase, was not intended to replicate the actual explosion — but rather the separation strength of an exemplar torch vessel. At about 30 psi of internal pressure, the mechanical seal connecting the top and bottom halves failed, causing separation of the two parts. This resulted in water leakage and depressurization of the torch (**Figure 2**).

Hydro pressure testing to failure of exemplar tabletop torch. The vessel failed catastrophically at ~30 psi of internal pressure.

that would result in failure of the mechanical joint designed to keep the top and bottom halves of the torch together. Given the 10-in. diameter of the torch, the effective surface area on which the pressure acts was approximately 78 square inches. This means that for every 1-psi pressure build-up inside the torch, the top and bottom halves of the torch were subjected to a 78-pound force that was pulling them apart from each other. At 30 psi internal pressure, the force pulling the top and bottom sections of the torch apart was approximately equal to 2,340 pounds — or more than a ton. This separation explains why the users got soaked with liquid fuel during torch explosions. The force of the explosion pushed the upper and lower halves of the torch (containing liquid fuel) away from each other, and, upon separation, the liquid fuel in the torch was expelled outward, covering the surrounding area.

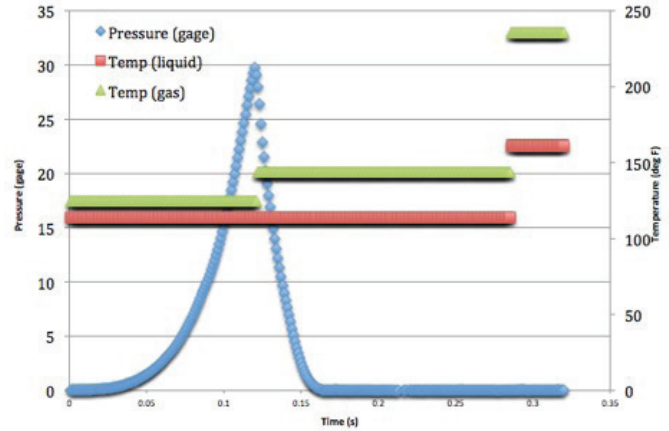
Figure 7

Pressure pulse (blue diamond data points) created within the torch as a result of an explosive event. Vapor fuel temperature (green triangle data points) and liquid fuel temperature (red square data points) are also shown in the graph for before and after the explosive event.

In two separate instances, the above test procedure resulted in the sudden generation of a pressure-pulse that blew the wick off of the torch, indicating an internal explosion. In the first attempt to recreate the explosion, after 20 minutes of uninterrupted burn time (and with the introduction of air from the air supply line), an internal explosion occurred that blew the wick out of the torch cap. In the second attempt at recreating the explosion, after roughly 2 hours of burn time (but within 20 minutes of continuous burn time) while toggling the air hose between low and off positions, yet another internal explosion within the torch occurred that blew the wick out of the cap. During the above tests and throughout the explosion events, the internal pressure and temperatures of liquid and vapor fuel phases were recorded, and one of the events is displayed graphically in **Figure 7**.

This illustration depicts the internal pressure buildup as well as the internal temperature of both liquid and vapor fuel phases. Upon explosion, the pressure gauge indicated a pressure spike of 30 pounds per square inch above atmospheric pressure. This pressure spike corresponds to an internal force spike of approximately 2,340 pounds (30 psi acting on a surface area of ~ 78 square inches) that spreads the top and bottom halves of the torch apart from each other during an explosion event. The temperature readings from the two thermocouples within the vapor fuel (green

data) and liquid fuel (red data) show an expected time lag following the explosion that occurs due to the finite time constant of the 24 gauge thermocouples. As depicted in **Figure 6**, following the explosion, the gas/vapor temperature reached above 236°F, while the liquid fuel temperature reached ~161°F. The results of the testing show that the air/fuel ratio within the torch, which is normally fuel rich and above the upper explosive limit (UEL), can be bought into the explosive range and ignited by the introduction of air into and around the torch cap.

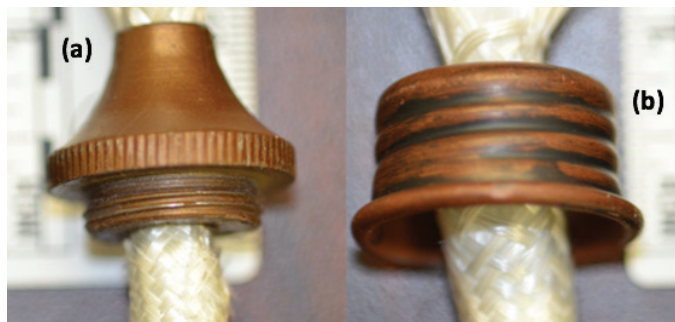
Figure 8

A screw-top cap (a) from a smaller torch model with an appropriate section for tightly holding the wick and disallowing the air and/or flame to be pushed into the interior vapor. As-designed subject torch cap (b), lacking proper sealing mechanism to keep the air and ignition source from entering the torch.

Figures 8 and **9** show a comparison of the design features of the screw-top cap on a small tabletop torch model, 8(a), and the cap on the subject torch, 8(b) and 9(b), both of which were designed by the same company (based on information obtained through discovery). Comparing these two wick holder designs reveals that the smaller model utilizes a tubular wick holder section that is absent in the subject model. With a tubular wick holder, the cap conforms tightly to the wick and remains in tight contact with it over a length of wick measuring about 0.75 inches. The wick in the subject model, however, simply passes through an open hole in the thin top of the cap.

- Keeping the temperature of the fuel used in the torch below its flashpoint for all operationally possible conditions;
- Redesigning the cap/wick holder assembly to make it a more effective flame arrestor by enclosing around the wick tighter and over a greater length;
- Including a flame snuffer with the torch;
- Marketing the product to be used with only compatible fuels;
- Using clearer verbiage on the product labels to ensure understanding of important safety information.

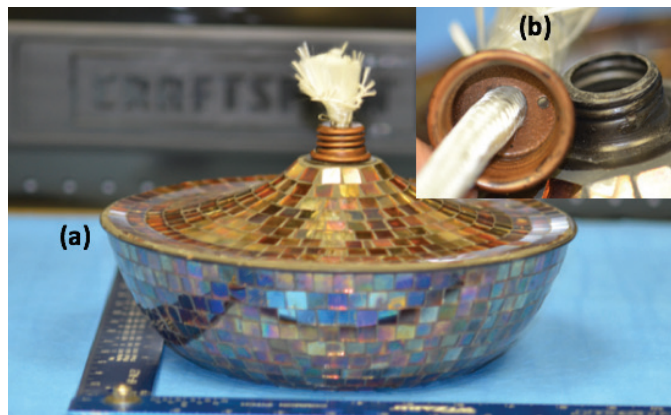
Figure 9

The purpose of the wick holder, aside from simply keeping the wick in place, is to restrict the ignition source from reaching the fuel-bearing chamber of the torch and igniting the oil within. A tubular section, such as the one found in the smaller model torch and shown in **Figure 8a**, accomplishes this by tightly securing the wick and providing protection against instances where the flame could travel down the wick into the fuel chamber. In the subject model, shown in **Figure 8b** and **Figure 9**, the wick is free to move and only restricted from falling down into the fuel

Subject tabletop torch (a) and close-up of the design of its screw-top cap (b). Note: Lack of a section to hold and contain the wick in order to separate the flame from the flammable vapors below the cap.

chamber by a small metal clasp. The open space between the cap orifice and the wick itself allows the flame access to the fuel vapor in the torch.
