Forensic Evaluations of Built-Up Roofing Storm Damage Claims and the Appraisal Process

By Todd Springer, P.E. (NAFE 422C)

Case Study #1 – Large Commercial Strip Mall

Case Study #2 – Five Building Hotel Complex

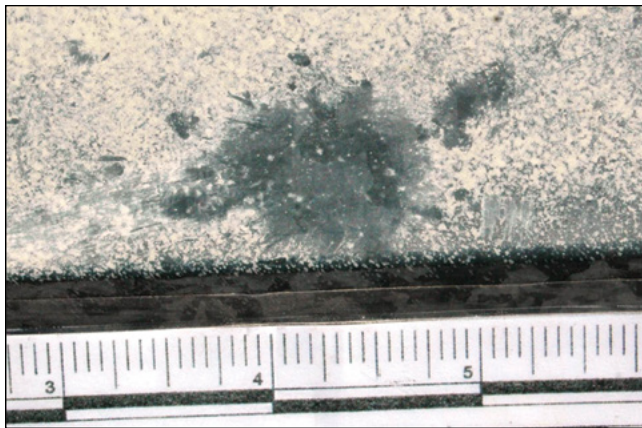
Figure 2

- The maximum size of hail experienced at the subject location was approximately 1 inch in diameter.
 - Photographs of the observed spatter were provided in support of this statement. **Figure 2** presents a photograph of one of the largest spatter marks observed at this location.
- The widespread granule loss on the roofing systems was not a result of the subject storm.
 - Historical aerial images provided by Google Earth were presented, demonstrating similar amounts of granule loss before and after the storm.
- Areas of missing granules were not consistent with hailstone impacts.
 - References to simulated hailstone impact testing were provided in support of this conclusion.
- No bruising was observed or tactilely experienced.
 - Bruising has historically been defined as the fracture of the fibers within the mat of the roof

Spatter mark from hailstone impact (ruler demarcated in inches).

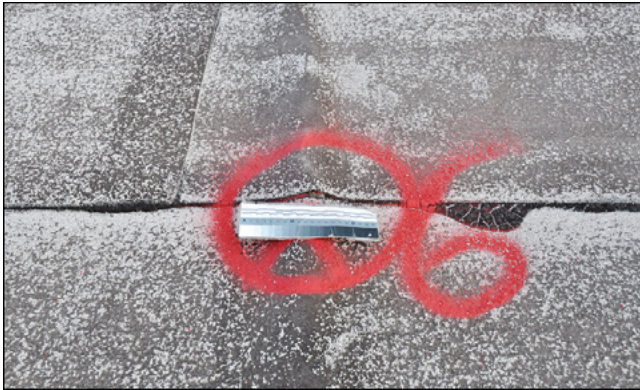
An example of wind damage, as identified by the public adjuster, is shown in **Figure 3**.

Figure 3
Area identified as wind damaged.

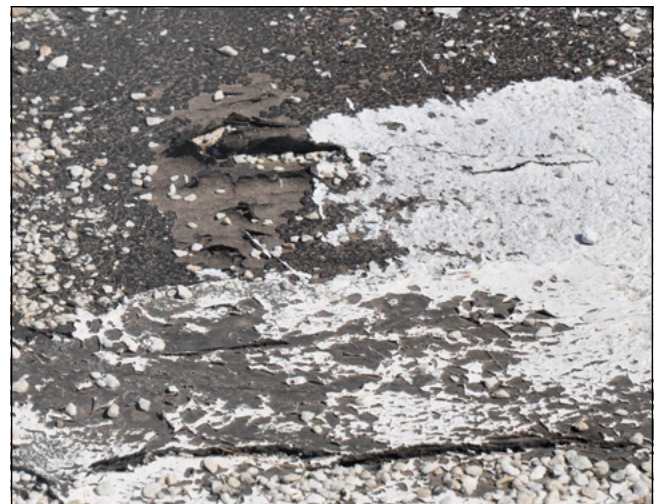
Figure 5

Areas similar to that shown in **Figure 5** were observed throughout the roofing systems over the two-story buildings. No areas of impact damage were observed on any of the roofs. Spatter marks observed throughout the property were consistent with only minor hail, approximately 0.25 inches in diameter. Additionally, conversations with onsite maintenance personnel during the inspection revealed that the roof had been leaking for years. This was consistent with observations of the interior spaces.

Split/failing section of roofing.
