Vol. 40 No. 1 June 2023

Methodology and Tools for Forensic Engineering Analysis of Electrical Shocks

By Chris Korinek, PE, DFE (NAFE 716S)

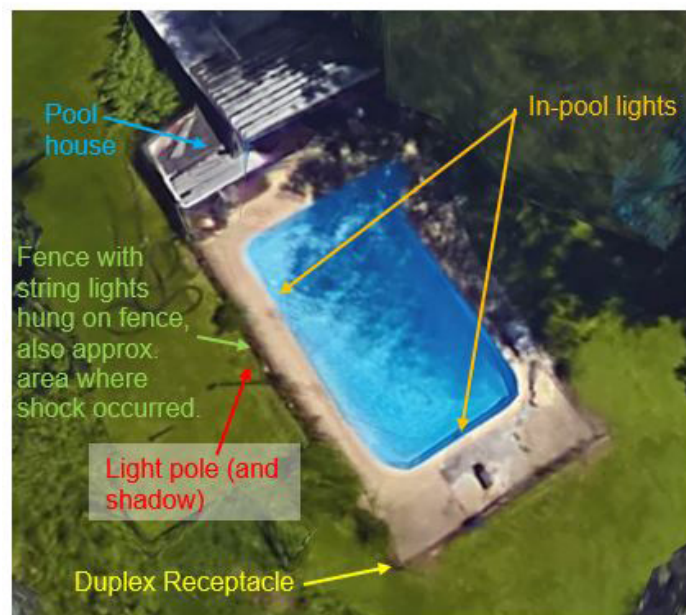
Figure 12
Pool layout.

The layout of the pool is shown in **Figure 12** (a Google Earth image from before the incident). The electrical system for the pool is fed by the circuits in the pool house, and there is a chain link fence that surrounds the pool and deck. Electrical circuits in the immediate vicinity of the pool include in-pool lights, a string of lights hung on the fence that was powered from an extension cord, a light pole approximately 23 in. west of the chain link fence, and a receptacle on the southern corner of the fence.

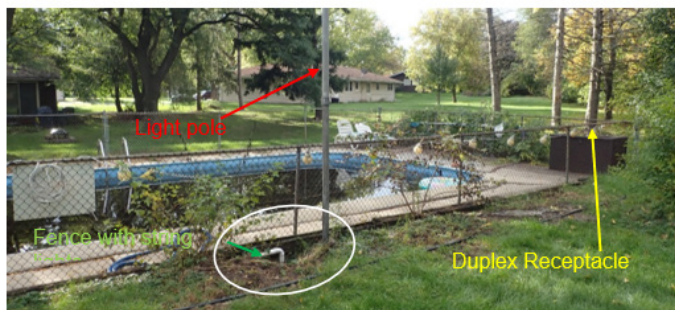
Figure 13

The author found a hole in the lawn where there were individual visibly exposed wires (with colored insulation) as 7 in. of the underground conduit had disintegrated due to corrosion as seen in the white ellipse in **Figure 13**. Plus, there were many unanswered questions about the detailed actions of the man and other site anomalies, which caused the team to only do a non-destructive brief broad survey of the electrical characteristics over a large physical area.

Pool layout and hole in lawn (see white ellipse).

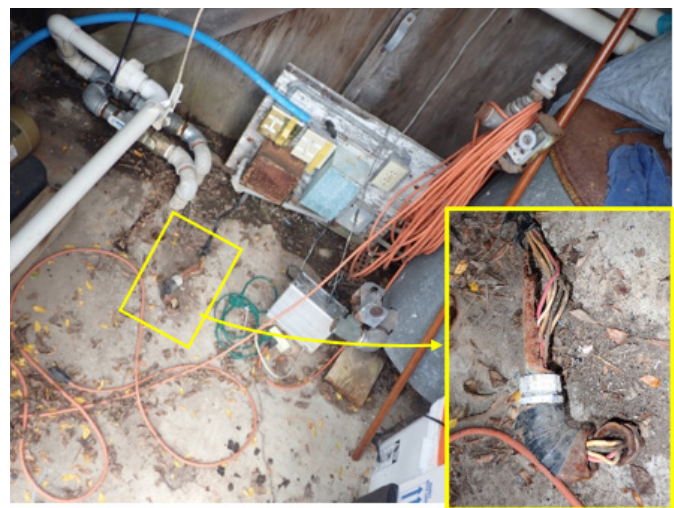
Figure 14 shows the state of the electrical pool controls inside the pool house that had a doorway, but no door. Damage found included corroded enclosures, corroded and disintegrated conduits (one is shown inside the yellow rectangles), multiple cords, and rodent damage. The individual visibly exposed wires (with colored insulation) in the yellow rectangle in **Figure 14** were similar to the wires that were visible in the hole in the lawn in the white ellipse in **Figure 13**.

Pool house electrical controls.

3. The abnormalities and damage to the light pole conduit and wire in the hole in the lawn and the conduit in the pool house, detailed in this report, were conditions of disrepair and lack of maintenance of the pool electrical system that were visible to the homeowner.

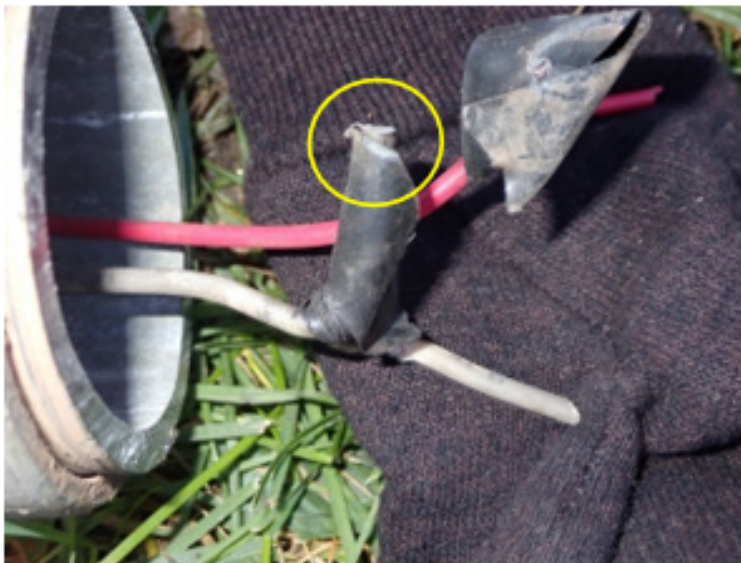
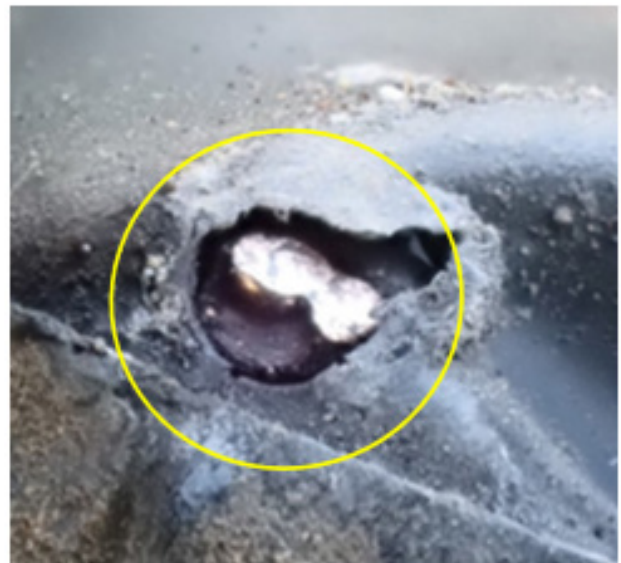
Figure 15 illustrates two photos that show a portion of the internal wiring for the light pole that had splices with electrical tape for insulation. It was found that a bare copper wire had worn through the tape (as seen in the yellow circles), and the copper wire was able to touch the inside of the light pole to energize the metallic light pole with 102VAC.

Internal wiring for the light pole with a bare copper wire protruding through a worn hole in electrical tape.

- pole circuits such that stray voltage and current occur, resulting in the light pole becoming energized. This failure was a lack of insulation on the electrical conductors such that an energized copper wire came into contact with the inside of the metallic light pole, allowing stray voltage and current to enter the light pole.

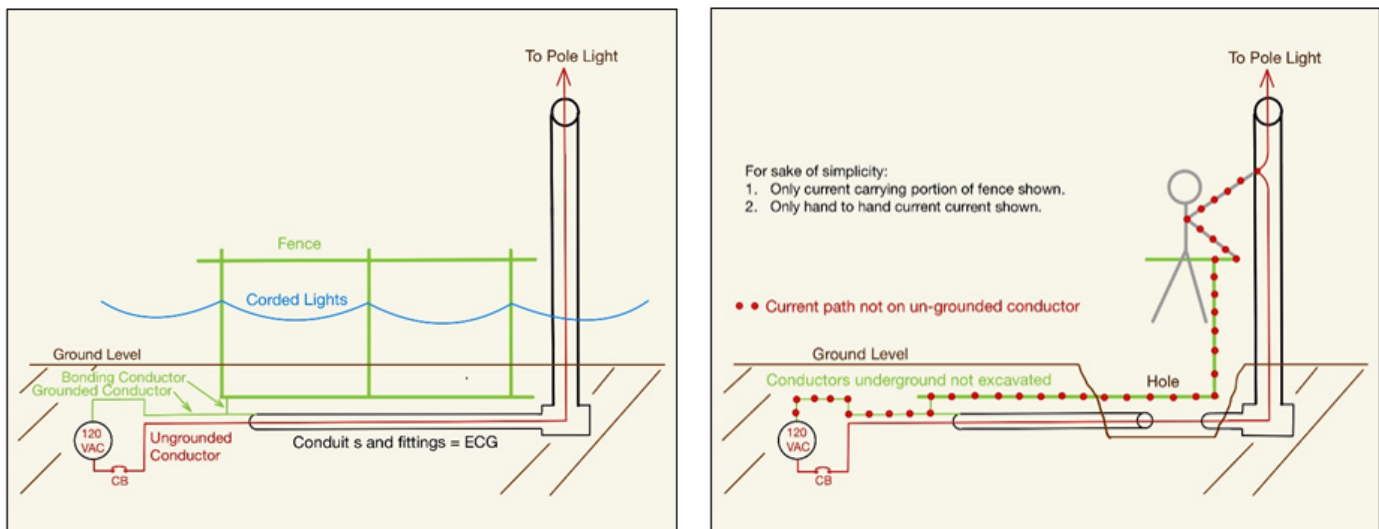
Figure 16

For clarity's sake, **Figure 16** shows two diagrams of the pertinent pool circuit components. The left-hand diagram shows the circuits as they should have existed under prevailing codes and standards such that a short circuit to the light pole could be carried to ground by continuously connected conduits as EGCs. The right-hand diagram shows the pool circuits as they were in the incident where the conduits were not continuous, eliminating this as a current path and creating the causal hazard.

Two diagrams — reasonably safe circuits on the left; hazardous circuits on the right.
