Vol. 38 No. 1 June 2021

Forensic Issues from the Investigation of a Marine Shaft Failure

By Stephen R. Jenkins, CPEng (NAFE 11)

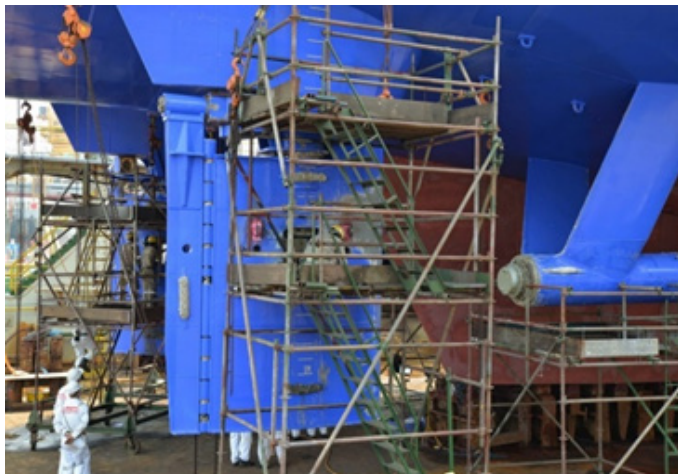
Figure 1

Arrangement of shaft, propeller, and rudder. The exposed shaft end is where the starboard propeller was mounted before it was lost.

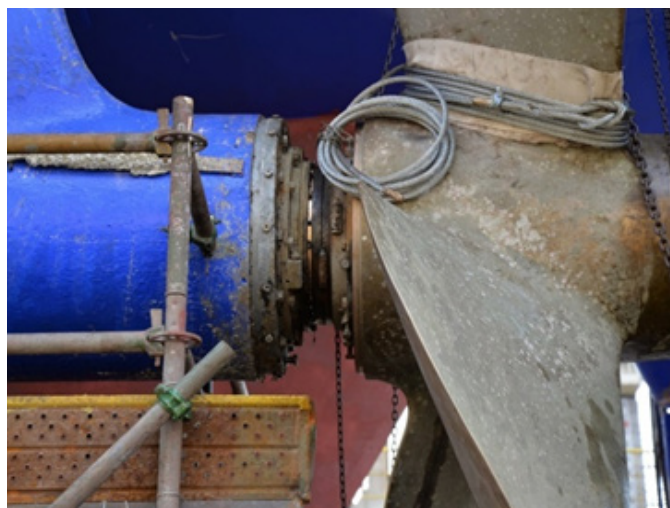
Figure 3

The fracture in the starboard shaft occurred just inside the propeller hub.

It was noted that the fracture face was approximately 20 millimeters inside the propeller hub, and that a certain amount of damage to the propeller hub could clearly be attributed to relative movement between the two halves of the shaft as the failure progressed.

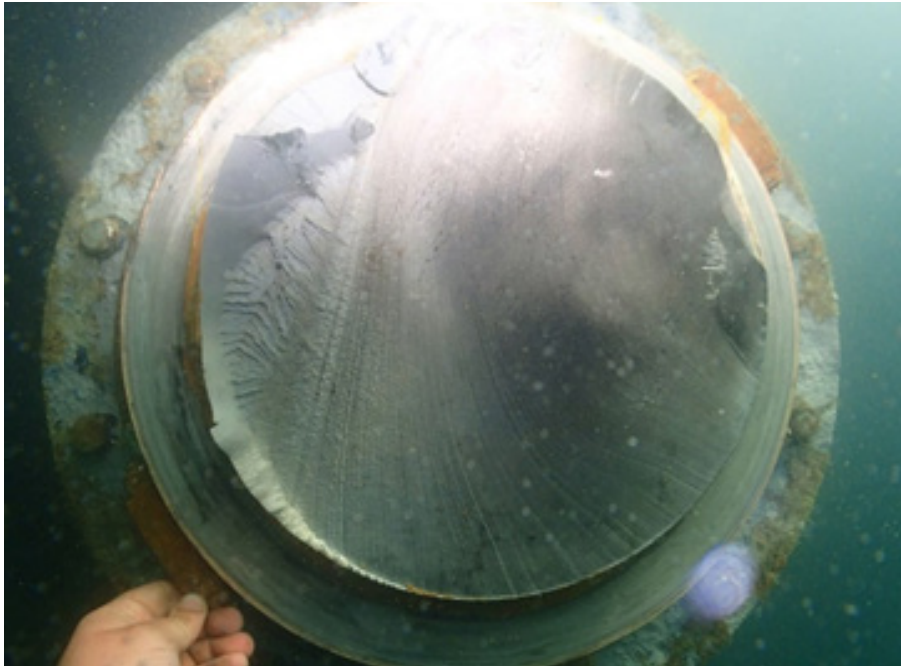
Figure 4

The high-resolution underwater photographs (**Figure 4**) showed a distinctive pattern on the fracture face, which clearly indicated that the failure was a uni axial fatigue failure^{1,2}. This type of failure is caused by a fluctuating force that increases and decreases stress on one side of the shaft and generates a fatigue fracture with a single origination point that progresses across the shaft from the side where the force is being applied and results in the final overload failure occurring on the opposite side from the fluctuating force.

This fracture is distinctive and cannot be generated by any other loading pattern.

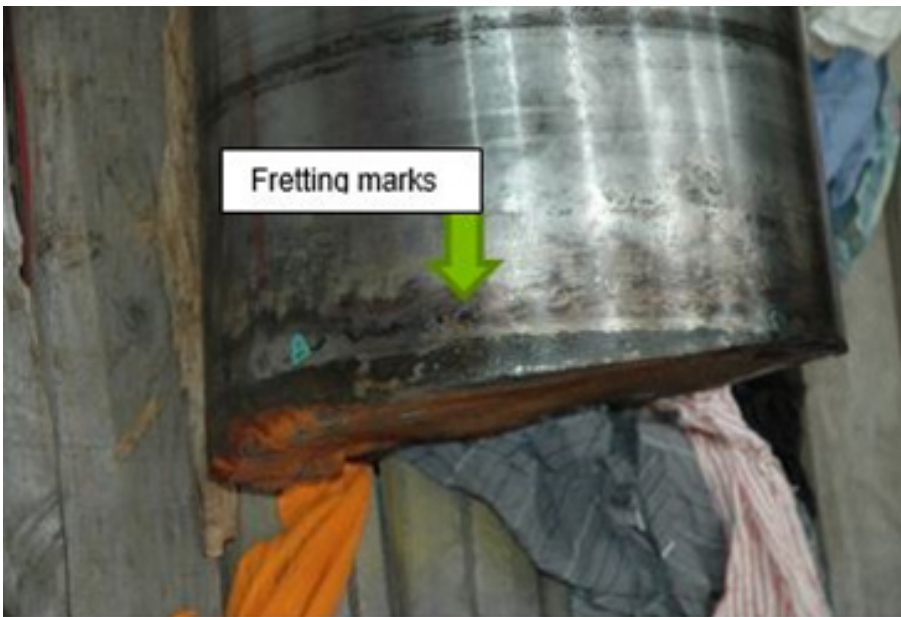
Figure 5

When the shaft stub was removed from the propeller hub, there were marks on both the shaft and the bore of the propeller that indicated there may have been fretting occurring at the shaft to propeller hub interface

(Figures 5 and 6). Fretting is a form of surface damage that occurs when there are very small relative movements between two surfaces in very close contact. Fretting is known to reduce the ability of steel shafts to resist fatigue loading. While it can facilitate the initiation of a fatigue crack, the full development of the crack into a

Fretting marks on the shaft stub.

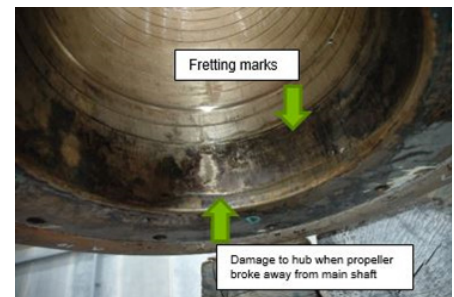
Figure 6

Fretting marks and failure damage on the propeller hub.

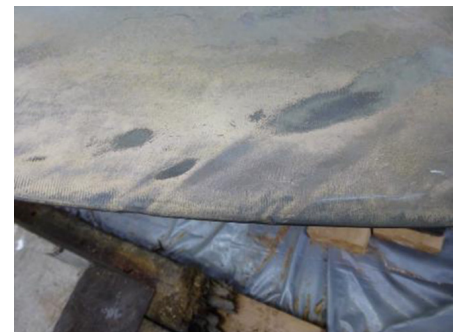
Figure 7

Cavitation erosion caused by small indentations and poor edge form to the leading edge.

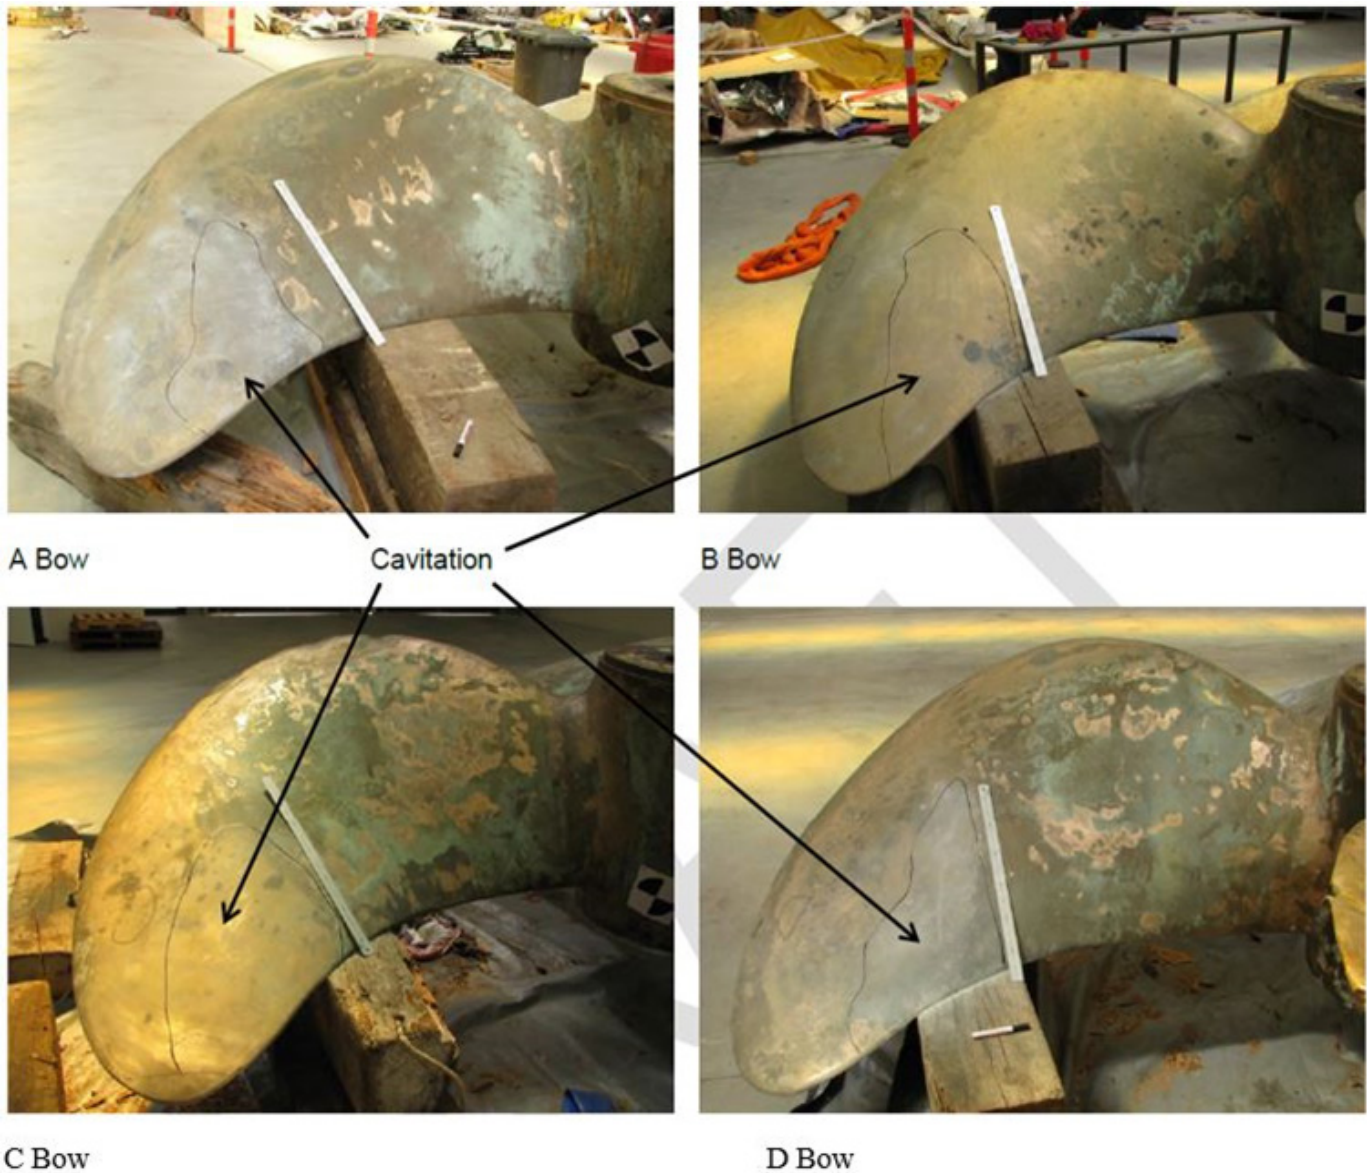
Figure 8

Cavitation patterns were observed on the suction (bow) side of the starboard propeller varying in depth and area. The C blade was the worst.

severe on the C blade (**Figure 8**).

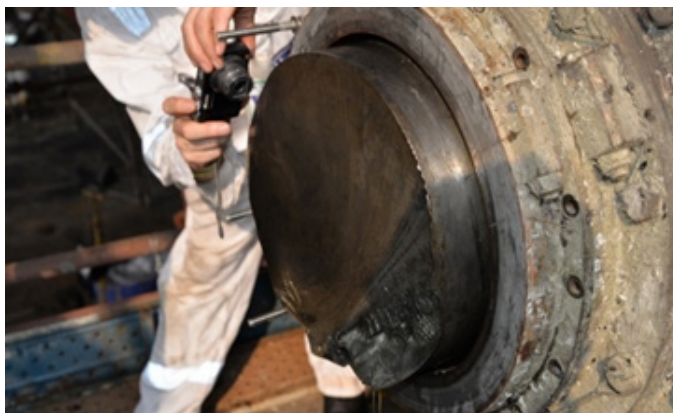
Figure 9

The fracture face on the tail shaft after removal of the protective cap.

starboard shaft was uncovered (**Figure 9**) and examined metallurgically in place. It was also noted that there was an unusual pattern of paint removal on the starboard rudder that was consistent with cavitation damage (**Figures 10** and **11**). This paint damage was not present on the port rudder.

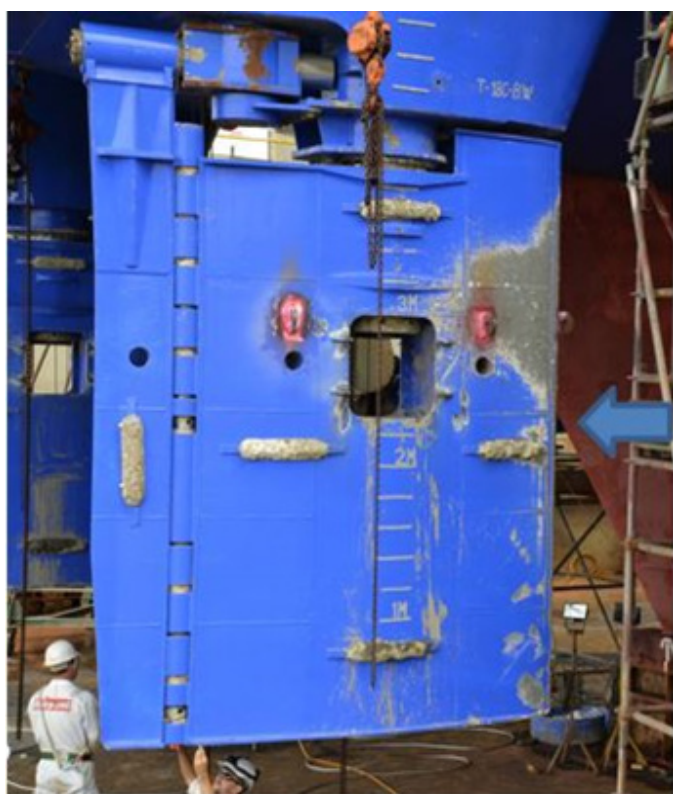
Figure 10

Starboard rudder outboard side leading edge to right.
Arrow is at center line of propeller shaft.

It was noted that the paint damage on the inboard side of the rudder was significantly more than on the outboard side. It is known that there is a wide boundary layer called a wake field along the vessel hull and that hydrodynamic conditions in this boundary layer are different from the free field flows over most of the propeller operating volume. These facts were both relevant when evaluating the effects of the cavitation damage observed on the starboard propeller later.

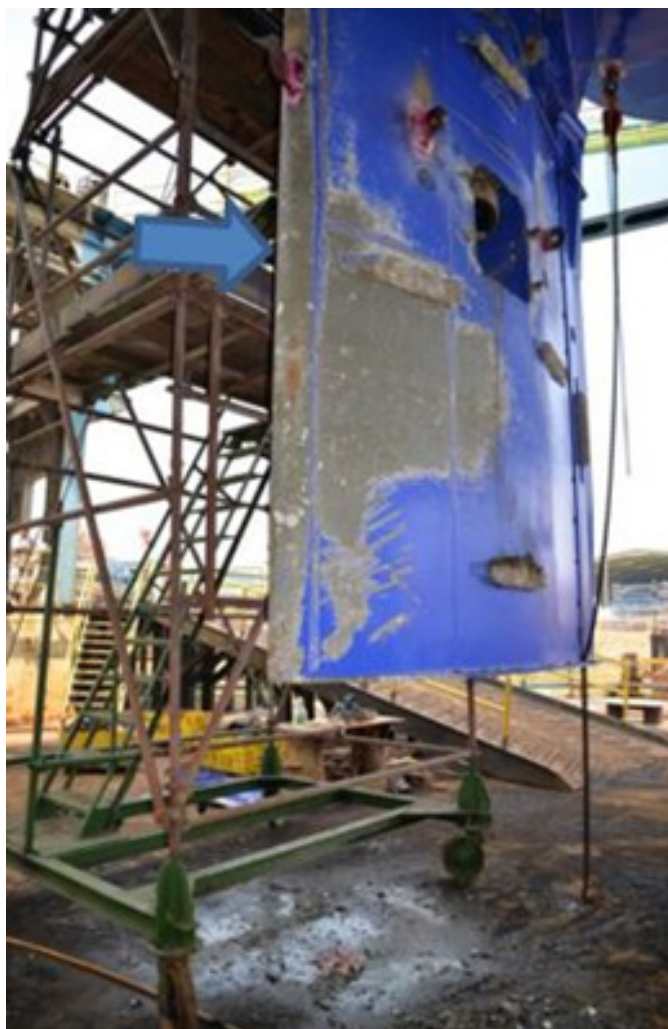
Figure 11

Starboard rudder inboard side leading edge to left.
Arrow is at center line of propeller shaft.

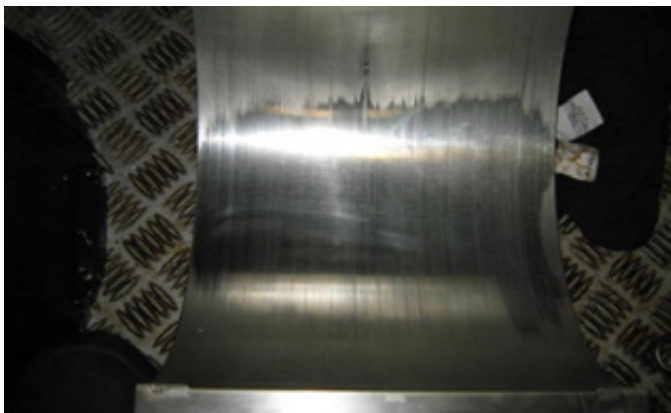
Figure 12
Starboard aft bearing.

While in Singapore, the alignment of the shafts was thoroughly checked and the bearings examined for signs of vibration damage. While the alignment was found to be less than satisfactory, there was no damage to the bearings that could be attributed to vibration. There was a small area of fatigue failure on both aft stern tube bearings, which was consistent with normal loading (**Figures 12 and 13**). There was no wiping of the bearing material, and no unusual wear patterns when assessed against ISO 7146-1:2008 *Plain Bearings Appearance and Characterisation of Damage to Metallic Hydrodynamic Bearings Part One General*.

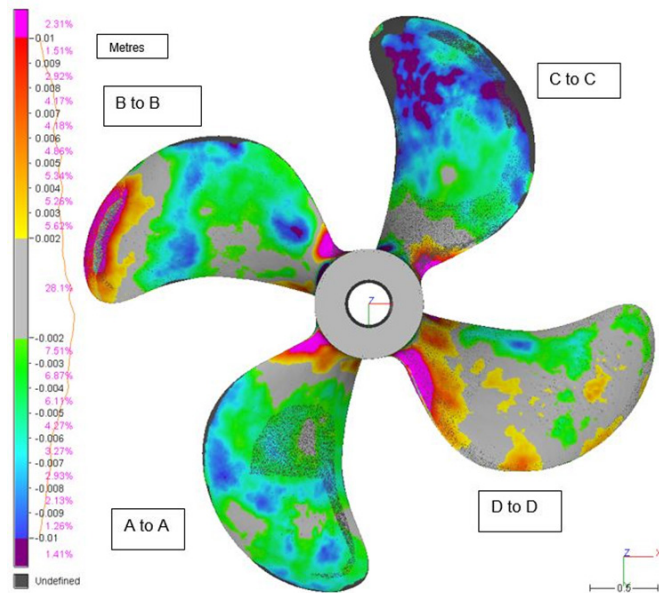
Figure 17
Digitally calculated differences between the suction faces of the two propellers.

It was clear from this comparison that there were significant differences between the A, B, and C blades of the port and starboard propellers, while the D blades fell largely within the base tolerance zone. **Figure 18** compares the pressure faces of the two propellers. The C blades were significantly different, and the C blade of the starboard propeller was also displaced rotationally around its main axis (**Figure 19**). Comparison between the mapped differences in shape (colors), and the observed cavitation (inside line) showed a close correlation in location when the two images were overlaid (**Figure 20**).

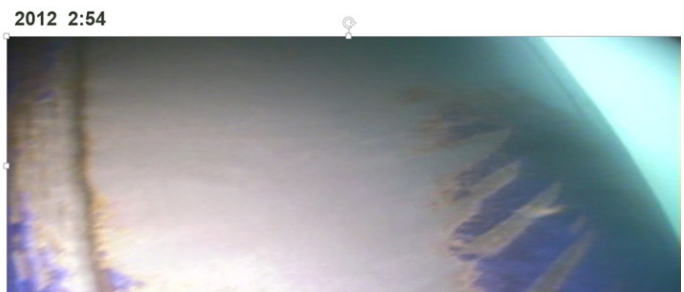
Figure 22

The investigation team was able to show from underwater dive surveys that the paint damage to the starboard rudder (**Figure 22**) was present after one year of service and prior to the appearance of the bent tip on the starboard propeller C blade. The presence of cavitation damage to the paint before the bend appeared on the propellers was accepted as evidence that the bend was not significant as suggested by other experts early in the investigation.

The investigation team considered that the paint damage on the inboard side of the rudder was due to cavitation bubbles being shed as the propeller passed through the boundary layer along the hull. Physical observation of the starboard propeller showed one blade with significantly more surface damage from cavitation than the other three blades. It was considered likely by the investigation team that the blade showing the surface damage cavitated as it passed through the boundary layer.

2012 dive inspection shows paint loss on starboard rudder.
