Forensic Engineering Investigation of PVC Piping Failure in a Multistory Condominium Building

By John Certuse, PE (NAFE 708F)

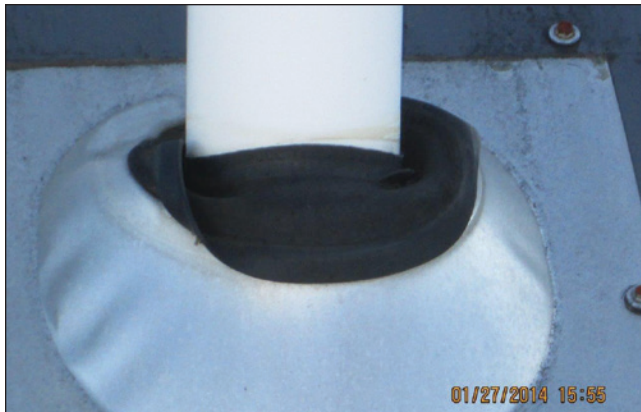
As seen in **Figure 3**, water leakage was initially thought to be caused by a leaking roof boot seal around vent piping, due to the manner in which the boot was damaged. The boot was damaged in a manner consistent with heavy snow load deflecting the roof sheathing and distorting the rubber seal and aluminum flange. It was later determined that this was not possible, however, due to the steel roof construction and strength of the roof truss system. Another explanation was sought.

Figure 3
Damaged roof vent boot.

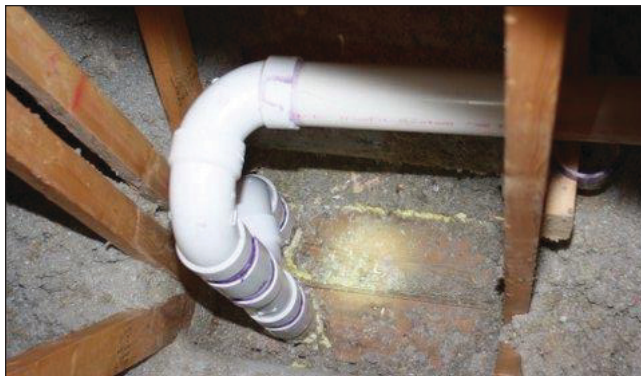
Figure 4
Vent piping entering attic space.

Below the attic, as seen in **Figure 4**, the two piping waste stacks serving both buildings passed vertically through a common wall between both building units and intersected in the attic space.

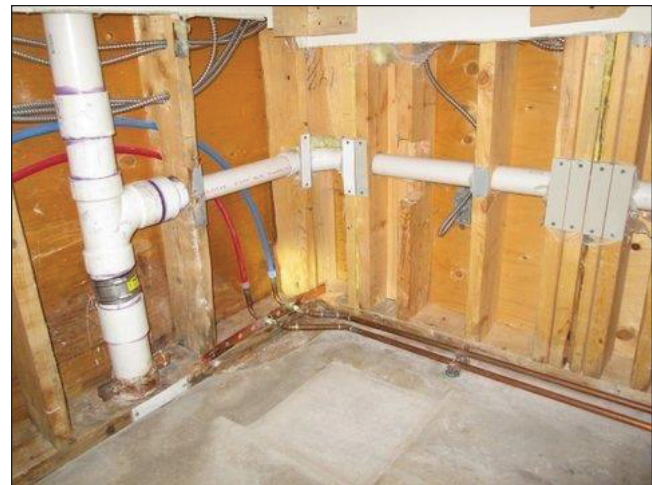
discounted, further investigation identified that water was found in a common piping chase way behind the abutting condominium units' kitchen cabinets. At the time of the author's involvement in this investigation, four of the condominium units were sealed off and undergoing restoration for water and mold damage (**Figure 5**).

Figure 5
Kitchen walls removed, exposing piping.

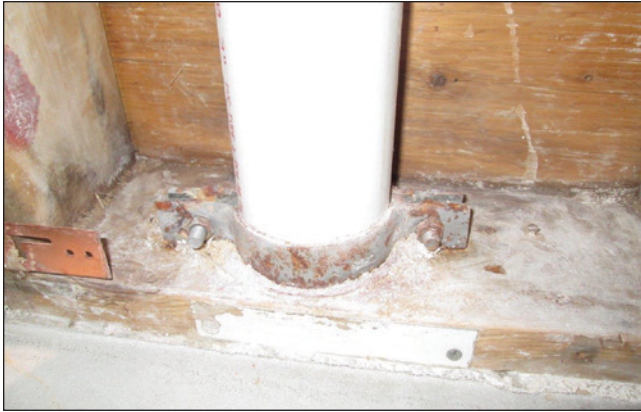
Figure 6
Vent stack pipe resting on riser clamp.

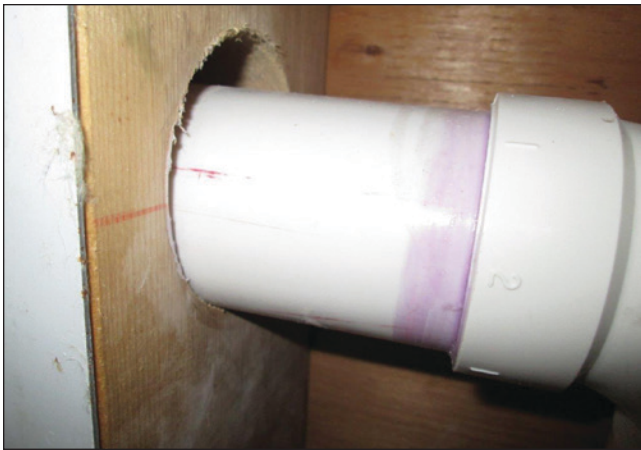
Kitchen wastewater was connected to the 4-inch main drain waste line by way of horizontal 2-inch PVC piping sections that passed through (and were restrained within) holes in framing members, significantly limiting vertical movement. (**Figure 7**).

Figure 7
Horizontal piping restrained within framing.

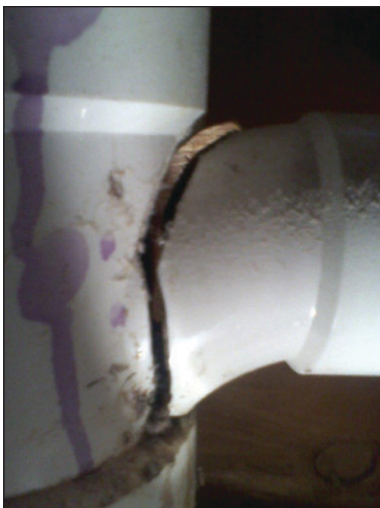
Figure 8
Provided photo of cracked “tee” fitting at riser.

Although photograph documentation was not provided from the earlier pipe breaks from past years, the most recent event’s damaged fitting was photographed by the condominium management staff and provided to investigators (**Figure 8**).

These conditions, in addition to the constraints on the horizontal kitchen waste lines, caused the weight of the estimated 200+ feet of vertical stack piping (and any internal liquid) to be imparted to these 2-inch horizontal pipes. As seen in **Figure 8**, this condition resulted in cracking of the “T” fittings connecting these 2-inch

waste lines to the vertical 4-inch riser within the chase way due to excessive weight and stress overload.

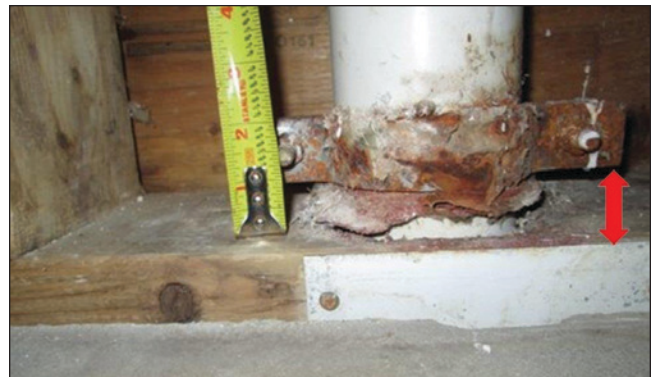
Although past piping repairs had already been performed, examination of the piping chase way and vent stack piping revealed that the piping was not resting on the riser clamps designed to secure a pipe against vertical downward movement and that the riser clamps were actually suspended off of the sill plates (**Figure 9**).

Figure 9
Riser clamp suspended above sill plate due to framing settling and pipe expansion on third floor of building.

Due to thermal expansion of the piping, as well as shrinkage of the four stories of the wood framing of this structure, the vertical riser vent stack was not being supported by the riser clamps fastened to the piping at the sill plate locations at each floor penetration. Wood framing shrinkage also added to the distance between the riser clamps and sill plates.

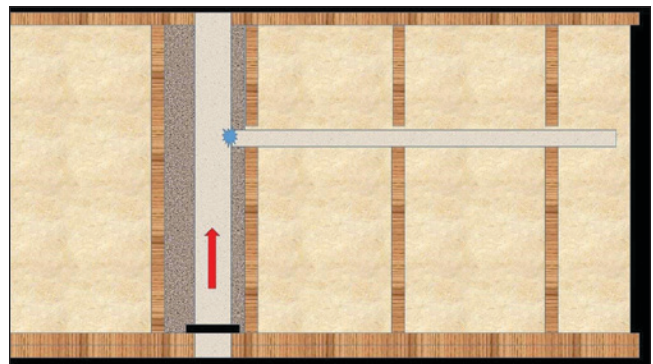
The installation method of this piping being constrained (see **Figure 10**) without accommodation for expansion, contraction, or building movement — combined with reports of where past plumbing repairs were located (and how they failed) — led to the author’s opinion that a plumbing system design defect was the cause of the piping failures and building damage.

Figure 10
Diagram of piping connection to vent riser.

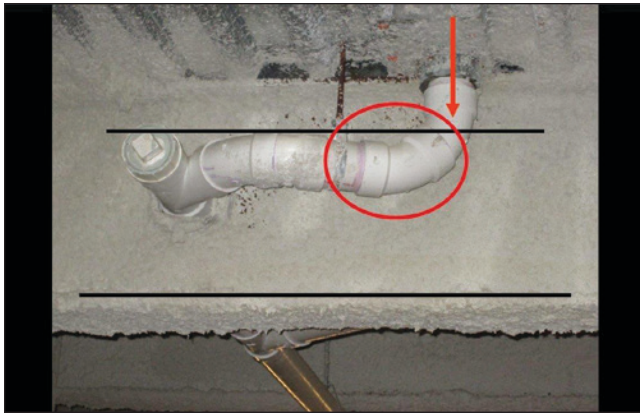
Figure 11

Additionally, the base of the stack systems, which were supported by a steel Milford hanger, was also deflected in a downward direction due to this one pipe support securing a major portion of the weight of the piping system (**Figure 11**).

Basement vent stack out of plumb due to excessive weight.
