Vol. XV No. 1 June 1998

Scientific Analysis of a Chicken Coop Fire

by Joseph A. Cristino, P.E., (NAFE 543M)

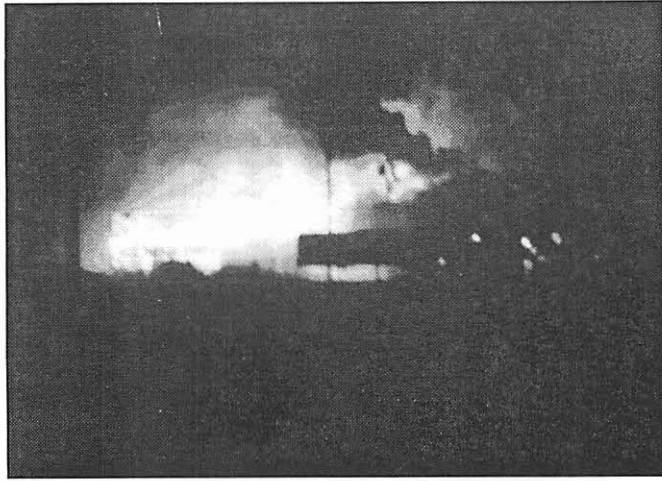
Photo 1

On April 11, 1988, an automatic alarm was received by a private alarm company. Because of a previous arrangement, the egg farm's owner was notified and responded to the farm. Sometime later, he made a telephone call to the local emergency dispatch center who notified the fire department. The fire chief was first to arrive on the scene. In the course of driving down the access road, he was faced with a fully-involved structural fire in Coop #2 and smoke emanating from Coop #1.

“What the fire chief saw upon arrival.”

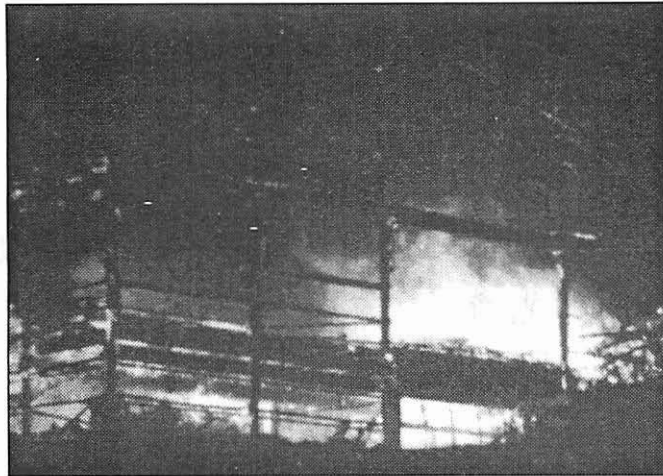
Photo 2

View of front portion of coop # 2.

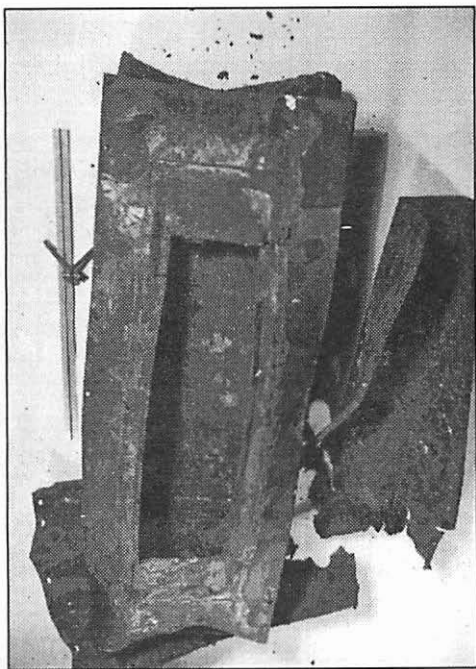
Photo 3

The first viewing of the evidence was at the plaintiff's fire expert's storage facility. Three pieces of electrical trough, two electrical enclosures and various bits and pieces of conductors and damaged parts were shown and it was revealed that the two coops and all of the remaining electrical system components had been demolished shortly after the fire.

Electrical panel and raceway that were retained by plaintiff's expert.

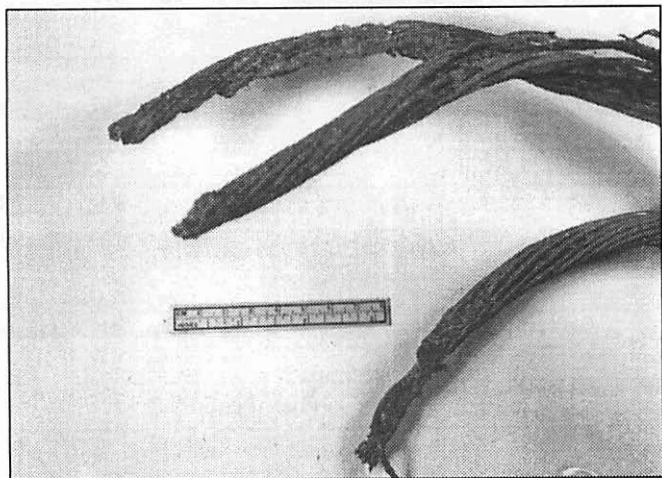
Photo 4

Damaged power conductors retained by plaintiff's expert.
This photo is intended to show the evidence that was retained.

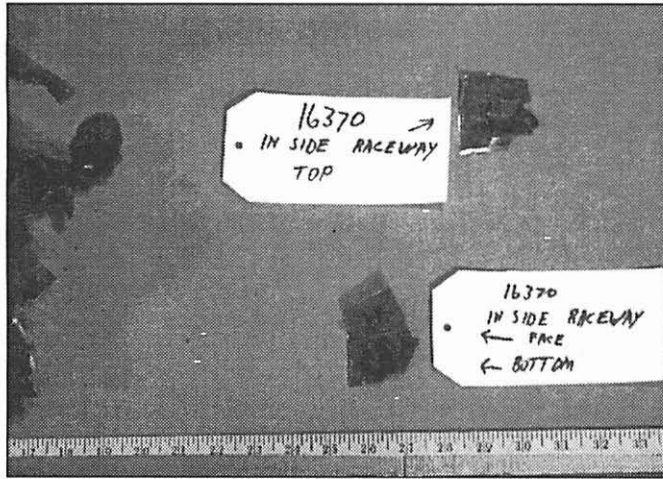
Photo 5

After reviewing the plaintiff's metallographic analyses, it was requested that samples from the retained evidence be taken. Areas of visible fault activity, as well as those where none was evident, were chosen for comparison purposes. Although the plaintiff's conclusion that the observed damage was the result of high-energy faults, the author was confident that the faults were the result of fire impingement. However, the hypothesis needed to be supported with hard data. The plaintiff's metallurgist was present and took samples at each location where the defendant's experts had taken theirs.

Samples cut for metallographic analysis by plaintiff's metallurgist.

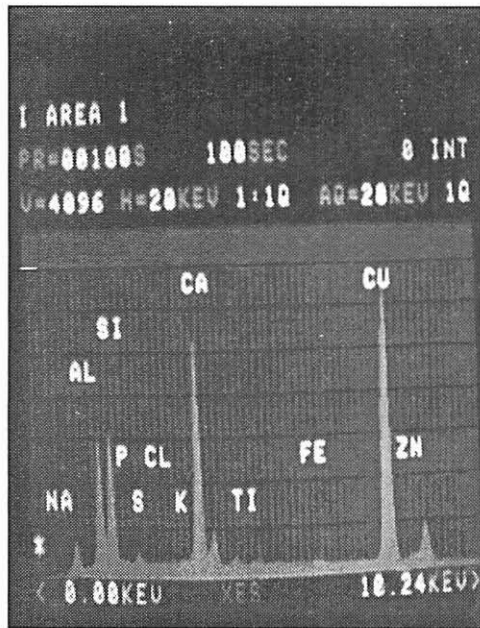
Photo 6

Approximately three weeks after the day of gathering metal samples, the metallurgist called. All of his test results confirmed the catastrophic failure of the electrical system. He found copper particles in the grain boundaries of the steel from the electrical troughs. Again, documenting high-energy faulting as the plaintiff's expert had done previously. All data pointed to energized electrical failures at the points where the samples were taken. His most significant finding, however, was the identification of the white tubular specimen found in one of the troughs. By performing specific analyses, he was able to obtain sufficient data to refer to published reference material. What we had discovered were bone platelets from a rat's vertebrae. And by further analysis he was able to determine that the rat had been alive at the time of the fire. The electrical troughs were of sufficient size to house rats and mice, and the chicken feed provided a plentiful supply of nourishment. The plastic insulation on certain electrical wiring has been found to be attractive to mice and rats. By gnawing on the insulation, conductors are left void of insulation and short circuits can evolve. Following negotiations, an out-of-court settlement was agreed upon, that was approximately 14% of the original subrogation.

Typical scanning electron microscope analysis of a metal sample.
