# Forensic Engineering Use of Graphics To Analyze and Reconstruct a Ladder Accident

by E. Ross Curtis, P.E. (NAFE 571M)

Plaintiff fell from a ladder in June, 1994. In 1997 he filed suit against the manufacturers of the ladder and ladder levelers which had been attached to the ladder. Upon visiting the accident site in April 1998, it was found that site conditions had changed. Careful inspection, an interview of the homeowner and graphical analysis of the site and ladder set-up enabled the author to determine what had actually happened and to prepare the case for litigation.

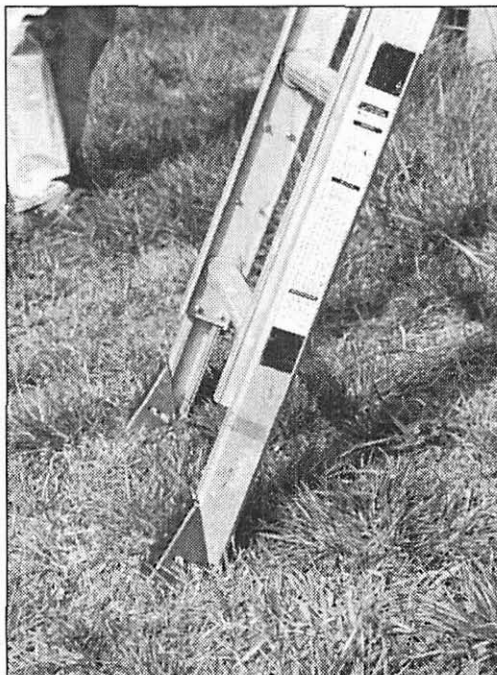
**Photo 1**  
Ladder Leveler with Swivel Feet

The ladder leveler is a device with a sliding leg fitted to each rail of the ladder. The motion of the legs is controlled by rack and pinion mechanisms, interconnected by a metal rod and locked by spring loaded "cams" when the ladder is loaded. See photograph 1. The ends of the legs are tipped with a fixed semi-circular rubber cap (a fixed foot) to which swivel feet are attached. The swivel feet are faced with a polymeric (rubber) anti-slip material for use on hard surfaces such as concrete, wood floors, etc. and there is a "spade" at one end with a serrated edge. The feet can be rotated so the spade can be pushed into softer

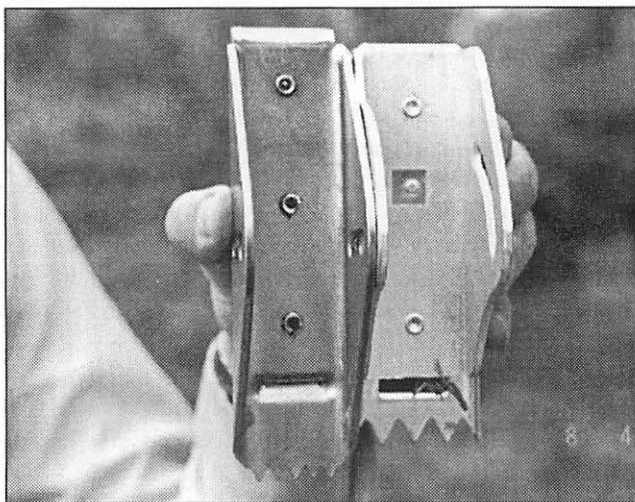
**Photo 2**  
Top of Swivel Feet

surfaces such as lawn, soil, etc. to provide stability for the ladder. Photographs 2 and 3 show the tops and bottoms of two different versions of swivel feet.

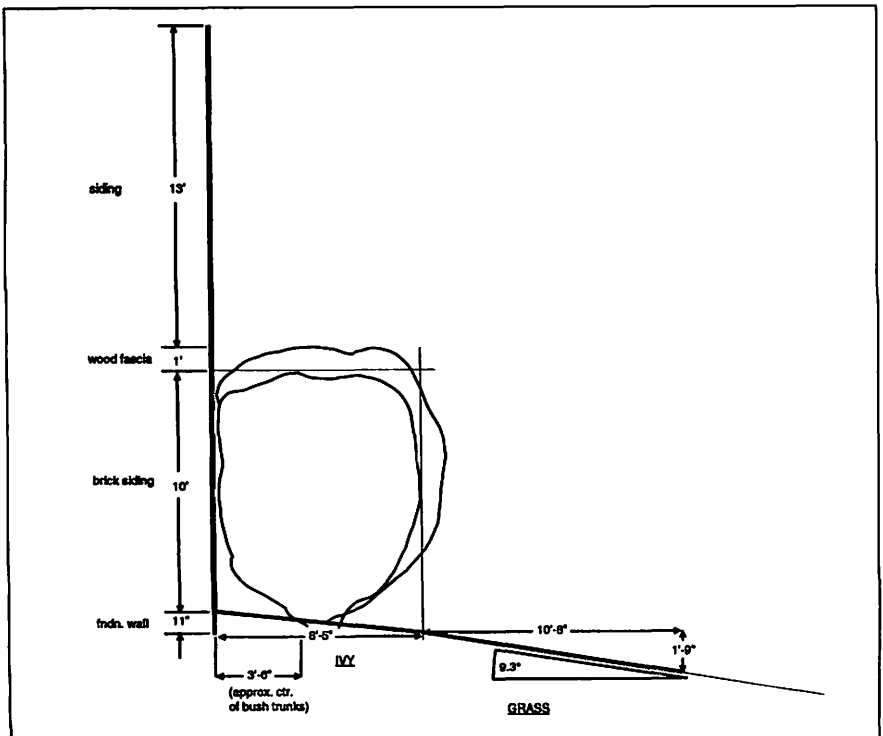
**Figure 1**  
Conditions at the Time of the Accident

At the accident site, it was observed that the bushes had been severely cut back within recent months, based on the freshness and cleanliness of the cuts on their trunks. Measurements of site conditions were made and are shown on figure 1. The homeowner was interviewed and it was determined that although the

bushes had been cut, the ground surface and the structure had not been altered. The homeowner stated that at the time of the incident the bushes were thick, up to the top of the brick veneer, and out to the edge of the ivy. The outline of the bushes as they were in 1994 are approximated on figure 1.

On figure 1 it will be noted that the ground was gently sloped away from the house for approximately 8-1/2 feet, to the edge of the ivy. The slope got steeper at that point with the slope in the grassy area calculated from field measurements to be 9.3°. The height of the house was indirectly measured to be 24 feet at the peak of the roof. The ladder was not available at the incident site for set-up and measurements at that time, as it was several miles away at the supervisor's home.

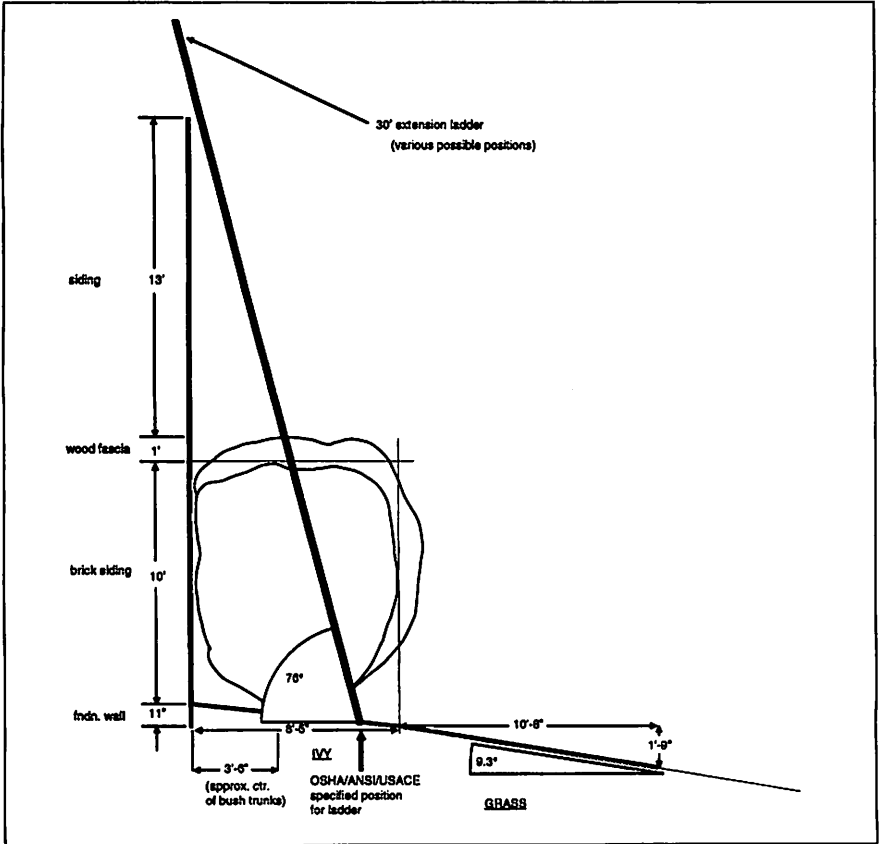
**Figure 2**  
Recommended Ladder Set-Up

first step was to show the OSHA/ANSI/USACE mandated position of the ladder superimposed on the drawing of the 1994 site conditions, producing figure 2. As can be seen, this would have placed the ladder in the middle of the bushes and was physically impossible.

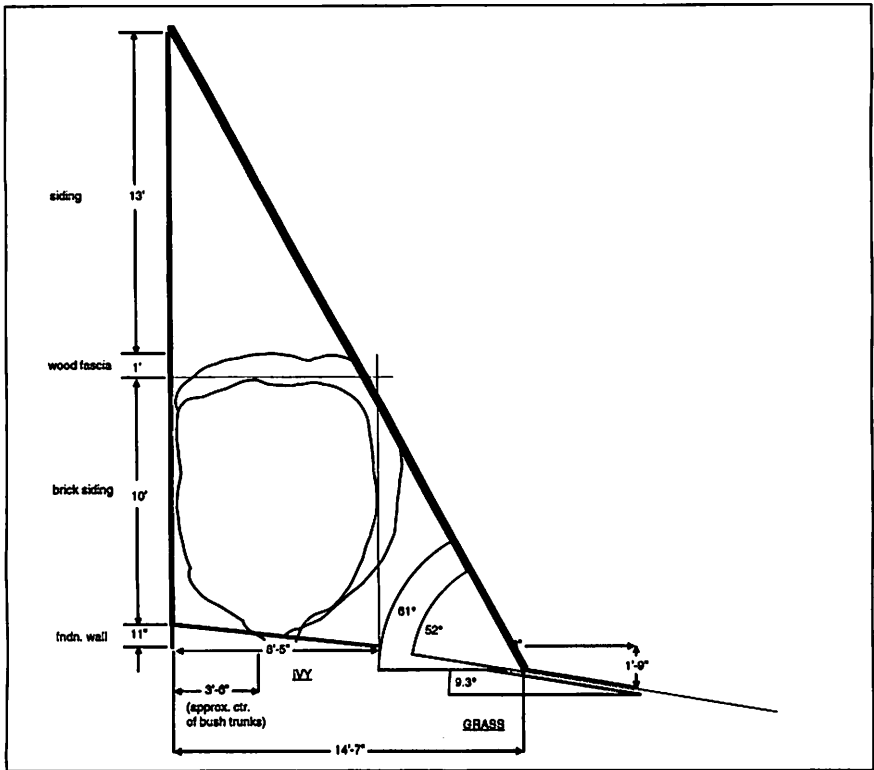
**Figure 3**  
Most Likely Position of Ladder at Time of Accident

The next step was to determine how the ladder would have had to have been placed in order to reach the peak of the roof, just touching the bushes. This position was considered to be the position most likely used by the plaintiff to set up the ladder at the time of the accident. Figure 3 shows the 30 foot ladder in this position. The angle it makes with horizontal is 61°. Since the ground sloped away from the house at an angle of 9.3°, the effective angle of the ladder with the ground surface is actually 52°, which is also shown on figure 3.

When this result was compared to the angles shown on figure 3 it was noted that in the position in which the ladder was most likely used ( $61^\circ$  from horizontal), the effective angle with the ground surface was only  $52^\circ$ . This angle is in the range where only friction between the ground surface (grass) and the rubber leg cap prevents the ladder from slipping away from the wall.

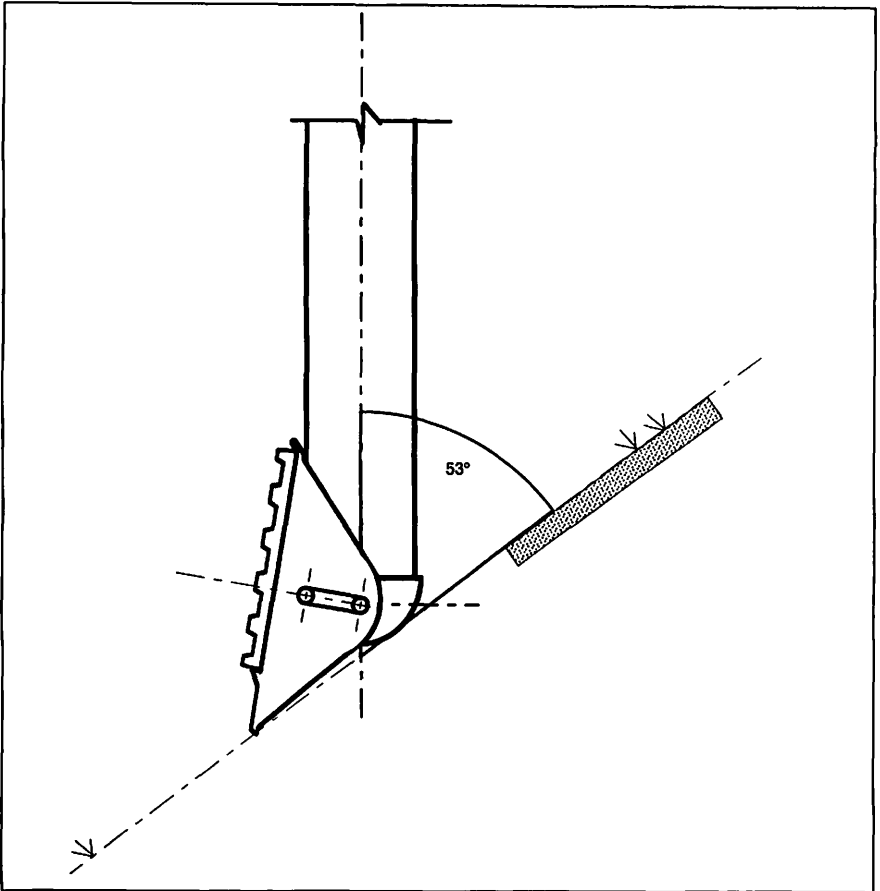
**Figure 4**  
Swivel Foot on Leg at Minimum Contact

Manufacturer's instructions direct the user to place the ladder against the wall, and on soft surfaces rotate the swivel feet so they are away from the wall with the spade pointed down, penetrating the soft surface upon which the ladder is set. In this case the soft surface was the lawn pitched  $9.3^\circ$  to drain away from the house. A leg of the ladder leveler and an exemplar swivel foot were measured and a half scale drawing of each was produced. These two sketches were then combined to show how the leveler leg looked with the mounted swivel foot rotated into position for use on soft ground. See figure 4.

A line was then drawn to represent the surface of the ground at the angle where the tip of the spade just contacted the ground and began to take a bite into the surface. This angle was measured with a protractor to be  $53^\circ$ . Please refer to figure 4. At this angle the spade becomes ineffective, and all that supports the ladder is the fixed rubber caps on the ends of the leveler legs so the ladder is dependent solely on friction with the bearing surface for stability against slipping.

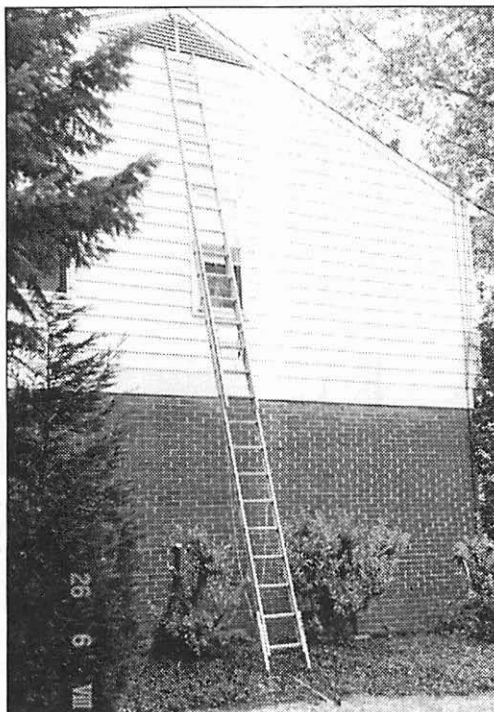
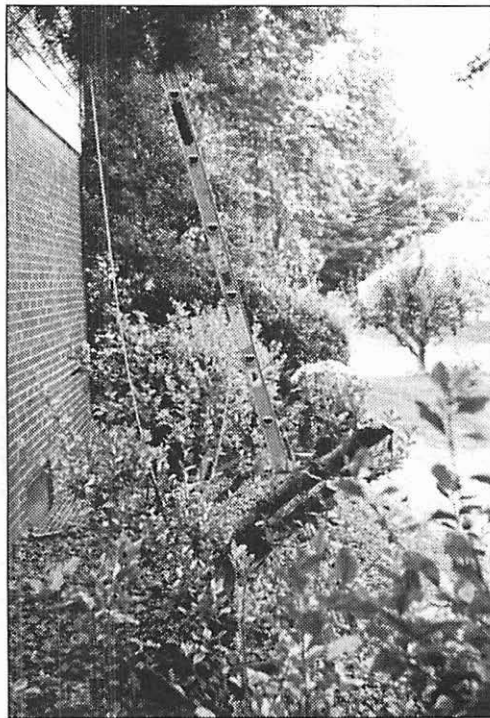
On June 26, 1998 in preparation for court, the ladder was taken to the incident site and set up for video taping. At this time the author and client attorney had the opportunity to test the reassembled ladder and leveler "in situ" to confirm analysis results. Photographs 4 and 5 show the ladder set up at the recommended  $76^\circ$  angle, in compliance with safety regulations. It is clearly in the

**Photo 4**  
Ladder at 76°

thick of what used to be heavy bushes. Even if it could have been set up there, it would have been unusable. (In the re-construction the ladder was not fully extended and set to the peak of the roof because of safety concerns caused by the electrical power service to the house at that point and the desire to avoid damage to the attic vent louvers.)

**Photo 5**  
Ladder at 76°

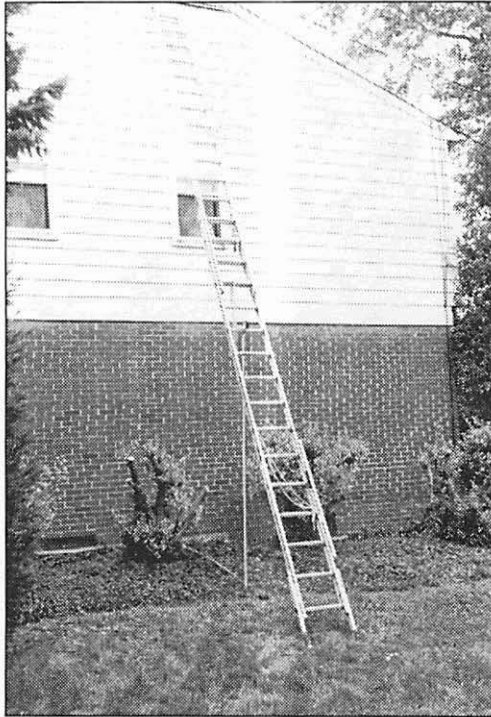
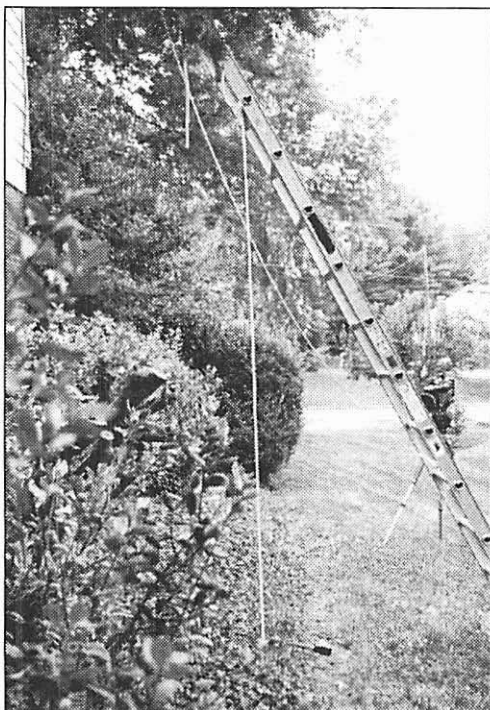
The ladder was then extended to 29 feet, almost full usable length, and moved to a position at an angle of 63° with horizontal (again avoiding the louvers and power service.) See photographs 6 and 7. It was confirmed under these conditions the spades of the swivel feet did not penetrate the lawn (the soil was moist and soft enough to penetrate, had the angle of the spade been appropriate.) See photograph 8.

**Photo 6**  
Ladder at 63°

**Photo 7**  
Ladder at 63°

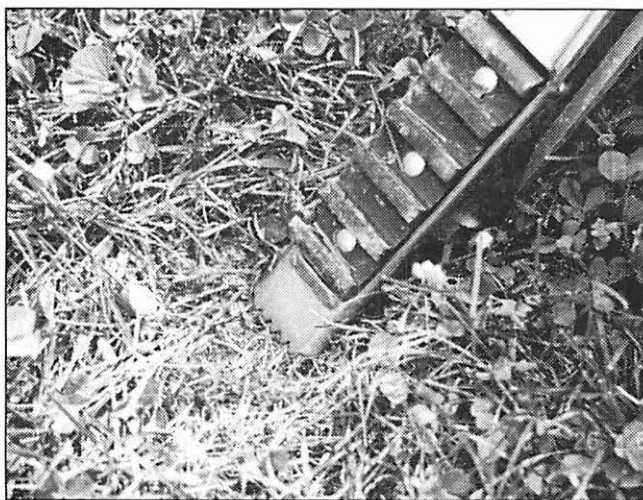
**Photo 8**  
Swivel Foot with Ladder at 63°
