Vol. XVI No. 2 December 1999

Forensic Analysis for Headlights ON or OFF?

by W. T. 'Dusty' Yaxley, C.S.P., P.E. (NAFE 270F)

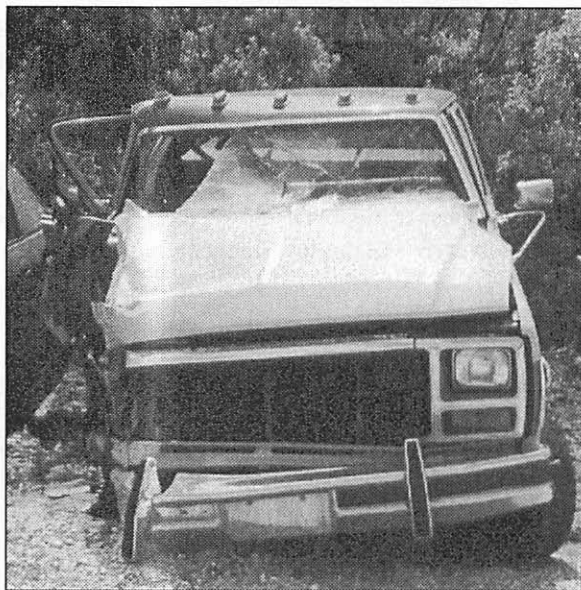
Figure 1

Front view of pickup truck showing damage to the right side fender and headlight area. The right front fender and headlight/running/turn light portion were pushed rearward to the middle of the passenger side door.

The damaged pick-up truck (See Figure 1) was stored at Sadisco (Insurance Co. holding facility); Riverview, FL. The pick-up truck was totaled due to the

damage from the impact. The right front fender was pushed back into the passenger side door. The right front wheel was severed during the impact. The pickup truck suffered significant induced damage outside the direct contact area. The concrete truck was not available for inspection because the damage was not sufficient to hold the truck out of service.

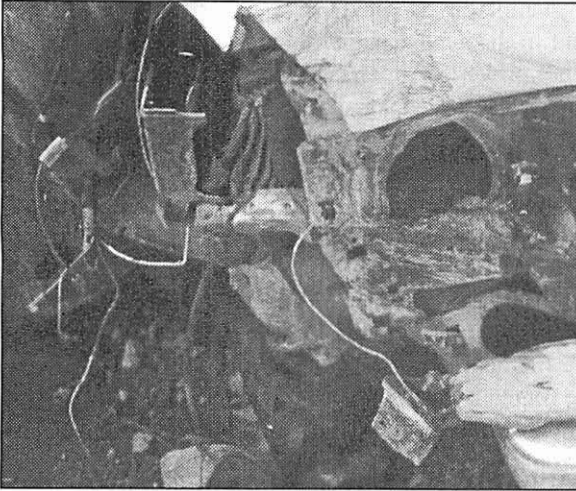
Figure 2

Close up view of right side headlight area. Note the headlamp and running lamp including the housings were missing. The headlight socket with three wires was found in the bed with other debris from the accident.

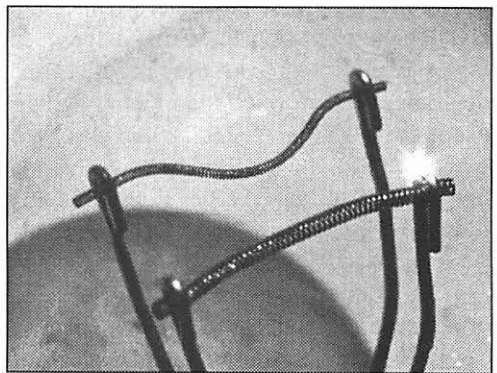
Figure 3

The left running light (See Figure 3) below the headlight on this pick-up

truck contained a lamp with two filaments. This lamp was a common 1152 running/stop light lamp that lamp contains two filaments. The smaller gage filament is the running light or 'tail-light' while the larger gage filament is the turning light or 'stop light' filament. The smaller gage filament on the driver's side front running light was significantly deflected indicating an incandescent (running light on) filament at the time of impact. A microscope inspection also

Curved filament running lamp, straight filament turn/hazard lamp filament. A closer view of the smaller filament was darker and more pitted than the heavier filament.

confirmed that the running lamp was used extensively because of the darker color and the pitting present in the smaller gage filament used for the running lamp. However, this does not prove that the headlights were on at the time of the impact. The running lights can be engaged without the headlights. These lights would have been visible by the concrete truck driver, but would not meet the law requiring the headlights must be on before sunrise. No filaments or lamp parts were available from the right side running light; therefore, no analysis could be made from right side the lamp filaments for their on or off condition at the time of impact.

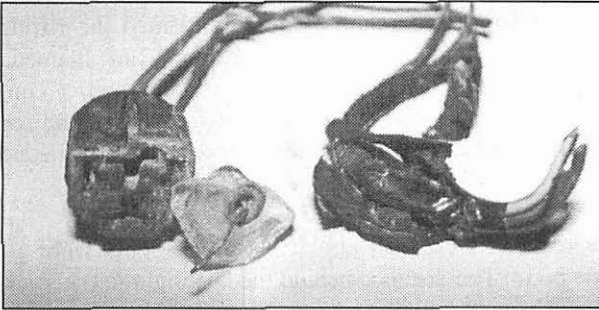
Figure 4
Right front headlight socket and approximately 8"
of three wires.

An examination of the passenger side headlamp area showed all remnants of either the high beam or the low beam filaments were missing. However, by carefully searching the bed of the pick-up truck the remnants of a socket and three braided, color coded wires approximately 8 inches in length were found (See Figure 4). A comparison of these wires to the drivers side headlight socket wires confirmed the same configuration and color coding of the wires. The mechanics shop manual provided further confirmation of the color coding and

socket was still available for inspection. A microscope examination of the wire ends revealed convincing physical evidence to prove the lights were on at the time of the impact.

ator. Among the debris was a headlight socket with three wires approximately 8 inches in length. Each of the conductors consisted of multiple small wires to make the conductor. Each wire had enough insulation still intact to provide a positive color code. A comparison to the shop manual confirmed the wiring color code for the heavy (high beam) filament, the smaller (low beam) filament, and the neutral wire. A microscope inspection of the three braided wires confirmed one was well rounded on the ends, one was slightly rounded, and the other was sheared clean with no indication of rounding of the individual braided wires.

The three braided wires that were still attached to the socket were all sheared very near the same point. The distance behind the headlight to the shear point was 8 inches or less. Using a crushing speed of 50 miles per hour this would suggest approximately 10 milliseconds after initial impact to sever the wires. The battery was located behind the severed wires, allowing the electrical current to be present in the wires when severed. The three severed braided wire ends were closely viewed and photographed with the aid of a microscope.

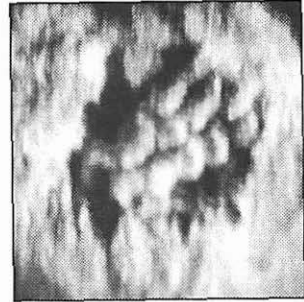
Figure 7

The black insulation covered wire, the neutral wire, had all the individual wires well rounded. This confirmed without doubt that the neutral definitely had current at the time this wire was severed. With the neutral wire definitely carrying current, the wire with the slightly rounded wires would be the most likely continuation of this circuit. That circuit passed through the low beam headlight on the right side of the pick-up truck at the time of impact.

Black wire neutral, showing strong rounded ends, a positive proof that this wire was energized at the time of severing.
