Vol. XVII No. 2 December 2000

Deposition & Court: Quotes That Altered the Engineering Case

by Michael Kravitz, P.E. (NAFE 451S)

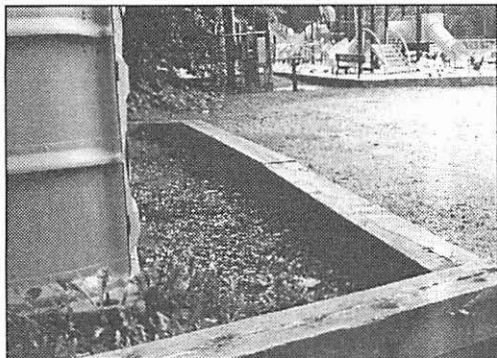
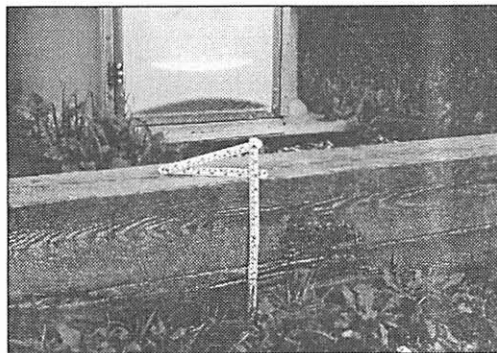
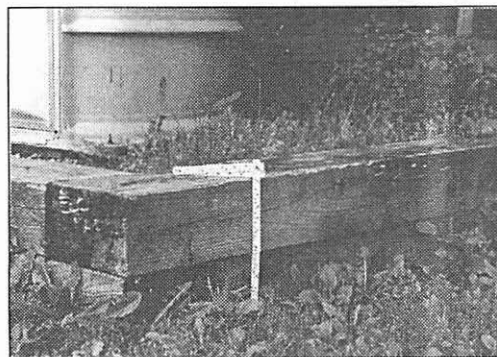
the three (3) portable toilets, reviewed the deposition of the Director of Recreation for the town park and the deposition of the plaintiff. The writer was not authorized by the plaintiff's attorney to visit the site. The author reviewed regulations regarding amusement devices and temporary structures along with architectural standards and issued an opinion that the means of ingress and egress to and from the portable toilets was in violation of the standards. The defendant's position was that the means of ingress and egress was appropriate and safe. The photographs had been provided to us by the plaintiff's counsel. The first photograph showed the general area of the portable toilets.

The remaining photographs are closer views of the railroad ties surrounding the toilets. From all photographs supplied it was obvious that anyone who attempted to use the toilets would have to climb over the railroad ties. When the case went to trial the author on cross examination was presented by defense counsel with an additional photograph showing that the railroad ties did not go all the way around the toilets but left two (2) entrances and exits paths open and unobstructed next to the wooden boundary fence in back of the toilets. In addition, there was a light fixture and a sign. The photograph was a wider view of the area than which had been provided to us by the plaintiff's counsel. The plaintiff's attorney did not object to the defense's presentation of the photograph that clearly meant that the photograph had been exchanged but the plaintiff attorney had chosen not to give it to the expert. This was a gross mistake on the part of the plaintiff's attorney. On cross examination the writer had to admit that the pathway revealed in the photograph were adequate. The jury
