Vol. XIX No. 1 June 2002

Forensic Engineering Review: Causes of Sudden Unexpected Vehicle Acceleration

by Michael D. Leshner, P.E. (NAFE 559F)

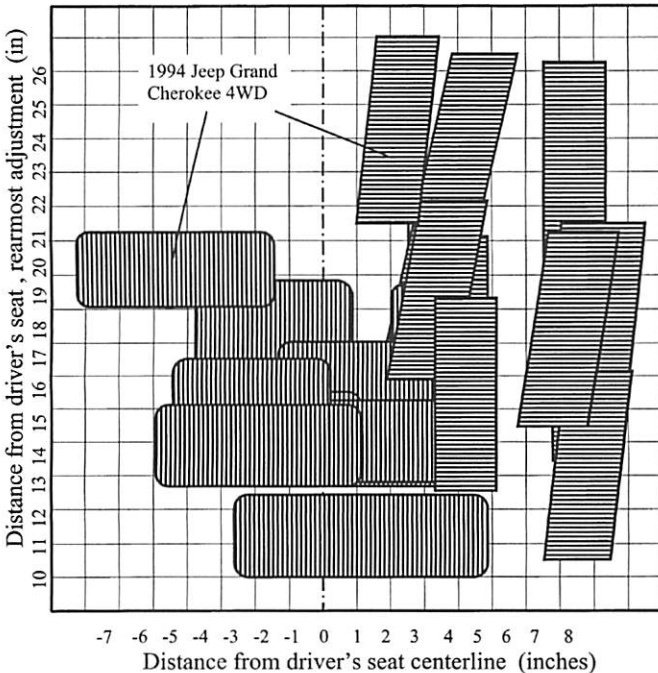
Figure 1
Brake and gas pedal positions relative to the driver's seat

As shown in Figure 1, the Jeep Grand Cherokee 4X4 pedals are positioned farther to the left than any of the other models in this group. Most models position the gas pedal well to the right of the seat centerline. Of these models, the Jeep Grand Cherokee places the gas pedal closest to the seat centerline. The gas pedal on the Jeep Grand Cherokee is located at a position where most drivers would expect to find a brake pedal.

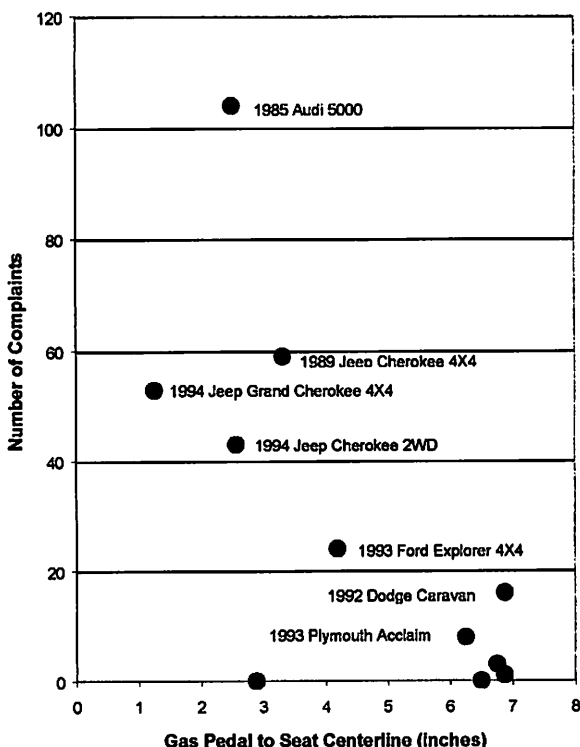
Number of sudden acceleration complaints vs. gas pedal position

Figure 2 indicates a strong correlation between gas pedal position and sudden acceleration reports. In general, those vehicles with the gas pedal near the seat centerline have the highest number of sudden acceleration complaints.

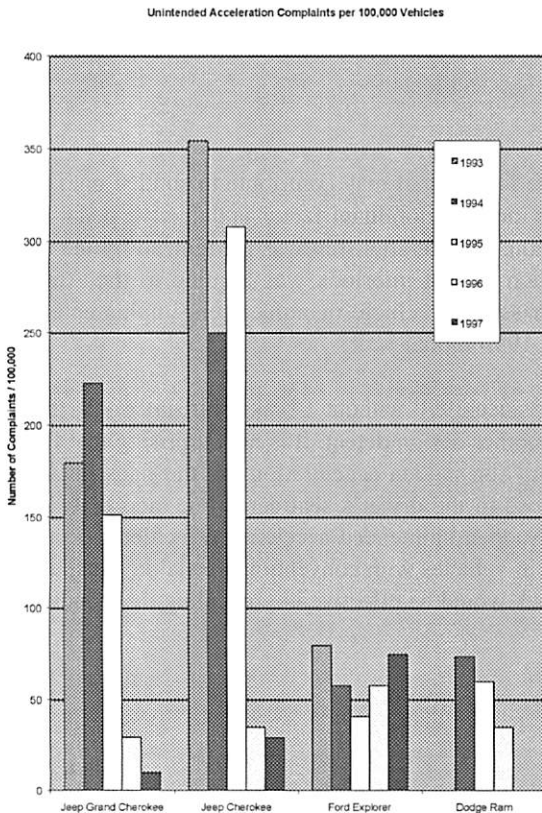
Figure 3

Rate of sudden acceleration complaints for 4 models over 5 years

- a. 1993-95 Jeep Cherokee and Grand Cherokee models have an unusually high number of sudden acceleration complaints relative to comparable sport utility vehicles, and;
- b. When Jeep added a shift-interlock in the 1996 model year, the sudden acceleration complaints were reduced dramatically.

The disproportionately high number of sudden acceleration reports in pre-1996 Jeep Cherokee and Grand Cherokee models is the result of two design defects. First, the location of the gas pedal is near the centerline of the driver's seat, where most drivers expect to find the brake pedal. This defective layout causes some drivers to step on the gas when they intend to step on the brake. Secondly, the absence of a shift interlock causes this unintentional pedal misapplication to result in accidents. The presence of a shift interlock would eliminate most sudden acceleration accidents.
