STRUCTURAL FAILURE REVIEW

Forensic Engineering Structural Failure Review By Finite Element Analysis

by W. T. Yaxley, CSP, P.E. (NAFE 270F) W. Bracken, P.E. (NAFE 605M)

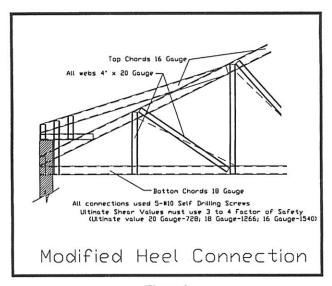
Figure 3

This was the field modification that the engineer of record designed and helped to modify in the field.

the revised end condition. The condition, shown in Figure 3, was the revised condition erected at the home. The original simple truss consisted of common triangles but was modified at one end heel connection by adding some indeterminate elements that seriously challenged the critical heel connection.

After the hearing and final judgement by the board, the board's consultant specifically asked W. C. Bracken to analyze the end connection modification, using a finite element analysis. The further analysis was to determine if the revised connection met the Standard Building Code requirements for wind load. The Bracken generated finite element analysis confirmed the serious overstress created by this field modification, by the engineer of record.

The balance of the Finite Element Analysis consisted of modeling and evaluating the as-built & as-modified conditions. These conditions yielded results to support the original investigative findings and to refute the assertions and conclusions offered by the design engineer at trial. More specifically, top chord members were found to be in tension, bottom chord members were found to be in compression and web members were found to be in bending. Therefore, the sufficiency of the design and the assertions and conclusions offered by the design engineer at trial ultimately were found to be erroneous.
