Vol. XX No. 1 June 2003

Anatomy of a Forensic Engineering Case

by Michael Kravitz, P.E., (NAFE 451S)

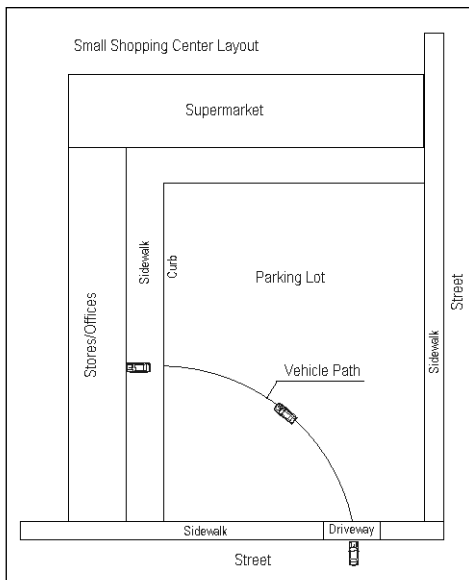
Figure 1

The Plaintiff was standing in a strip mall in front of an office waiting for the owner to open for business. The stores and offices were adjacent to and along side of the mall parking lot. A sidewalk was between the edge of the parking lot and the front of the store/offices. (See figure 1.) The store owner arrived through the driveway parking lot in 1997 Volkswagen Passat and was attempting to park in a painted stall in front of the office where the plaintiff was standing. The Passat accelerated instead of slowing and jumped a 3-1/4" high curb pinning the Plaintiff between store front and car. The air bags of Passat did not deploy. The Passat insurance company paid the full policy. The Plaintiff's physical and mental condition deteriorated with time and the Plaintiff was confined to a nursing home, probably for the rest of her life. Plaintiff sued the property owner and asphalt contractor who resurfaced parking lot several months prior to accident. The writer was consulted and was disclosed as the expert for asphalt contractor. The Plaintiff engaged an expert to prepare a case against the owner and asphalt contractor.

The purpose of opposing expert citing this section was to establish that the 3-1/4" curb reveal was not sufficient and was a result of the resurfacing, and that this type of accident should have been foreseen, i.e., vehicles mounting the curb. He opined that an 8" curb should have been maintained when the parking lot was resurfaced. In addition, the contractor was negligent when he allowed the curb reveal to become less than the "required" 8". The writer opined that this section did not apply for 2 reasons;

The resurfacing practice had been in effect in the City of New York since 1980. The reveal of the curb height in front of the store was 3-1/4" and was therefore within the minimum acceptable range of 2-1/2" and 4".

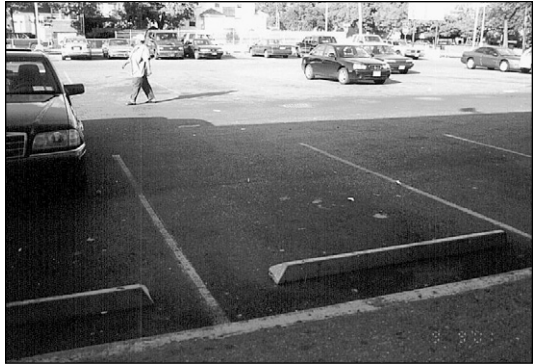
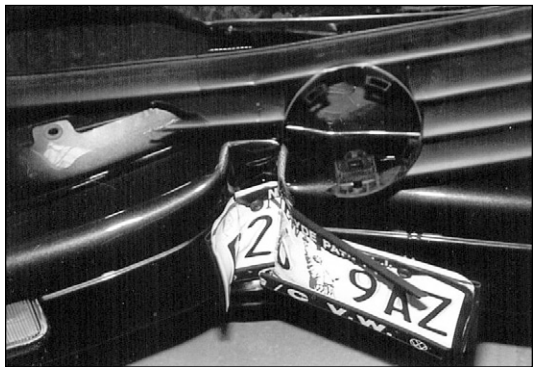
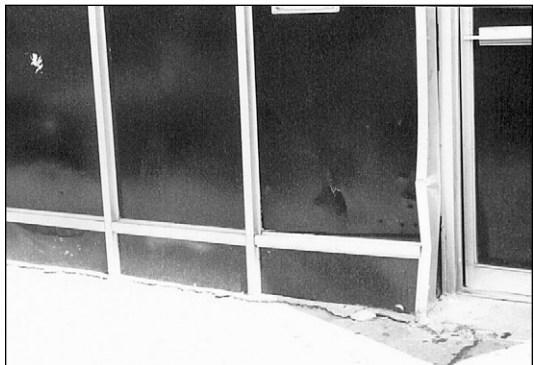
The owner resurfaced the parking lot in order to maintain the surface in a safe condition and therefore did not violate Section 27-128 (Owner Responsibility) of the current 1968 Building Code. Prior to resurfacing the surface of the parking lot was uneven and contained potholes.

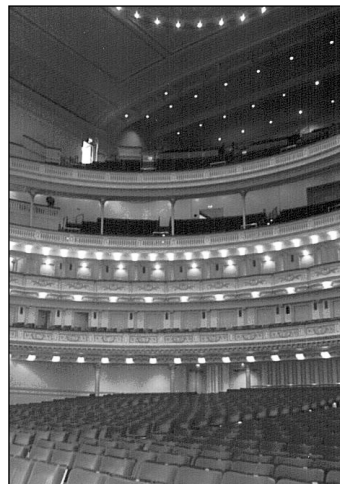
A Woman tripped and fell descending the upper balcony steps of an old auditorium. The New York City Building Department Public Access Property Profile Overview classified the building as a public assembly building with landmark status. There were New Building Permits (NB) issued in the years 1882, 1883, 1889, 1925, 1983 and 1986. This indicated that the building was constructed in compliance with the 1882 Building Code of the City of New York, and according to the 1916 and 1968 Building Codes of the City of New York depending on the year of the alteration. The Judge ruled that the 1892 Building Code would apply. The balcony section was the original construction with only cosmetic changes. The 1892 Building Code amended to 1885, required that for the construction of theaters, stairs and stairways shall have risers no higher than 7-1/2". The defendant had an expert at the time of the inspection but did not disclose the expert as the case progressed.

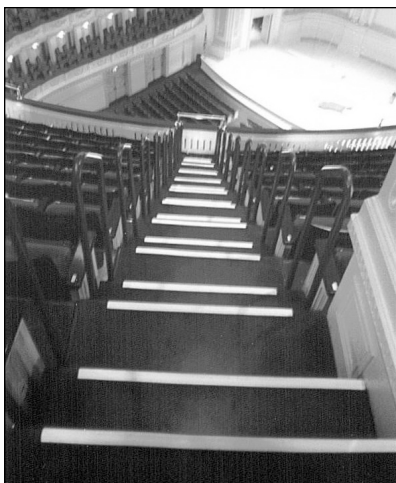
Aisles were not defined as either being steps, ramps or level. Aisles were only defined as being separations between rows of seats. Therefore, this particular aisle which included a series of steps, violated the riser height of the Old Building Code, the code to which the auditorium was constructed.
