Vol. XXI No. 1 June 2004

Forensic Engineering Investigation of Leakage at Flanged Windows In Stucco

by *Geoffrey G. Jillson P.E. (NAFE 429S)*

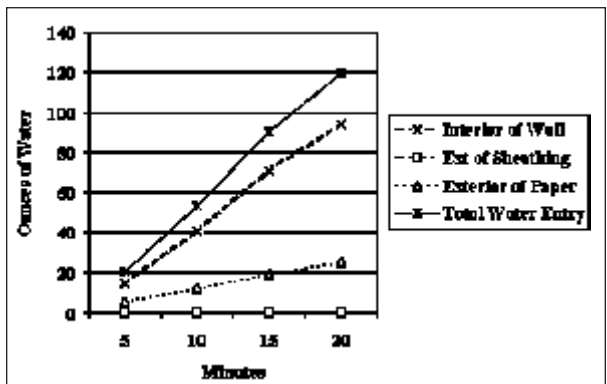
Figure 1

The data are presented in the following four graphs which show water entry at three zones of the test assemblies at the end of each of the four segments of the test sequence and a fourth curve showing total of all water entry. The test assembly with the flanged window experienced total water entry of 119.5 ounces with 79% passing into the wall cavity (figure 1). Application of sealant/caulk at the perimeter joint between the stucco siding and the clad surface which covered the 0.015 inch gap at the perimeter reduced water entry to 0.9 ounces resulting in reduction of water entry by more than 99% (Figure 2).

Water Entry by Zone – Flange Window without Caulk.

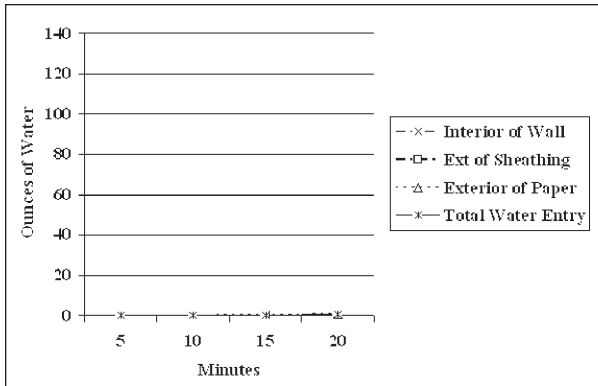
Figure 2

Water Entry by Zone – Flange Window with Caulk

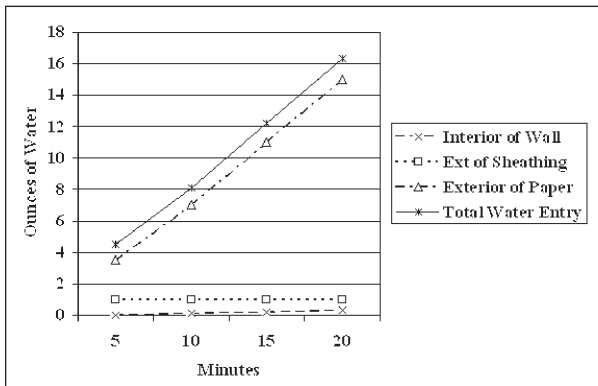
Figure 3

In the test section with the wood window without caulk total water entry was 16.3 ounces with 92% of water appearing on the exterior of the building paper and 0.3 ounces or less than 2% entering the wall cavity (figure 3). In certain commonly utilized acceptance standards such American Architectural Manufacturers Association (AAMA) 502-90, the allowable quantity of water entry is 0.5 ounces.

Water Entry – Wood Window Without Caulk

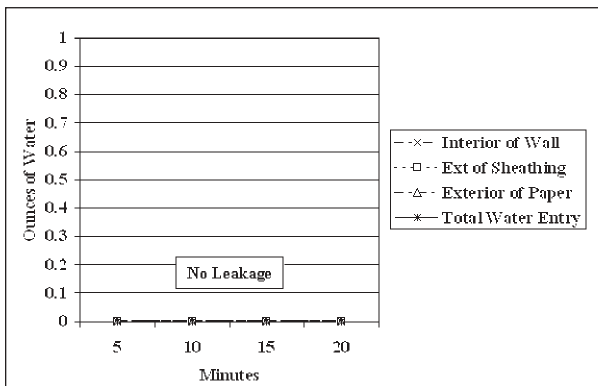
Figure 4

Wood Window with Caulk.

siding and the brick mold surface reduced total water entry to zero (figure 4).
