**Vol. XXI No. 2 December 2004**

# Forensic Engineering Analysis at a Traffic Signal: Who Had the Green Light?

by Robert T. Hintersteiner, P.E. (NAFE 327F)

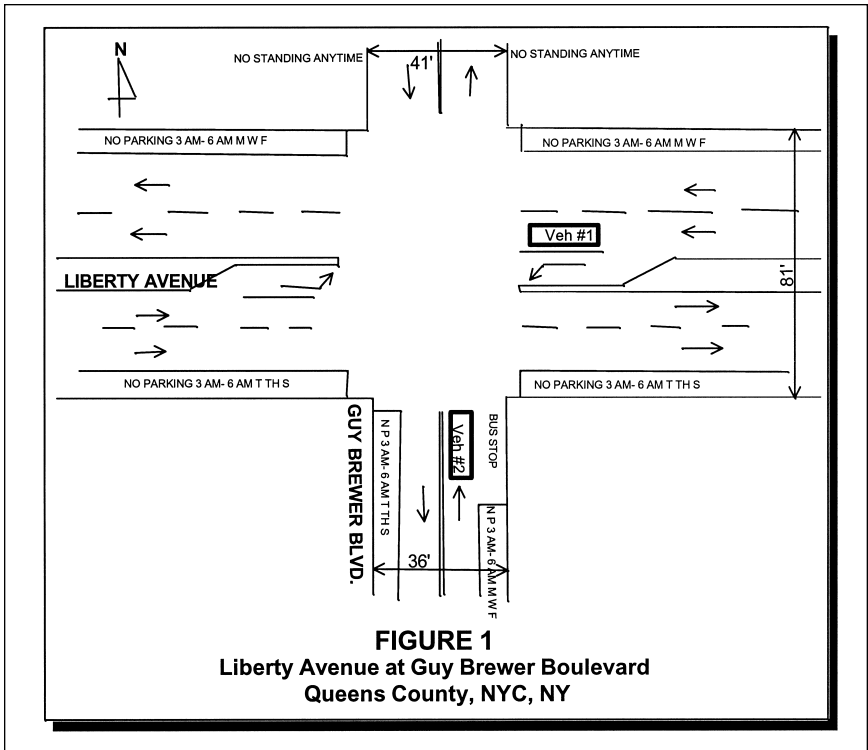
This case concerned a two vehicle accident that occurred when the traffic signal was in an all out condition, at the intersection of Liberty Avenue and Guy R. Brewer Boulevard, Jamaica, Queens County, NYC, NY. The question for the Forensic Engineer was to determine who would have had the Green Light? A condition diagram (Figure 1) was produced from an investigation of the intersection:

The Police Accident Investigation Report stated that the subject accident occurred Wednesday, February 23, 2000, at 5:30 AM, at dawn. A review of the Farmer's Almanac for 02/03/00 showed that Sunrise was at 6:39 AM. Therefore, the subject accident occurred while it was still night. The Police Accident Report also stated that Mr. F's vehicle (Vehicle #1) was traveling westbound on Liberty Avenue, and that Mr. R's vehicle (Vehicle #2) was traveling northbound on Guy Brewer Boulevard (see Figure 1).

An analysis and evaluation of the Electrical Contractor's Maintenance Work Sheets showed that the subject intersection controller had undergone three repairs of the same type during an eleven day period. The traffic signal was Out Of Time [coordination not working] at 6:18 PM on February 22, 2000, and it was repaired by replacing the Timing Dial (M-30), which was completed by 2:20 AM on February 23, 2000. During the following two and one half hours the traffic controller failed again, and it was reported as All Out at 5:00 AM on February 23, 2000 by a passing transit bus driver. An "All Out" condition means that the controller did not have any power and that a fuse in the controller cabinet had to be replaced. A second report was made at 8:59 AM by a citizen. Repairs were made and completed by 9:55 AM. However, the type of work done, which took 15 minutes, was not stated on the Work Sheet. This controller failed some time again during the next eleven days, which was reported on March 3, 2000, at 5:19 AM. The repairs done on the controller took 30 minutes and the maintenance person relocated the pinion gear on the switching motor

and replaced the fiber gear on the Timing Dial, which was No Good. Note that the same fiber gear (a part within the Timing Dial) was replaced just days before on February 23, 2000. In addition, the fuse blew soon after the original repairs were completed on February 23, 2000 at 2:20 AM.

The Electrical Contractor, per its own Work Sheets, was under contract to respond within two hours of notification for the above type of problems. However, the first call on 2/22/00 took 7 1/2 hours for a response, the second call on 2/23/00 took over 4 1/2 hours for a response, and the third call on 3/3/00 took over 2 3/4 hours for a response. If the Electrical Contractor had responded to the first call within the 2 hour period, and had repaired the Controller properly, then the subject accident would not have occurred.

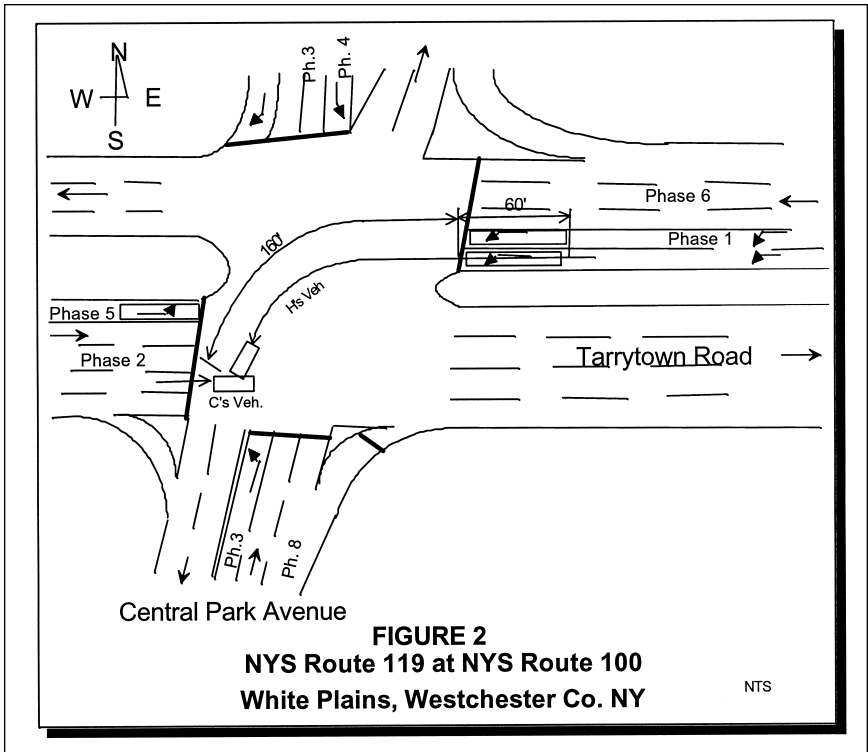
This case concerns two vehicles colliding at the intersection of Tarrytown Road and Central Avenue, in the City of White Plains, County of Westchester County, New York. The question for the Forensic Engineer was to determine who had the Green Light? A condition diagram (Figure 2) was produced from an investigation of the intersection.

The controller that operated the intersection of Tarrytown Road at Central Park Avenue had eight phase modules that controlled the timing and signal indications. They were as follows (see Figure 2):

To determine who had the right of way, an evaluation of timings for each phase was taken from the traffic signal timing sheets. Phase 1, Minimum Green Arrow interval, was 5 seconds, that is 5 seconds for the start of the Westbound Green Left Turn Phase. After the Initial Green time, the Green would keep extending an additional 1 second as long as a vehicle was located within the detection area, up to a maximum Green interval of 12 seconds. Upon loss of vehicle detection or upon reaching the Maximum Green interval, the signal would immediately change to a Yellow Arrow Change Interval of 3 seconds, followed by an All Red Clearance Interval of 2 Seconds, for a total of 5 seconds. Phase 2, eastbound Green Ball indications, would start immediately after the All Red Clearance Interval from Phase 1.

The Detection Area was located within the westbound double left turning lanes and it extended 60 feet east from the Stop Line. The path Ms. H traveled from the Stop Line to the Point of Impact was approximately 160 feet (see Figure 2). The total distance that Ms. H had to travel was approximately 220 feet

**Therefore, Ms. H had to go through the Red Arrow Indication.**

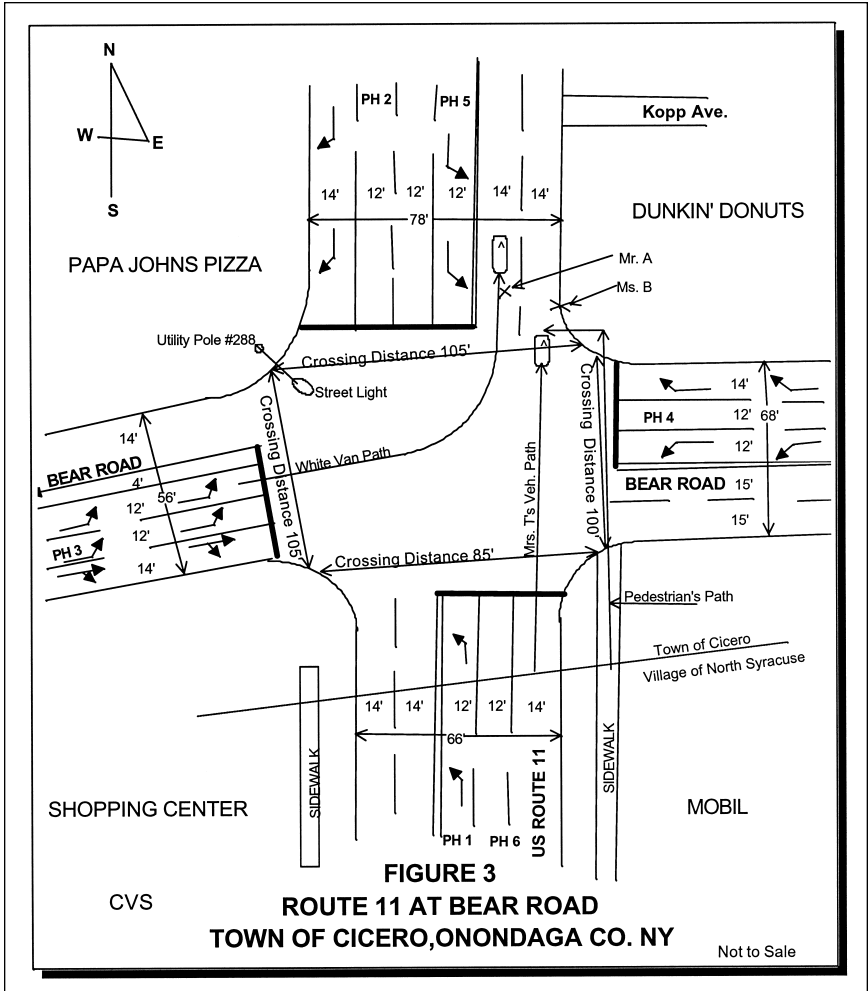
This case concerned two pedestrians crossing US Route 11 at Bear Road and being struck by two vehicles in the Town of Cicero, County of Onondaga, New York. The question for the Forensic Engineer was to determine did the pedestrian have a adequate time to cross the intersection? A condition diagram (Figure 3) was produced from a investigation of the intersection.

Bear Road was an east west roadway with three lanes approaching Route 11 and two leaving. The intersection was located in the Town of Cicero (Figure 3). The east approach was 68 feet in width, and the west approach was 56 feet in width.

There were no pedestrian signals, pedestrian push buttons, nor crosswalk lines located at the subject intersection to inform pedestrians where to cross and how much time they had to cross the intersection safely. Street lighting was located along the west side of Route 11 by the Village of North Syracuse, which included the intersection of Bear Road. There were no street lights located on US Route 11 north of Bear Road, and also on both approaches of Bear Road in the Town of Cicero. A review of the documents obtained from the NYS DOT revealed that numerous letters were received since 1991 regarding the unsafe pedestrian crossing conditions across Route 11. The NYS DOT's position was that they could not do anything to improve pedestrian safety until the law was changed. No pedestrian studies were conducted along Route 11.

An investigation of the subject accident revealed that it occurred at about 2:10 AM when Mr. A and Ms. B were walking north on the east side of Route 11 toward Bear Road after leaving a pub. They crossed Bear Road from the southeast corner to the northeast corner. When they started to cross Route 11 from the northeast corner to the northwest corner, they were struck by Ms. T's vehicle in the right lane (Figure 3).

When a pedestrian crossed any of the approaches to the subject intersection he could observe only a side view of the signal heads controlling that approach. This did not tell a pedestrian when it was safe to cross, because the other approaches had continuous traffic movement across the unmarked crosswalk. When Route 11 had a Red Indication eastbound, Bear Road (Phase 3) had a Green Arrow Indication, indicating a vehicle on Bear Road had the right of way without conflicting with vehicles and pedestrians. In addition, there were two lanes turning left, and any pedestrian would be caught between two side by side left turning vehicles. When the westbound Bear Road (Phase 4) traffic had a Green Indication, the eastbound traffic was stopped. The length of the unmarked crosswalks are shown in Figure 3, and a pedestrian would require at least 26 seconds to cross the north approach (105 feet/4 fps). The Green Indication extended from a minimum of 6 seconds to a maximum of 20 seconds, causing a pedestrian to be stranded in the middle of Route 11 traffic. There were no Pedestrian Push Buttons or Pedestrian Signals provided to permit a pedestrian to safely cross Route 11 and Bear Road.

The minimum crossing time for a pedestrian to cross the Route 11 north approach was 26.25 seconds (105 feet/4 fps). The Minimum Green time for westbound Bear Road (Phase 4 - current crossing movement) was 6 seconds with a Maximum of 20 seconds. There was no time for a pedestrian to cross this intersection safely. The time for the traffic controller to clear Route 11 and respond to a single vehicle detection on Bear Road and return to US Route 11 Green would have been 15.3 seconds (4.8 sec. for Route 11 Yellow & All Red + 6 sec. for Bear Road Green + 4.5 sec. for Bear Road Yellow and All Red Indications) which was less than the minimum time needed for a pedestrian to cross. A pedestrian would not have had enough time to cross Route 11 even if he started out at the beginning of the Bear Road Green Indication.

**Thus, I was able to show that the conditions that existed at the subject intersection caused pedestrians to walk against the traffic signal and into conflicting traffic when crossing any of the four approaches.**

Since the intersection of Route 11 at Bear Road had defacto crosswalks, the NYS DOT should have provided Pedestrian Push Buttons

and Pedestrian Indications to direct and provide the required timing to safely protect pedestrians crossing this extremely wide intersection.

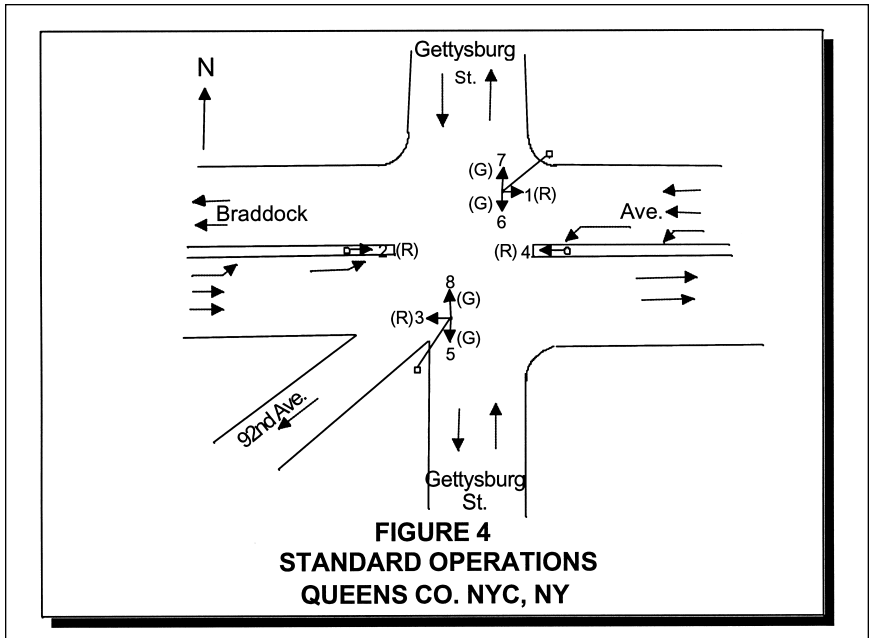
Figure 4 shows the traffic signal indications under normal operations as depicted in the NYC DOT Bureau of Traffic Operations Signal Plan.

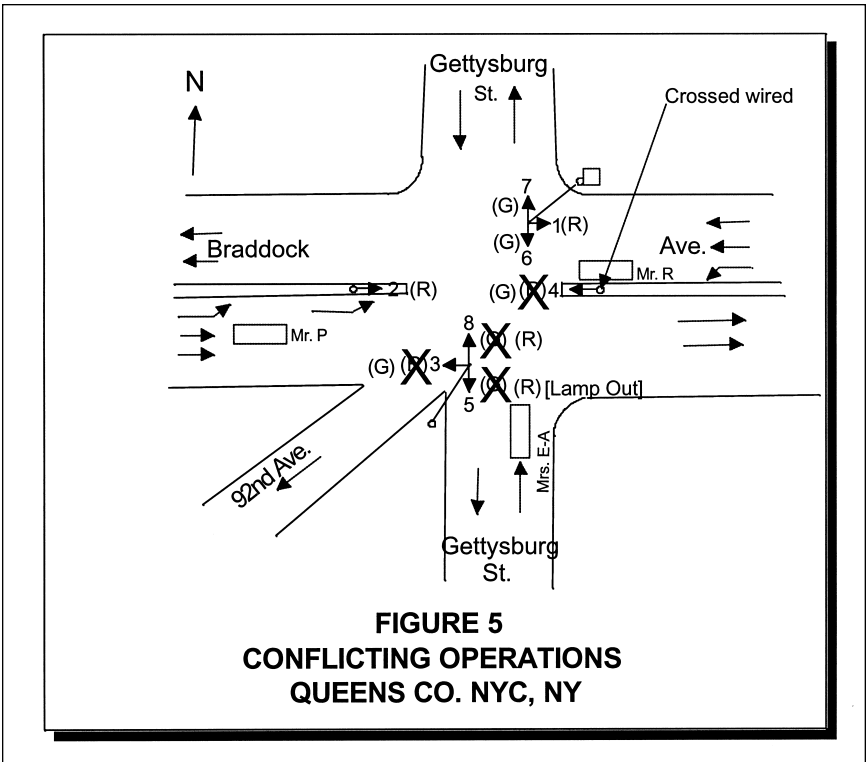
**FIGURE 5  
CONFLICTING OPERATIONS  
QUEENS CO. NYC, NY**

The question to be resolved was were all or some of the witnesses lying or were they all telling the truth? How could all the witnesses be right? After carefully analyzing the maintenance records I determined that the Contractor's maintenance personnel compounded the problems at the subject intersection. The key problem centered on the missing traffic pole which was assigned to the east center island, which was reported missing on 10/03/93. The maintenance crew repaired the signal wire between the controller to the east center island and the southwest corner mast arm. Splices were made at the east center island to connect the signal on the southwest corner mast arm pole. The connection to the signal cable were made in the base of the traffic pole on the east center island. However, at that point the wires were reversed, causing the following conflicting signal indications, which resulted in the subject accident:

1. Braddock Avenue Westbound – Two (2) **RED** Indications facing east.
2. Braddock Avenue Eastbound – Two (2) **Green** Indications facing west.
3. Gettysburg Street Southbound – One (1) **Green** Indication facing north on the northeast corner Mast Arm Pole. One (1) **Red** Indication facing north on the southwest corner Mast Arm Pole. (**Note: Conflicting Signal Indications**).
4. Gettysburg Street Northbound – One (1) **Green** Indication facing south on the northeast corner Mast Arm Pole. One (1) **Red** Indication (Lamp Out) facing south on the southwest corner Mast Arm Pole. (**Note: Conflicting Signal Indications**).

Figure 5 shows the traffic signal indications on the day of the subject accident, which were caused by conflicting signals as a result of improper splicing of the signal cable.

**Thus, due to the insulating of the signal wires with black electrical tape, each individual wire looked the same as the others, without displaying the standard wire color coding to match the signal indications and phases. The Contractor switched the Braddock Avenue signal indications with the Gettysburg Street signal indications, resulting in the conflicting Greens as shown in Figure 5.**

**The 10/03/93 work order stated that the damaged wires were re-insulated, which was not in accordance with acceptable industry practices. All exposed wire had to be removed or the entire cable had to be replaced. There was no acceptable industry standard for re-insulating stripped wires.**

When the S-1 pole was hit, the wires were pulled out of the conduit. As the wires were pulled out of the conduit, the plastic covering or insulation was stripped off the wires by the sharp edge of the conduit. The Electrical Contractor did not replace the pole, but only separated the wires and re-insulated the damaged wires with black electrical tape. No record was made of which wires was thus insulated.

One 10 Conductor cable came from the controller cabinet on the northeast corner, and the other 10 Conductor cable came from the mast arm pole on the southwest corner. The proper procedure was to replace both 10 Conductor cables. Therefore, since the wires had black tape around them, they all looked alike, resulting in the Braddock Avenue signal indications being switched with the Gettysburg Street signal indications, thus creating conflicting Greens.
