Vol. 38 No. 1 June 2021

# Forensic Engineering Analysis of a Swimming Pool Electric Shock Injury

By Robert O. Peruzzi, PhD, PE, DFE (NAFE 954M)

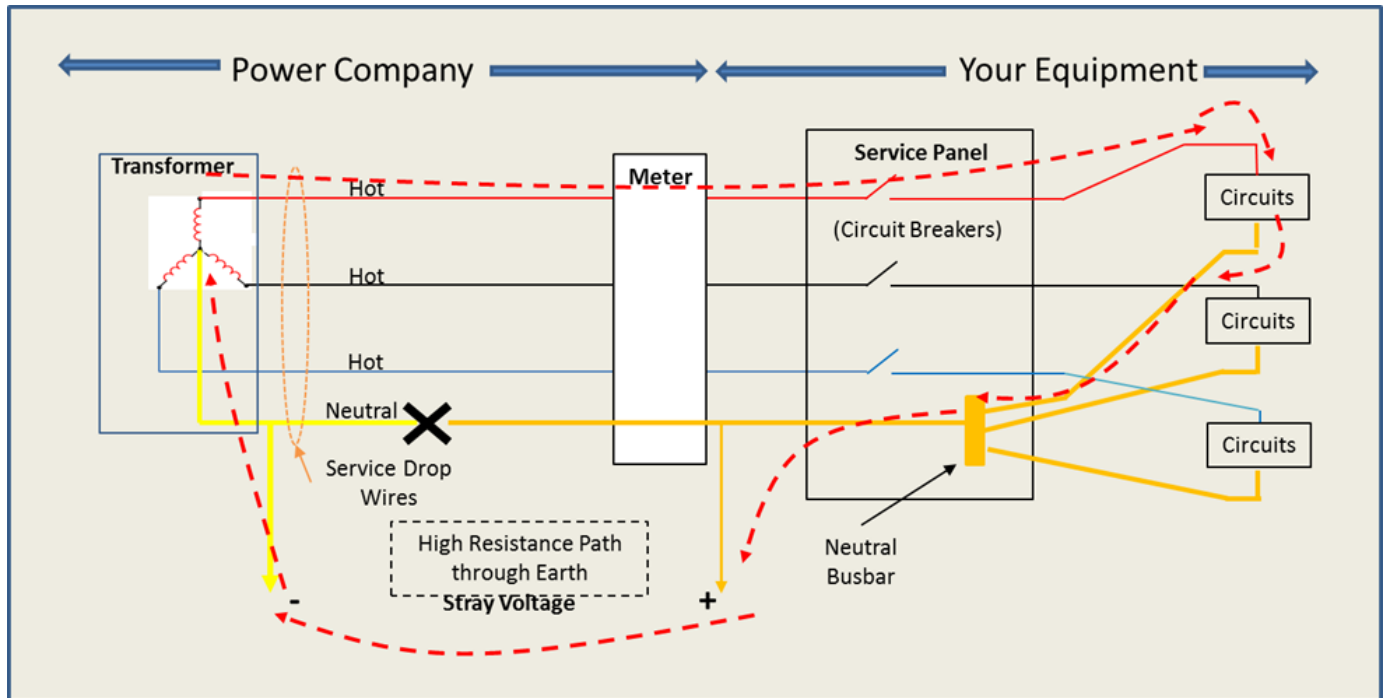
**Figure 5**  
Current flow with severed neutral in the service drop.

drop was severed, resulting in a dangerous condition. If the neutral wire of the service drop is severed as shown in **Figure 5**, the return current finds a different path back to the transformer. This alternative flow is from the service panel’s neutral busbar (yellow rectangle) through the grounding wire and ground rods, through the earth, through the utility pole ground rods and grounding wire, back up to the transformer’s neutral terminal. This path is not low resistance and is not intended to be a useful alternative to the neutral wire. “The earth shall not be considered as an effective ground-fault current path<sup>8</sup>.” The ground rods and wires are intended only to provide a voltage reference for the low-resistance neutral wire from the service panel to the transformer.

A severed or impaired neutral wire allows stray current flow through surface and voltage gradients across the surface. **Figure 5** illustrates an electrical system where the neutral return wire from the meter to the utility transformer has been severed or impaired (indicated by the large X). “Impaired” means the wire is partially severed or corroded and its resistance is much greater than it should be.

One such current path is indicated by the red dashed-arrows on **Figure 5**, flowing from the hot red terminal of the transformer through the meter, panel, wiring, and appliances. Return current cannot flow through the severed neutral. As the arrows indicate, the current flows from the neutral busbar, through the grounding wires and ground rods, through the earth, through the utility pole’s ground

rod, and back to the transformer’s neutral terminal. **Figure 5** shows the wires in this path as orange.

Referring to **Figure 5** for the case at hand, since return current could not flow through the severed neutral, the current flowed from the neutral busbar, through the grounding wires and ground rods, through the earth. This stray current took whatever path offered the least impedance to get back to the utility pole's ground rod, and ultimately back to the transformer's neutral terminal. That path in general will change from moment to moment according to changes in impedance due to moisture, temperature, and other factors. A likely path would have included the swimming pool and its surrounding fixtures and soil. As discussed in the section on ESD, conductivity is higher through the human body than through fresh water. Persons entering the pool lower the overall impedance of the path through the pool. Depending on a person's size, depth in the pool, and orientation versus the stray electric field across the pool, they may become part of the stray current path and receive a shock.
