Forensic Engineering Report: Finite Element Analysis of a Flex-Fan Blade Failure

by John Marcosky, P.E. (NAFE 205F)

Abstract

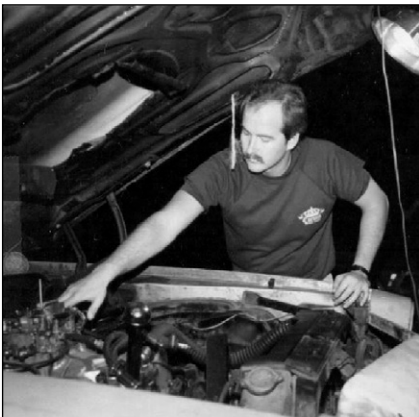
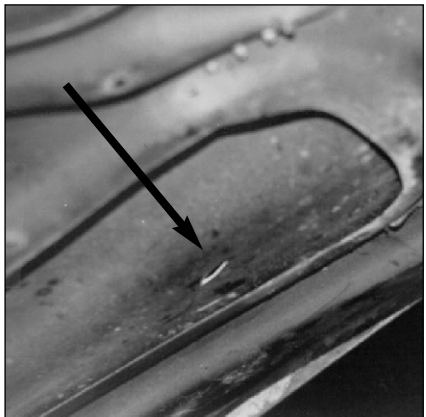
Following this test drive an open hood, engine running examination was conducted during which the throttle linkage was blipped three times. Estimated peak engine speed was between four and five thousand rpm. The operator was standing adjacent to the vehicle left front fender facing the engine compartment. His right hand was extended to the carburetor throttle linkage and left-hand resting on the fender. During the last rev cycle, three adjacent flex-fan blades separated from the hub assembly. One struck the operator in the face and another penetrated the open hood panel as shown in photo #1 and 2. A third struck an adjacent car.

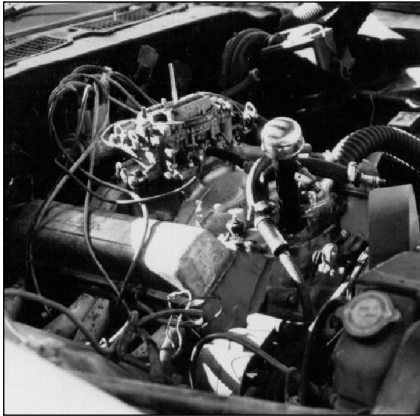
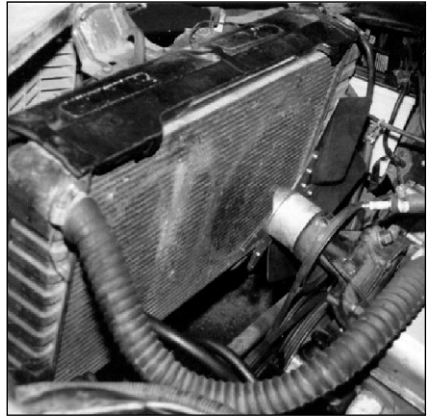
Examination of the engine bay revealed the replacement fan hub assembly and two inch spacer were properly attached to the water pump pulley. This vehicle was not equipped with a radiator fan shroud as shown in photo #3 and #4.

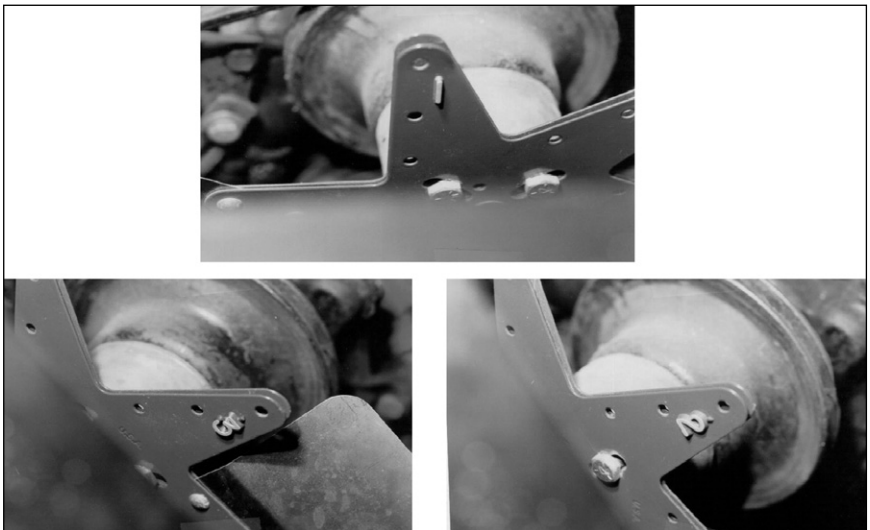
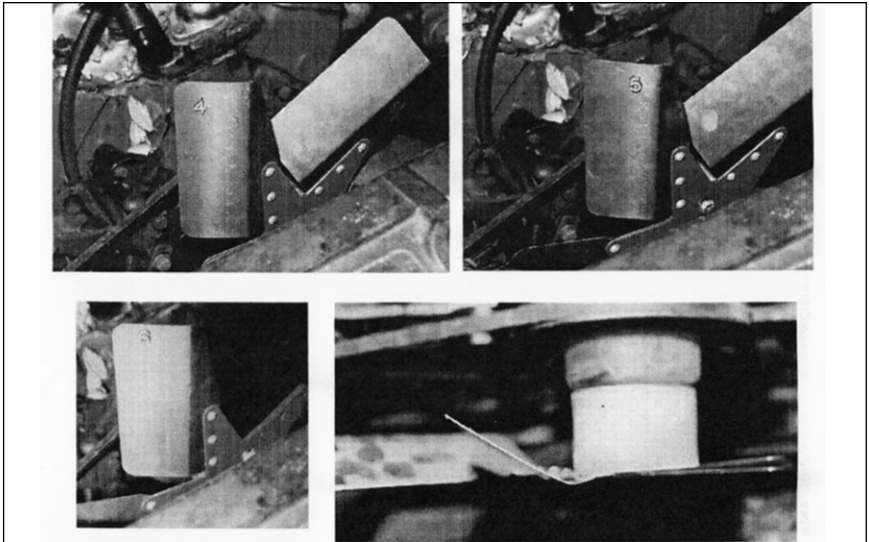
Each hub spider leg and corresponding remaining fan blade was assigned a reference number for photographic identification purposes. Three stainless steel blades remained attached to the steel fan hub spider by their aluminum rivets as shown in photo #5 and 6. Blade numbers 4 and 6 were loose at their rivet attachments and could be rotated at the outer edge approximately 1/32 inch.

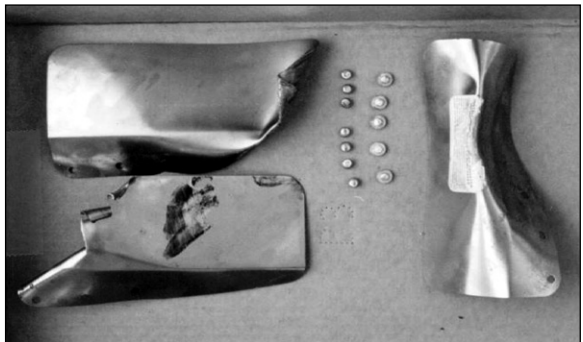
Photo 7

Three detached highly deformed fan blades, five manufactured rivet head segments and seven formed (bucked) rivet end segments were recovered from the scene as shown in Photo #7.

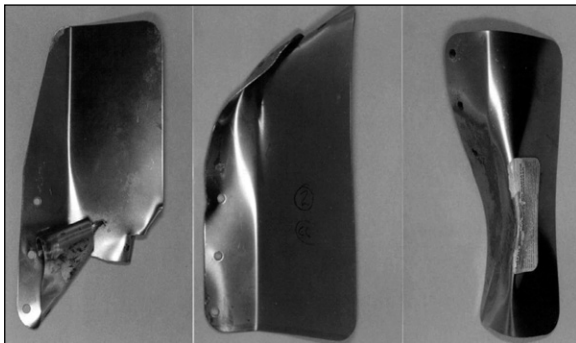
Photo 9

The three detached fan blades to be examined were numbered for purposes of identification; fan blades 1, 2 and 3 and are shown in Photo # 9. For ease of reference, the two sides of each blade were called the concave (cc) and convex (cx), respectively; rivet holes were identified as the inner (I), center (C) and outer (O), referring to their distance from the center of the fan assembly. Blades 1 and 2 exhibited possible evidence of multiple strikes. Blade 3 did not exhibit as severe a damage pattern, but had

been “pinched” at a point just beyond the tip of the spider. Blade 3 also had the installation-information note attached.

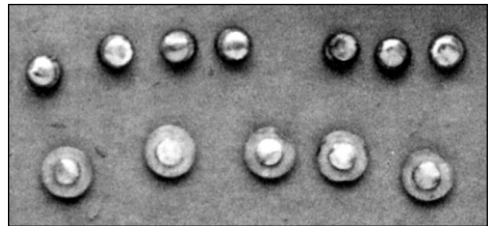
Photo 10

Four of the five failed manufactured rivet head segments and six of the seven failed bucked rivet end segments recovered at the scene shown on photo #10 were available for this examination. Reportedly, no other rivet pieces were found at the accident scene.

Failure of the nine rivets used to assemble the three blades to the spiders would be expected to result in a total of eighteen rivet pieces, there are apparently six rivet pieces missing.

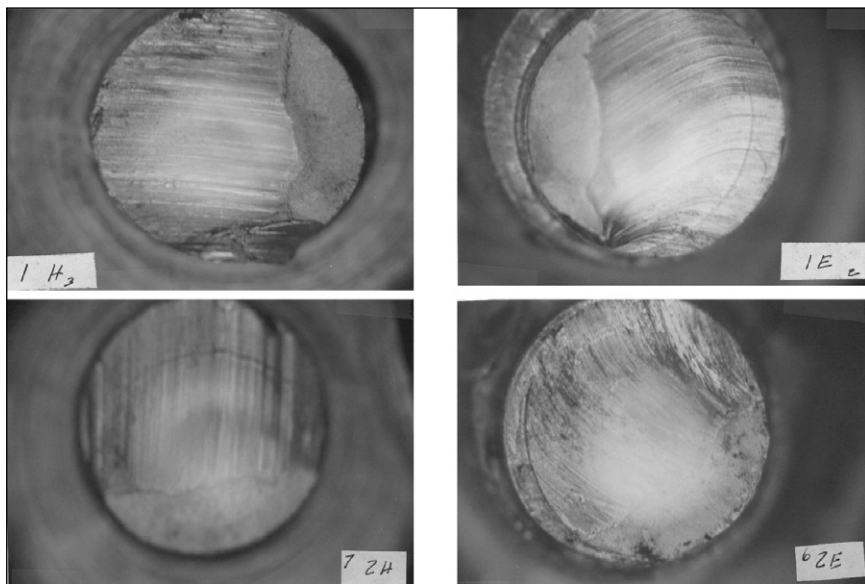
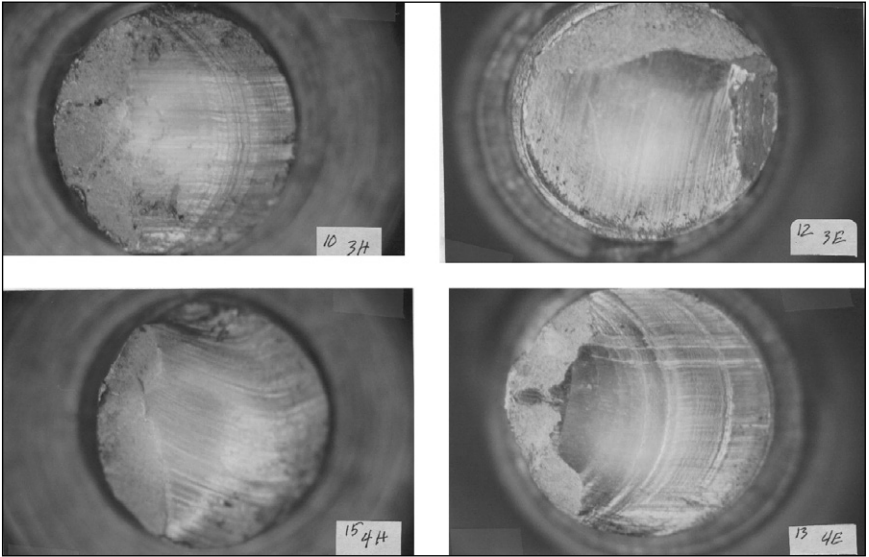
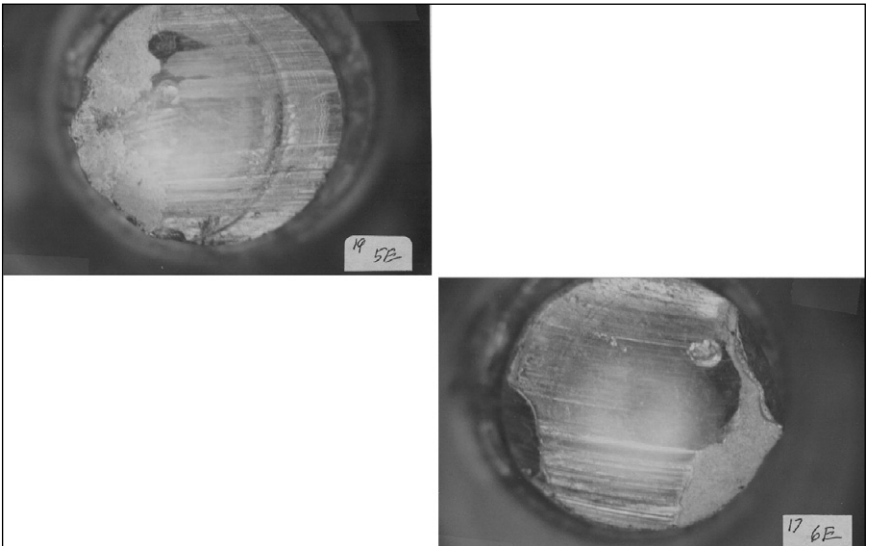
Optical photographs of the rivet fracture surfaces are shown on photos #11, #12 and #13. All of the fracture surfaces are relatively flat, perpendicular to the rivet axis, and composed of two different appearing areas on the fracture surface: a large, shiny, rubbed area and a small, dull-appearing, area. The dull area on all the rivet pieces were found to be composed of “dimples”. “Dimple” is a term used to describe the details of the fracture surface generated by microvoid coalescence, which is the characteristic mode of failure of ductile metals when they have been subject to loads in excess of their strength. In addition, the shape of the “dimples” relates to the direction at which the loads were applied relative to the fracture surface. For example; on the fracture surface of these rivets, the shape of the “dimples” corresponds to shear fracture. The general deformation of the rivet segments supports the finding of a rivet shear failure. The shiny area will be described during the analysis of photo #14.

No evidence of a typical prior fatigue crack, any other sub-critical crack growth, or any material or manufacturing defect was found on any of the rivet segments. Fatigue striations or “beach” marks would be a concentric ring pattern emanating from the origin site of the fatigue crack and were not observed both optically and in the scanning electron microscope. Additionally, the detailed

structure of the dull portion of the rivet showed that deformation had occurred, and in the fracture failure the forces involved were usually well below the yield stress of the material in shear. Therefore, deformation does not occur except in the last area to fail and would be limited in scope. In these rivets, there exhibited extensive evidence of deformation.

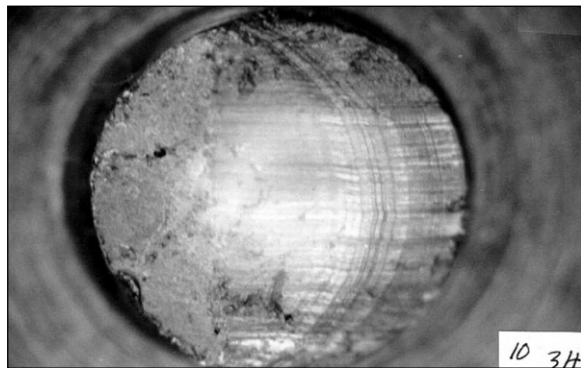
Photo 14

Shiny fracture surface of rivet (3H) reveals both straight and semicircular lines leading to a final fracture surface; shown on photo # 14. The straight lines are shear and the semicircular are chatter marks or "chatter band" where the shear formation occurred. These chatter marks are part of

a concentric circle and appear formed by the outside surface of a hole as it chattered, sheared and was pulled across the fracture surface. Chatter marks differ from fatigue marks which would be concentric around a point of origin, instead they are concentric about a point more or less in the center of the shank. Additionally, fatigue beach marks would have to predate the shearing process and the shearing process would obliterate them. Therefore, these marks had to be created at the same time as the shearing process in order to still be in existence and therefore are not fatigue beach marks.

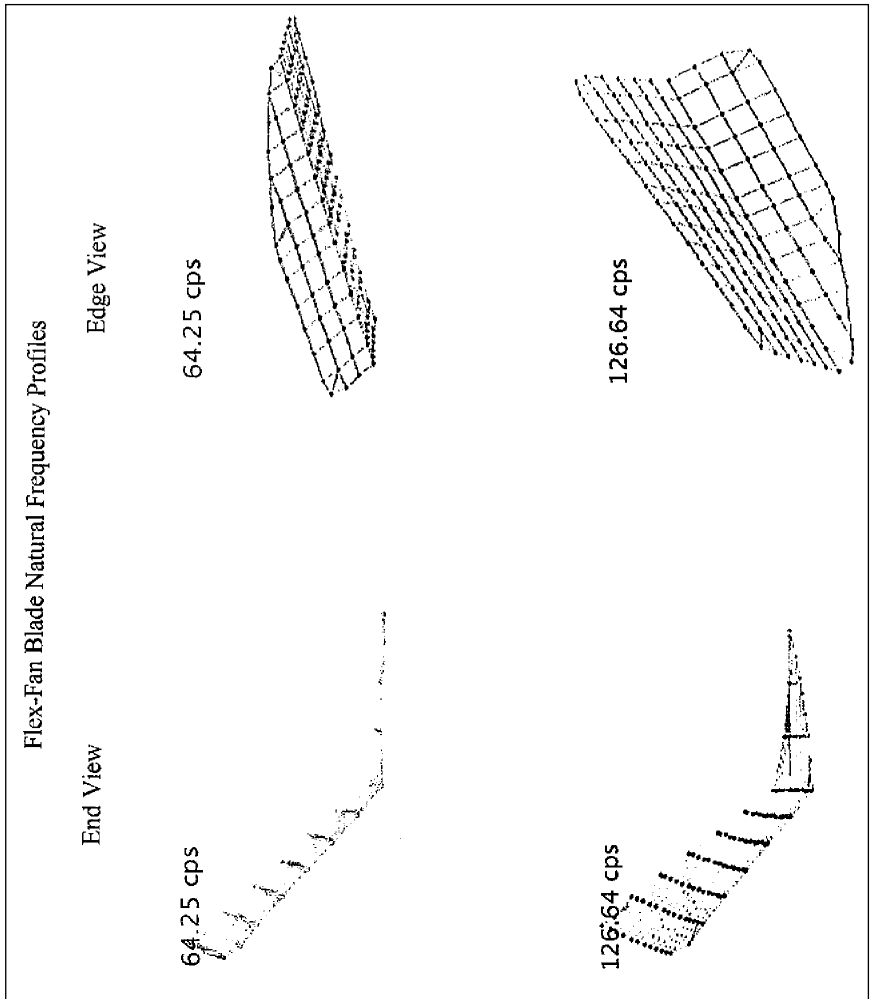
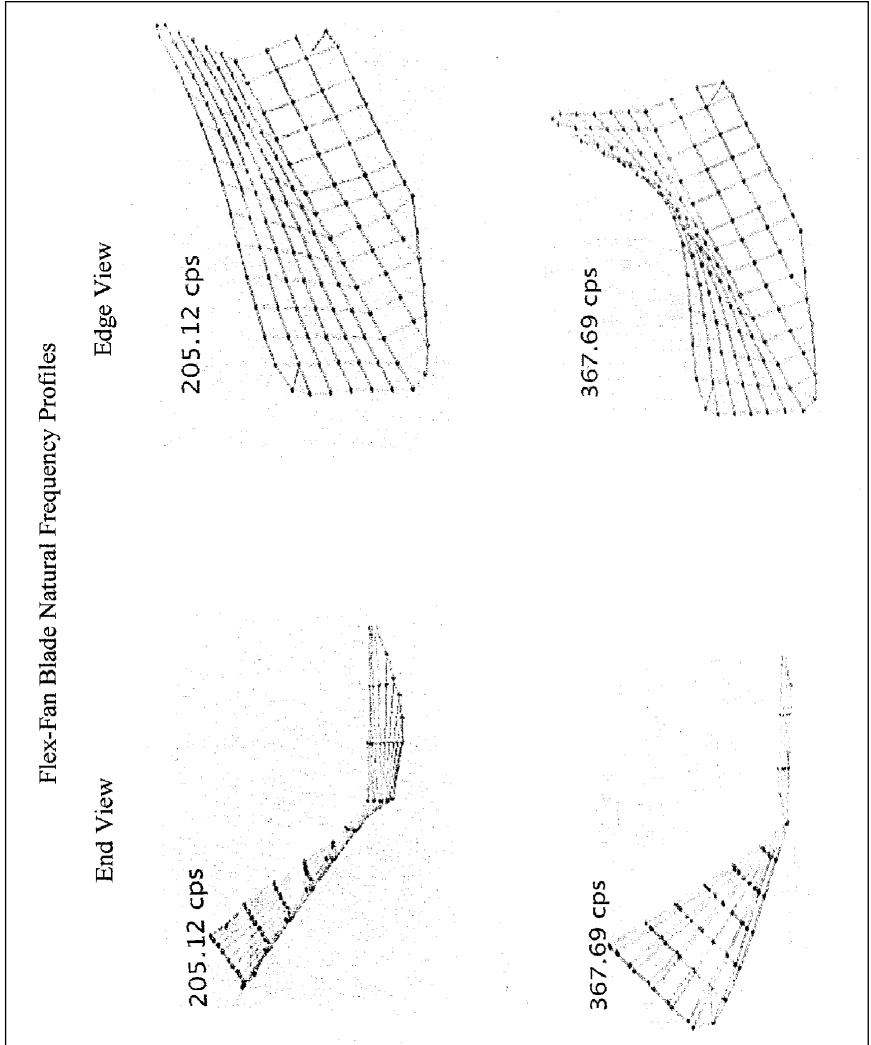
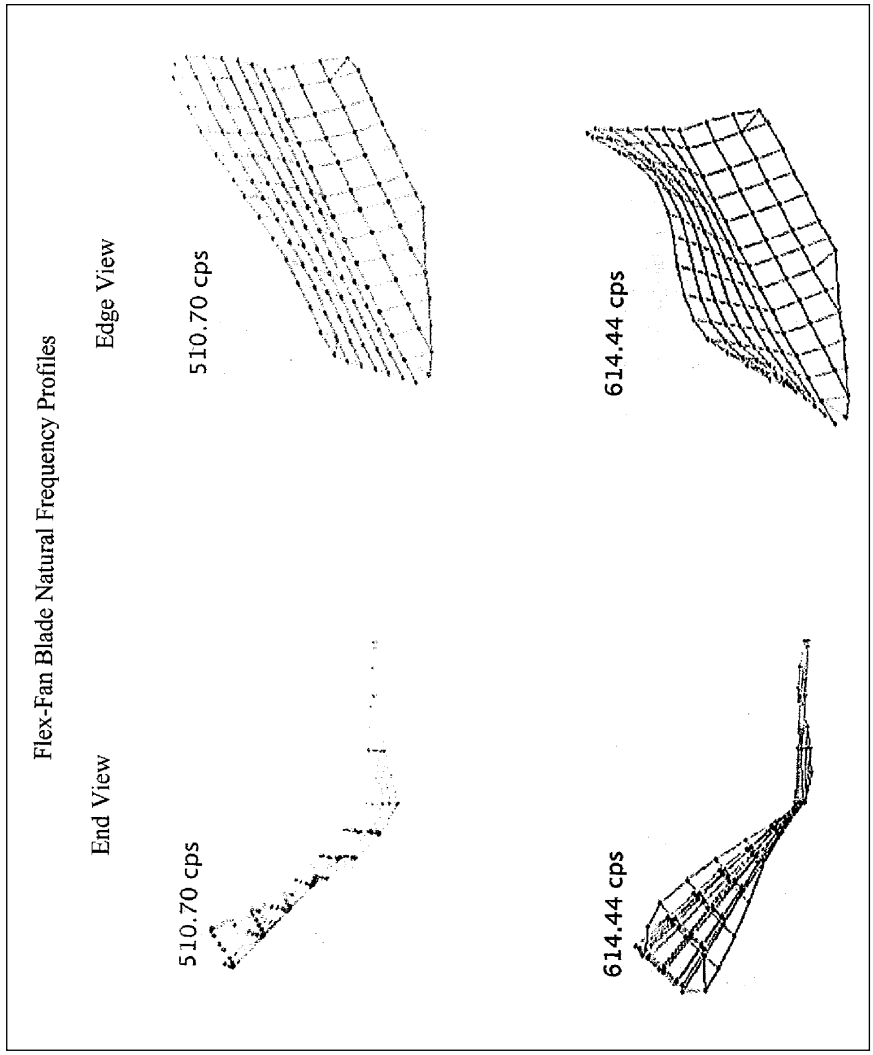
Analysis during the engine operating range revealed insufficient centrifugal force acting on the blades which would produce rivet overload stress and subsequent failure. Figure #6 is a tabulation of the generated flex-fan blade centrifugal force, at various engine rpm. Flex-Fan blade natural frequencies were obtained which revealed dynamic blade flutter. Figure #7 is a tabulation of these flex-fan blade natural frequencies. Photos #15, #16 and #17 are flex-fan blade configurations during these natural frequencies.

Analysis of flex-fan blade flutter revealed compromising of rivet retention due to tensile induced loads and subsequent compromising of the retaining hub, permitting blade movement. Engine firing frequency creates a rotational fan assembly pulse consistent with the identified rivet chatter lines resulting in rivet failure and separation of the flex-fan blade from the companion hub.
