Forensic Engineering Analysis of Falling Merchandise in a Retail Warehouse

by *Wilbur T. Yaxley, P.E., C.S.P. (NAFE 270F)*

Jeffrey D. Armstrong, P.E. (NAFE 644S)

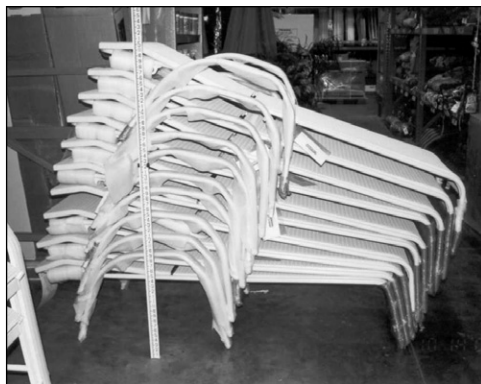
Figure 1
Exemplar stack of lounge chairs.

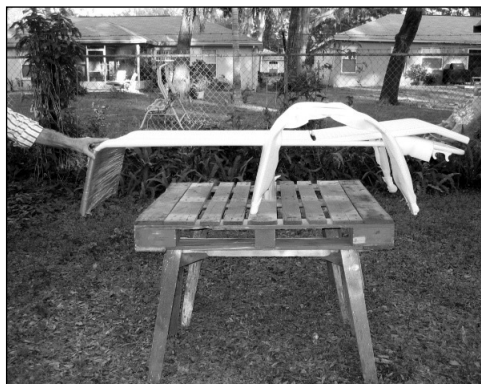
Figure 2
Single lounge chair on fork lift pallet.

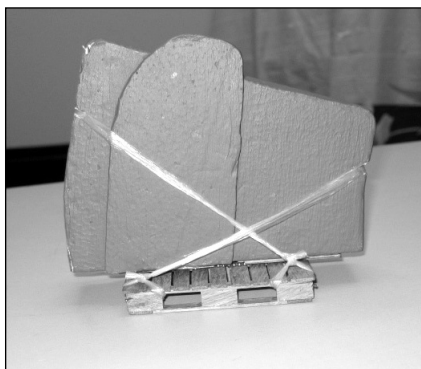
Scale model stack of chairs attached to pallet with stretch-wrap in X-bracing configuration.

The effectiveness of the X-bracing configuration shown in Figure 4 used with the lounge chairs was evaluated. With the stretch wrap cords capable of maintaining a constant stretched tension of approximately ten (10) to twenty (20) pounds, the amount of tension that was applied by the X-brace cords in the longitudinal (parallel to the lounge chairs), lateral (perpendicular to the lounge chairs), and vertical (up and down) directions was calculated. Table 1 summarizes the longitudinal forces, lateral forces and the vertical forces that were provided by the stretch wrap cords for a range of tensile forces of ten (10) to twenty (20) pounds in the cords if the chairs are centered on the pallet. Longitudinal forces resist movement of the chairs on the pallet from front to back. Lateral forces resist movement of the chairs on the pallet from side to side. Vertical forces hold the chairs down to the pallet. The calculation of longitudinal, lateral, and vertical forces are provided for both the upper cord (around the head-end of the chairs) and the lower cord (around the foot end of the chairs) is shown in the table.

It is notable that depending on the overall tension, each cord provides from 7 to 17 pounds of longitudinal force to resist movement of the chairs from front to back on the pallet, while providing from just 0.7 to 1.7 pounds in the lateral direction to resist movement of the chairs from side to side. This shows that the X-bracing using the stretch wrap material is inadequate to secure the stack of chairs to the pallet due to the inability of this configuration to resist the lateral forces which would prevent lateral movement of the stack of chairs on the pallet.

With the stretch-wrap cords providing only minimal resistance to lateral movement, it is probable that the wheeled stack of chairs rolled to the edge of the pallet during transport with a forklift or reach truck. Fork lift operators typically tilt the forks back once a load is picked up to ensure the load is not dropped during transport and stocking. If this happened, the wheel of the positioning frame could have slipped off the edge of the pallet, preventing the chairs from returning to the center of the pallet. This would have moved the center of mass closer to the front of the pallet, and would have changed the tension in the stretch-wrap cords. Table 2 provides a summary of the lateral, longitudinal, and vertical forces in the cords when the chairs have shifted to the front edge of the

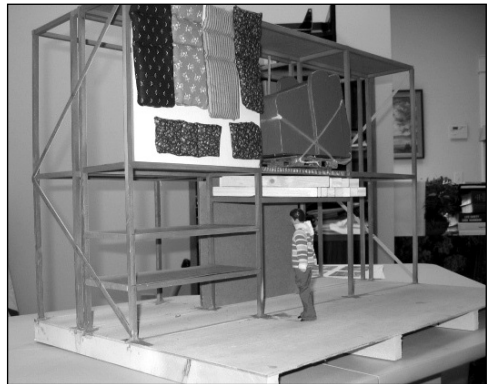
Figure 5
Overall view of scale model with chairs in overhead racks.

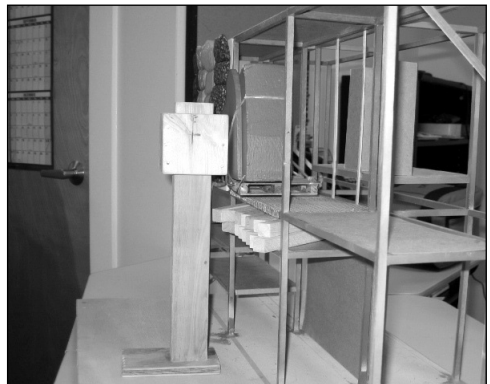
Figure 6
Overall view of scale model. Long boxes beneath chairs interfere with proper placement and viewing of lounge chairs.

There were approximately fifteen (15) long narrow boxes in the rack just beneath the rack that contained the stack of lounge chairs as represented in the scale model in Figure 6. It was determined from the photos that these boxes are approximately six (6) feet long based on their angled placement in the racks. They are placed in the racks at an angle to minimize their overhanging the front of the rack.

The forklift or reach truck operator would have encountered problems placing the pallet on the eight-foot rack due to the presence of the long boxes that extended out beyond the front of the racks approximately twelve (12) to eighteen (18) inches. The mast of the forklift would have struck the corner of the boxes, preventing the forklift from maneuvering close enough to the racks to place the pallet completely on the shelf. Damage to the corners of the long boxes that stick out the farthest can be seen in the accident scene photos, and provide evidence of possible contact from the forklift. These boxes would also have impeded the view of the shelves, making it difficult for the operator to determine whether the pallet had been placed completely within the racks. Engineering calculations suggest that the pallet was placed on the shelf so that the front of the pallet extended approximately six (6) to twelve (12) inches beyond the front of the rack, with the stack of chairs sitting at the front (closest to the aisle) of the pallet. The overhanging pallet may have been less noticeable during routine inspections than it might otherwise have been due to the overhanging long boxes directly beneath it.

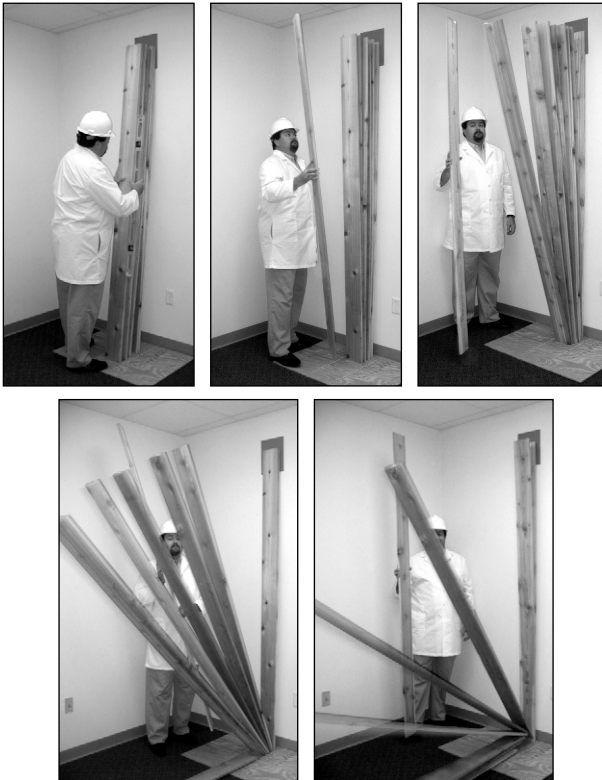
Figure 7

The incident was re-enacted by stacking boards vertically, with the bottom of the back board separated from the wall by a 2" by 4" board. The re-enactment revealed that even when the boards were stacked at an incline there was a tendency for them to "spring apart" once the first boards were removed. It was determined that if the back board was placed less than approximately four inches away from the back of the bin that the boards could fall approximately two to four seconds after the front boards were removed, due to the decompression of the warped boards. Our re-enactment of the incident was video-taped and shown at mediation. Sequential photographs of the re-enactment are shown in Figure 7.

- The plaintiff's description of the falling incident was reasonable and possible
- Stacking the boards too tightly compresses them so that when the front boards are removed, the remaining boards can then decompress and fall forward.
- If the boards are stacked with an insufficient incline they can fall forward
- The restraining bar was 6 inches higher than the top of the boards. A proper restraining bar would have prevented the incident.
