Vol. XXIII No. 2 December 2006

Forensic Engineering Analysis of Codes Causative of Building Envelope Failures

by *Geoffrey G. Jillson P.E. (NAFE 429S)*

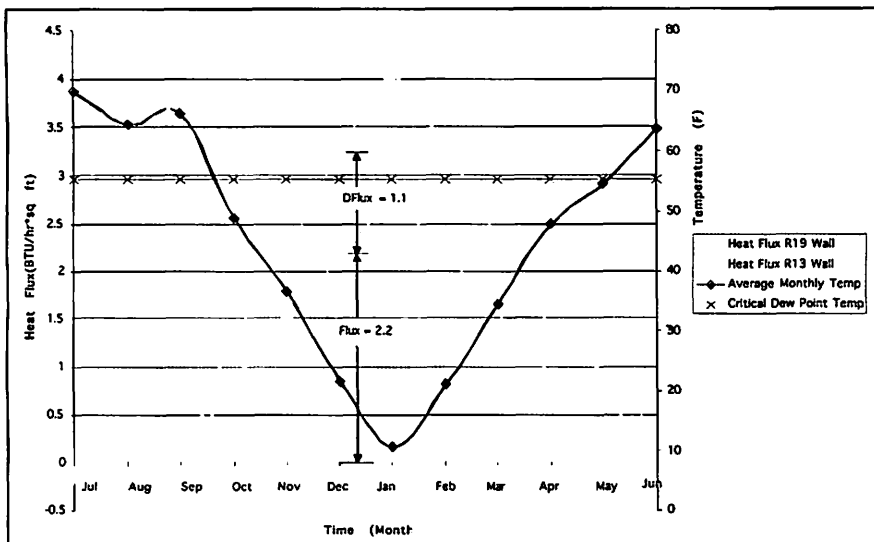
Heat Flux Through Wall

graph displaying the calendar year along the abscissa, heat flux expressed in Btu/hr-ft²·°F on the left ordinate and temperature in degrees Fahrenheit along the right ordinate. January 1st was set at the center of the graph for purposes of graphical simplicity and interpretation. The data generally show a heat flux decrease with the R-19 wall compared with the R-13 wall cavity of approximately 50 percent. The graph shows that the area between the curves of the R-19 wall heat flux versus the R-13 heat flux is substantial and that the differential extends over a long period of time.

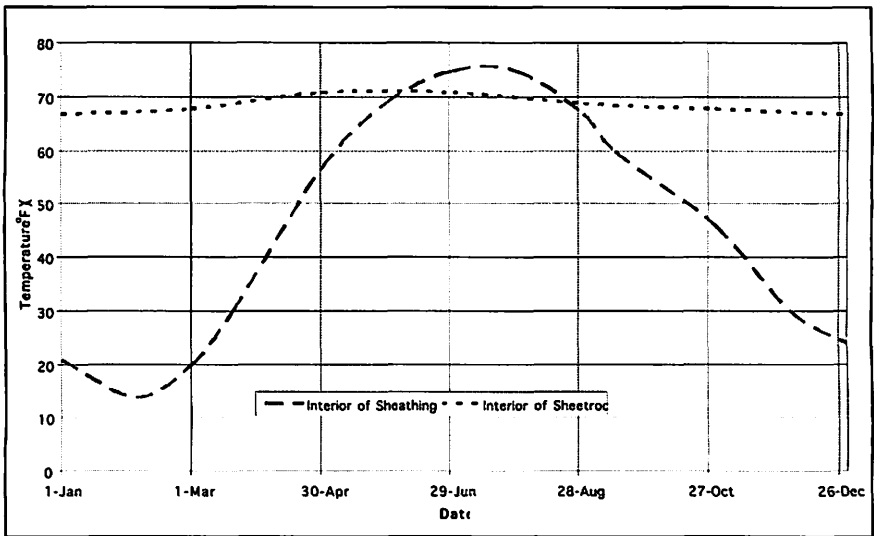
Average Temperature in Wall Cavity

The average temperatures at the interior of sheathing and at the interior of the sheetrock are calculated for the same wall assembly as was used for the humidity calculations shown above and also for a north exposure wall. Note that temperatures at the sheathing layer during the winter months are at or below freezing level of 32 deg F for extended periods. This is consistent with field observations which often reveal ice or frost on the interior surface of the sheathing layer within the wall cavity. The analysis is based upon water vapor present

on the exterior permeating through the hard coat stucco and moisture communicated from the habitable space through the gypsum wall board. As shown in the graph showing the temperatures in the wall cavity compared with the relative humidity levels, it is readily seen that intrusion of moisture into the wall cavities will result in condensation within the wall cavities.

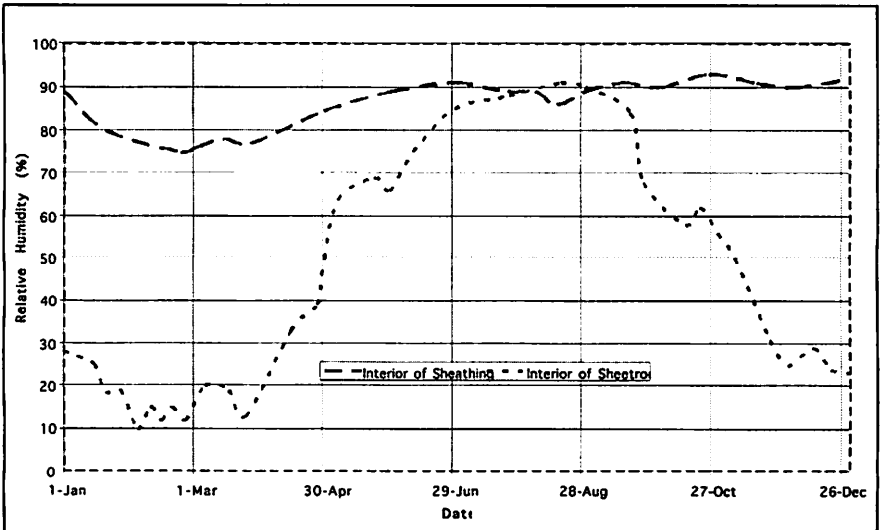
Average Relative Humidity in Wall Cavity

Modeling of relative humidity within the wall cavity and temperature in the wall cavity were performed utilizing a 2x6 standard construction fiberglass fill wall cavity with hard coat stucco. The graph presented shows the interior surface of the exterior sheathing within the wall cavity. This is shown with the calendar days on the abscissa and the relative humidity expressed on the left ordinate. The graph also shows the surface of the gypsum wall board on the interior of the habitable space. The days are expressed numerically with day 0 as January 1st and increasing to the right. The actual relative humidity level on the interior should be assumed to be continuous with the right hand portion of the curve at day 365. The data are computed for Minneapolis, Minnesota for a north exposure wall as described above. Note that relative humidity at exterior sheathing layer in the wall cavity remains high (above 70% rh throughout the year) even though large variations in interior humidity occur. This demonstrates that the poly vapor barrier is quite effective at blocking moisture migration into the wall cavity from the interior of the habitable space.

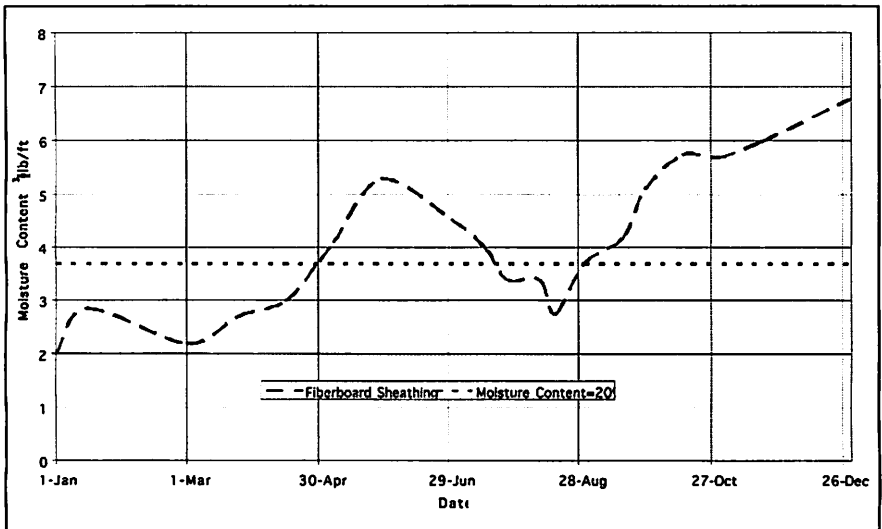
Moisture Content of Fiberboard Sheathing

Moisture content in the sheathing on the exterior of the wall cavity was modeled using the material wood fiberboard at the Minneapolis, Minnesota latitude and longitude approximately 44 degrees north latitude with a 2x6 standard stud wall construction and fiberglass fill insulation. The graph displays water content in sheathing expressed as pounds per cubic foot. Days begin with January 1 as day 0. The analysis results in moisture contents expressed as a percentage in the range of approximately 33 percent at the end of the annual cycle. In the mid winter period water content ranges from approximately 16 percent to

approximately 27 percent. The data reflect percentages above 20 percent, as shown on the graph. It is commonly accepted that at moisture content levels chronically above 20 percent deterioration (rotting) of wood products will occur. It is interesting to note that the moisture content in sheathing continues to increase throughout the period.

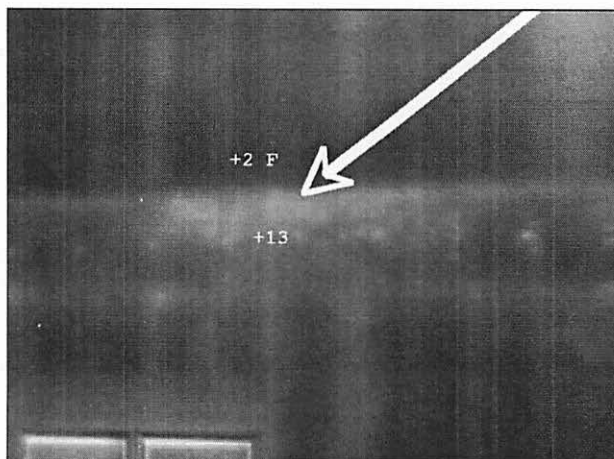
Infrared image depicting area of insulated rim joist showing effects of HVAC leakage.

greater than the habitable area. As a consequence, the overall slight negative pressure within the building habitable spaces does not result in air infiltration at the joist spaces but rather air exfiltration from pressurization of the joist spaces. The interior atmosphere in winter months has almost uniformly much higher relative humidity levels than the exterior due to the sharp temperature differentials. As a consequence, pressurized, moisture laden air enters the wall cavities. Sealing of ductwork is not required by the codes at static pressures below 0.25 inches water column in the supply ducts. Residential systems observed by this office have always been below this static pressure and therefore excluded from the requirement of sealed ductwork. Consequently, the effects of the high insulation levels in the walls and un-sealed ductwork have resulted in a conflict with the result that moisture laden air is driven into the building envelope.

During multiple field inspections where penetrations are cut through the exterior of the building envelope through the siding and sheathing at rim joist levels, the condition of air leakage from the interior to the exterior has been readily observed without instruments. The volume of air movement is large as compared with the relatively small volume in the wall cavities. Exteriors of the wall cavities are not sealed as compared with the interiors which require vapor barriers and therefore provide air flow and continuous supply of moisture. Consequently, there is an overall exfiltration into the wall cavity of moisture laden air as pressure relief through the exterior occurs. The relatively cold surfaces of the exterior sheathing level within the wall cavity provide surfaces upon which the moisture condenses. The effects of leakage in ductwork appear to have been under estimated or ignored by the promulgators of the energy code with unforeseen adverse effects.
