Forensic Engineering Use of Surrogates in Injury and Fatality Cases

by John P. Leffler, PE (709M)

Case 1: Limousine crash on highway

Case 3: Tractor/mower operator fatality

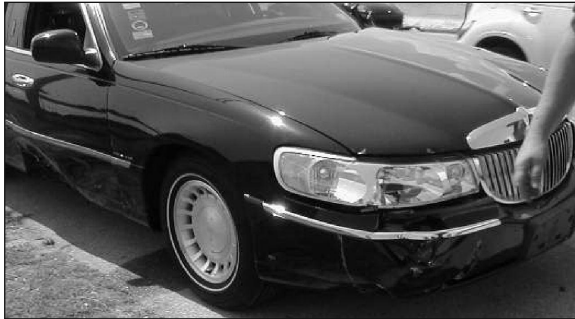
The client was an attorney representing the insurer of a truck freight firm. One of the firm's panel delivery truck drivers lost control and spun sideways on a multilane highway while braking for stopped traffic. A following limousine was unable to stop and impacted the side of the delivery truck with a delta-V of 5-10mph. A motorcycle then impacted the driver's side of the limousine. See Figures 1 and 2.

Figure 1
Damaged front of limousine

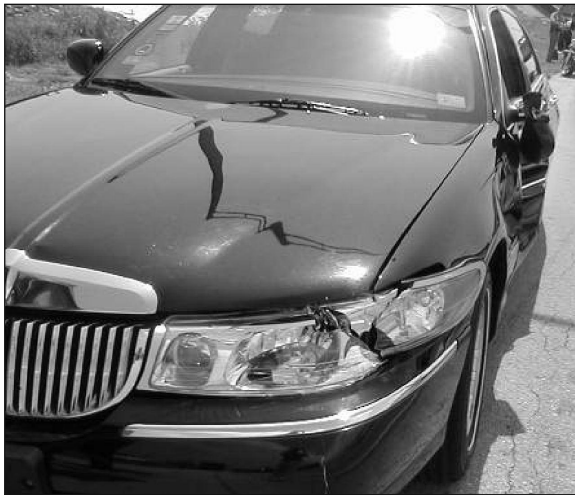
Figure 2
Damaged front and side of limousine

The right side rear-seat limousine passenger (Mr. Jones) suffered fractures of three left ankle bones, in a manner consistent with torsional loading of the lower extremity. He was interviewed and left the scene in an ambulance. After a few weeks of recovery, further treatment in an overseas medical facility led to an ankle infection and his death. The plaintiff, his wife, sued our client for causing the crash and the associated ankle injuries.

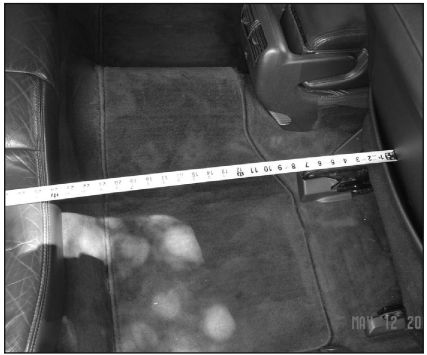
Figure 3
Measurement of exemplar limousine

An exemplar limousine was found, as was a 35-year old male having the desired physical proportions. The surrogate evaluation allowed us to determine the significance of the front passenger’s seat position, the seat track location and geometry, the comfortable foot positions and ranges of motion for the surrogate, and the ability of the surrogate’s foot to be trapped or otherwise restrained by the footwell components. See Figures 3 – 5.

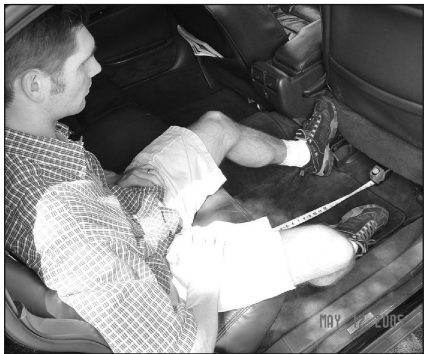
Figure 4
Surrogate seated in right rear of limousine

The key information we determined from the surrogate evaluation was that it was possible for the surrogate to have his foot trapped in the footwell, even while seated in a comfortable position, and that such a position was possible while properly restrained by the seatbelt. That information, combined with knowledge of the body movement that can be expected while restrained in a frontal collision, led to our conclusion that it was possible for Mr. Jones to suffer this injury while restrained. The case was settled before trial.

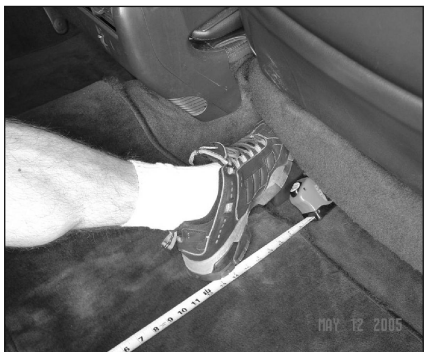
Figure 5
Surrogate’s foot in seat track area

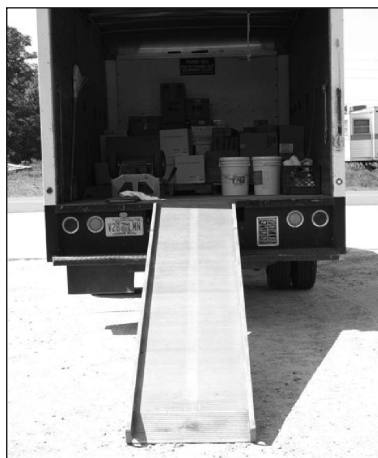
Figure 6
Delivery truck and ramp

See Figures 6 and 7 for views of the truck, ramp, and hand cart. Note the top "hoop" of the hand cart – this is what allegedly struck the plaintiff's chest.

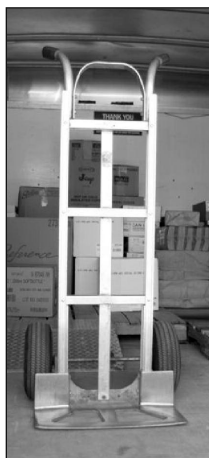
Figure 7
Subject hand cart

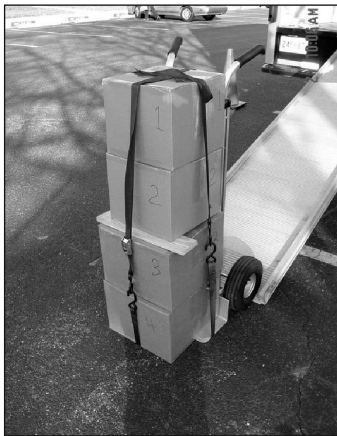
An exemplar delivery truck/ramp and hand cart were obtained. The 20 pound hand cart was loaded with four appropriately-sized boxes of dirt, each weighing 30 pounds. Finding an appropriately-sized surrogate was a challenge, due to the 5 foot tall, 285 pound proportions of the plaintiff Mr. Brown. Anthropometrically, this represents a person two inches shorter than a 1.0 percentile male that is 40 pounds heavier than a 99.0 percentile male.² An actor was found who was 5 feet 3 inches tall and 185 pounds. See Figures 8 – 9.

Figure 8
Exemplar hand cart

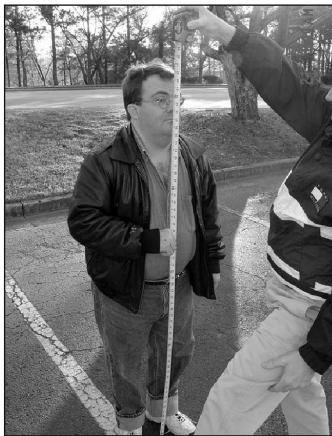
Figure 9
Surrogate

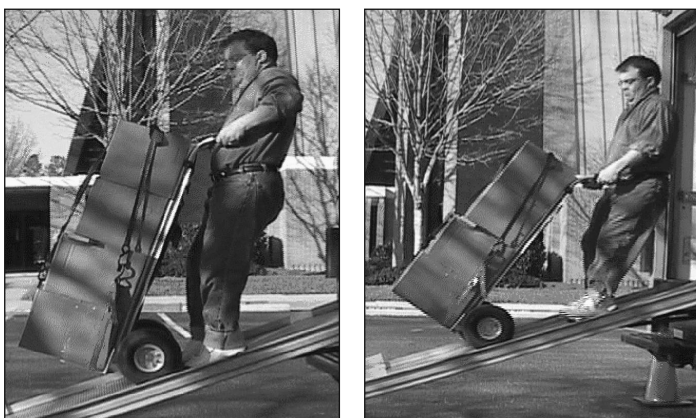
unstable task. See Figure 10 for a comparative view of these positions – and note the position of the top hoop of the hand cart in either view; it is at least 12 inches below the mid-sternum of the chest.

Comparison of plaintiff's claimed method of handling the cart (left) and surrogate's method that he found comfortable (right)

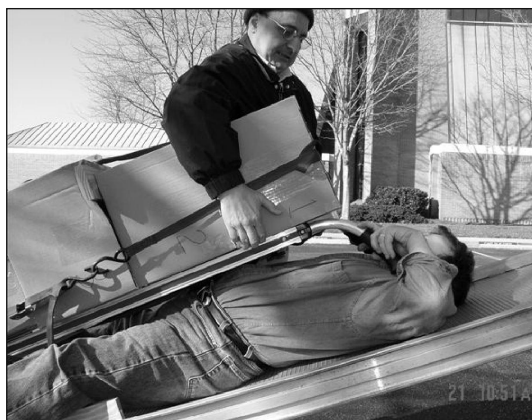
Figure 11

Another questionable action was that the plaintiff, Mr. Brown, maintained that he held the hand cart handles to his chest throughout and after the fall. Aside from the fact that his instinctive (unconscious) fall-protective reflexes would have caused him to let go of the cart in an effort to protect himself, this seemed unlikely from a biomechanics standpoint. We positioned the surrogate on the ramp with the loaded hand cart in the necessary position for the top hoop of the cart to contact his chest. The surrogate could not securely grip the cart handles due to extreme hyperflexion of the wrists and the associated pain and discomfort,

and in fact it was necessary for the consultants to support the weight of the cart. See Figure 11.

Surrogate in position claimed by plaintiff

The conclusions from the surrogate evaluation were that the plaintiff, Mr. Brown, likely did not operate the hand cart on the ramp in the manner described, and that he could not have been struck in the chest by the top hoop (or any other part) of the hand

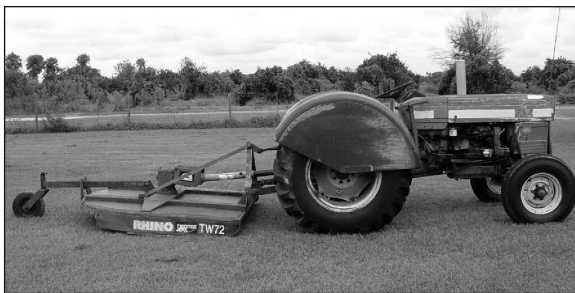
Figure 12

A farm worker (Mr. Smith) was mowing a friend's orange grove using his friend's small farm tractor and 6-foot diameter mower. The man was last seen at 10am and didn't show up for lunch. He was found dead in the grove with catastrophic injuries, having been crushed by the tractor's rear wheel and then run over by the mower. The tractor/mower was found some distance away in the grove, where it struck an orange tree. It was found with the engine running and the mower blades and tractor wheels turning. See Figures 12 and 13.

Subject tractor and 6 foot diameter mower

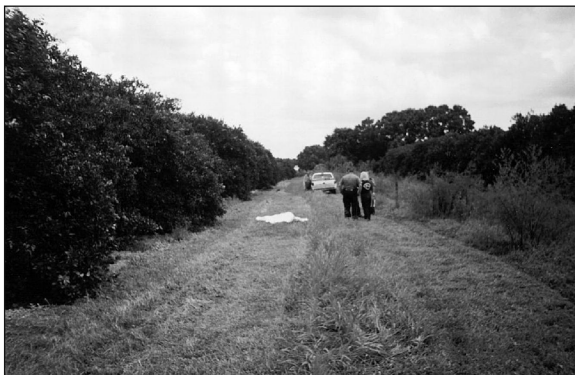
Figure 13

Scene photograph taken by police

The local police did a detailed inspection of the scene. They reported that the mowed area along the tractor's travel trajectory was largely level, with no ruts, boulders, or other obstacles. The mowed trajectory of the tractor/mower itself was largely straight along the entire incident location. The tractor was not found to have any significant mechanical problems.

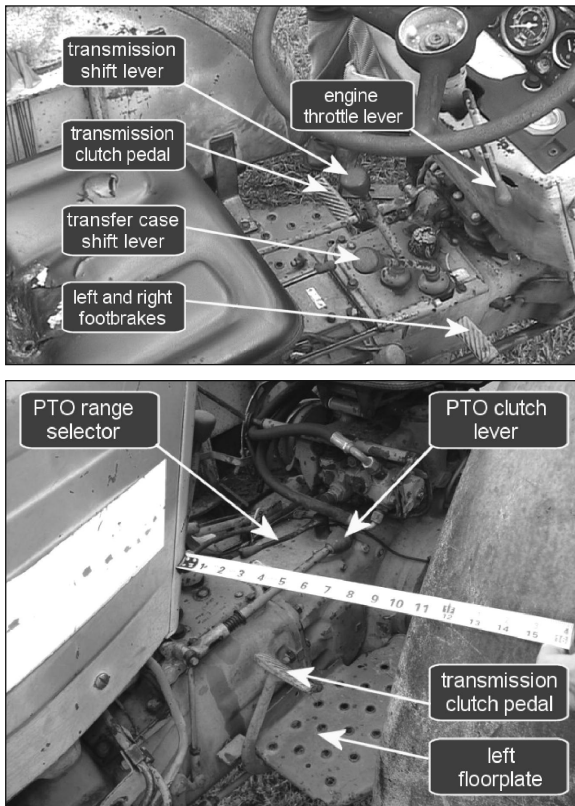
Figure 14
Tractor components and controls

This tractor could only be mounted or dismounted from the left side, due to the presence of a right-side bracket. When seated, the tractor operator sits astride the transmission with a variety of control levers surrounding him. This tractor had also been fitted with rear fenders; there was a narrow 11 inch gap between the left fender and both the steering wheel and dashboard edge. See Figure 14.

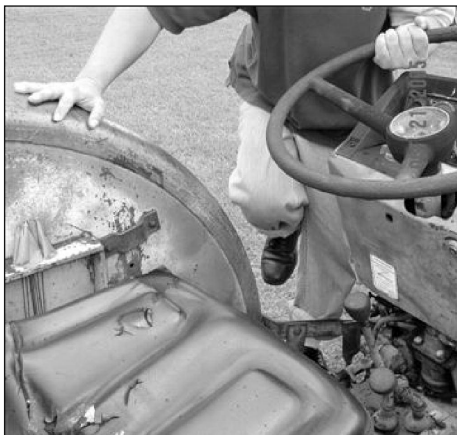
Figure 15

The surrogate was directed to mount and dismount the tractor in any manner he found appropriate. It became apparent that a complex series of movements was required, due to the positions of the fender, fender support, steering wheel, shift levers, pedals, and transmission housing. It was necessary to brace against the smooth fender edge with the right hand when mounting and dismounting. Once seated, the narrow 11 inch gap between the steering wheel and fender hampered the ability of the surrogate to “fall” from the seat. See Figures 15 and 16.

Surrogate bracing against the fender during mounting

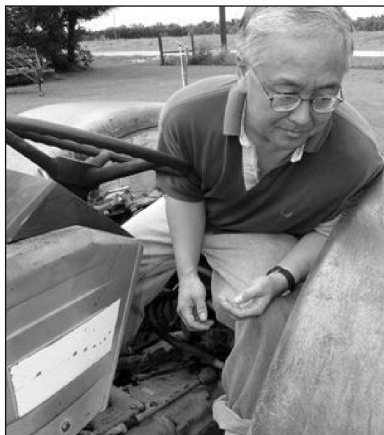
Figure 16

Surrogate demonstrating narrow gap between steering wheel and fender

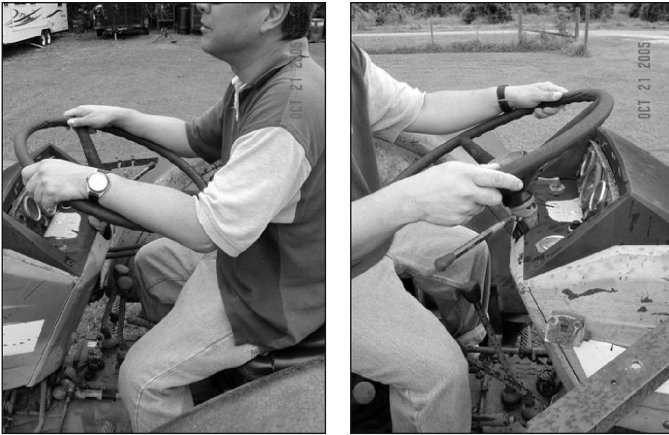
The positions of the various controls relative to the surrogate were evaluated to see if one of the controls could have been inadvertently bumped in a way that could have caused ejection from the seat. The throttle lever was “guarded” by the steering wheel and was too high for inadvertent knee contact, and bumping the transmission shift lever or transfer case shift lever with the legs would knock the transmission into neutral. See Figures 17 and 18.

One key finding (though not unexpected) was that the transmission could be forced into first gear while the engine was running, without using the clutch, and that this could be done with the power-take-off or PTO (that drives the mower) engaged. This opened up the possibility that Mr. Smith may have knocked the

Figures 17 & 18
Control positions relative to surrogate

tractor into gear from neutral, but that was not likely to happen while he was seated based on our surrogate evaluation. The force vector necessary to move the shift lever from neutral into first gear points towards the operator's mounting position. With this finding, and considering that mounting the tractor requires a complex sequence of body pull-up actions, that include bracing against the smooth fender with the right hand, we hypothesized a reasonable causation scenario.

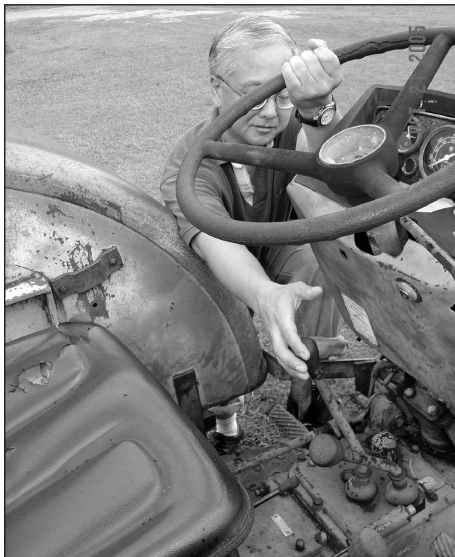
If Mr. Smith was mounting or dismounting the tractor, at a time while it was running in neutral with the mower blades turning, and he slipped or stumbled during that mounting or dismounting, he may have grabbed at the tractor to steady himself. In doing so, he may have grabbed at the nearby shift lever, which would have provided the right force vector to force it into first gear and run him over. See Figure 19.

Figure 19
Surrogate (standing on ground)
can pull tractor into first gear

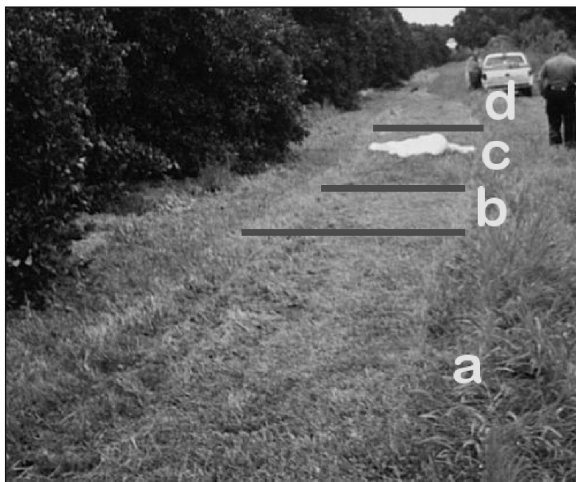
Figure 20

the front radiator grill provided one potential reason for him to dismount the tractor. We had earlier calculated that he had started that particular mowed trajectory about 23 seconds (at 5.6 mph) before the accident – we concluded that it was not likely enough time for him to have fallen asleep. At about the same time, incidental further study of one of the scene photos led to a poster-sized color photo enlargement and an observation that soundly buttressed the incident scenario of falling during mounting/dismounting. See Figure 20.

We observed that there were clearly four separate areas of mowed grass along the trajectory. As seen in Figure 20, in Zone A, the mowing had been occurring at about 3.2 blade cuts per foot of trajectory, leaving many blades uncut. As the rear wheel and mower went over the decedent, the mower rose up and left long grass in Zone C. In Zone D, the shading of the grass appears to show it is mowed “more” than Zone A. And in Zone B, the shading also shows it is mowed more than Zone A. The color photo enlargement shows clearly that the tractor/mower appeared to be stopped with the mower blades turning when the mower deck was over Zone B, completely cutting the grass in that area. This photographic evidence is consistent with Mr. Smith having been mowing at the normal 5.6 mph speed in Zone A, stopping (possibly to get a drink of water) in neutral with the mower cutting over Zone B, accidentally pulling the tractor into first gear (during mounting or dismounting) and getting run over in Zone C, and then the tractor/mower running slowly at 1.5 mph (in first gear) off into the trees in Zone D. This photographic evidence is not consistent with the plaintiff’s theory of Mr. Smith having suddenly fallen from the mower’s driver’s seat (due to an unknown ejection force or collapse) while mowing normally at 5.6 mph.

to show it is mowed “more” than Zone A. And in Zone B, the shading also shows it is mowed more than Zone A. The color photo enlargement shows clearly that the tractor/mower appeared to be stopped with the mower blades turning when the mower deck was over Zone B, completely cutting the grass in that area. This photographic evidence is consistent with Mr. Smith having been mowing at the normal 5.6 mph speed in Zone A, stopping (possibly to get a drink of water) in neutral with the mower cutting over Zone B, accidentally pulling the tractor into first gear (during mounting or dismounting) and getting run over in Zone C, and then the tractor/mower running slowly at 1.5 mph (in first gear) off into the trees in Zone D. This photographic evidence is not consistent with the plaintiff’s theory of Mr. Smith having suddenly fallen from the mower’s driver’s seat (due to an unknown ejection force or collapse) while mowing normally at 5.6 mph.
